Re: Report of Discharge from Sanitary Sewer at the University of Maryland

University of Maryland Photo Log
9/03/2019 – Sewage Overflow at South Campus Dining Hall

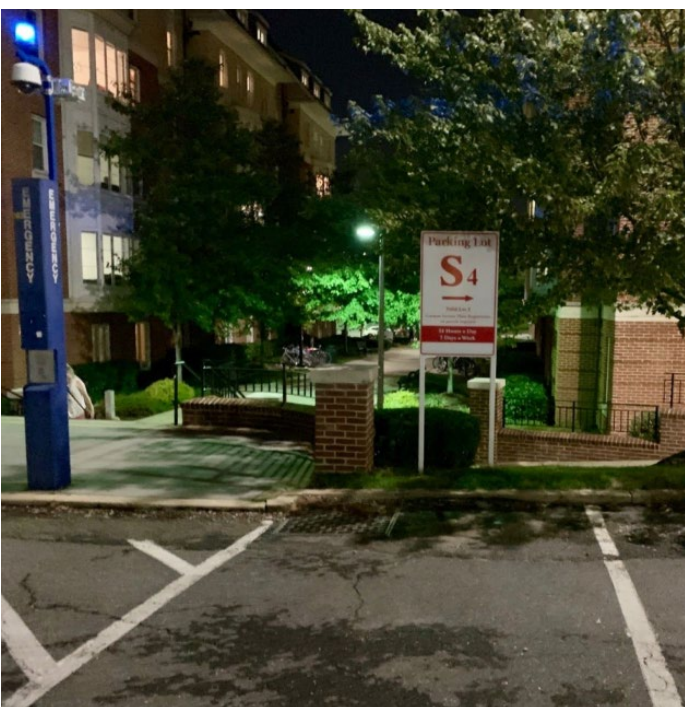
Impact on waters of the State: Approximately 400 gallons entered the stormwater system via two inlets in the loading dock area of the South Campus Dining Hall. Approximately half of the discharge evaporated before entering the storm system. The impacted inlets are connected to Outfall 012, which discharges to Guilford Run.

Bottom Left: One (1) of the two (2) stormwater inlets affected. Most of the standing water in the parking lot evaporated before entering the storm system.

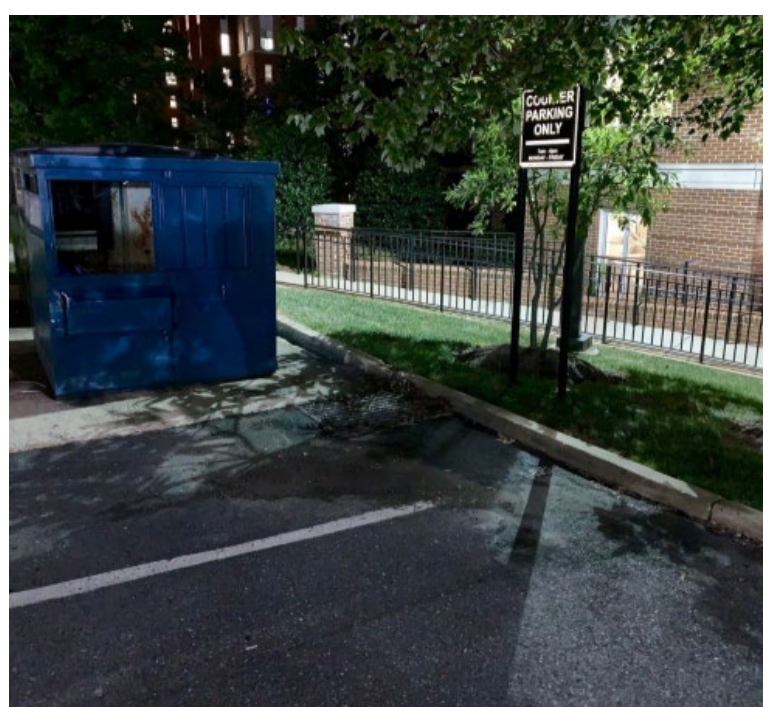
Bottom Right: Two (2) of the two (2) stormwater inlets affected. Most of the standing water in the parking lot evaporated before entering the storm system.
