University of Maryland, College Park
National Pollutant Discharge Elimination
System MS4 Phase II
FY2021 Annual Report
General Discharge Permit #13-SF-5501

Task 2: Findings and Recommendations Report

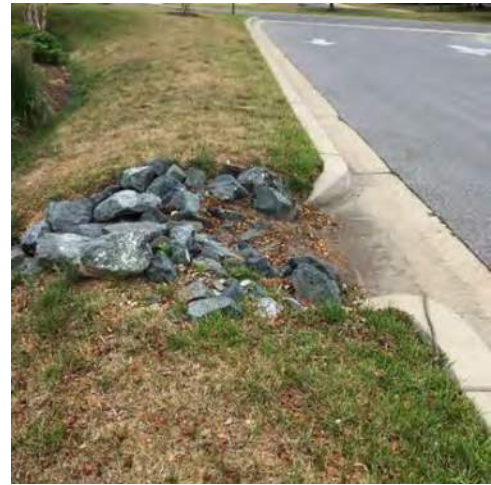
The facility is a micro-bioretentation constructed for new development, therefore providing treatment toward the baseline. MES completed inspection of the facility in June 2021. Overall, the micro-bioretentation was in good condition but requires minor maintenance. The grading at the inflow is suspected to be causing accumulation prior to water entering the facility. Minor erosion and exposed matting were also observed at the inflow. Minor erosion was present on the north edge of the basin. Leafy debris was observed within the control structure.

MES recommends regrading the inflow to ensure proper flow into facility. Debris should be removed from within inflow riprap and minor erosion should be repaired. Leafy debris should be removed from within the control structure.

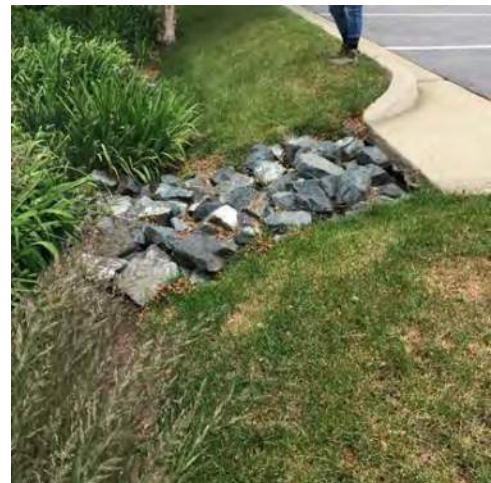
The facility is a micro-bioretentation constructed for new development, therefore providing treatment toward the baseline. MES completed inspection of the facility in June 2021. Overall, the micro-bioretentation was in good condition but requires minor maintenance. Minor erosion and exposed matting were observed at the inflow and at the control structure. Additionally, minor debris was observed within the inflow riprap.

MES recommends removing debris from within the inflow riprap. Minor erosion at the inflow and at the control structure should be repaired.

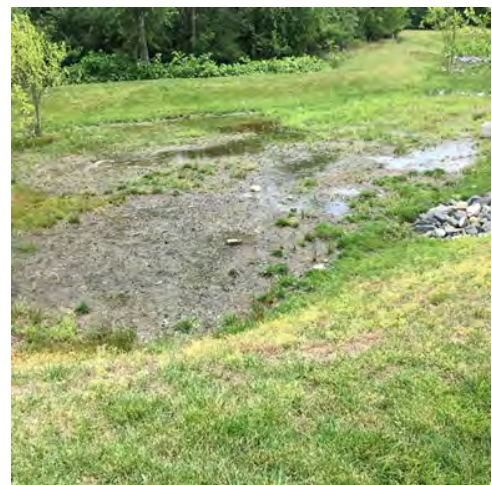
The facility is a submerged gravel wetland (SGW) constructed for new development, therefore providing treatment toward the baseline. MES completed inspection of the facility in June 2021. Overall, the SGW was in good condition but requires minor maintenance. Minor erosion and debris were observed at the north forebay inflow. Minor erosion was also observed on the upstream embankments. Additionally, minor ponding and muck were present within both forebays.

MES recommends repairing erosion at the north forebay inflow and on the embankment. Vegetation should be removed from the inflows. Additionally, the forebay bottoms should be seeded for stabilization and to prevent muck development.

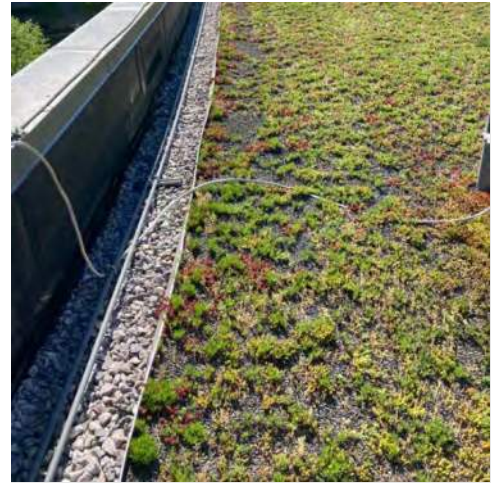
UMCP20BMP0273 NOAA Green Roof 1

The facility is a green roof constructed for new development, therefore providing treatment toward the baseline. MES completed inspection of the facility in May 2021. Overall, the green roof was in good condition but requires minor maintenance. Minor bare areas were observed within the green roof. MES recommends establishing vegetation within these areas to ensure full water quality treatment is provided.

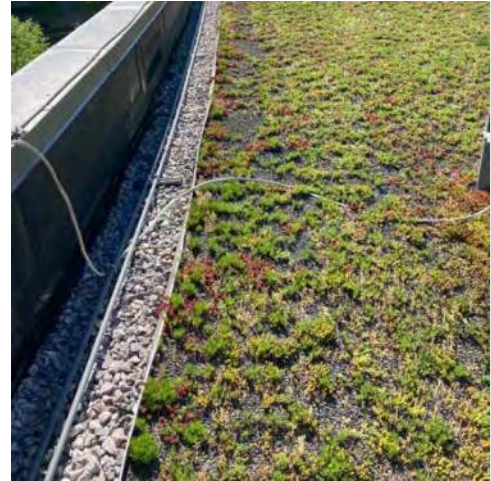
The facility is a green roof constructed for new development, therefore providing treatment toward the baseline. MES completed inspection of the facility in May 2021. Overall, the green roof was in good condition but requires minor maintenance. Several areas were observed to have minimal to no vegetation growth. MES recommends establishing vegetation within these bare areas to ensure full water quality treatment is provided.

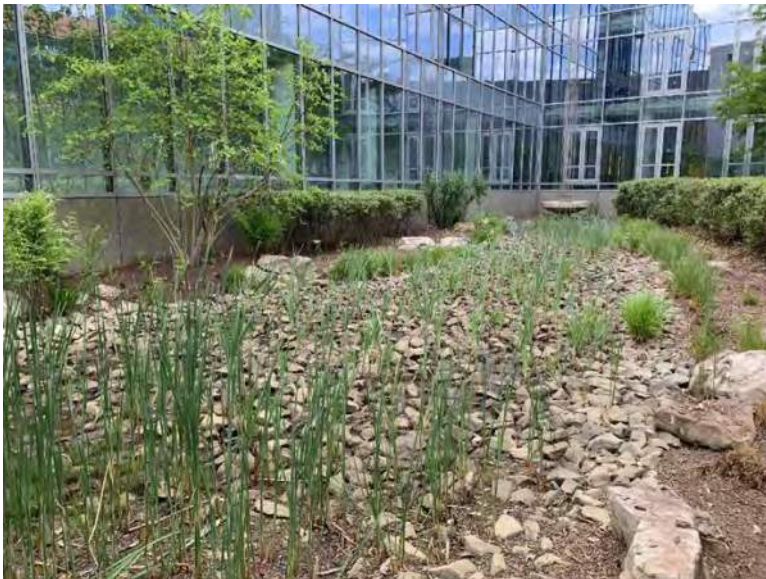
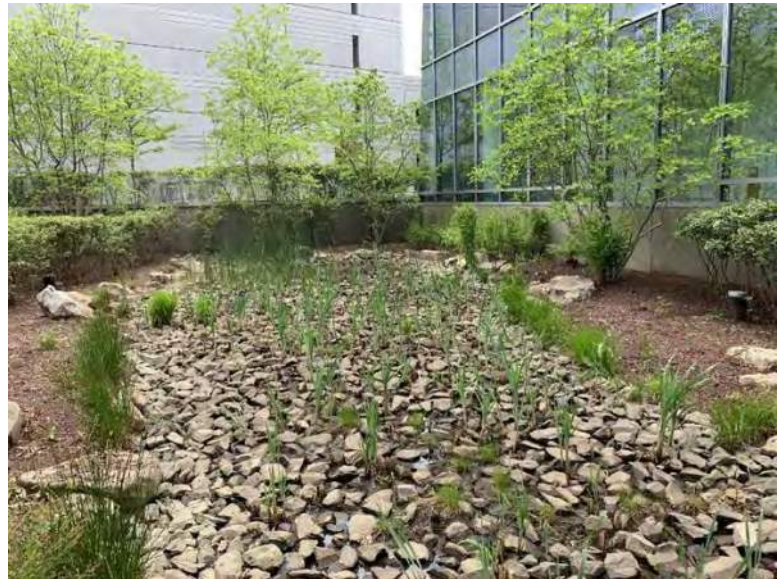
- **BMP Access** – Poor
- **Access Comment** – Glass barrier surrounding BMP.
- **Debris & Sediment** - Fair
- **Vegetation** – Good
- **BMP Contamination** - Good
- **General Site Conditions Comments:** Excess sediment and debris in rip rap area of basin
- **Other Repair Comments:** Rip rap area holding water
- **Inflow Condition** - Good
- **Inflow Comments:**
- **Forebay** – N/A
- **Conveyance Stability** - Good
- **Downstream Condition** – Good
- **Downstream Condition Comments:** Small area of erosion above outfall end wall

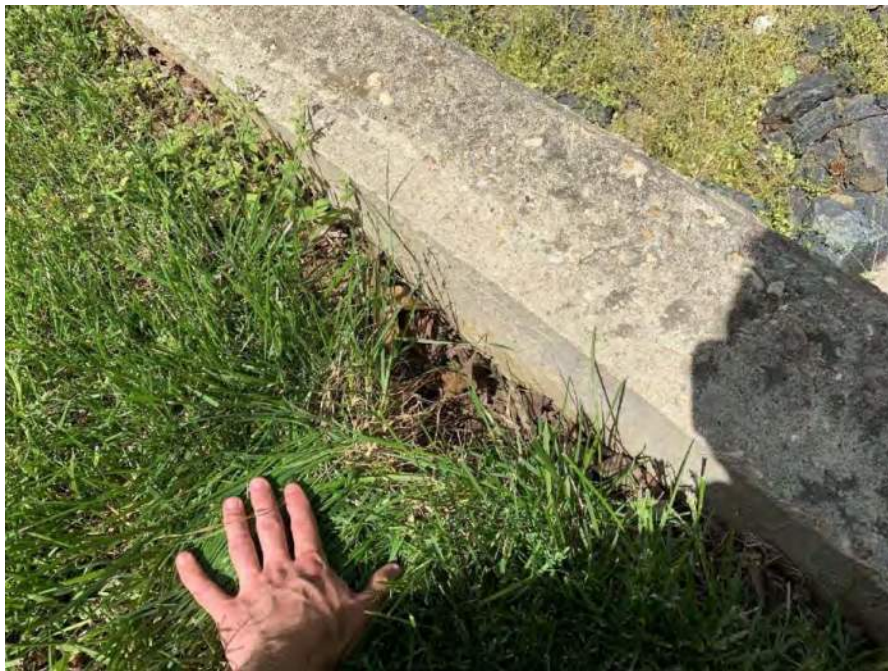
Erosion Outfall Endwall

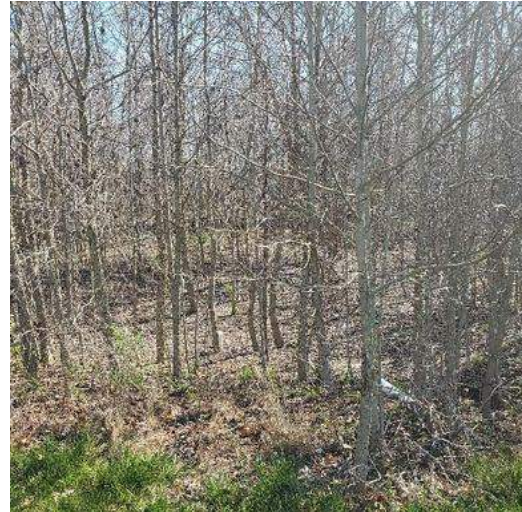
The BMP, shown in Figure 1, is a micro-bioretenention facility that receives runoff from 0.27 acres of impervious within a 0.54-acre drainage area. The micro-bioretenention is located to the east of the Laboratory for Telecommunication Sciences parking lot, and MES accessed the facility from this lot. Stormwater enters the facility through a 4" PVC drain flowing from the direction of the parking area to the southeast of the micro-bioretenention. There is no control structure, but there is an earthen embankment and an underdrain that outfalls at the northeast section of the facility and daylights near the Waters of the US a couple hundred feet northeast of the facility. Upon inspection, the facility was determined to be failing and requires major maintenance.

Figure 1. Overall view of Micro-bioretenention

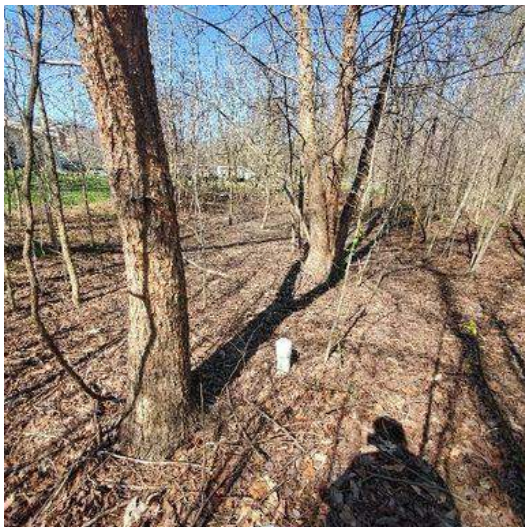
Several feet of ponding was observed in the cleanout, shown in Figure 2, most likely due to a clog in the underdrain or clogged filter media. Due to construction in the area, MES was unable to access the

Figure 2. Micro-bioretenention Treatment Area and Cleanout

downstream channel to inspect the underdrain and downstream condition, to verify if there is an issue there contributing to the ponding. The downstream channel and pipe outfall should be investigated further to determine their condition. Also potentially contributing to the ponding is the overgrown woody vegetation throughout the basin, shown in Figure 1 and 2. In addition to the overgrown woody vegetation in the basin, the embankments surrounding the facility also have excessive woody vegetation,

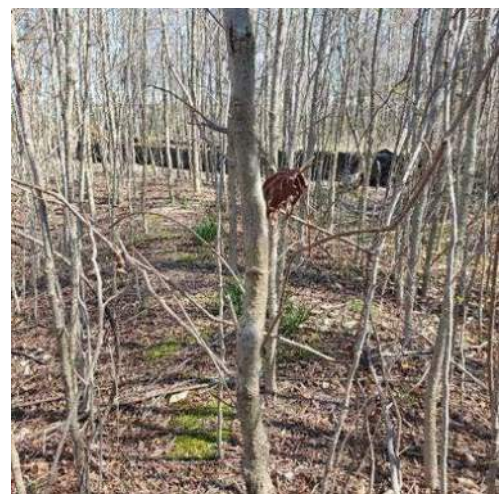
Figure 3. Tree Growth on Embankment

shown in Figure 3, which should be removed.

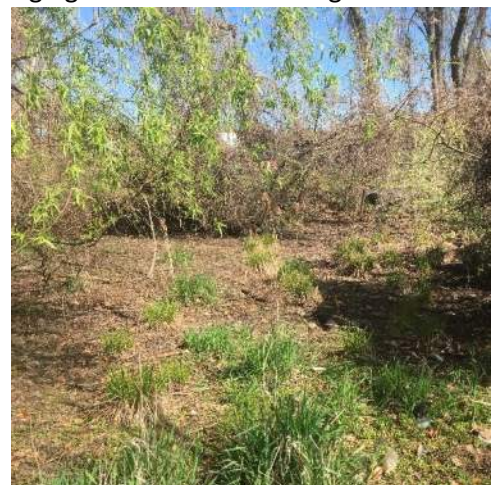
Figure 4. Pond basin
