University of Maryland, College Park  
National Pollutant Discharge Elimination  
System MS4 Phase II  
FY2023 Annual Report  
General Discharge Permit #13-SF-5501

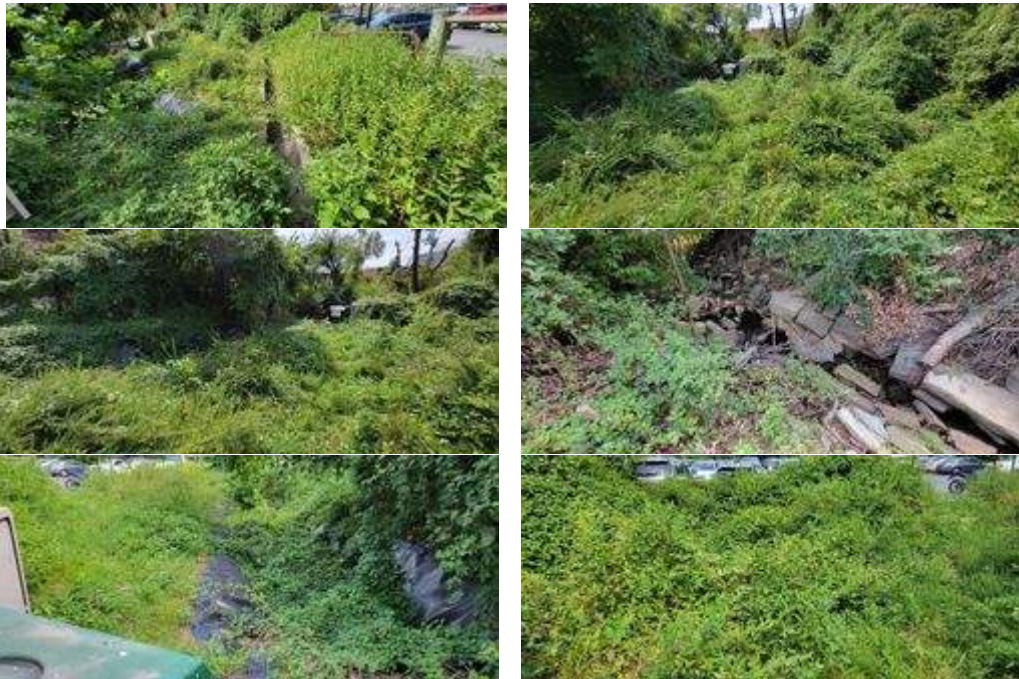
- **BMP Access** - Fair
- **Debris & Sediment** - Good
- **Vegetation** - Fair
- **BMP Contamination** - Good
- **General Site Conditions Comments:** Access is a bit overgrown. BMP is completely overgrown and taken over by invasive, with some native volunteer plants present

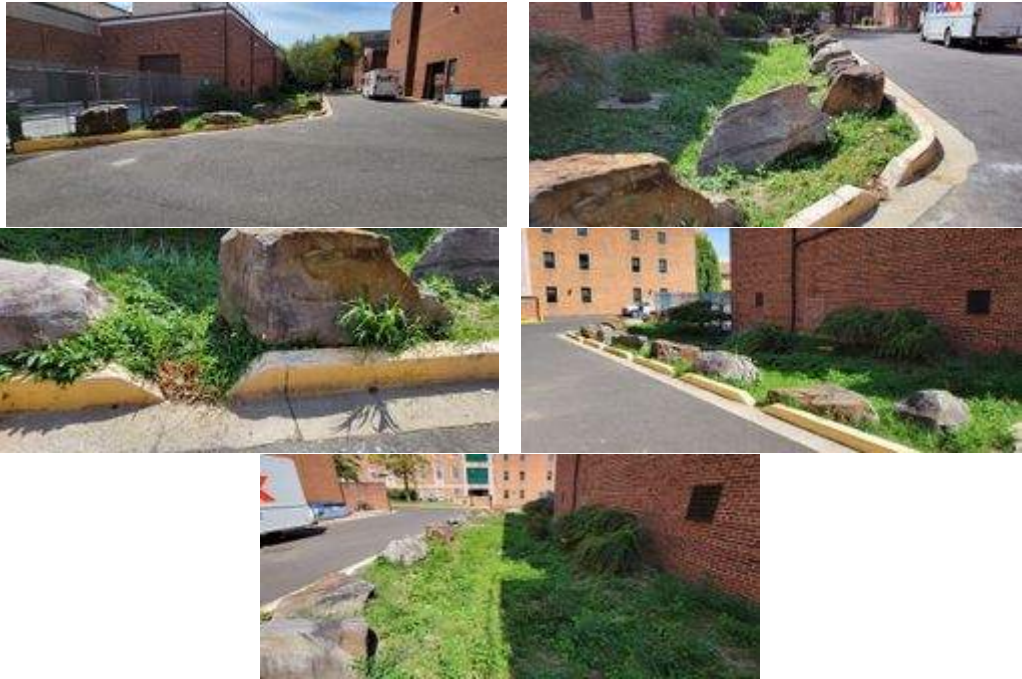
- **BMP Access** - Good
- **Debris & Sediment** - Good
- **Vegetation** - Fair
- **BMP Contamination** - Fair
- **General Site Conditions Comments:** There is vegetative coverage, but mostly invasive and undesirable weeds. Some curb cuts are partly blocked by weeds and debris. One Boulder has moved and needs to be repositioned.

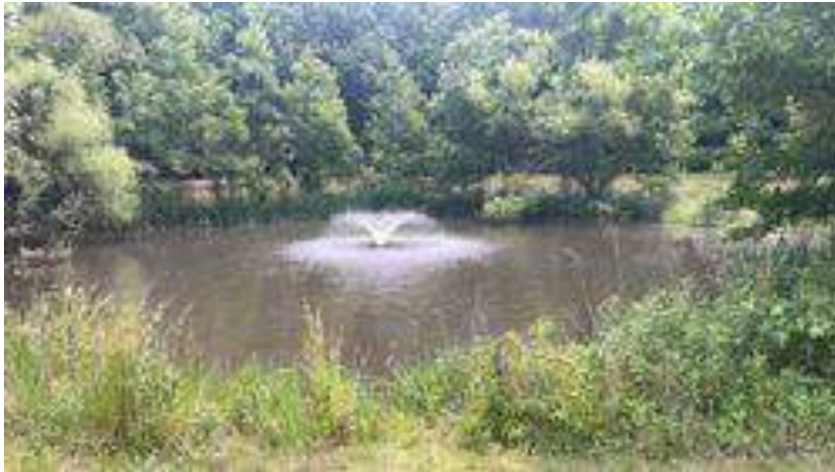
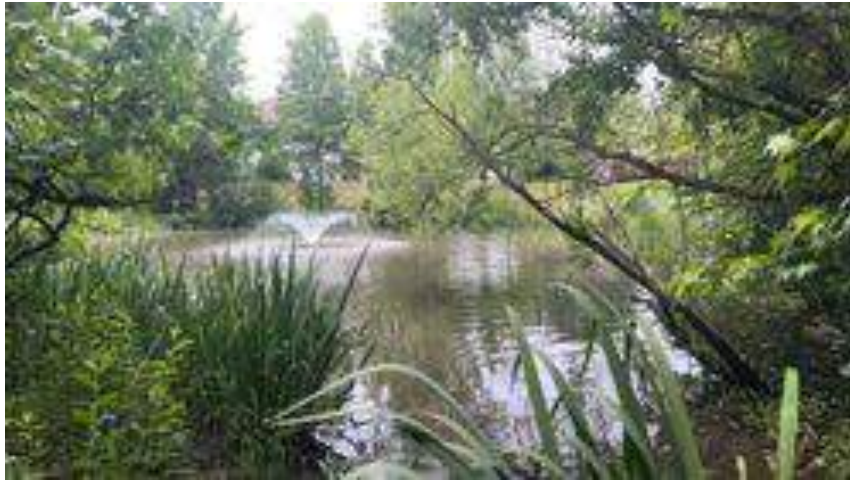
**Overall Photos**

- **BMP Access** - Good
- **Debris & Sediment** - Good
- **Vegetation** - Fair
- **BMP Contamination** - Good
- **General Site Conditions Comments:** Some overgrowth of vegetation as well unplanned vegetation.

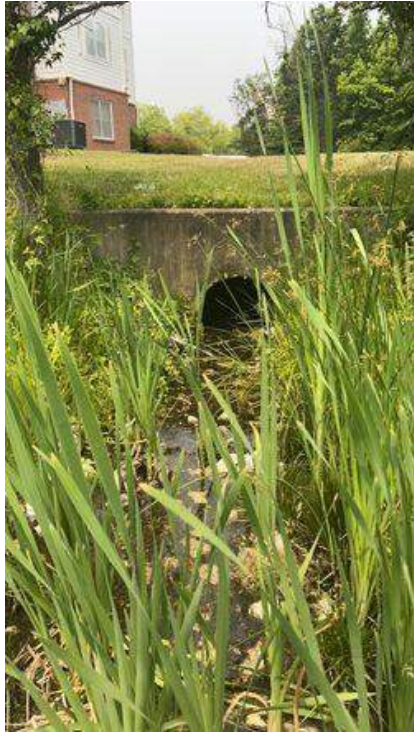
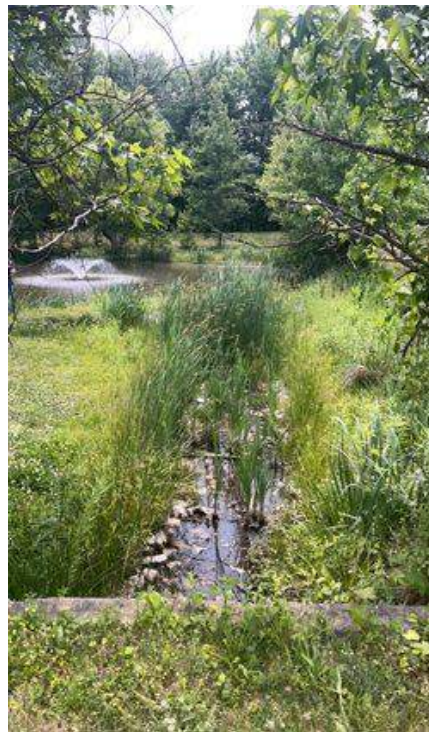
**NW Inflow Condition**

- **Inflow Condition** – Poor
- **Inflow Comments** - NW inlet has woody vegetation growth in front of end wall as well as invasive vegetation in riprap, and water standing at inflow has a sheen. SW inflow has minor vegetation growth, and moderate sedimentation.
  - **Other Repair Items** - Remove vegetation and sedimentation at inflows and refill riprap where needed.
- **Forebay** – Fair
  - **Other Repair Items** - Invasive vegetation growth in NW forebay. Sedimentation in SW forebay. Displaced riprap from inflows into forebays leading to minor conveyance instability in forebays.

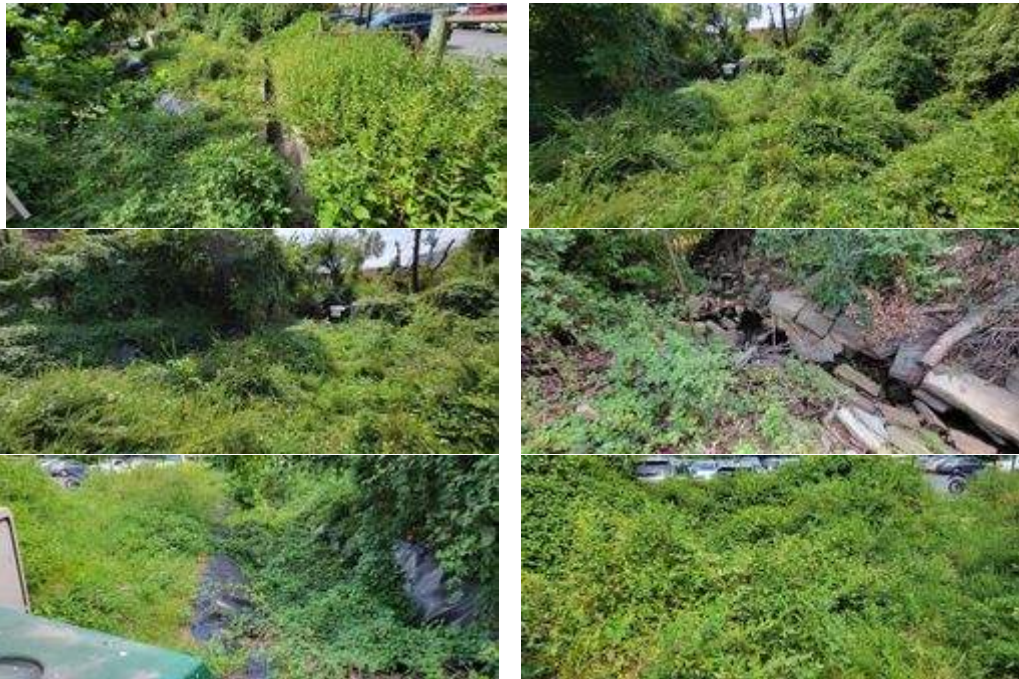
- **BMP Access** - Fair
- **Debris & Sediment** - Good
- **Vegetation** - Fair
- **BMP Contamination** - Good
- **General Site Conditions Comments:** Access is a bit overgrown. BMP is completely overgrown and taken over by invasive, with some native volunteer plants present

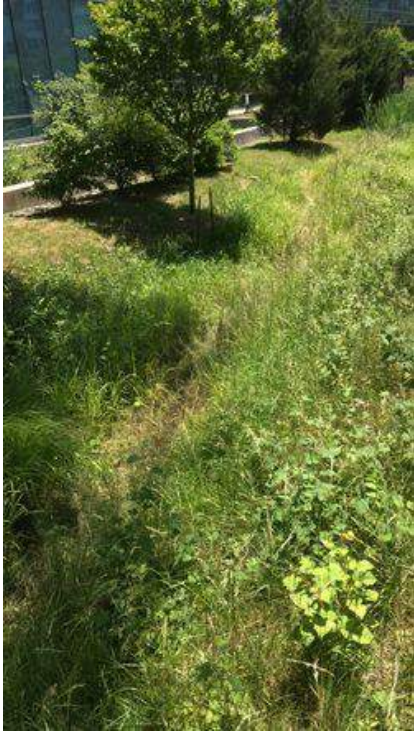
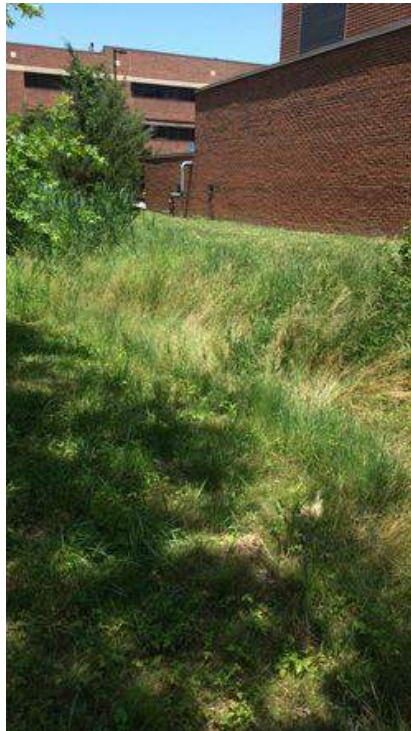
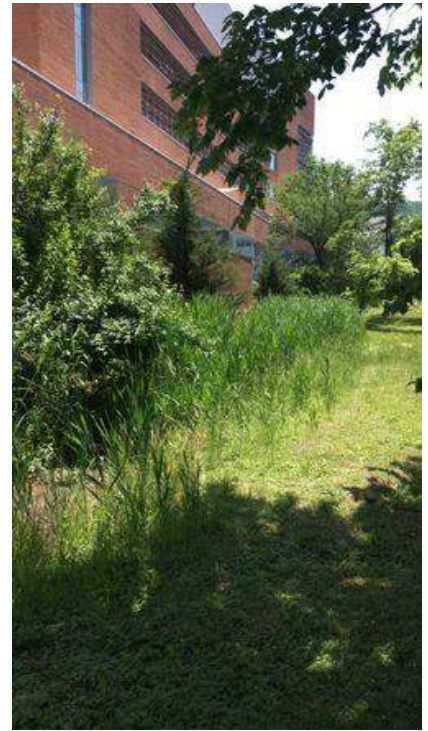
Overall Site Condition

- **BMP Access** - Fair
- **Debris & Sediment** - Poor
- **Vegetation** - Fair
- **BMP Contamination** - Good
- **General Site Conditions Comments:** Excessive sediment near outfall

**Maintenance & Remediation Recommendations** – Trim vegetation. Remove excess sediment from outfall. Repair erosion around outlet culvert and repair damage concrete as needed.

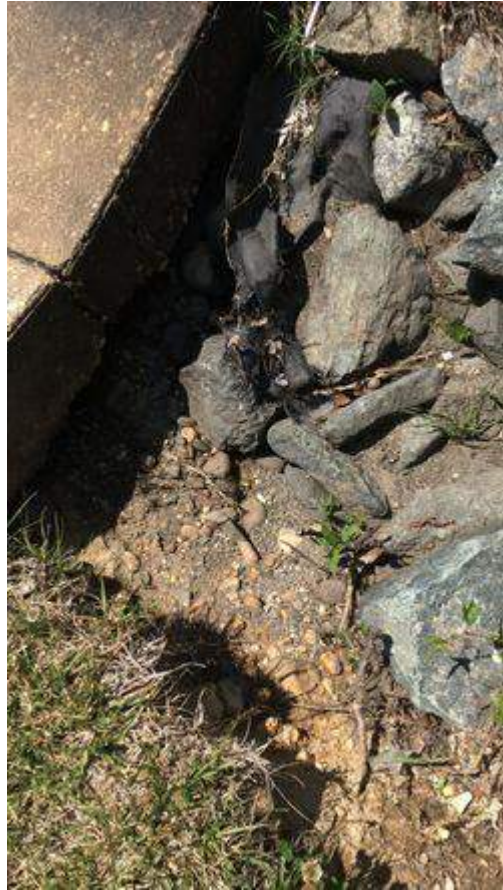
Erosion around culvert. Potential damage

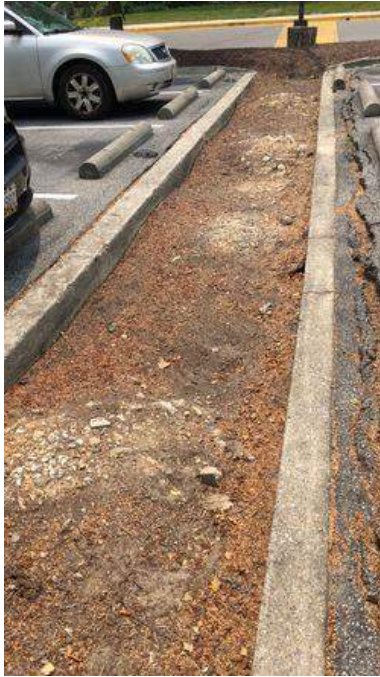
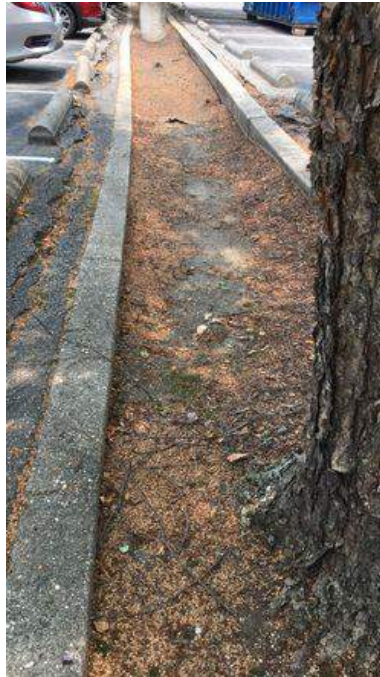
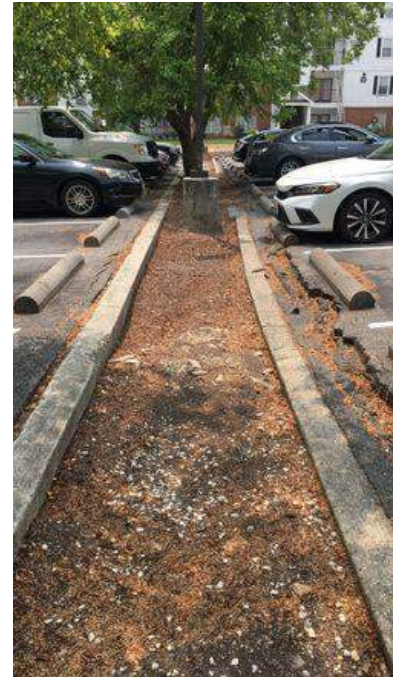
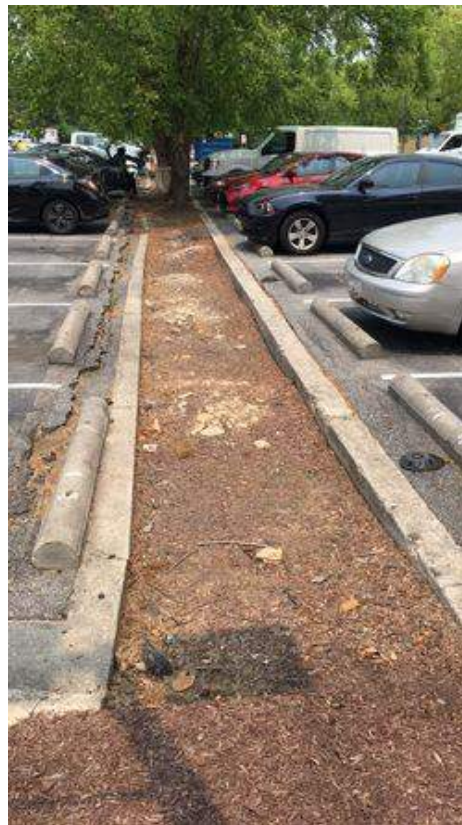
**Bare patches of medium and sedimentation:**

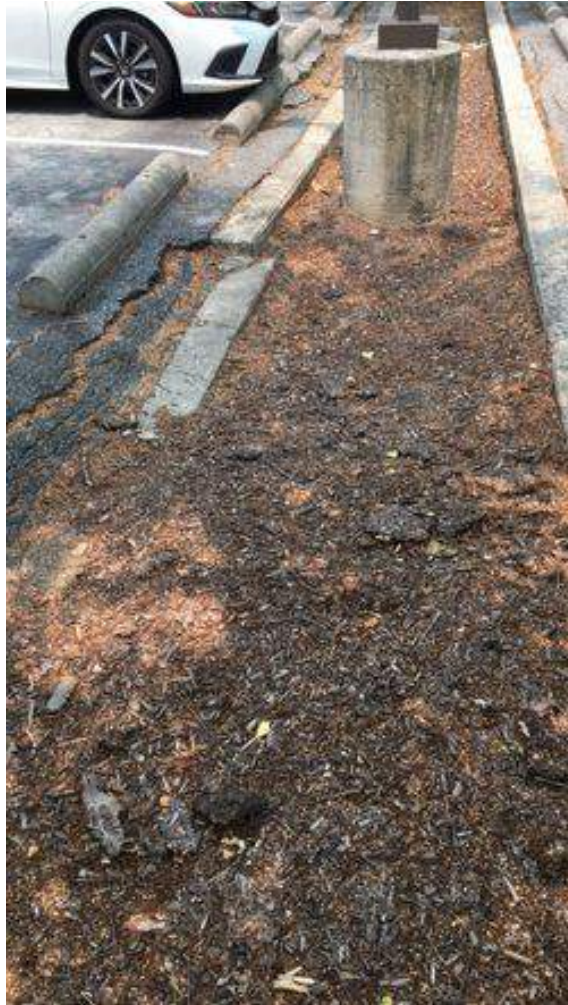
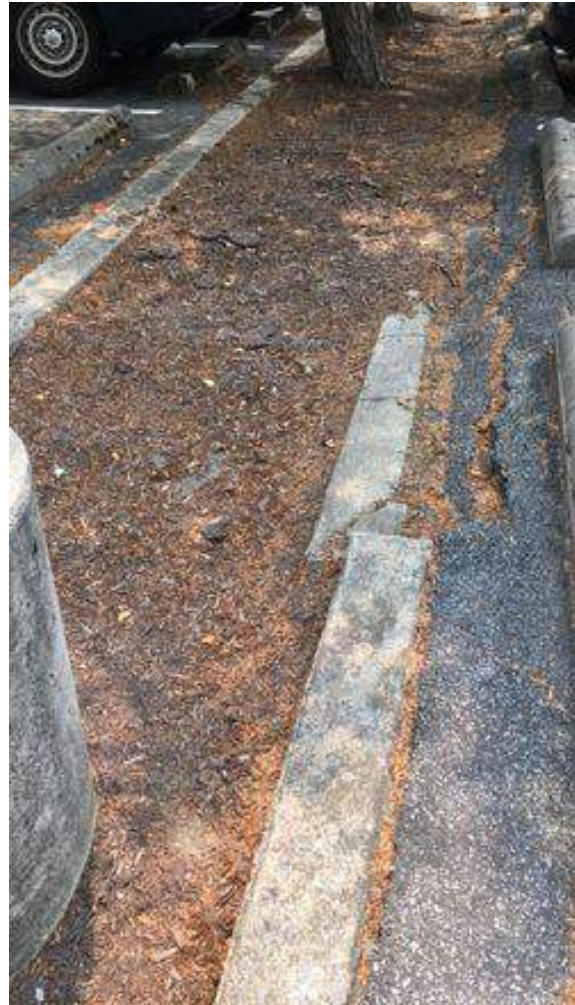
**Structure failure:**

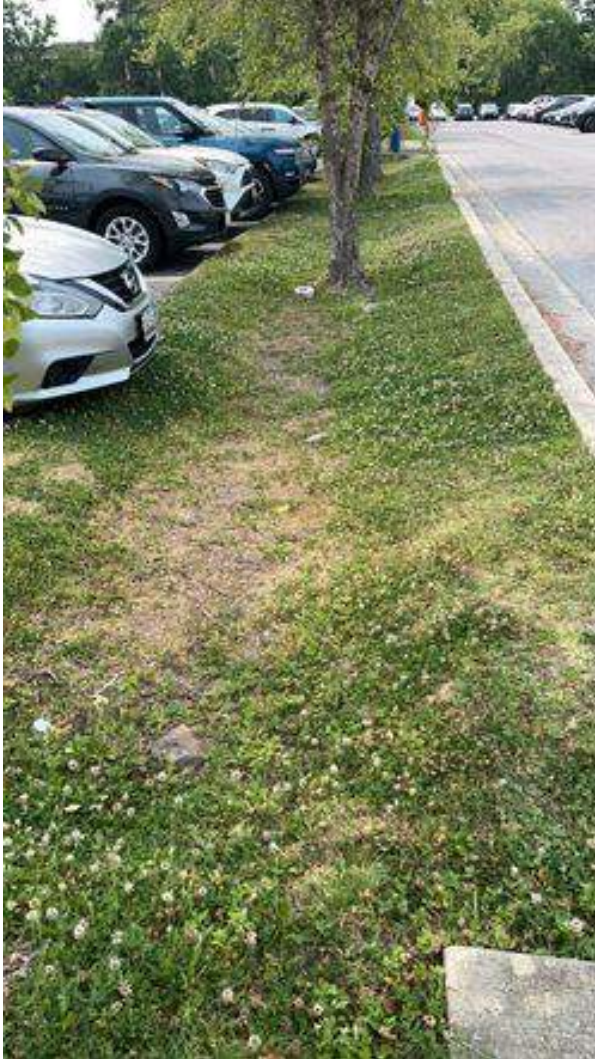
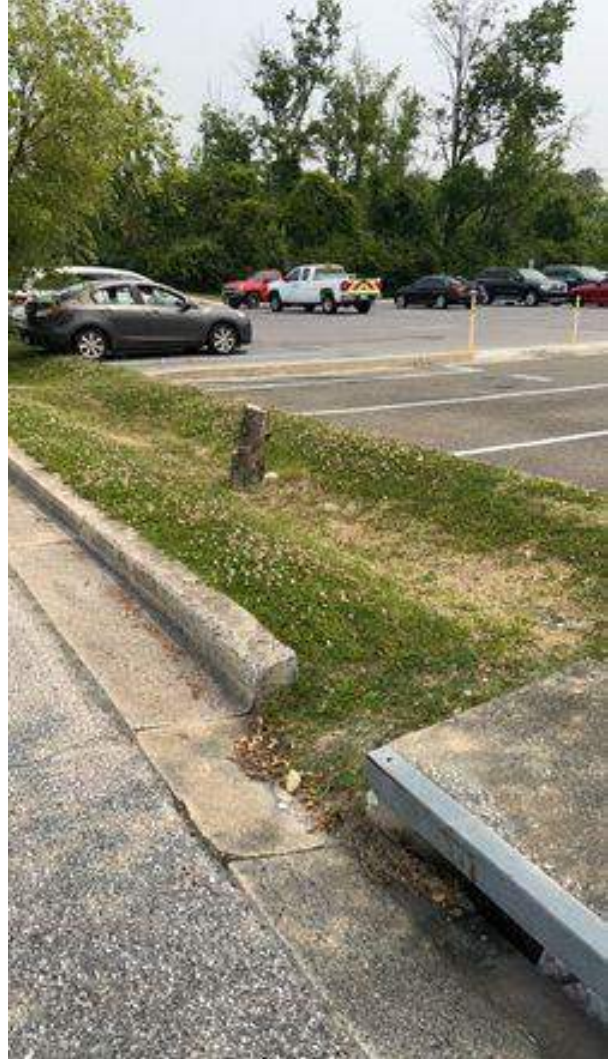
**Bare spots in conveyance basin**

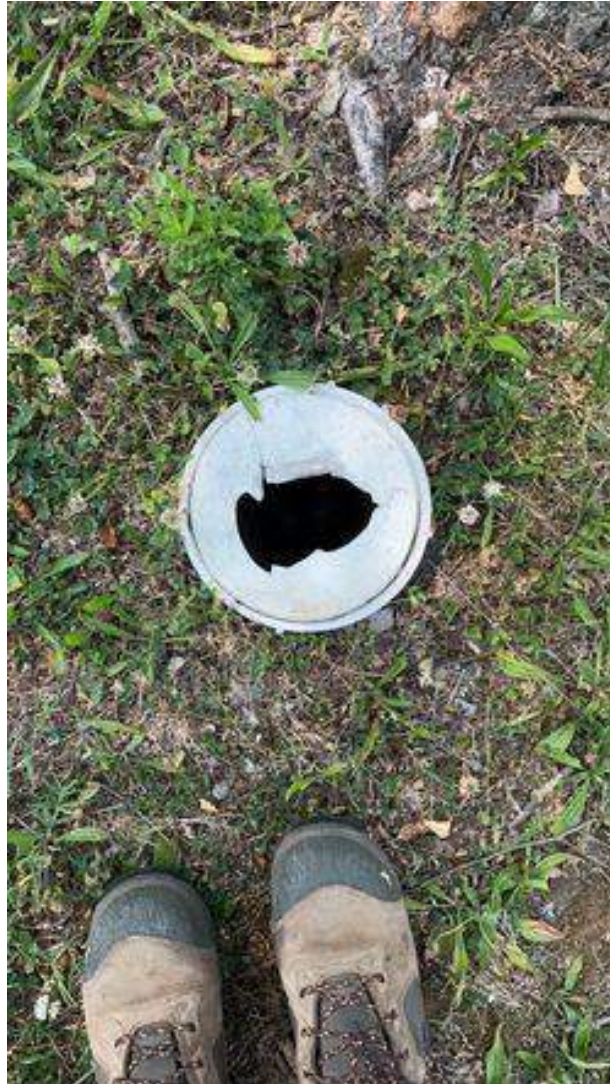
**Broken Cleanout:**

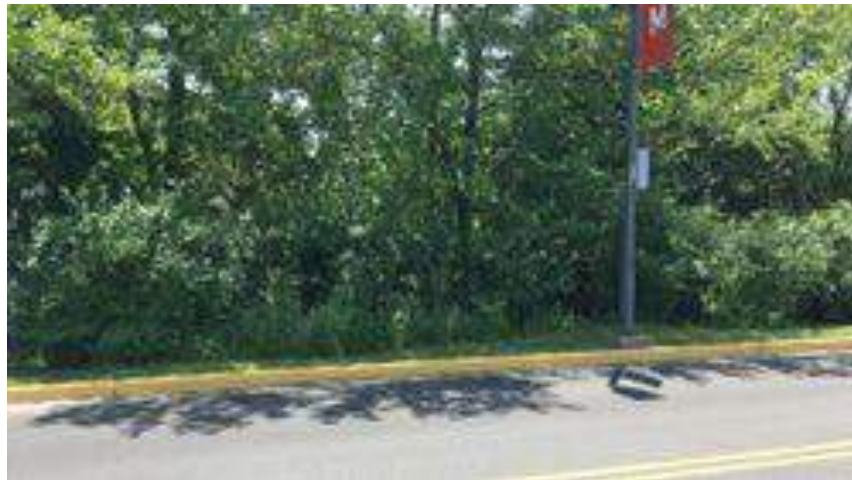
Overall Photo Showing Overgrown Vegetation

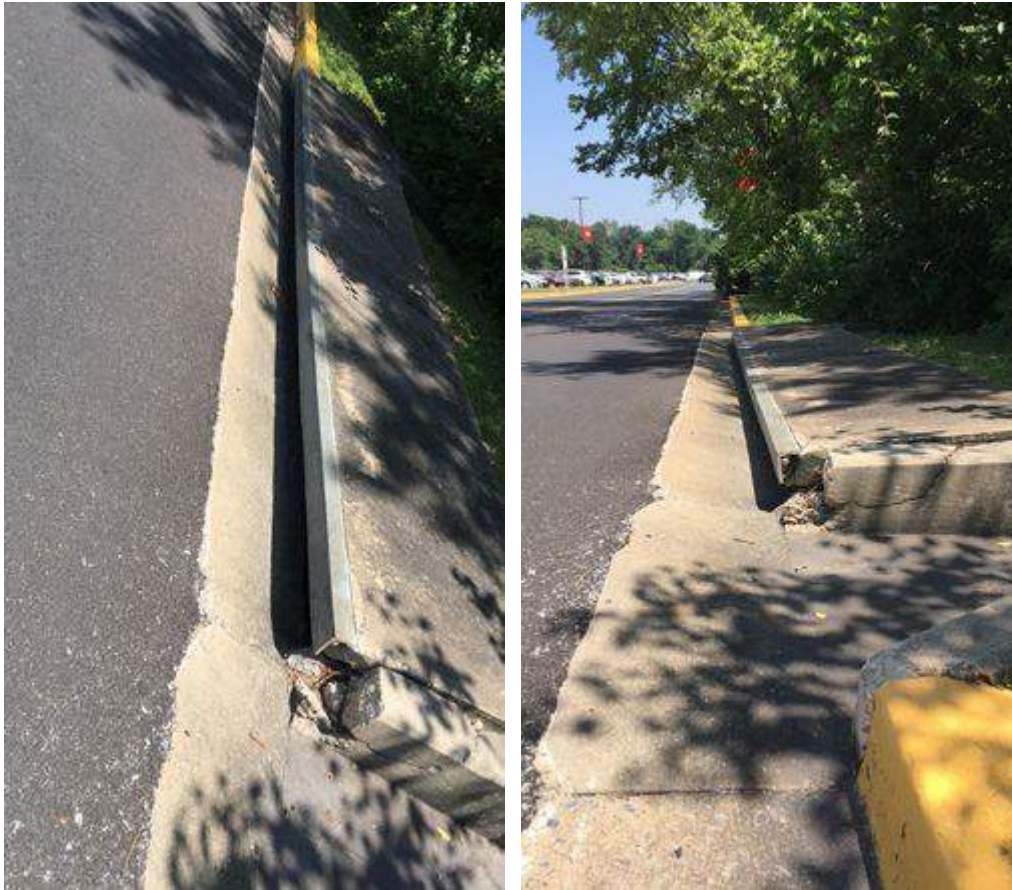
Inflow Condition Showing Damaged Curb

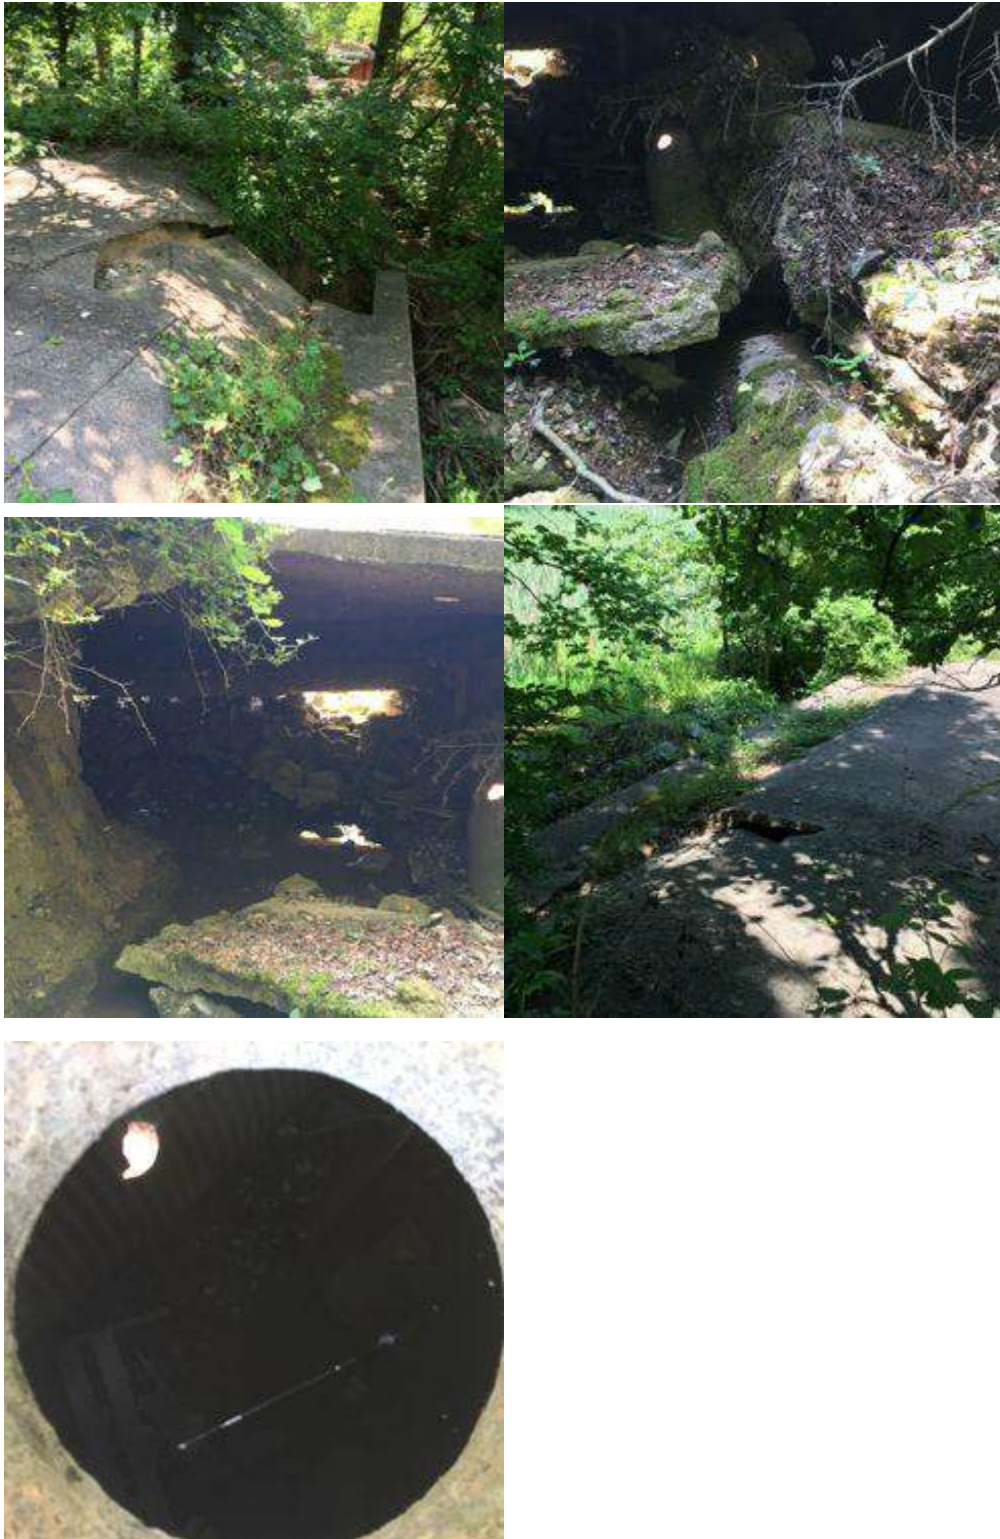
**Failing Control Structure:**

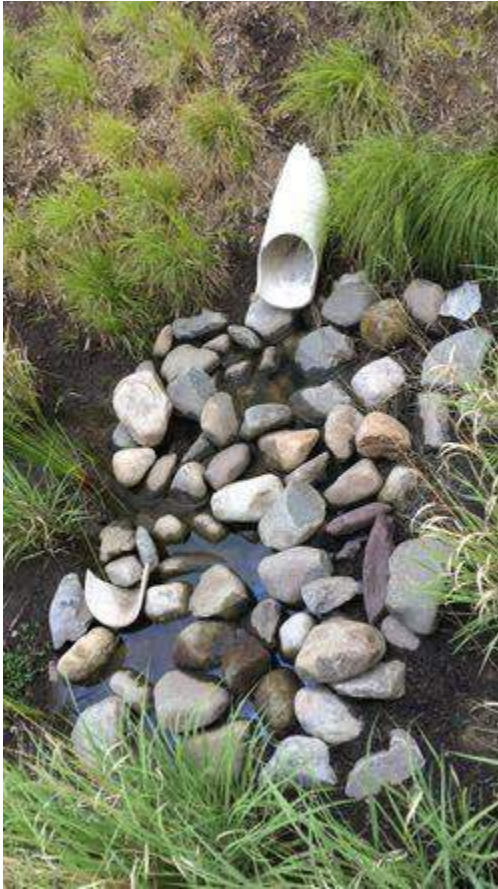
Broken Inflow:

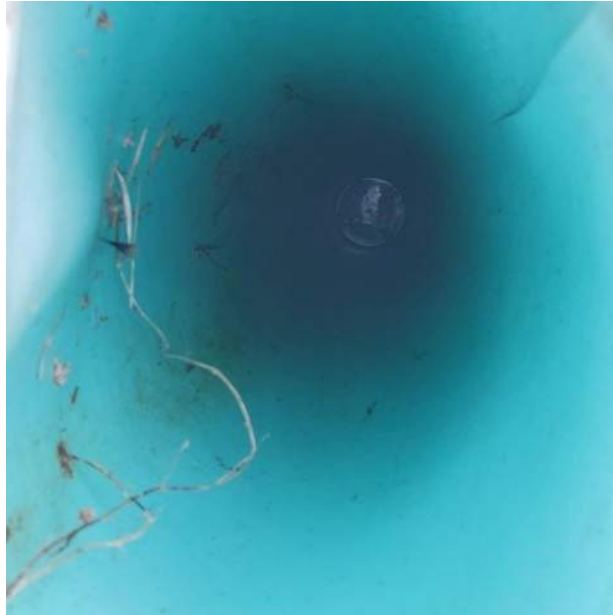
Cleanout 1 – Standing water

Mitigate ponding, replace damaged cleanout, remove trash above downstream cleanout
