University of Maryland, College Park  
National Pollutant Discharge Elimination  
System MS4 Phase II  
FY2024 Annual Report  
General Discharge Permit #13-SF-5501

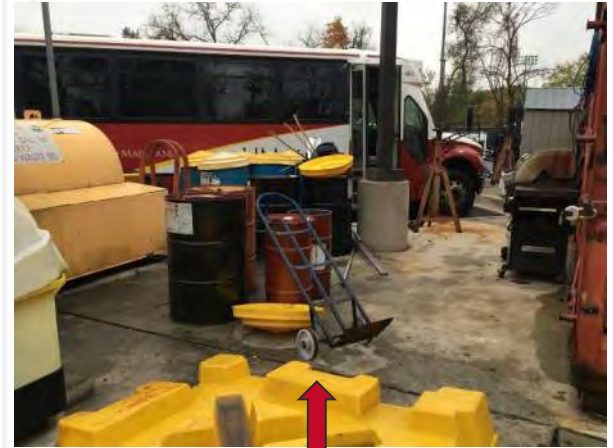
Severely rusted and pitting occurring

Poor housekeeping, not in containment, exposed, rusting.

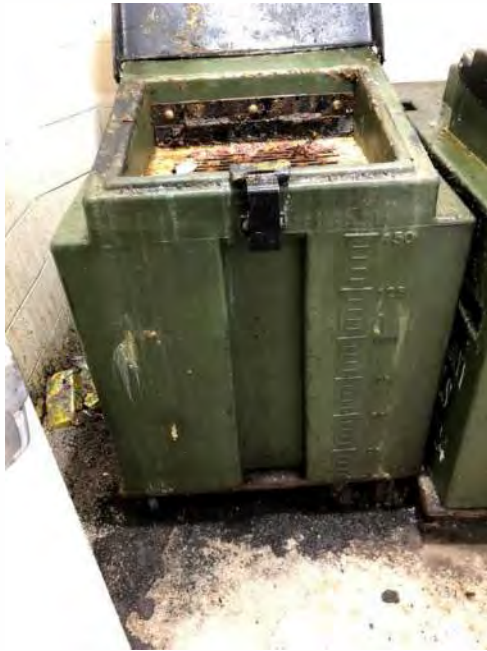
Spillage and absorbent around tank, no signage.

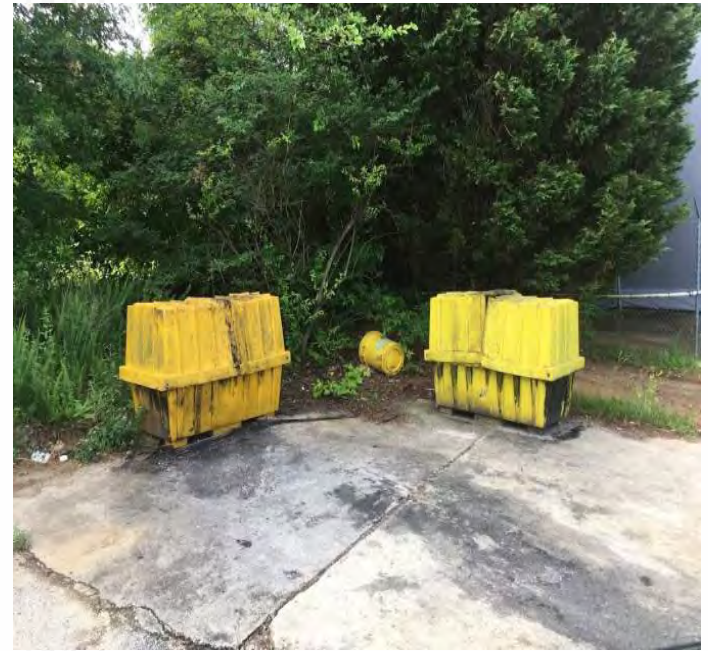
Containments are stained and have grease on the exterior, they are located in close proximity to the grassy areas, no spill kits.

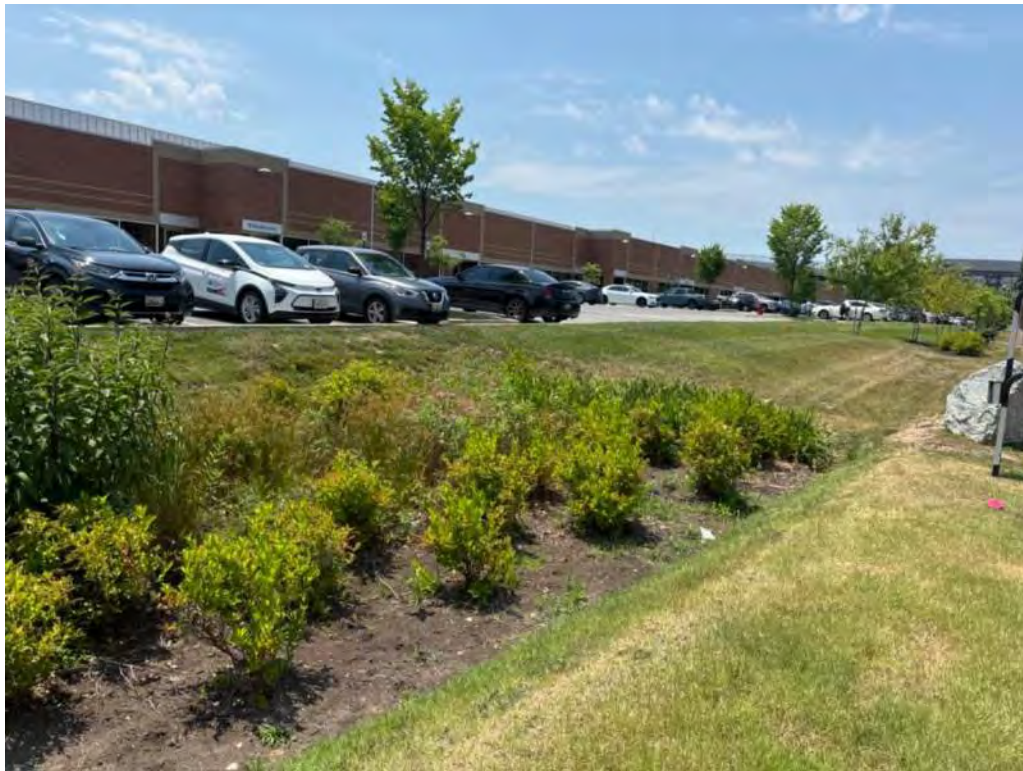
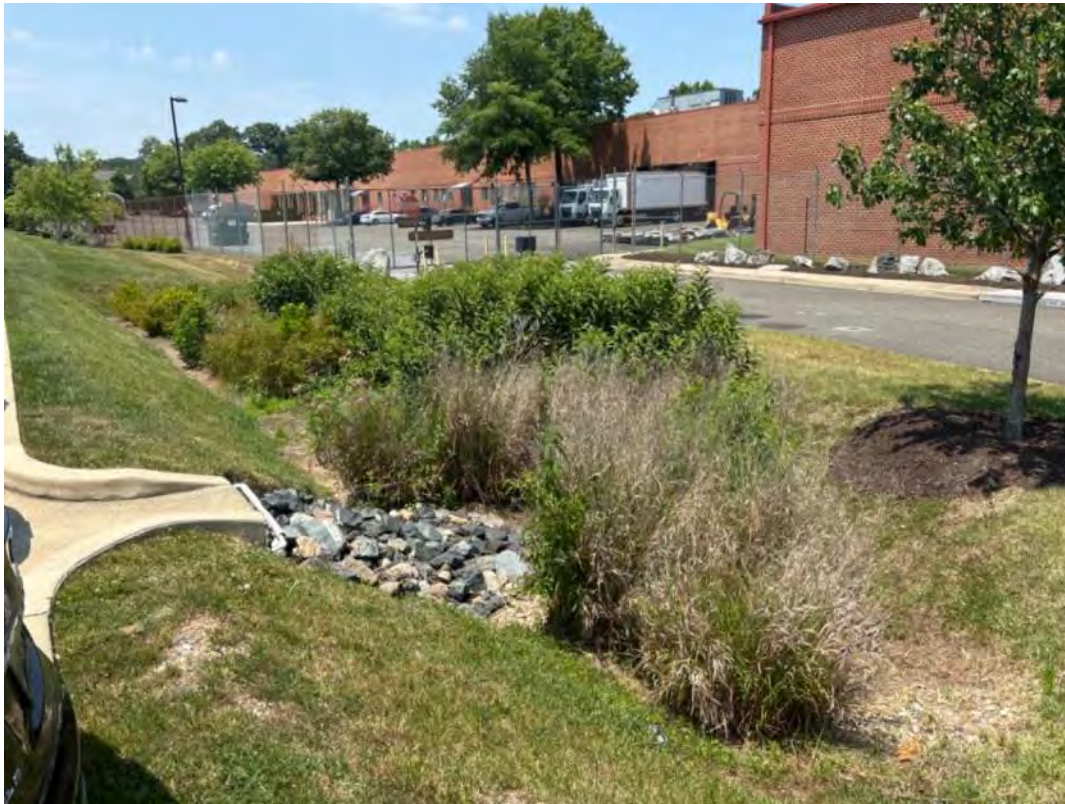
- **BMP Access** - Good
- **Debris & Sediment** - Good
- **Vegetation** - Good
- **BMP Contamination** - Good
- **General Site Conditions Comments:** vegetation needs trimming around control structure

Minor maintenance. Repair erosion around inflow

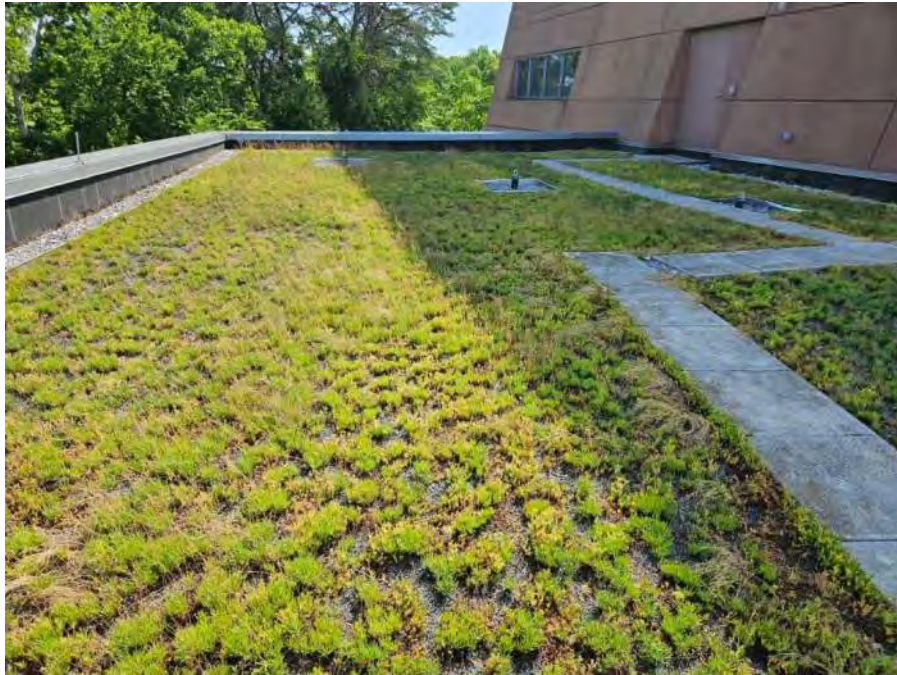
Overall in good condition. Replant bare areas.
