University of Maryland, College Park
National Pollutant Discharge Elimination
System MS4 Phase II
FY2025 Annual Report
General Discharge Permit #13-SF-5501

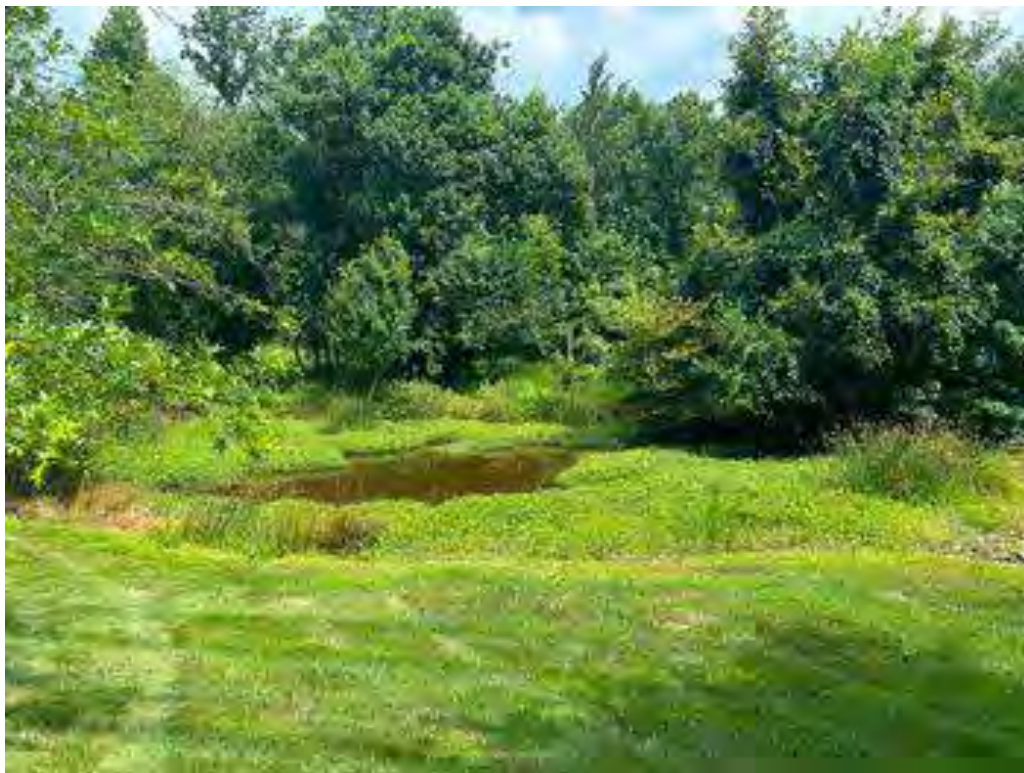
Overall Photo

Date of Inspection:	July 25, 2025 11:38 AM	Inspector Initials:	SK,SF
BMP ID:	UMCP19BMP0002	Inspection Firm:	MES
BMP Type:	Retention Pond (Wet Pond)	Underground BMP?	No
BMP Status	Pass	Overall Inspection Comment:	Minor sedimentation in forebay
Maintenance Level	Minor Maintenance (Use of Hand Equipment for Repairs)

- **BMP Access** - Good
- **Debris & Sediment** - Fair
- **Vegetation** - Good
- **BMP Contamination** - Good
- **General Site Conditions Comments:** Sedimentation in forebay

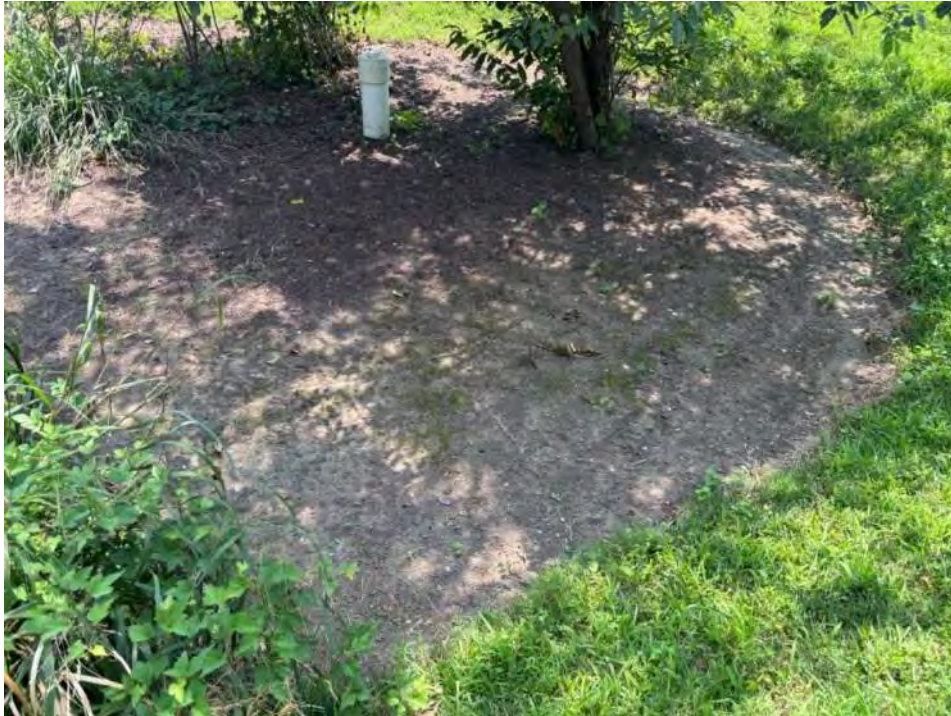
- **BMP Access** - Good
- **Debris & Sediment** - Fair
- **Vegetation** - Fair
- **BMP Contamination** - Good
- **General Site Conditions Comments:** Minor trash and debris in treatment area, some of planted bushes are dead

Treatment basin

Replace dead bushes in treatment area, re-mulch eroded parts of treatment area, clear out trash and debris

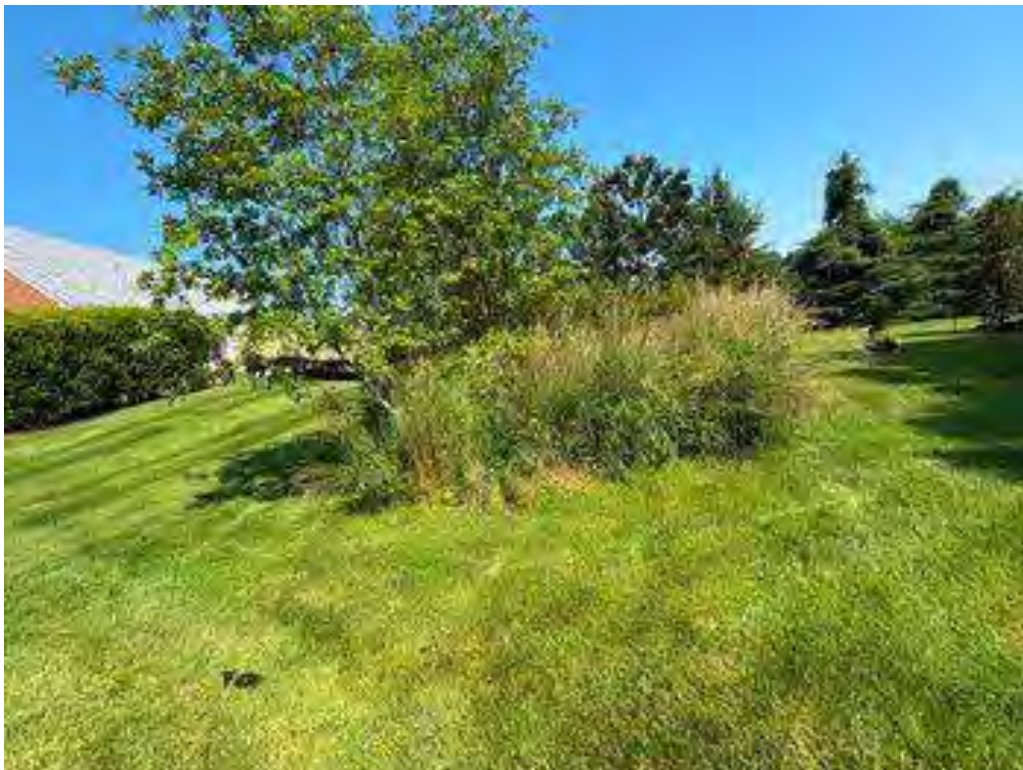
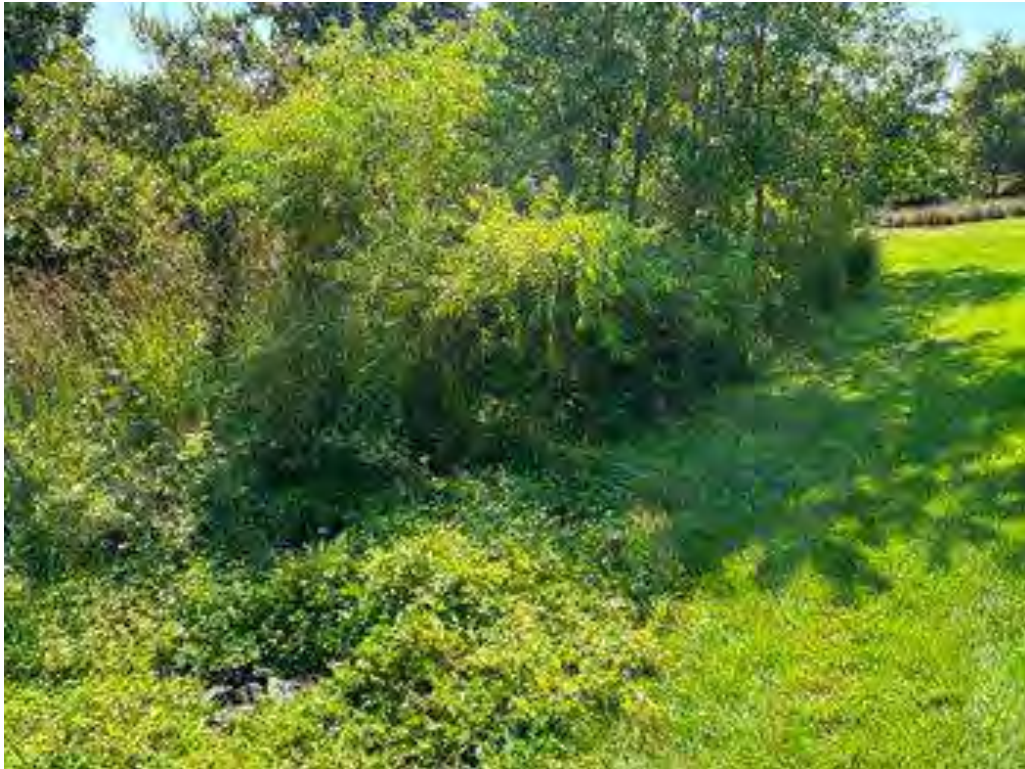
Overall Photo

Date of Inspection:	July 25, 2025 10:00 AM	Inspector Initials:	SM
BMP ID:	UMCP19BMP0033	Inspection Firm:	MES
BMP Type:	Micro-Bioretenion	Underground BMP?	No
BMP Status	Pass	Overall Inspection Comment:	Overgrown with grassy vegetation, rip rap overgrown
Maintenance Level	Minor Maintenance

- **BMP Access** - Good
- **Debris & Sediment** - Good
- **Vegetation** - Fair
- **BMP Contamination** - Good
- **General Site Conditions Comments:** Slightly overgrown with grassy vegetation

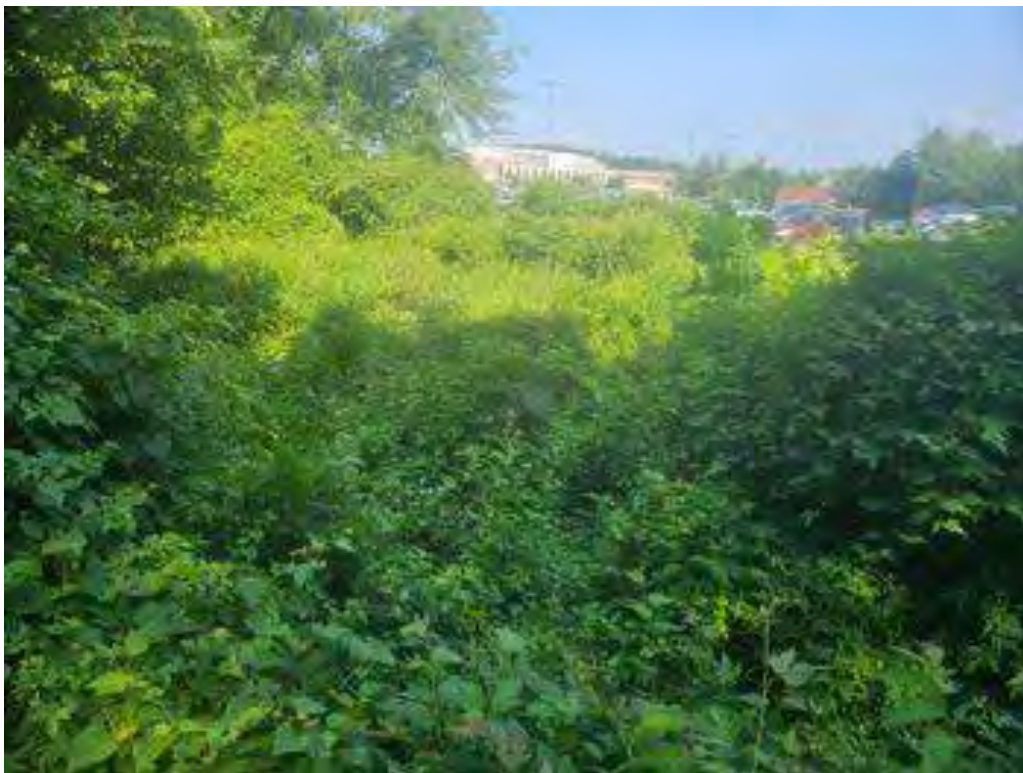
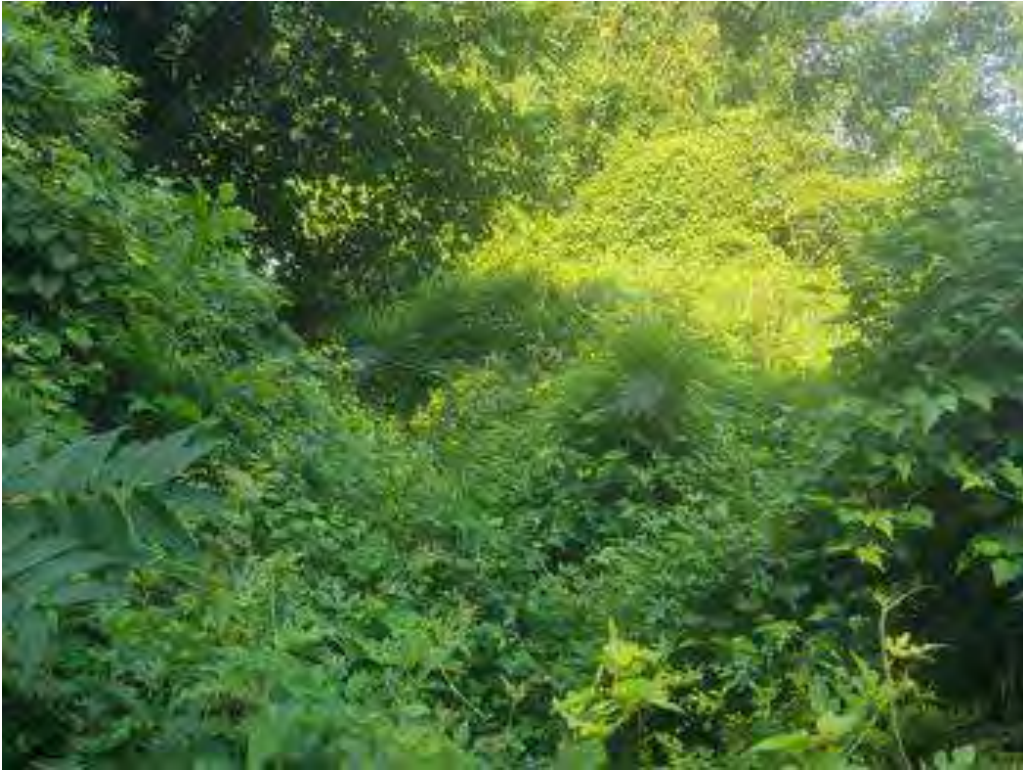
Overall Photo

Date of Inspection:	July 25, 2025 10:22 AM	Inspector Initials:	SK,SF
BMP ID:	UMCP19BMP0043	Inspection Firm:	MES
BMP Type:	Bioretention	Underground BMP?	No
BMP Status	Fail	Overall Inspection Comment:	BMP overgrown and should be cleared
Maintenance Level	Major Maintenance (Use of Heavy Machinery for Repairs)

- **BMP Access** - Poor
- **Debris & Sediment** - Not Rated
- **Vegetation** - Poor
- **BMP Contamination** - Not Rated
- **General Site Conditions Comments:** Overgrown Vegetation

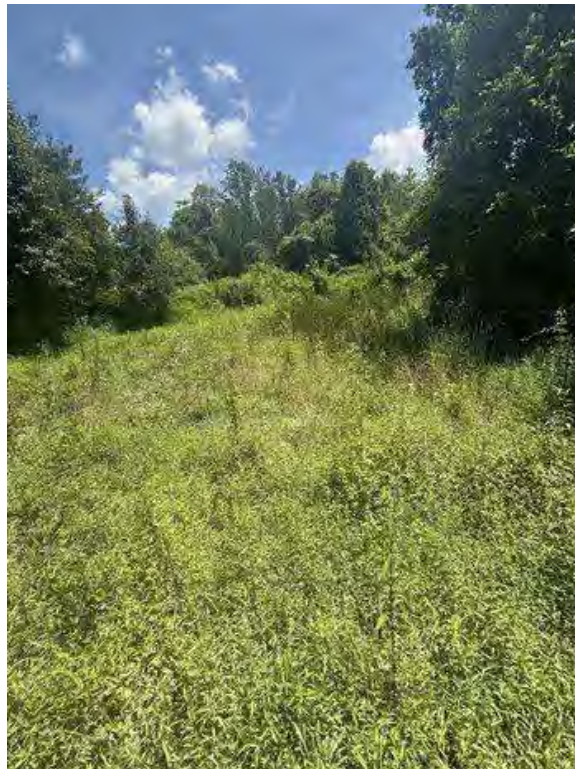
Date of Inspection:	July 28, 2025 1:01 PM	Inspector Initials:	SM
BMP ID:	UMCP19BMP0065	Inspection Firm:	MES
BMP Type:	Grass Swale	Underground BMP?	No
BMP Status	Fail	Overall Inspection Comment:	Excess vegetation impedes access to structures, minor erosion at inflow
Maintenance Level	Major Maintenance (Use of Heavy Machinery for Repairs)

- **BMP Access** - Fair
- **Debris & Sediment** - Good
- **Vegetation** - Fair
- **BMP Contamination** - Good
- **General Site Conditions Comments:** Excess vegetation made access of structures difficult

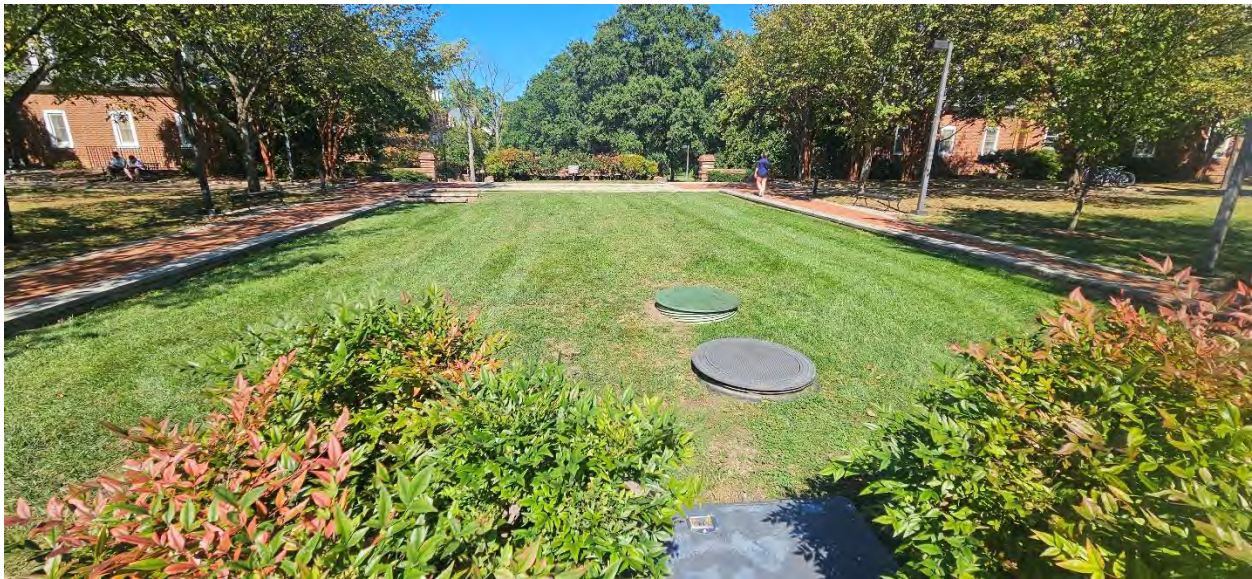
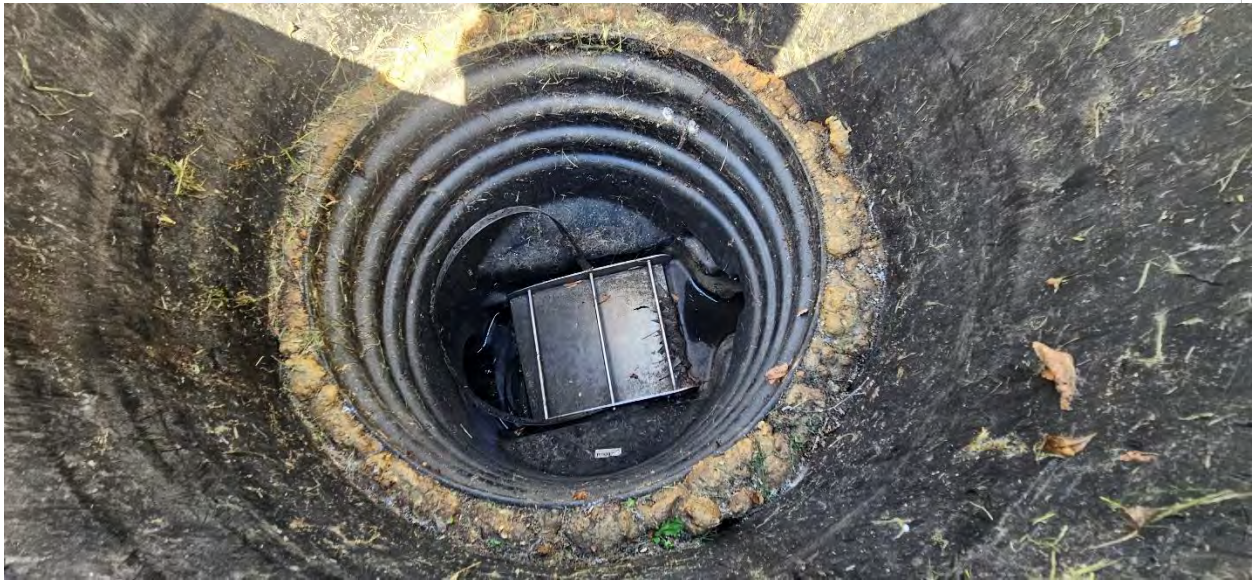
Overall Photo

Date of Inspection:	October 1, 2025 1:15 PM	Inspector Initials:	SK,PP
BMP ID:	UMCP19BMP0085	Inspection Firm:	MES
BMP Type:	Rainwater Harvesting	Underground BMP?	No
BMP Status	Pass	Overall Inspection Comment:	BMP in good condition
Maintenance Level	Routine Maintenance (Only needs Routine Maintenance)

- **BMP Access** - Poor
- **Debris & Sediment** - Good
- **Vegetation** - N/A
- **BMP Contamination** - Good
- **General Site Conditions Comments:** Could not Access Underground Storage, could only access Filter

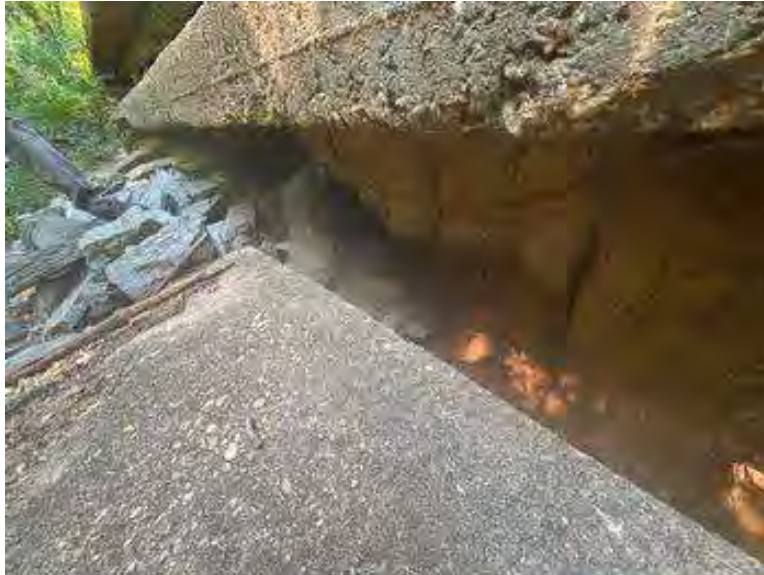
Collapsed concrete spillway

Repair collapsed concrete embankment, remove woody vegetation on and within buffer of embankment, clean out sedimented west side of pond

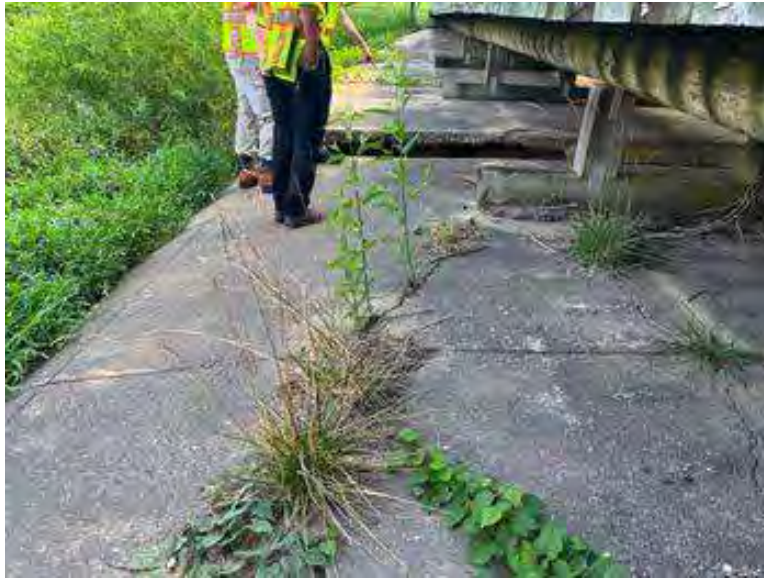
Cracks within concrete spillway. Golfcart path constructed on top.

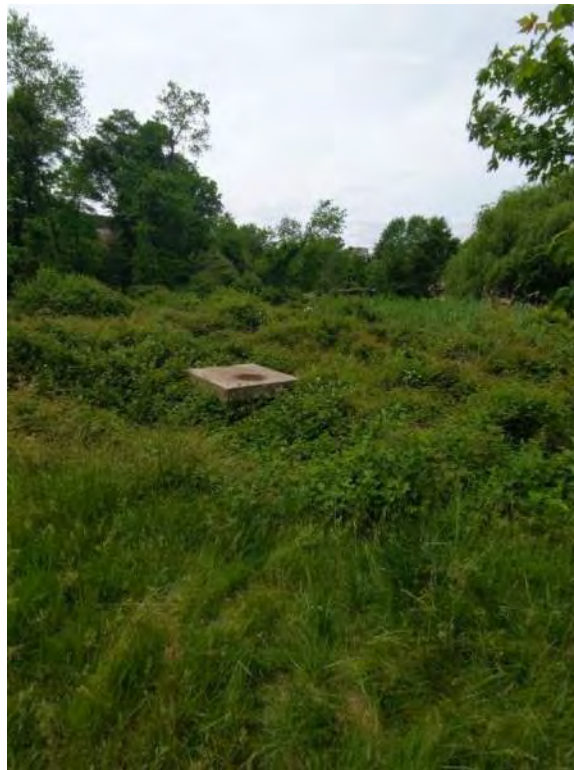
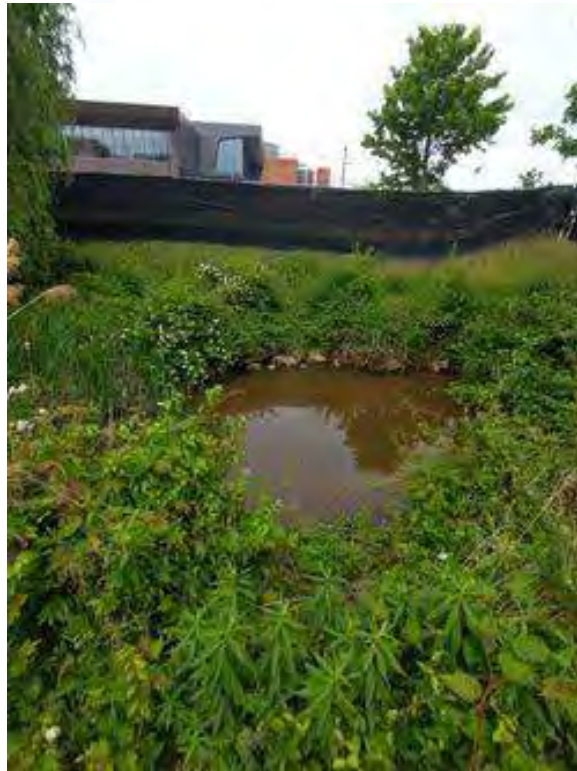
Overall Photo

Date of Inspection:	May 12, 2025 1:56 PM	Inspector Initials:	SK,SD
BMP ID:	UMCP19BMP0090	Inspection Firm:	MES
BMP Type:	Bioretention	Underground BMP?	No
BMP Status	Pass	Overall Inspection Comment:	BMP Overgrown and Needs Maintenance
Maintenance Level	Major Maintenance (Use of Heavy Machinery for Repairs)

- **BMP Access** - Fair
- **Debris & Sediment** - Good
- **Vegetation** - Poor
- **BMP Contamination** - Good
- **General Site Conditions Comments:** Invasive phragmites and overgrown vegetation

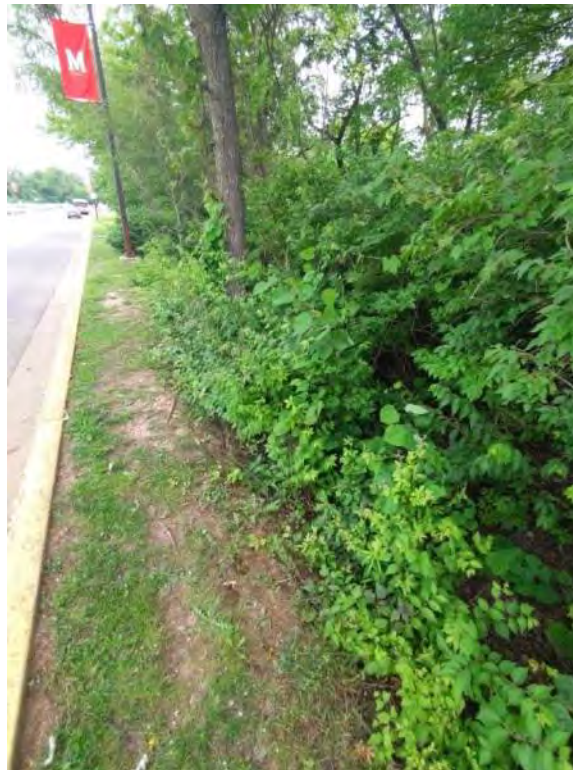
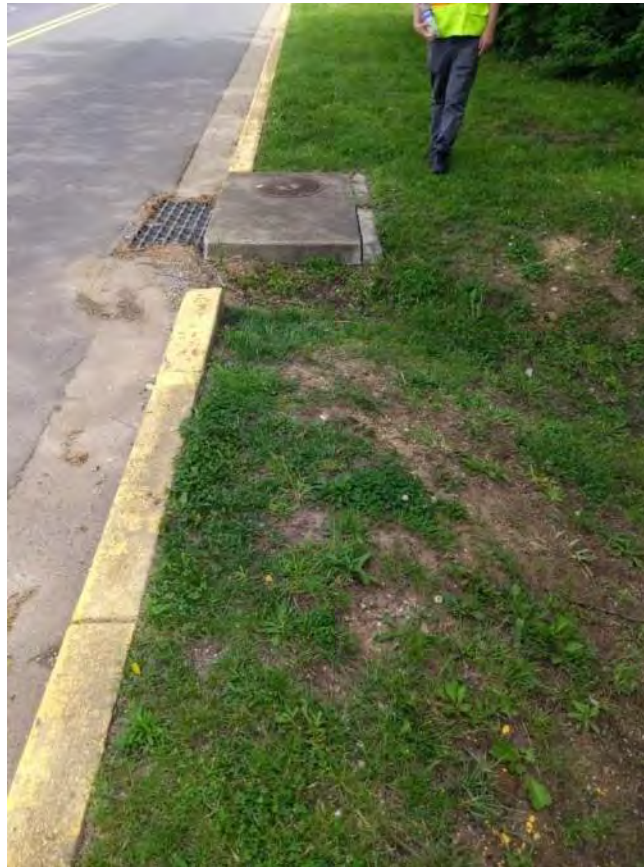
Overall Photo

Date of Inspection:	May 12, 2025 1:38 PM	Inspector Initials:	SK,SD
BMP ID:	UMCP19BMP0091	Inspection Firm:	MES
BMP Type:	Bioretention	Underground BMP?	No
BMP Status	Fail	Overall Inspection Comment:	BMP failing
Maintenance Level	Rebuild / Redesign (Use of engineering design to redesign or completely rebuild the facility)

- **BMP Access** - Good
- **Debris & Sediment** - Poor
- **Vegetation** - Poor
- **BMP Contamination** - Good
- **General Site Conditions Comments:** Sediment accumulation too high. Structure not functioning

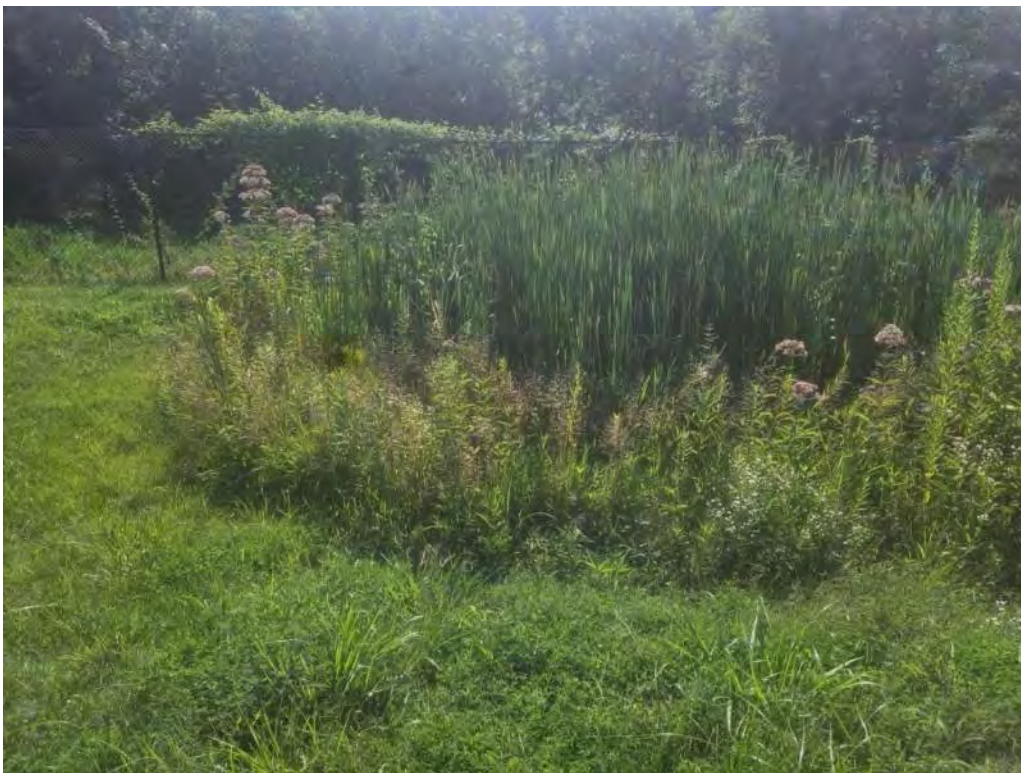
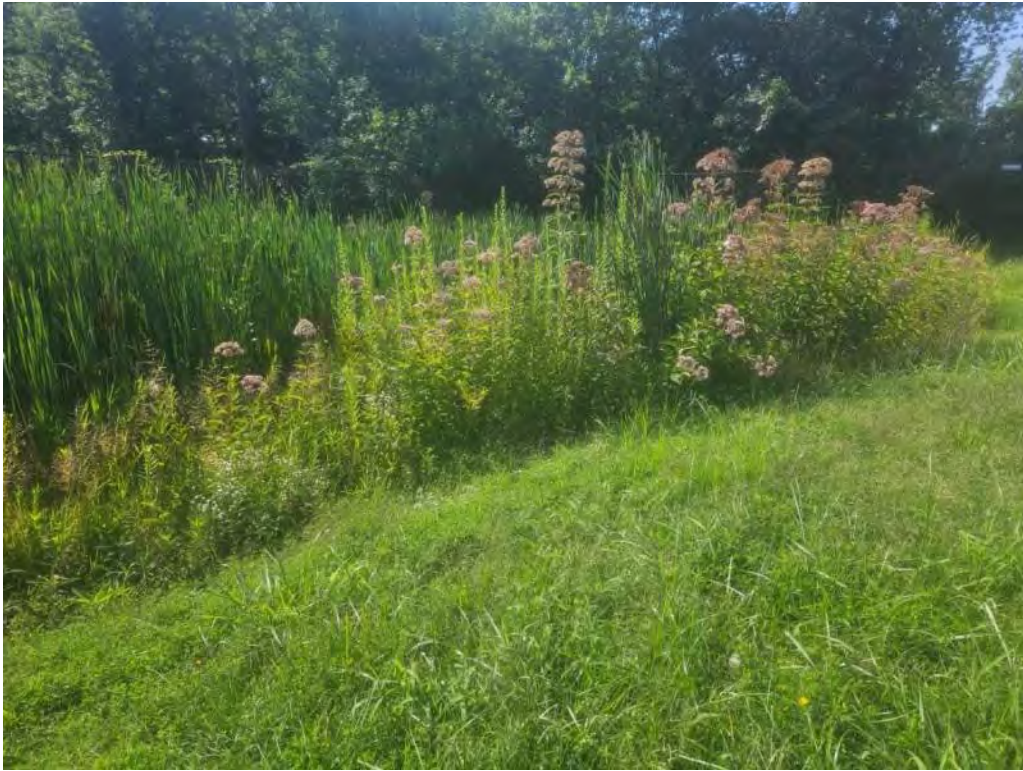
Overall Photos

Date of Inspection:	July 25, 2025 10:04 AM	Inspector Initials:	SK,SF
BMP ID:	UMCP19BMP0106	Inspection Firm:	UMD
BMP Type:	Retention Pond (Wet Pond)	Underground BMP?	No
BMP Status	Fail	Overall Inspection Comment:	Some erosion at principal spillway. Facility overgrown
Maintenance Level	Minor Maintenance (Use of Hand Equipment for Repairs)

- **BMP Access** - Good
- **Debris & Sediment** - Good
- **Vegetation** - Poor
- **BMP Contamination** - Good
- **General Site Conditions Comments:** Invasive Cattails

Repair erosion at principal spillway, remove invasive cattails

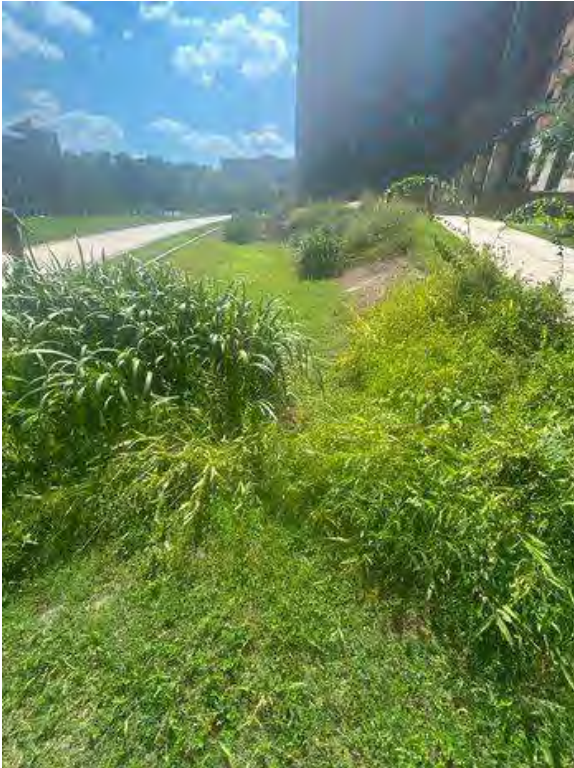
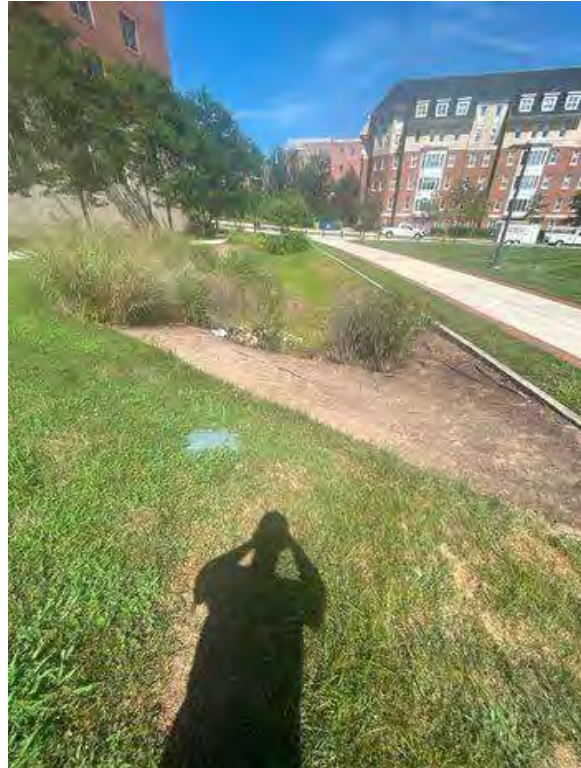
Overall Photo

- **BMP Access** - Good
- **Debris & Sediment** - Good
- **Vegetation** - Fair
- **BMP Contamination** - Good
- **General Site Conditions Comments:** Bare patches and mild erosion on embankment and north berm

Stabilize and reseed/remulch embankment/berms, repair inflow pipe

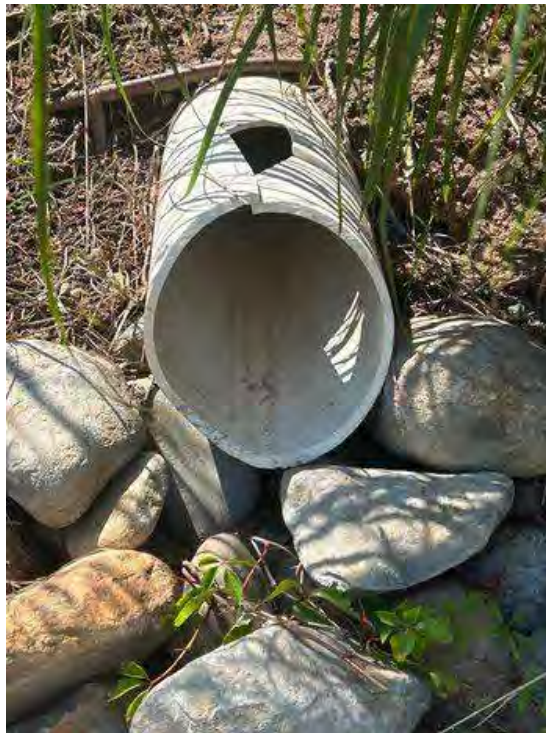
Damaged inflow pipe

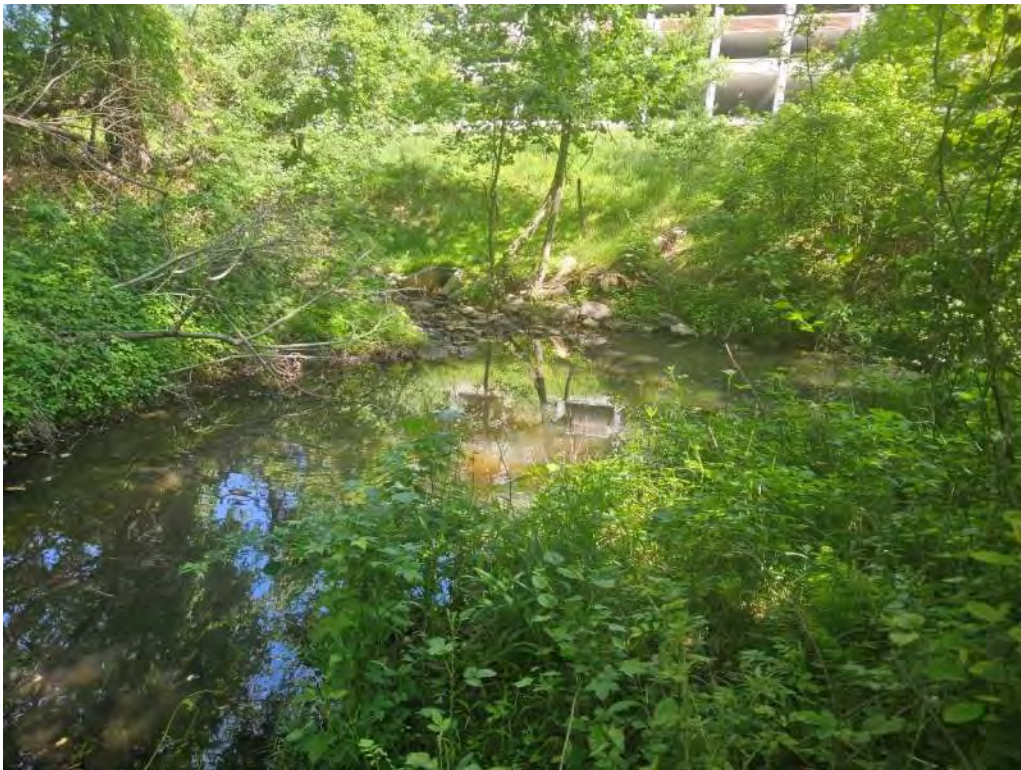
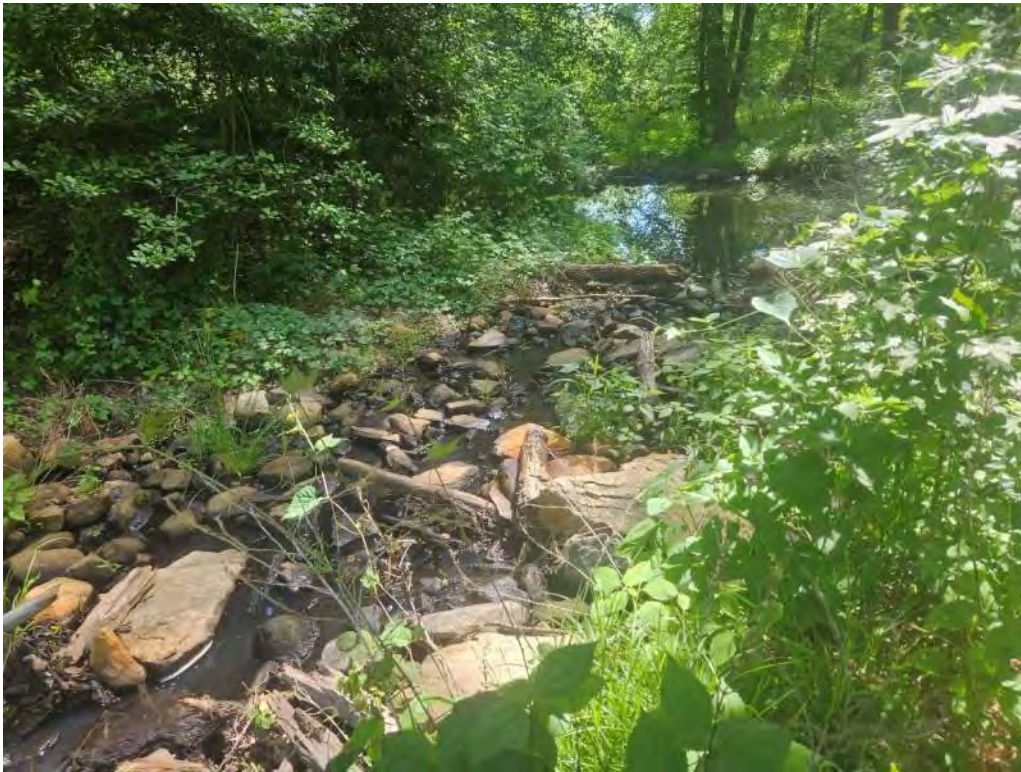
Overall Photo

- **BMP Access** - Good
- **Debris & Sediment** - Good
- **Vegetation** - Good
- **BMP Contamination** - Good
- **General Site Conditions Comments:** Some erosion on the northern bank

Remove Fallen Trees from Stream and Repair Erosion

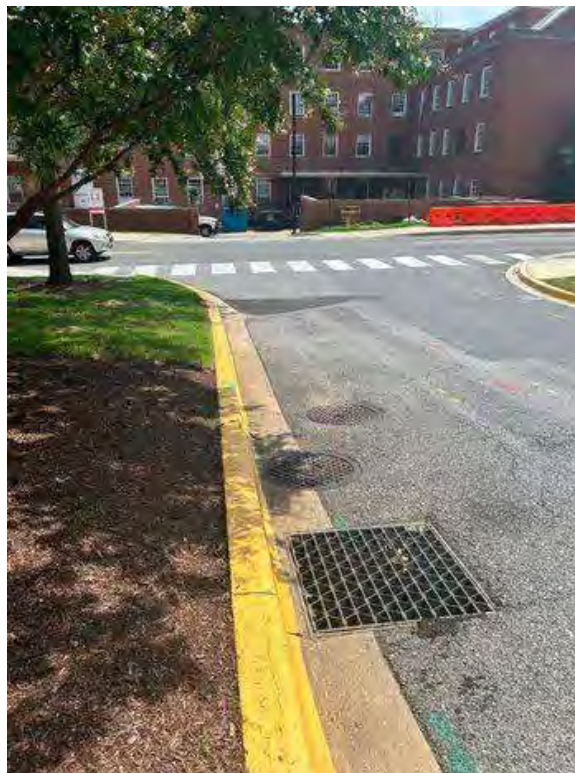
Overall Photo

- **BMP Access** - Good
- **Debris & Sediment** - Good
- **Vegetation** - N/A
- **BMP Contamination** - Good
- **General Site Conditions Comments:** Minor algal growth in principal spillway
