Re: Report of Discharge from Sanitary Sewer at the University of Maryland

University of Maryland Photo Log  
11/30/2018 – Sewage Overflow at Chincoteague Hall

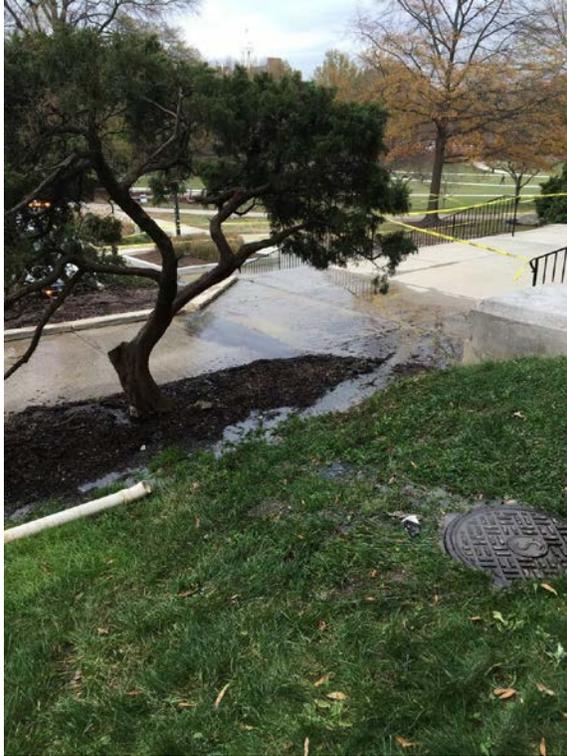
Description of overflow location: the overflow came from a sanitary sewer system manhole located in front of Chincoteague hall

Cause of overflow: blockage in pipe owned by WSSC.

Top Left: looking east towards McKeldin Library at the overflowing manhole in front of Chincoteague Hall. The impacted areas were blocked with caution tape.

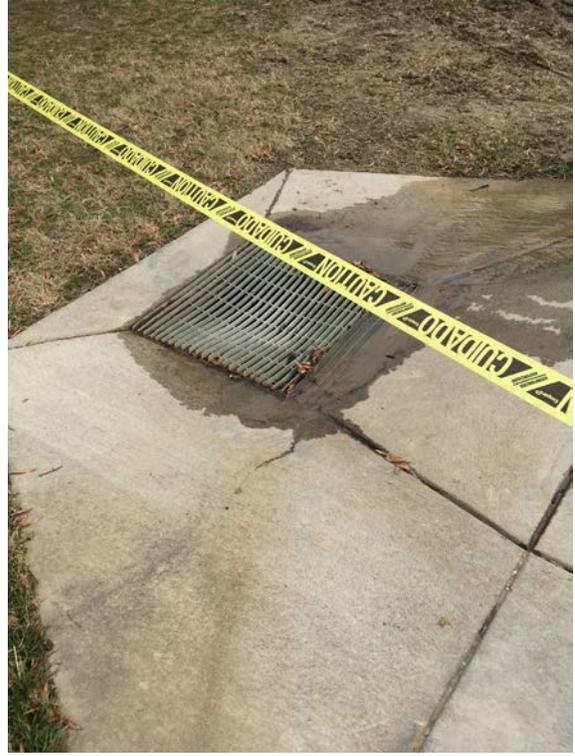
Impact on waters of the State: a portion of the overflow (approximately 250 gallons) entered the stormwater system via an inlet between McKeldin Library and Chincoteague Hall. This inlet is connected to Outfall 005 and discharges to an unnamed tributary of the Paint Branch.

Top Right: The stormwater inlet at the corner of McKeldin Library that discharges to Outfall 005. Sandbags and straw bales were installed around the inlet at approximately 2:30pm to prevent additional flow from entering the inlet. Approximately 250 gallons of sewage entered the inlet.

Measures taken to mitigate impact: Straw bales and sandbags were installed around the nearest storm drain to prevent flow from continuing to enter the storm drain system at

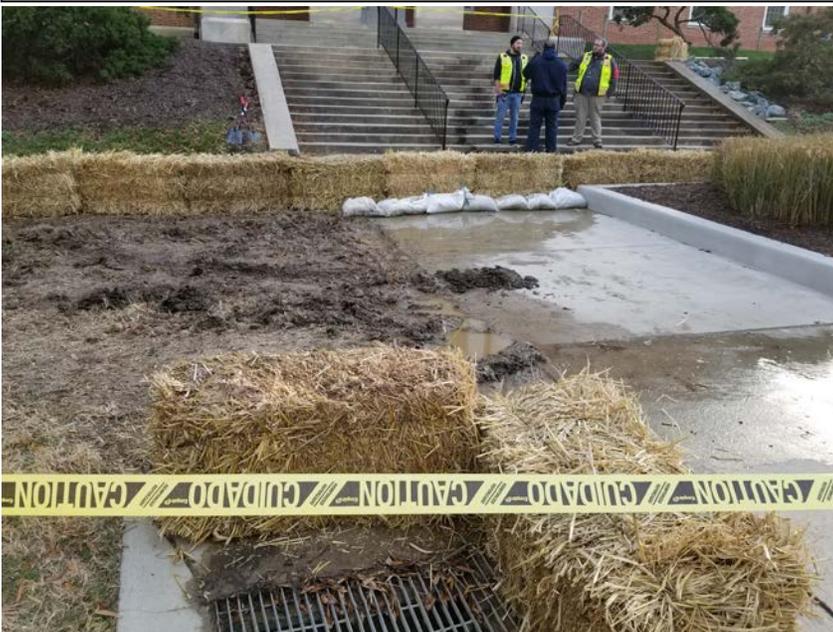
Bottom Left: looking west towards Chincoteague Hall, straw bales and sandbags were installed to direct the flow away from the stormwater inlet.

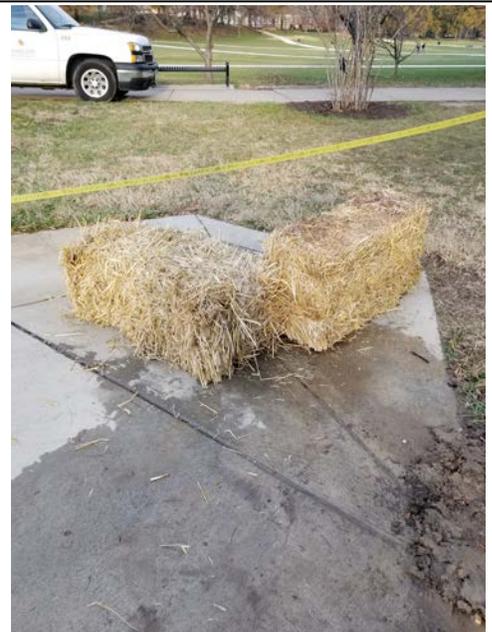
Bottom Right: looking southeast towards McKeldin Mall, straw bales installed around stormwater inlet.
