University of Maryland, College Park
National Pollutant Discharge Elimination
System MS4 Phase II
FY2021 Annual Report
General Discharge Permit #13-SF-5501

Task 2: Findings and Recommendations Report

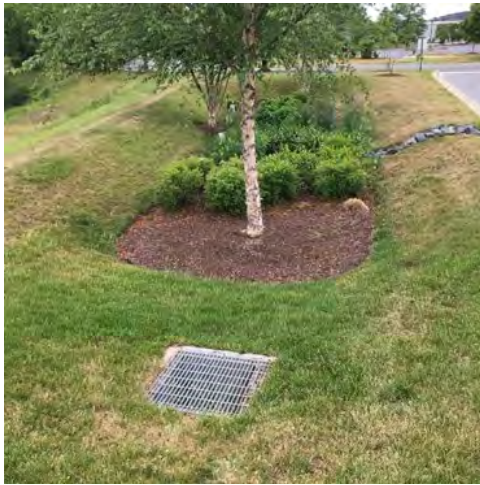
The facility is a micro-bioretentation constructed for new development, therefore providing treatment toward the baseline. MES completed inspection of the facility in June 2021. Overall, the micro-bioretentation was in good condition but requires minor maintenance. The grading at the inflow is suspected to be causing accumulation prior to water entering the facility. Minor erosion and exposed matting were also observed at the inflow. Minor erosion was present on the north edge of the basin. Leafy debris was observed within the control structure.

MES recommends regrading the inflow to ensure proper flow into facility. Debris should be removed from within inflow riprap and minor erosion should be repaired. Leafy debris should be removed from within the control structure.

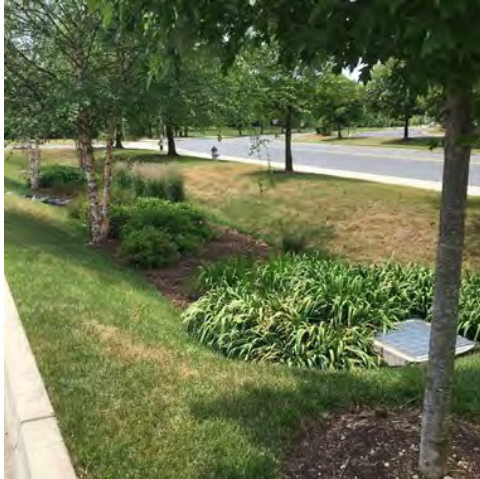
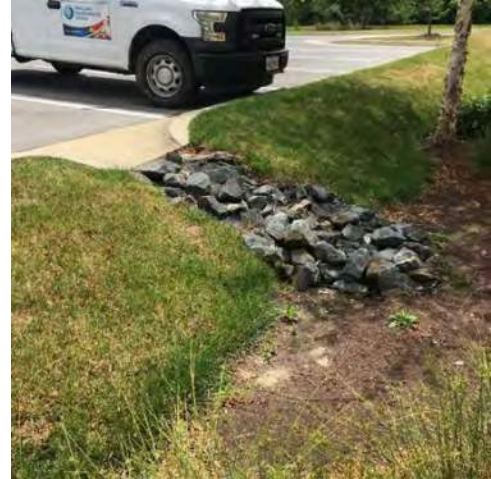
The facility is a micro-bioretentation constructed for new development, therefore providing treatment toward the baseline. MES completed inspection of the facility in June 2021. Overall, the micro-bioretentation was in good condition but requires minor maintenance. Minor erosion and exposed matting were observed at the inflow. Additionally, minor erosion was present on the northwest end of the basin. Minor debris was observed within the inflow riprap.

MES recommends removing debris from within the inflow riprap. Minor erosion at the inflow and along the basin edge should be repaired.

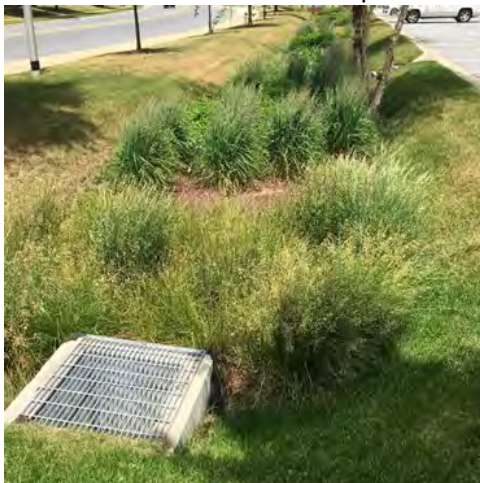
The facility is a micro-bioretentation constructed for new development, therefore providing treatment toward the baseline. MES completed inspection of the facility in June 2021. Overall, the micro-bioretentation was in good condition but requires minor maintenance. Minor erosion and exposed matting were observed at the inflow and at the control structure. Additionally, minor debris was observed within the inflow riprap.

MES recommends removing debris from within the inflow riprap. Minor erosion at the inflow and at the control structure should be repaired.

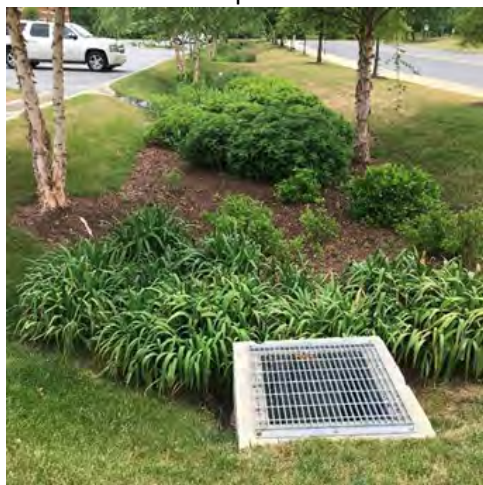
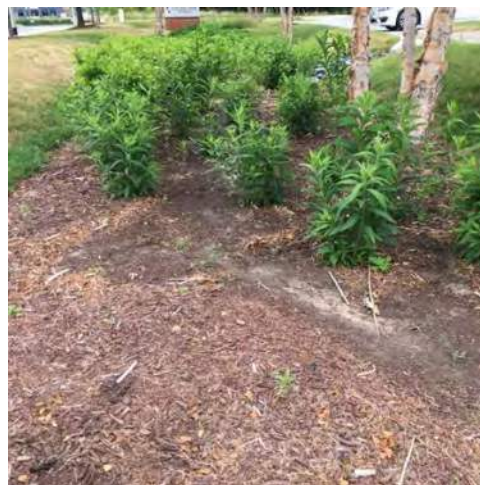
The facility is a micro-bioretentation constructed for new development, therefore providing treatment toward the baseline. MES completed inspection of the facility in June 2021. Overall, the micro-bioretentation was in good condition but requires minor maintenance. Minor erosion and exposed matting were observed at the inflow. Minor sediment accumulation was also observed at the inflow. Additionally, minor channeling was present within the conveyance.

MES recommends removing debris and sediment from within the inflow riprap. Minor erosion at the inflow should be repaired and channeling within the conveyance should be stabilized.

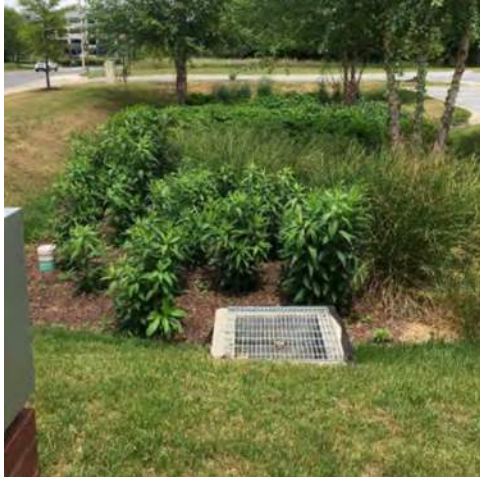
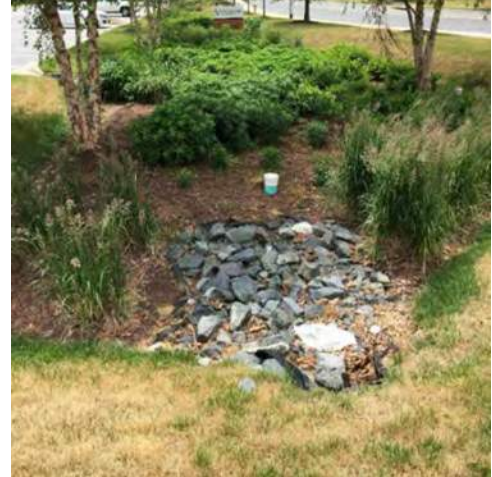
The facility is a micro-bioretentation constructed for new development, therefore providing treatment toward the baseline. MES completed inspection of the facility in June 2021. Overall, the micro-bioretentation was in good condition but requires minor maintenance. Minor erosion and exposed matting were observed at the inflow. Minor debris was also present at the inflow. Additionally, minor erosion was observed on the northeast side of the basin.

MES recommends removing debris from within the inflow riprap. Minor erosion at the inflow and along the basin edge should be repaired.

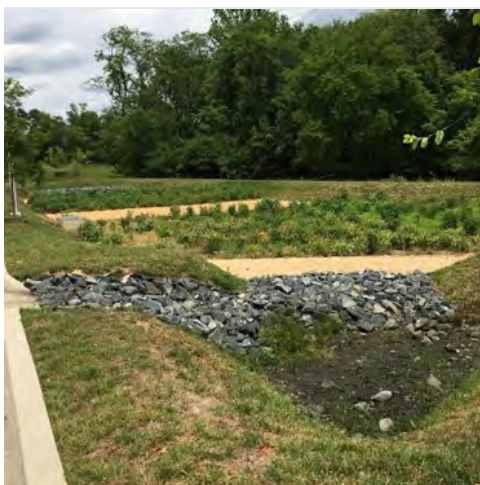
The facility is a submerged gravel wetland (SGW) constructed for new development, therefore providing treatment toward the baseline. MES completed inspection of the facility in June 2021. Overall, the SGW was in good condition but requires minor maintenance. Minor erosion and debris were observed at the north forebay inflow. Minor erosion was also observed on the upstream embankments. Additionally, minor ponding and muck were present within both forebays.

MES recommends repairing erosion at the north forebay inflow and on the embankment. Vegetation should be removed from the inflows. Additionally, the forebay bottoms should be seeded for stabilization and to prevent muck development.

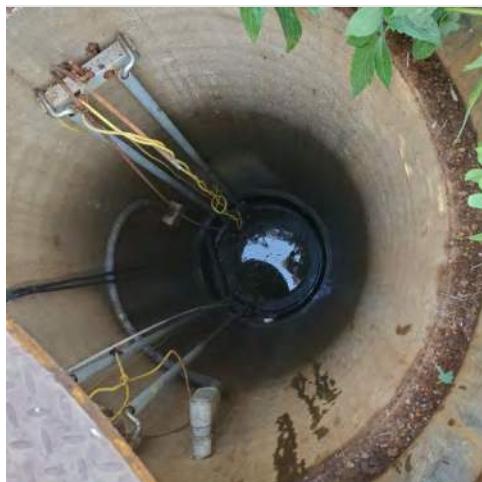
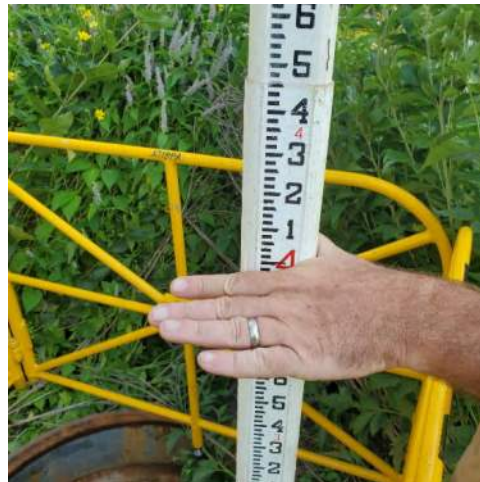
The facility is a rainwater harvesting cistern constructed for redevelopment in 2010. The water stored within the facility is confirmed to be used for irrigation, therefore is eligible for water quality treatment credit. Since the project did not result in a net increase in impervious and the existing impervious was not being treated, treatment provided by the cistern qualifies for restoration credit. MES completed inspection of the facility in July 2021. The facility was not dewatered at the time of inspection but was determined to be in good condition from what could be observed. The water level within the facility was appropriate according to design plans. However, the access manhole does not have a ladder. Therefore, even if the facility was dewatered, entry into the facility could not be completed for inspection.

MES recommends continuing routine maintenance for the facility. Additionally, MES recommends installing manual drain controls for building maintenance and an access ladder for inspection entry.

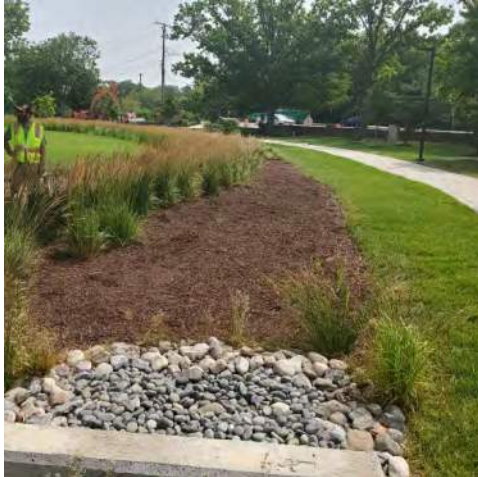
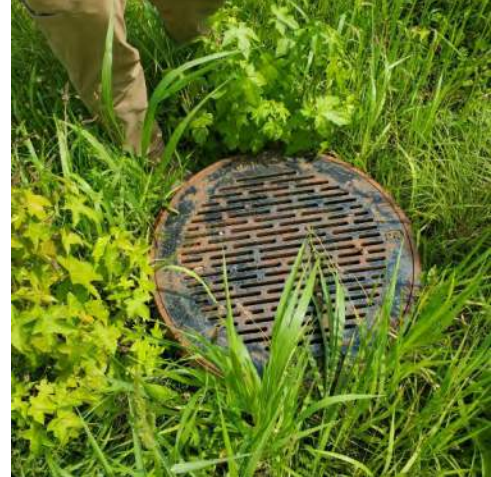
The facility is a bioswale constructed for redevelopment in 2019. Since the project did not result in a net increase in impervious and the existing impervious was not being treated, treatment provided by the bioswale qualifies for restoration credit. MES completed inspection of the facility in July 2021. The facility was determined to be in good condition but requires minor maintenance. Overgrown vegetation was observed at both the outfall and downstream.

MES recommends trimming vegetation to ensure the control structure does not become clogged. Vegetation downstream should also be trimmed. Additionally, routine maintenance for the facility should be continued.

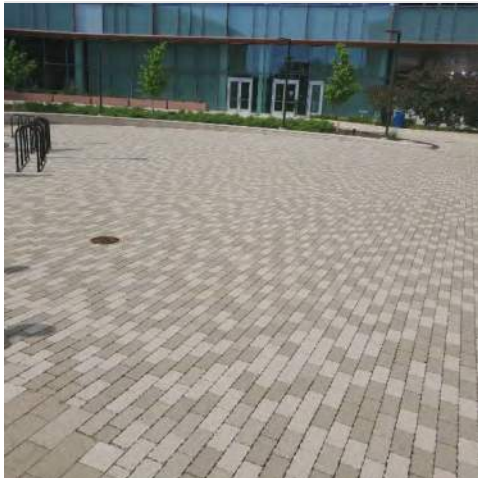
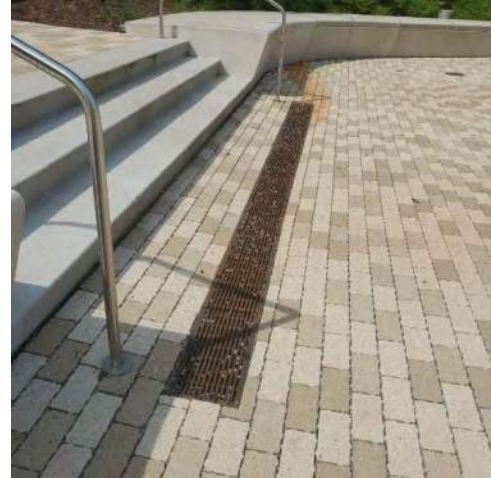
UMCP19BMP0244 Brendan Iribe 4

The facility is permeable pavement constructed for redevelopment in 2019. Since the project did not result in a net increase in impervious and the existing impervious was not being treated, treatment provided by the pavers qualifies for restoration credit. MES completed inspection of the facility in July 2021. The facility was determined to be in good condition and only requires continued routine maintenance. Additionally, the overflow inlet should be monitored for debris accumulation to prevent clogging.

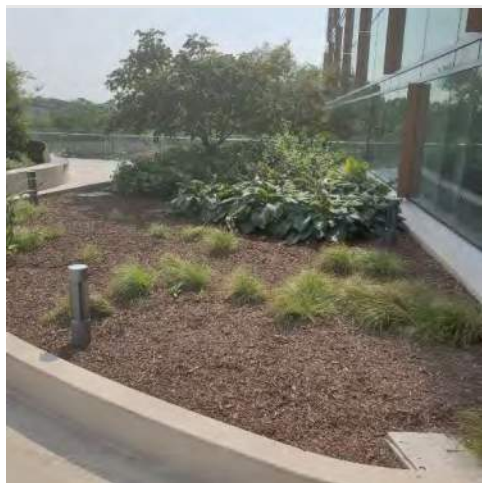
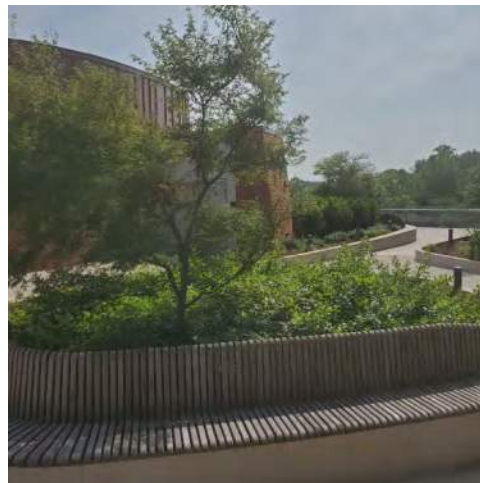
UMCP19BMP0245 Brendan Iribe 5

The facility is a green roof constructed for redevelopment in 2019. Since the project did not result in a net increase in impervious and the existing impervious was not being treated, treatment provided by the green roof qualifies for restoration credit. MES completed inspection of the facility in July 2021. The facility was determined to be in good condition and only requires continued routine maintenance. No maintenance action items were observed. However, it should be noted card access is required for inspection or maintenance access.

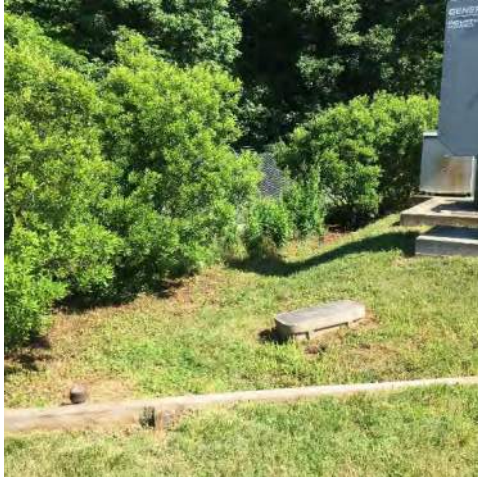
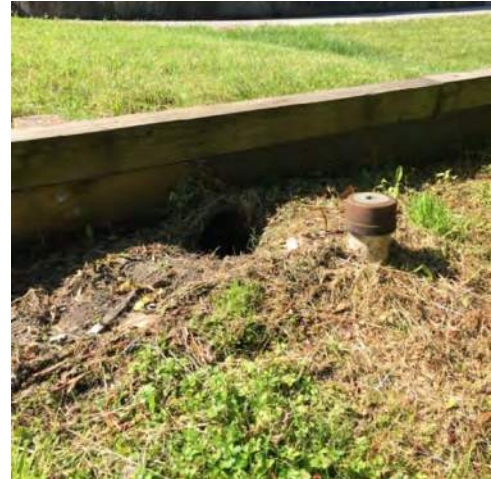
The facility is a micro-bioretenention constructed for new development, therefore providing treatment toward the baseline. MES completed inspection of the facility in June 2021. Overall, the micro-bioretenention was in good condition but requires minor maintenance. Minor erosion and sediment accumulation were observed at the southern inflow. Bare areas were present within the conveyance. Additionally, minor vegetation growth was observed within the outfall riprap.

MES recommends mulching bare areas within the basin to stabilize the conveyance. Erosion at the southern inflow should be repaired. Additionally, the southern inflow opening should be cleared of sediment to ensure no blockage of the inflow. Vegetation should also be removed from the outfall riprap.

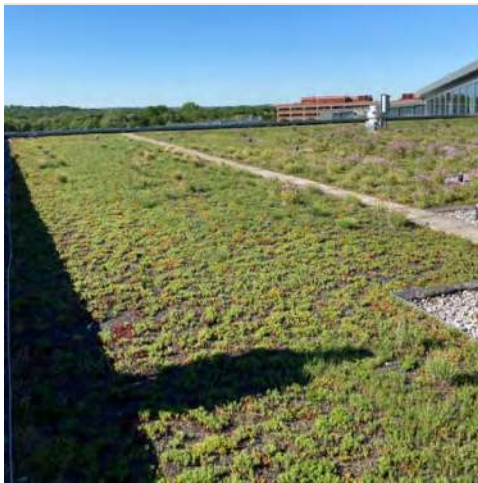
UMCP20BMP0273 NOAA Green Roof 1

The facility is a green roof constructed for new development, therefore providing treatment toward the baseline. MES completed inspection of the facility in May 2021. Overall, the green roof was in good condition but requires minor maintenance. Minor bare areas were observed within the green roof. MES recommends establishing vegetation within these areas to ensure full water quality treatment is provided.

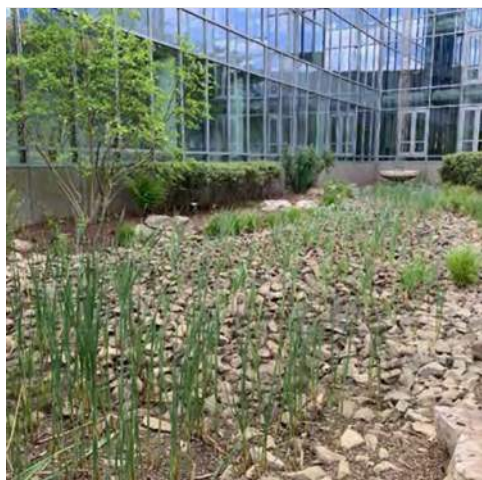
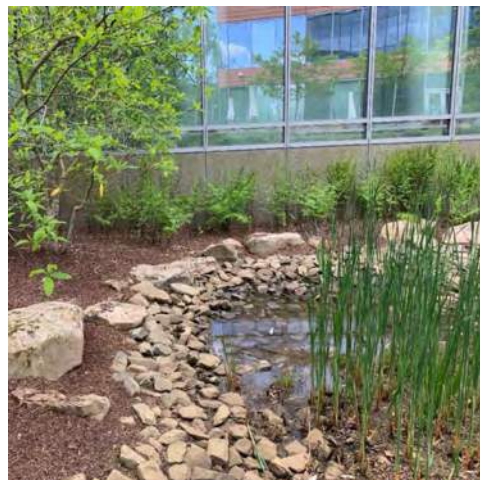
The facility is a micro-bioretention constructed for new development, therefore providing treatment toward the baseline. MES completed inspection of the facility in April 2021. The micro-bioretention was determined to be failing and requires major maintenance. Invasive species were present within the rip-rap basin area. The presence of standing water indicates the facility is not draining properly, most likely due to clogged filter media. Additionally, sedimentation within the rip-rap basin area further supports the filter media may be clogged. A small area of erosion was also observed above the outfall endwall.

MES recommends conducting an infiltration test to confirm clogging of filter media. First, the facility cleanouts should be cleared. If infiltration is still poor, the first 6-12" of filter media should be removed and replaced with new media. Unplanned vegetation should be removed from within the basin area. Additionally, erosion at the outfall endwall should be repaired.

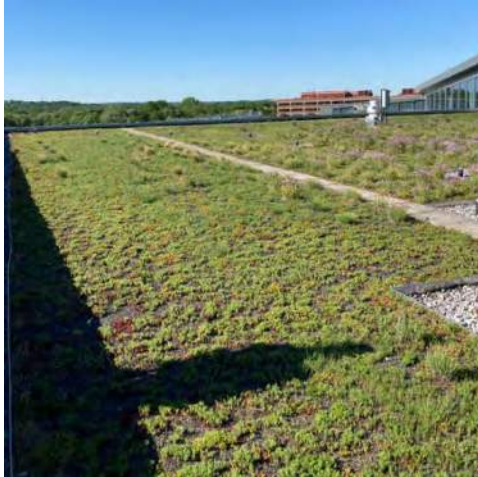
UMCP20BMP0275 NOAA Green Roof 2

The facility is a green roof constructed for new development, therefore providing treatment toward the baseline. MES completed inspection of the facility in May 2021. Overall, the green roof was in good condition but requires minor maintenance. Several areas were observed to have minimal to no vegetation growth. MES recommends establishing vegetation within these bare areas to ensure full water quality treatment is provided.

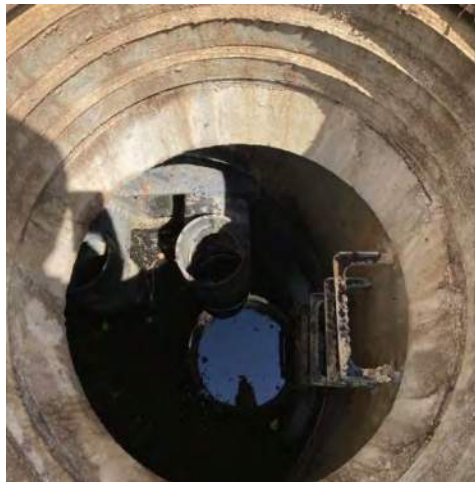
UMCP20BMP0276 NOAA WQ Manhole 1

The facility is a water quality (WQ) manhole constructed for new development. WQ manholes act as a form of pretreatment but do not qualify for treatment credit, therefore does not provide treatment toward the baseline. MES completed inspection of the facility in April 2021. Overall, the facility was in good condition and does not require maintenance at this time. However, routine maintenance should be continued to ensure the facility stays within functioning condition.

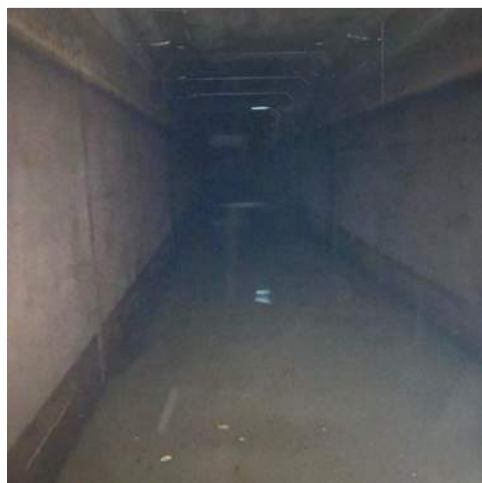
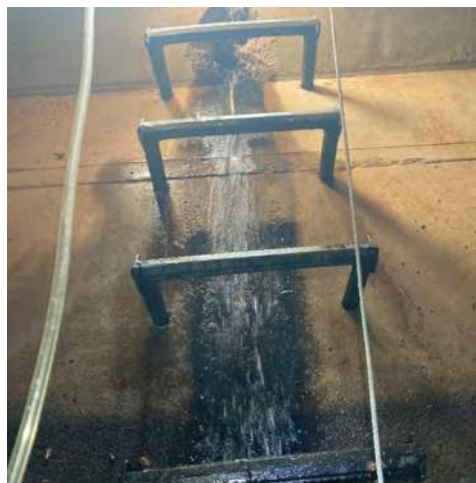
UMCP20BMP0277 NOAA Underground Cistern

The facility is an underground cistern constructed for new development. Cisterns only provide water quantity management, not water quality treatment, therefore the facility does not provide treatment toward the baseline. MES completed inspection of the facility in June 2021. Overall, the facility was in good condition and only requires routine maintenance. However, approximately 1' of water was present at the bottom of the cistern at the time of inspection. The facility had been dewatered prior to inspection. This water was suspected to be from an observed flow entering the facility outside of a rain event. It was undetermined if this flow was intentionally directed to the facility or if it is a result of damage to the structure. MES recommends investigating the source of the flow to ensure it will not compromise the function of the facility.

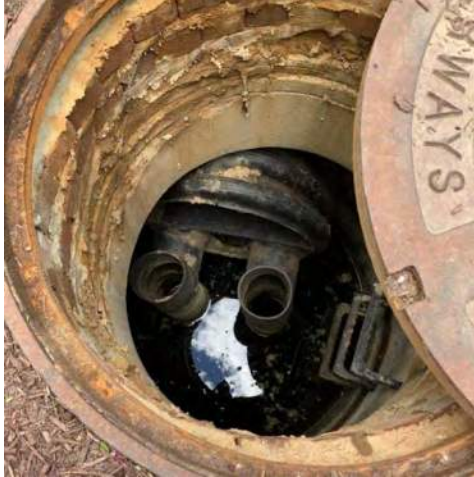
UMCP20BMP0278 NOAA WQ Manhole 2

The facility is a water quality (WQ) manhole constructed for new development. WQ manholes act as a form of pretreatment but do not qualify for treatment credit, therefore does not provide treatment toward the baseline. MES completed inspection of the facility in April 2021. Overall, the facility was in good condition and does not require maintenance at this time. However, routine maintenance should be continued to ensure the facility stays within functioning condition.

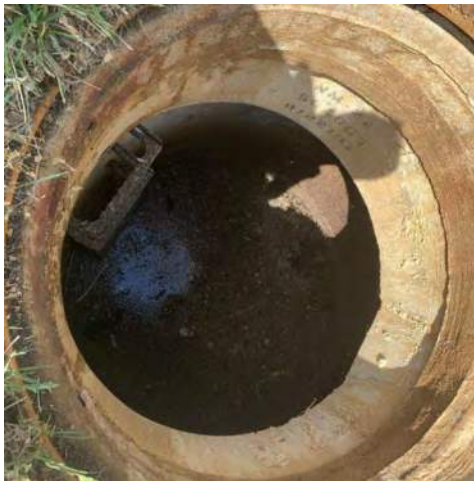
UMCP20BMP0279 NOAA WQ Manhole 3

The facility is a water quality (WQ) manhole constructed for new development. WQ manholes act as a form of pretreatment but do not qualify for treatment credit, therefore does not provide treatment toward the baseline. MES completed inspection of the facility in April 2021. Overall, the facility was in good condition but requires minor maintenance. Minor debris was observed to be accumulated at the bottom of the manhole. This debris should be cleared, and routine maintenance continued to ensure the facility stays within functioning condition.

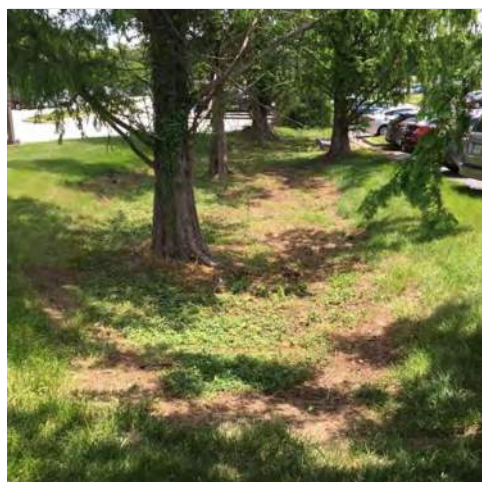
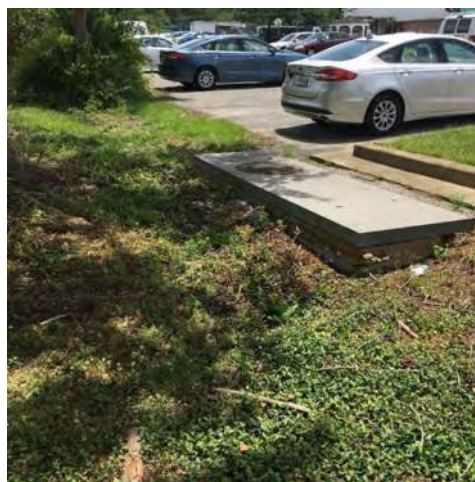
The facility is a micro-bioretention constructed for new development, therefore providing treatment toward the baseline. MES completed inspection of the facility in June 2021. Overall, the micro-bioretention was in good condition but was determined to be failing due to the grading of the facility. From inspection, it appeared water may flow directly through the facility to the inlet rather than ponding within the micro-bioretention. Therefore, the facility is unable to treat runoff as designed. MES's survey, completed in April 2021, confirmed minimal ponding would occur and that runoff would bypass treatment within the facility. In addition to improper grading, minor sediment and debris was present at the curb cut inflows. There were also minor bare areas within the basin.

Drainage Area (ac.)	Impervious (ac.)	Pe (in.)	Treatment credit (ac.)
0.79	0.59	0.02	0

MES recommends clearing sediment and debris from the curb cut inflows and seeding bare areas within the basin. MES also recommends excavating and regrading the facility to restore proper ponding. Due to the existing trees within the basin, excavation should be limited to a depth that will not compromise the tree roots, approximately 4". To further increase ponding within the basin, MES proposes raising the invert elevation of the inlet approximately 3". This raised invert would allow for more ponding within the facility while still maintaining sufficient freeboard. Additionally, this modification would not compromise drainage from the parking lot and would still facilitate flow directly into the inlet without causing ponding within the parking lot.

Cost Estimate for Repairs¹: \$13,000 - \$16,000

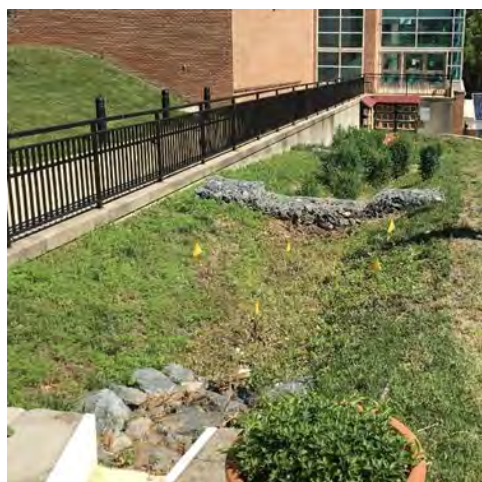
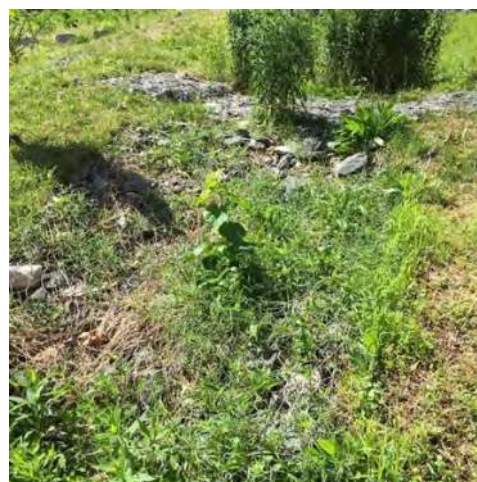
The facility is a bioretention constructed for restoration in 2013, therefore eligible for restoration credit. MES completed inspection of the facility in June 2021. Overall, the bioretention was in good condition but requires minor maintenance. Minor bare areas were present within the facility basins. Minor debris and vegetation were also observed within the inflow riprap after the second check dam.

It should be noted in MES's evaluation that the drainage area within the database was reduced after further investigation. Two trench drains west of the bioretention capture runoff and connect into the storm drain network, bypassing the bioretention. Inlets to the south of the facility were also determined to bypass the facility. Additionally, construction of a new building resulted in modifications to the most southern edge of the drainage area. These updates reduced the drainage area from 4.82 to 1.10 acres, and total impervious from 2.03 to 0.62 acres. However, even with this reduction the facility was still determined to be very undersized, only treating 0.12" of runoff.

The bioretention connects to a rainwater harvesting cistern. Therefore, the bioretention may be sized to only meet pretreatment volumes which is 10% of the required WQv. MES was informed that the facility was previously modified to increase the storage capacity due to flooding occurring in the area. MES's 2021 survey confirmed these modifications increased the provided treatment by approximately 40%. Since this modification, UMCP reported that the flooding is no longer occurring. Therefore, MES does not recommend further modifications to the bioretention at this time to increase storage capacity unless flooding issues return within this area.

MES recommends mulching bare areas within the basins. Debris should be removed from riprap protection and vegetation should be trimmed. Routine maintenance on the bioretention should also be continued to ensure the facility stays within functioning condition.

Cost Estimate for Repairs¹: \$550 - \$700

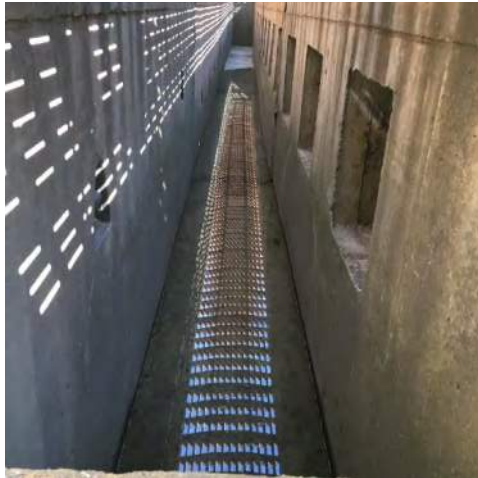
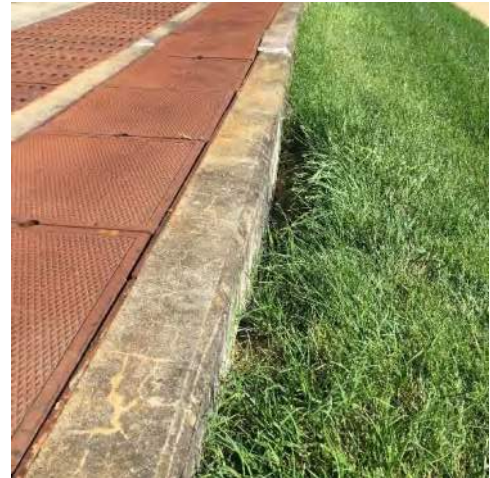
The facility is an underground sand filter constructed for new development, therefore providing treatment toward the baseline. MES completed inspection of the facility in June 2021. Overall, the sand filter was in good condition but requires minor maintenance. The interior of the facility had no observable deficiencies. Minor erosion was present on the outside of the facility. One of the iron slabs above the sand filter was also displaced.

MES recommends seeding the erosion on the outside of the facility. The structural integrity of the iron slab should be monitored and repaired if determined to be structurally compromised. Routine maintenance on the sand filter should also be continued to ensure the facility stays within functioning condition.

Cost Estimate for Repairs¹: \$200 - \$250

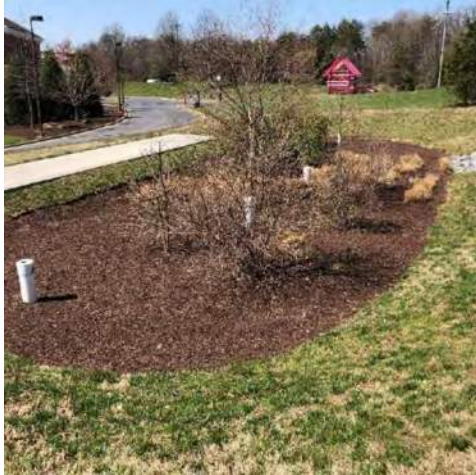
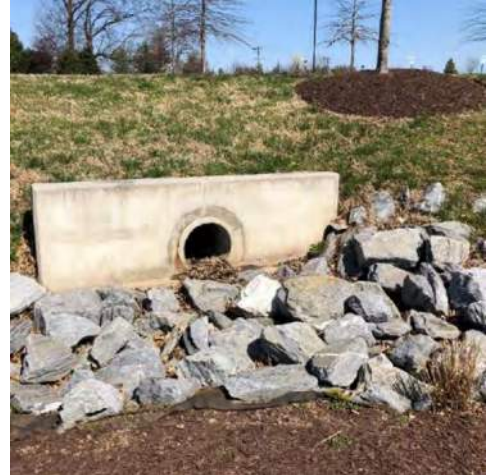
UMCP19BMP0019 University House Parking Lot

The facility is a micro-bioretention constructed for new development, therefore providing treatment toward the baseline. WBCM completed an inspection of the facility in April 2019 which MES used as reference for evaluation of the facility. WBCM indicated the facility was in good, functioning condition and appears to receive routine maintenance. In their evaluation, WBCM previously indicated the facility does not meet MDE criteria. However, WBCM still included this facility in the baseline treatment. MES suspects this evaluation was due to the facility not having a pretreatment area. However, micro-bioretentions, unlike bioretentions, do not have a pretreatment requirement. Taking this into consideration, along with the facility having available as-builts and an inspection record, MES determined the facility does meet MDE criteria and should remain as providing treatment toward the baseline.

Cost Estimate for Repairs¹: Repair not required at this time

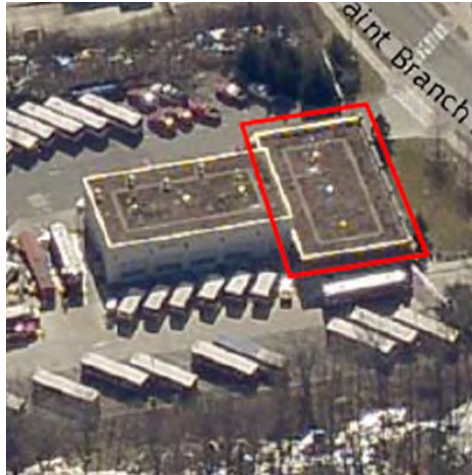
The facility is a green roof constructed for redevelopment in 2012. The project did not result in a net increase in impervious. However, the existing impervious fell within the drainage area of a dry swale (SWF026) installed in 2010. The dry swale was also constructed for redevelopment and the project did not result in a net increase in impervious, therefore treatment qualified for restoration credit. Since treatment of the impervious is already classified as restoration credit, treatment provided by the green roof would maintain this restoration credit. However, this impervious is no longer counted as being treated by the dry swale to prevent double crediting.

WBCM completed an inspection of the facility in May 2019 which MES used as reference for evaluation of the facility. WBCM indicated the facility was in good, functioning condition. In their evaluation, WBCM indicated the facility meets MDE criteria, but this facility was not previously included in the baseline assessment. It is undetermined why the facility was not previously included within UMCP's restoration credit. Since the facility meets all necessary design criteria and required documentation, MES determined the facility should be counted in the restoration credit.

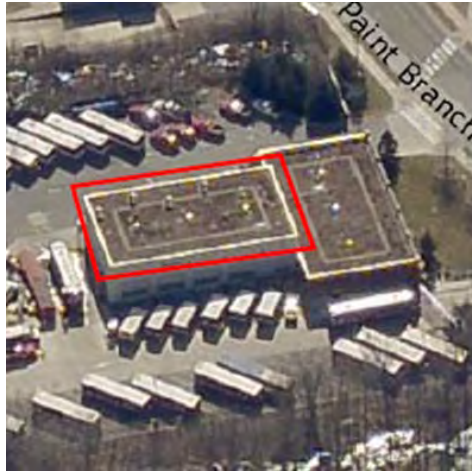
The facility is a green roof constructed for redevelopment in 2012. The project did not result in a net increase in impervious. However, the existing impervious fell within the drainage area of a dry swale (SWF026) installed in 2010. The dry swale was also constructed for redevelopment and the project did not result in a net increase in impervious, therefore treatment qualified for restoration credit. Since treatment of the impervious already classified as restoration credit, treatment provided by the green roof would maintain this restoration credit. However, this impervious is no longer counted as being treated by the dry swale to prevent double crediting.

WBCM completed an inspection of the facility in May 2019 which MES used as reference for evaluation of the facility. WBCM indicated the facility was in good, functioning condition. In their evaluation, WBCM indicated the facility meets MDE criteria, but this facility was not previously included in the baseline assessment. It is undetermined why the facility was not previously included within UMCP's restoration credit. Since the facility meets all necessary design criteria and required documentation, MES determined the facility should be counted in the restoration credit.

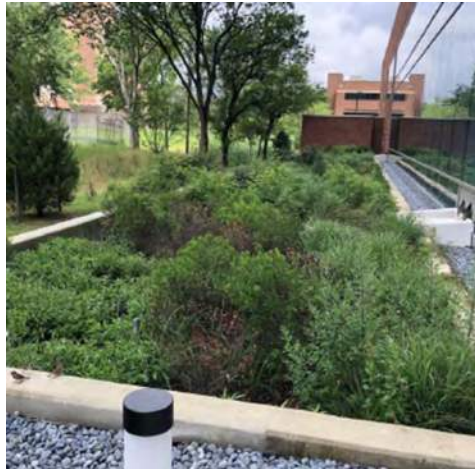
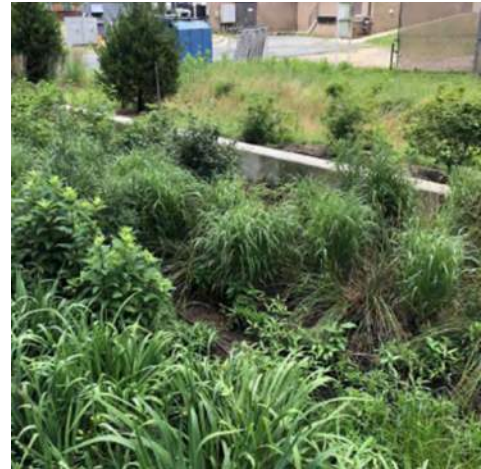
The facility is a micro-bioretention constructed for redevelopment in 2017. Since the project did not result in a net increase in impervious and the existing impervious was not being treated, treatment provided by the micro-bioretention qualifies for restoration credit. WBCM completed an inspection of the facility in June 2019 which MES used as reference for evaluation of the facility. WBCM indicated the facility was in fair condition. Noted deficiencies were the presence of trash and weeds within the basin. Additionally, water was present within the underdrain at the time of inspection. However, WBCM did not report any standing water within the facility, indicating a possible clog may be present within the underdrain, not the filter media. Therefore, the micro-bioretention qualifies as passing with minor maintenance needed.

In their evaluation, WBCM indicated the facility does not meet MDE criteria, therefore this facility was not previously included in the baseline assessment. MES suspects this evaluation was due to the facility not having a pretreatment area. However, micro-bioretentions, unlike bioretentions, do not have a pretreatment requirement. Taking this into consideration, along with the facility having available as-builts and an inspection record, MES determined treatment provided by the facility should be counted in toward UMCP's restoration credit. Trash and weeds should be removed from the facility and planned vegetation should be trimmed as routine maintenance. The underdrain should be cleared for potential clogging.

Cost Estimate for Repairs¹: \$1,500 - \$1,900

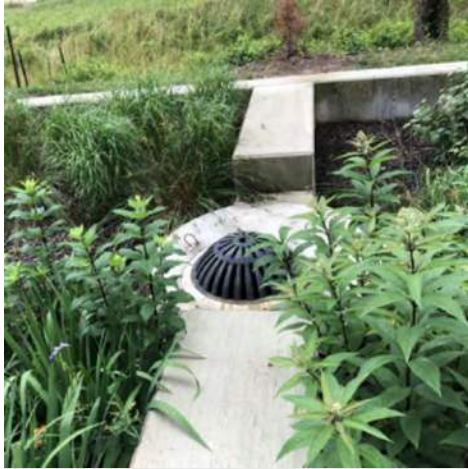
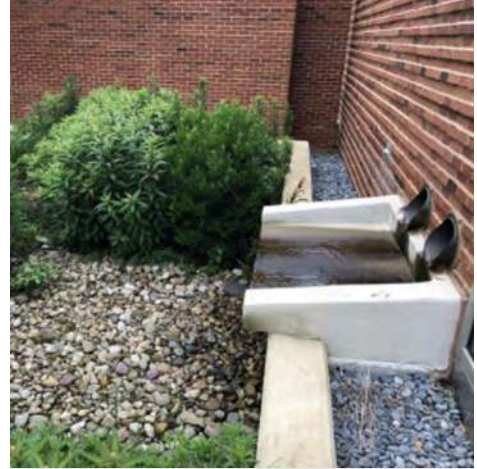
The facility is a micro-bioretention constructed for redevelopment in 2017. Since the project did not result in a net increase in impervious and the existing impervious was not being treated, treatment provided by the micro-bioretention qualifies for restoration credit. WBCM completed an inspection of the facility in June 2019 which MES used as reference for evaluation of the facility. WBCM indicated the facility was in fair condition. Noted deficiencies were the presence of trash and weeds within the basin, but the facility appeared to be functioning. Additionally, WBCM observed 6" of water within the control structure. This is consistent with design as there is approximately a 6" difference from the bottom of the inlet to the 15" RCP invert out elevation. Therefore, the micro-bioretention qualifies as passing with minor maintenance.

In their evaluation, WBCM indicated the facility does not meet MDE criteria, therefore this facility was not previously included in the baseline assessment. MES suspects this evaluation was due to the facility not having a pretreatment area. However, micro-bioretentions, unlike bioretentions, do not have a pretreatment requirement. Taking this into consideration, along with the facility having available as-builts and an inspection record, MES determined treatment provided by the facility should be counted in toward UMCP's restoration credit. Trash and weeds should be removed from the facility and planned vegetation should be trimmed as routine maintenance.

Cost Estimate for Repairs¹: \$1,000 - \$1,250

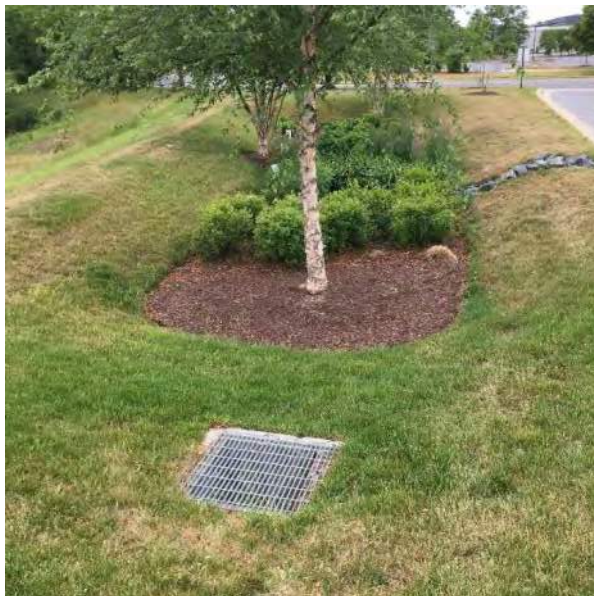
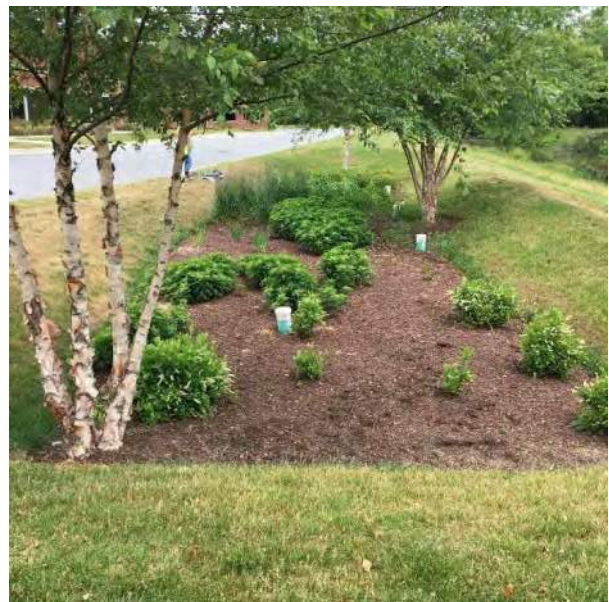
Overall Photo

Date of Inspection:	June 1, 2021, 1:37 PM	Inspector Initials	KR, DH
BMP ID	UMCP20BMP0267	Inspection Firm	MES
BMP Type:	Micro-bioretenction	Underground BMP?	No
BMP Status:	Pass	Overall Inspection Comment	Overall BMP in good condition. Grading at inflow causing accumulation prior to water entering facility. Minor erosion and exposed matting at inflow. Minor erosion north edge of basin. Leafy debris within control structure.
Maintenance Level:	Minor Maintenance (Use of Hand Equipment for Repairs)

- **BMP Access** - Good
- **Debris & Sediment** - Good
- **Vegetation** - Good
- **BMP Contamination** - Good
- **General Site Conditions Comments:**
- **Inflow Condition** - Fair
- **Inflow Comments:** Grading at inflow causing accumulation prior to water flowing into facility. Sediment accumulation, minor erosion and exposed matting.
- **Forebay** – N/A
- **Conveyance Stability** - Good
- **Downstream Condition** – Not rated
- **Downstream Condition Comments:** Downstream not accessible

Regrade inflow. Remove debris and repair erosion at inflow. Repair erosion north edge of basin. Clear debris control structure.

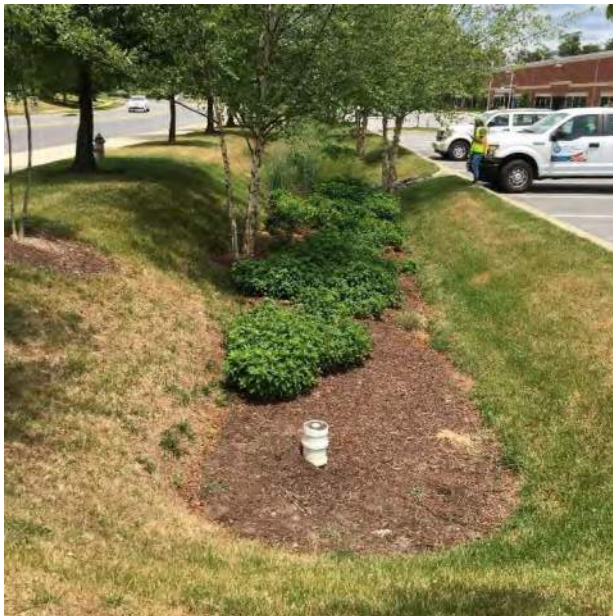
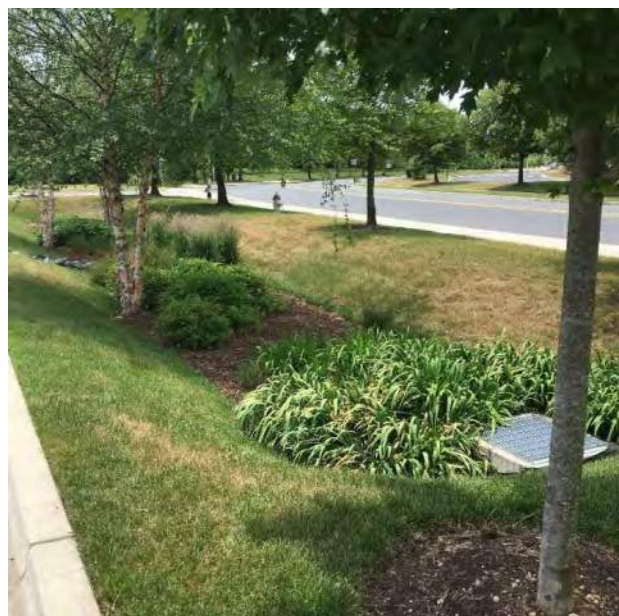
Overall Photo

Date of Inspection:	June 1, 2021, 1:08 PM	Inspector Initials	KR, DH
BMP ID	UMCP20BMP0268	Inspection Firm	MES
BMP Type:	Micro-bioretenction	Underground BMP?	No
BMP Status:	Pass	Overall Inspection Comment	Overall BMP in good condition. Minor erosion and debris at inflow. Exposed matting at inflow. Minor erosion north west end of basin.
Maintenance Level:	Minor Maintenance (Use of Hand Equipment for Repairs)

- **BMP Access** - Good
- **Debris & Sediment** - Good
- **Vegetation** - Good
- **BMP Contamination** - Good
- **General Site Conditions Comments:**
- **Inflow Condition** - Fair
- **Inflow Comments:** Minor debris inflow riprap. Minor erosion. Exposed matting.
- **Forebay** – N/A
- **Conveyance Stability** - Good
- **Downstream Condition** – Not rated
- **Downstream Condition Comments:** Downstream not accessible

Cover exposed matting. Repair erosion. Remove debris at inflow.

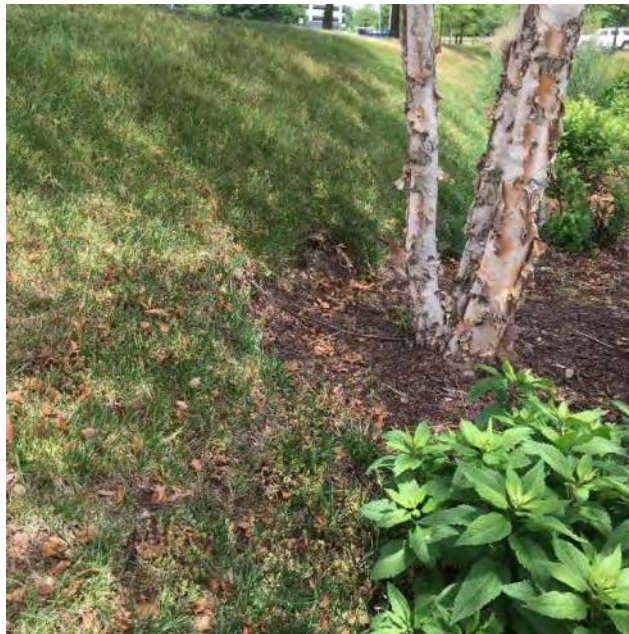
Erosion Basin

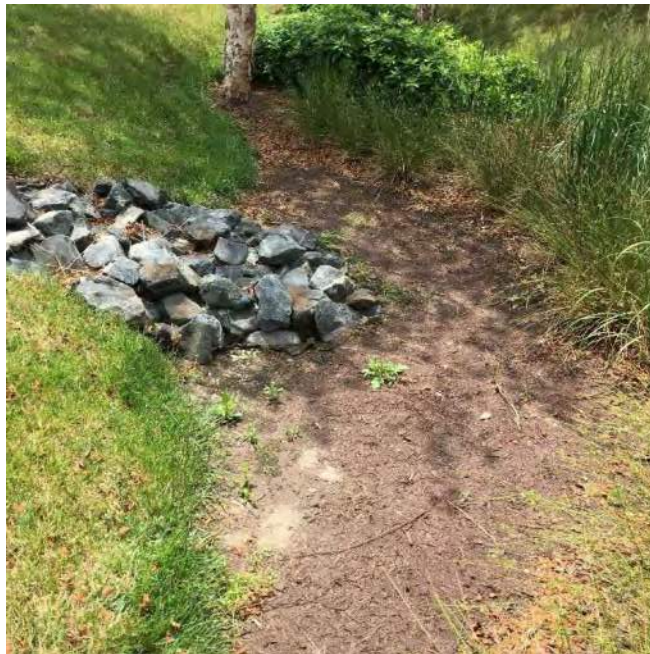
Erosion Inflow

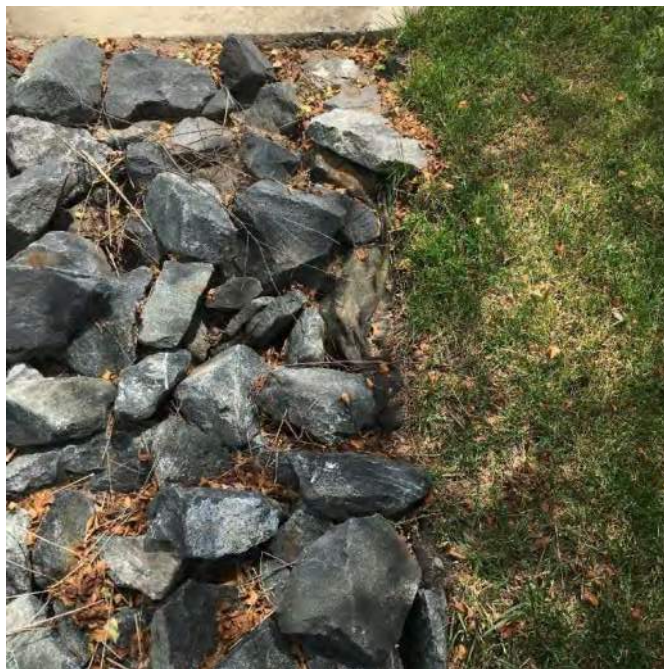
Exposed Matting Debris Inflow

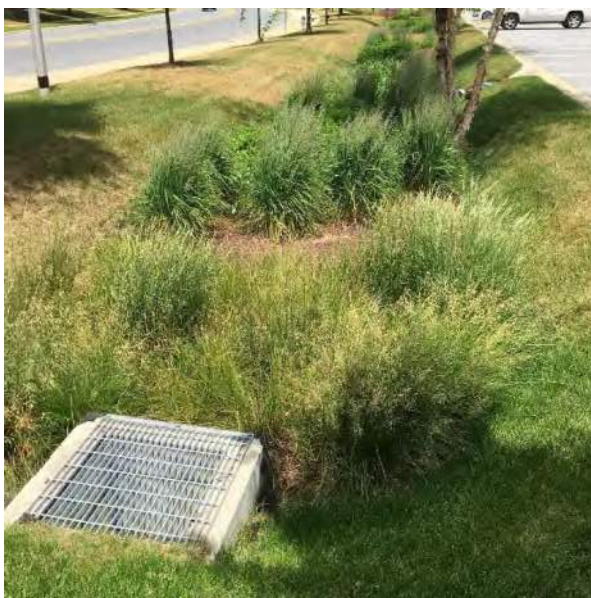
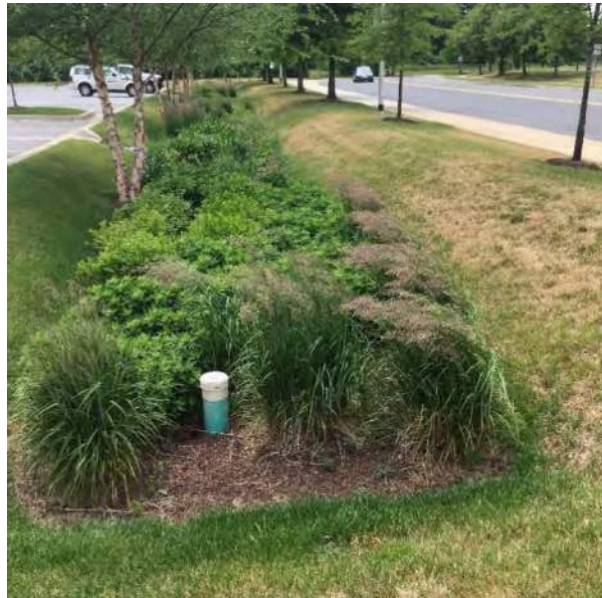
Overall Photo

Date of Inspection:	June 1, 2021, 1:17 PM	Inspector Initials	KR, DH
BMP ID	UMCP20BMP0269	Inspection Firm	MES
BMP Type:	Micro-bioretenction	Underground BMP?	No
BMP Status:	Pass	Overall Inspection Comment	Overall BMP in good condition. Minor erosion, debris and exposed matting at inflow. Exposed matting at control structure.
Maintenance Level:	Minor Maintenance (Use of Hand Equipment for Repairs)

- **BMP Access** - Good
- **Debris & Sediment** - Good
- **Vegetation** - Good
- **BMP Contamination** - Good
- **General Site Conditions Comments:**
- **Inflow Condition** - Good
- **Inflow Comments:** Minor debris, erosion and exposed matting at inflow.
- **Forebay** – N/A
- **Conveyance Stability** - Good
- **Downstream Condition** – Not rated
- **Downstream Condition Comments:** Downstream not accessible

Repair erosion and exposed matting at inflow and control structure.

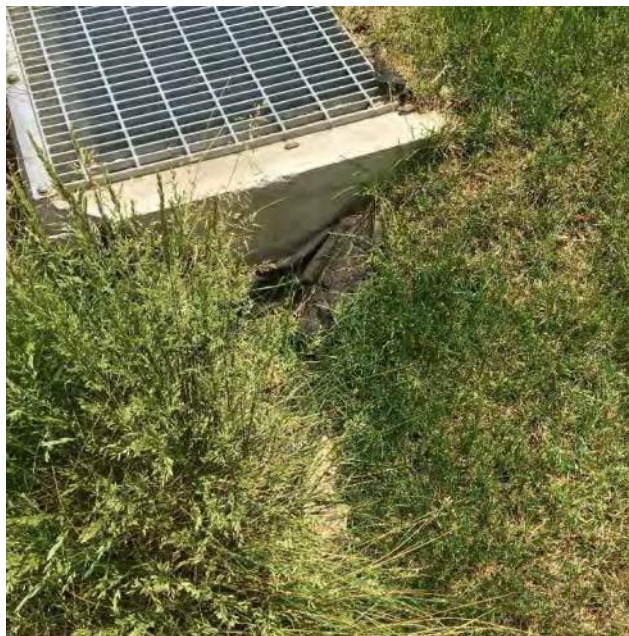
Exposed Matting Control Structure

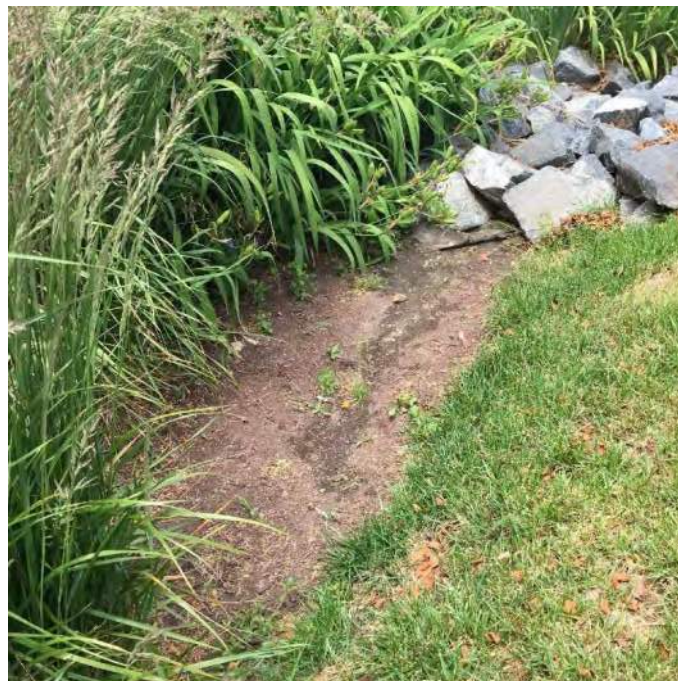
Erosion Inflow

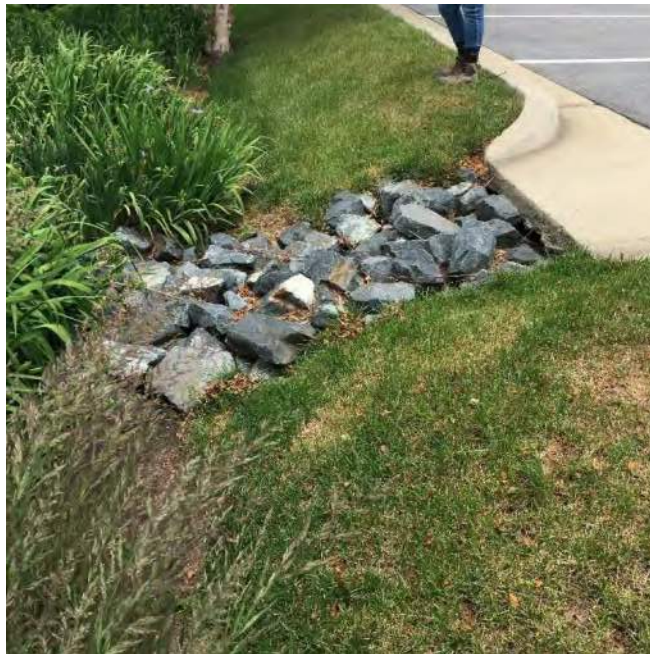
Exposed Matting Debris Inflow
