University of Maryland, College Park
National Pollutant Discharge Elimination
System MS4 Phase II
FY2021 Annual Report
General Discharge Permit #13-SF-5501

Task 2: Findings and Recommendations Report

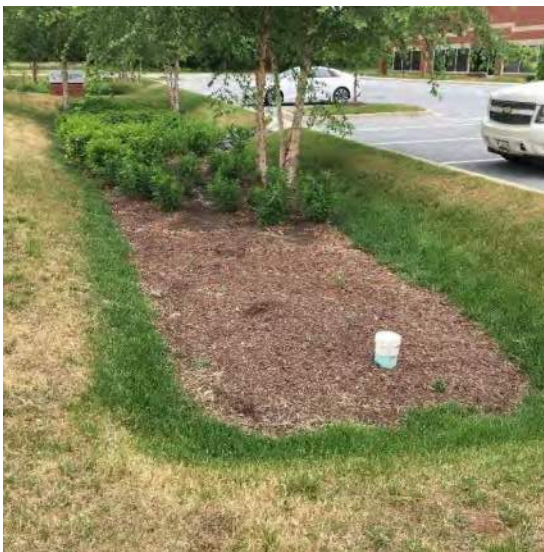
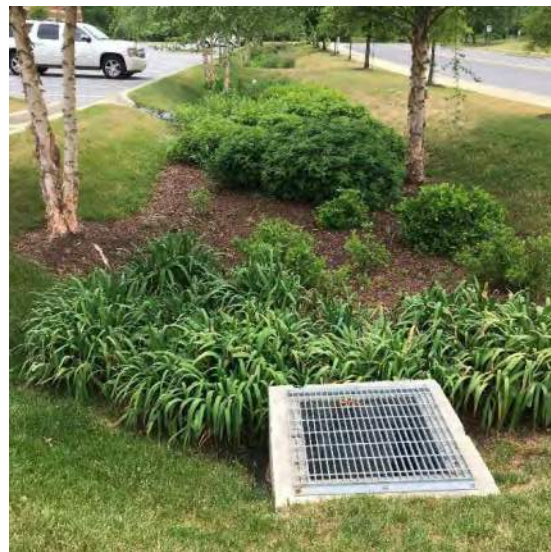
Overall Photo

Date of Inspection:	June 1, 2021, 1:23 PM	Inspector Initials	KR, DH
BMP ID	UMCP20BMP0270	Inspection Firm	MES
BMP Type:	Micro-bioretenction	Underground BMP?	No
BMP Status:	Pass	Overall Inspection Comment	Overall BMP in good condition. Minor erosion, sediment and exposed matting at inflow. Minor channeling within conveyance.
Maintenance Level:	Minor Maintenance

- **BMP Access** - Good
- **Debris & Sediment** - Good
- **Vegetation** - Good
- **BMP Contamination** - Good
- **General Site Conditions Comments:**
- **Inflow Condition** - Fair
- **Inflow Comments:** Minor erosion, sediment and exposed matting at inflow.
- **Forebay** – N/A
- **Conveyance Stability** - Fair
- **Downstream Condition** – Not rated
- **Downstream Condition Comments:** Downstream not accessible
- **Other repair items:** Minor channeling within conveyance

Stabilize channeling within conveyance. Remove debris and sediment at inflow. Repair erosion and exposed matting at inflow.

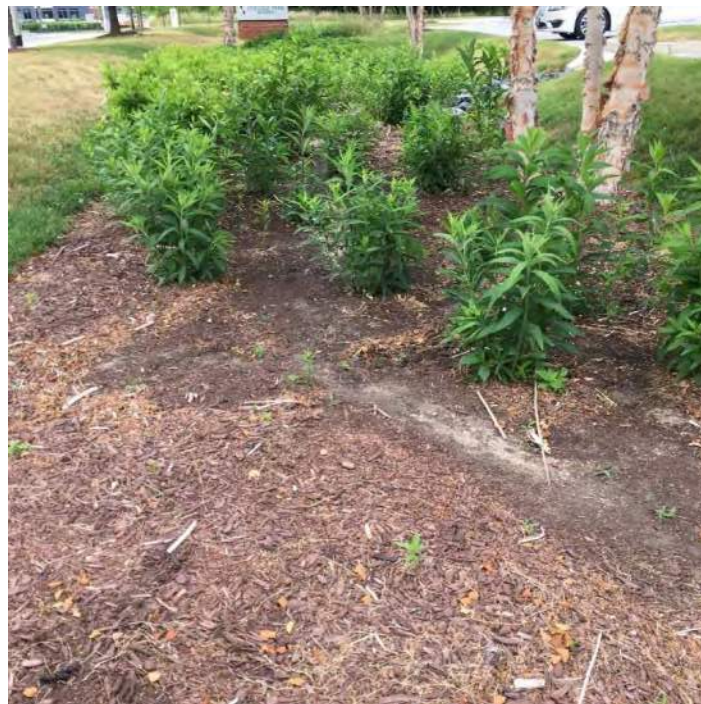
Channeling Conveyance

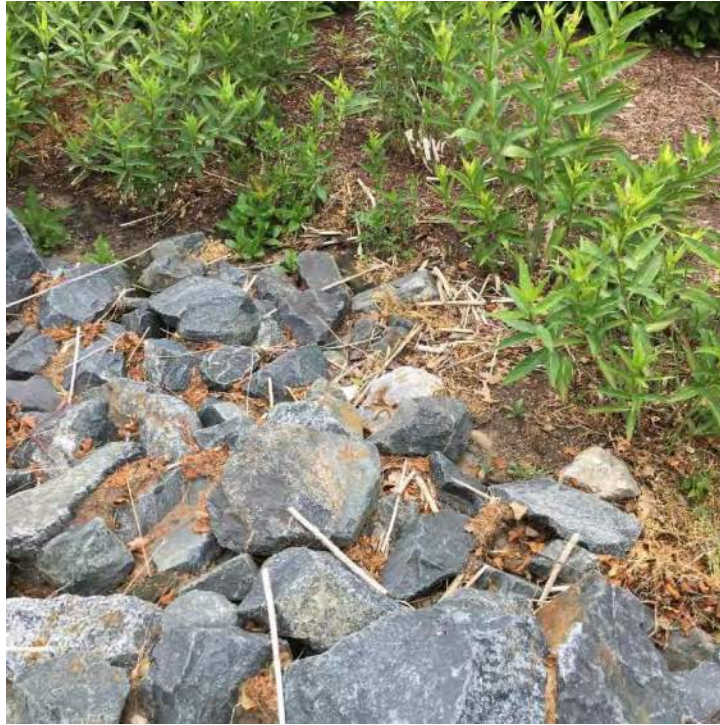
Debris Inflow

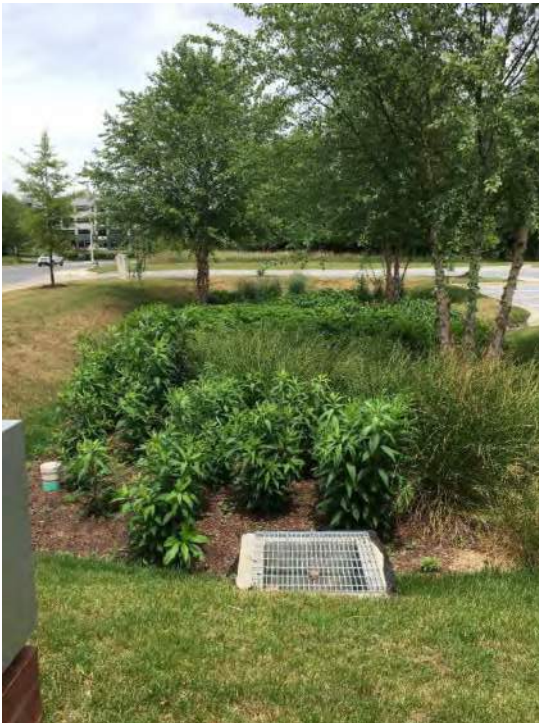
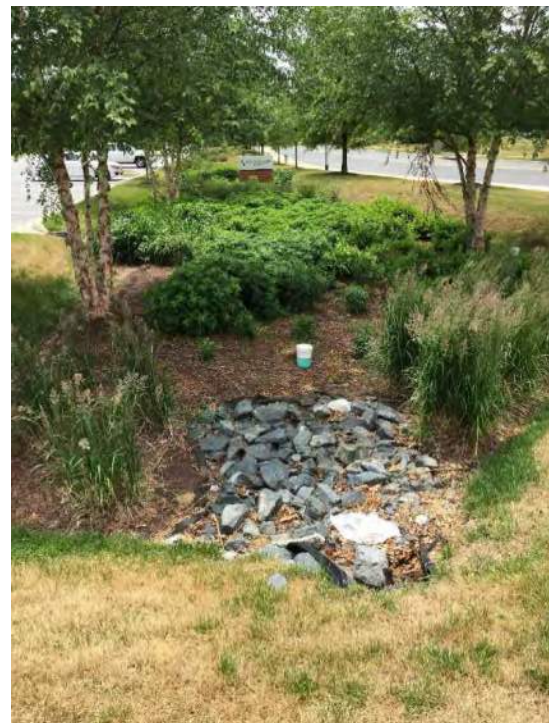
Overall Photo

Date of Inspection:	June 1, 2021, 01:29 pm	Inspector Initials	KR, DH
BMP ID	UMCP20BMP0271	Inspection Firm	MES
BMP Type:	Micro-bioretentention	Underground BMP?	No
BMP Status:	Pass	Overall Inspection Comment	Overall BMP in good condition. Minor debris, erosion and exposed matting at inflows. Minor erosion no north east side of basin.
Maintenance Level:	Minor Maintenance

- **BMP Access** - Good
- **Debris & Sediment** - Good
- **Vegetation** - Good
- **BMP Contamination** - Good
- **General Site Conditions Comments:**
- **Inflow Condition** - Fair
- **Inflow Comments:** Minor debris, erosion and exposed matting at inflows.
- **Forebay** – N/A
- **Conveyance Stability** - Good
- **Downstream Condition** – Not rated
- **Downstream Condition Comments:** Downstream not accessible

Remove debris at inflows. Repair erosion and exposed matting at inflows. Repair erosion northeast end of basin.

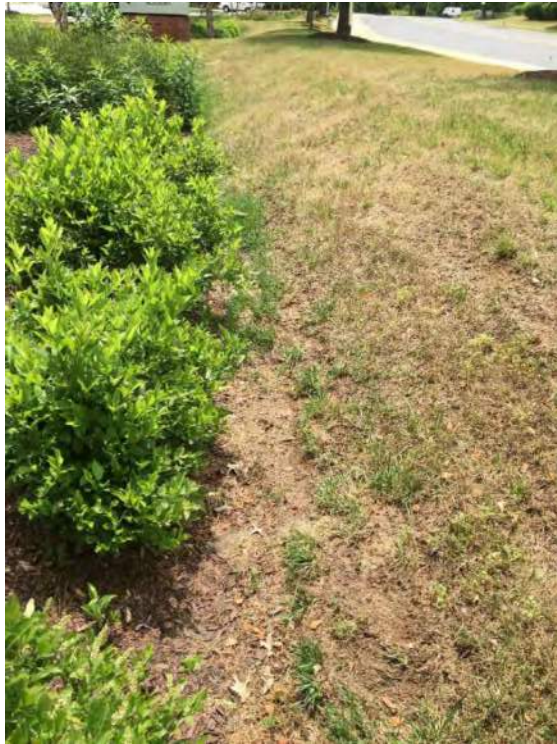
Erosion

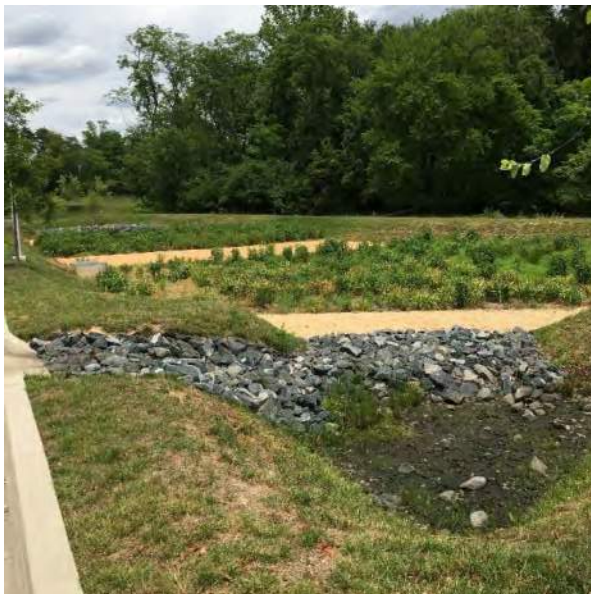
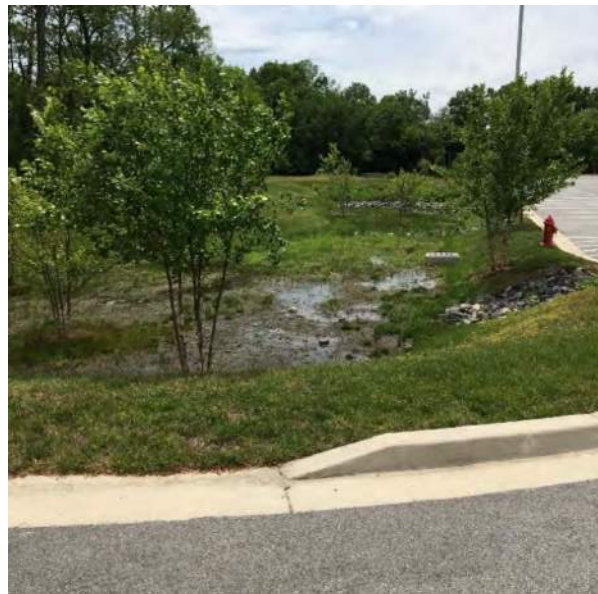
Overall Photo

Date of Inspection:	June 1, 2021, 1:23 PM	Inspector Initials	KR, DH
BMP ID	UMCP20BMP0272	Inspection Firm	MES
BMP Type:	Submerged Gravel Wetland	Underground BMP?	No
BMP Status:	Pass	Overall Inspection Comment	Minor erosion and debris north forebay inflow. Minor erosion upstream embankments. Minor ponding and muck within both forebays.
Maintenance Level:	Minor Maintenance (Use of Hand Equipment for Repairs)

- **BMP Access** - Good
- **Debris & Sediment** - Good
- **Vegetation** - Good
- **BMP Contamination** - Good
- **General Site Conditions Comments:**
- **Inflow Condition** - Fair
- **Inflow Comments:** Minor erosion, debris, vegetation north forebay inflow
- **Forebay** – Fair
- **Conveyance Stability** - Good
- **Downstream Condition** – Not rated
- **Downstream Condition Comments:** Downstream not accessible

Repair erosion at inflows and in embankments. Remove vegetation from inflows. Seed forebay bottoms.

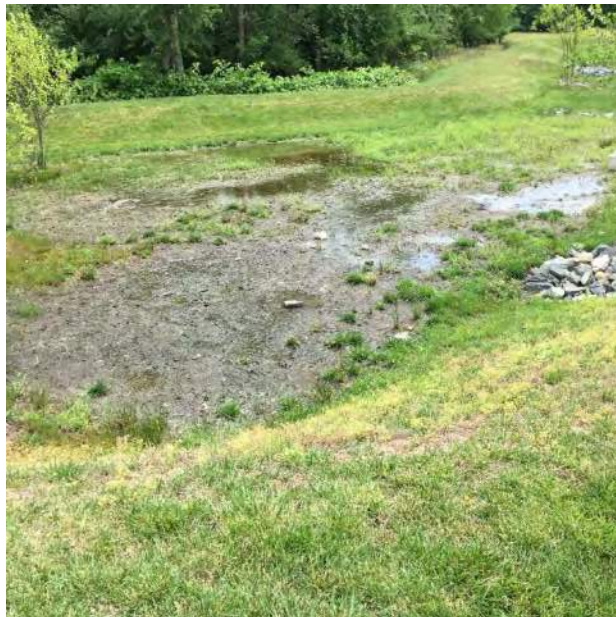
North Forebay

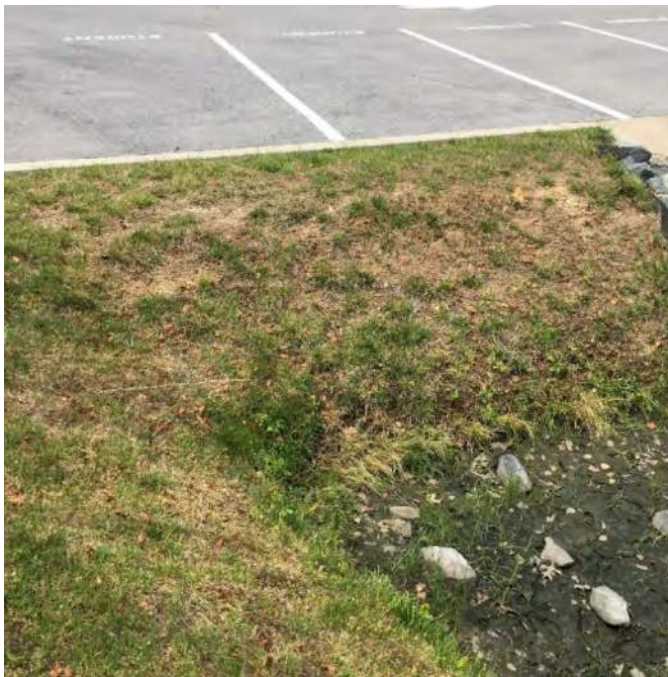
Erosion South Forebay

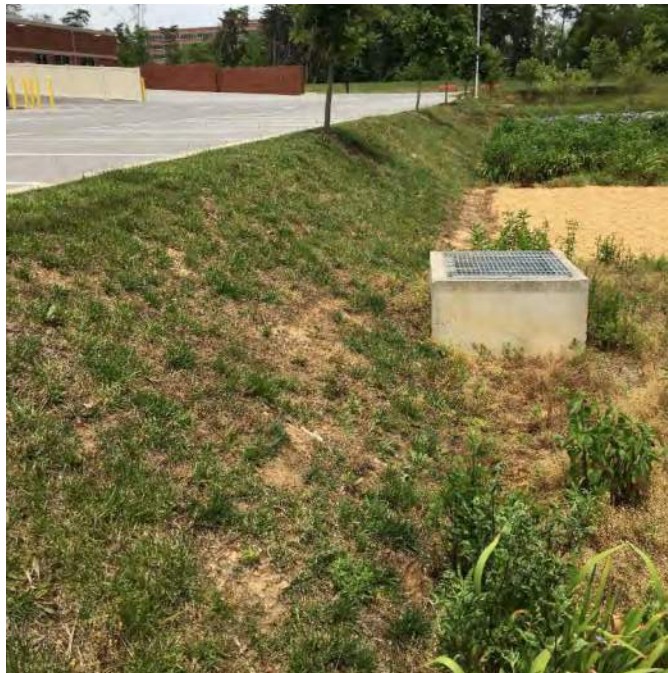
Embankment Erosion A

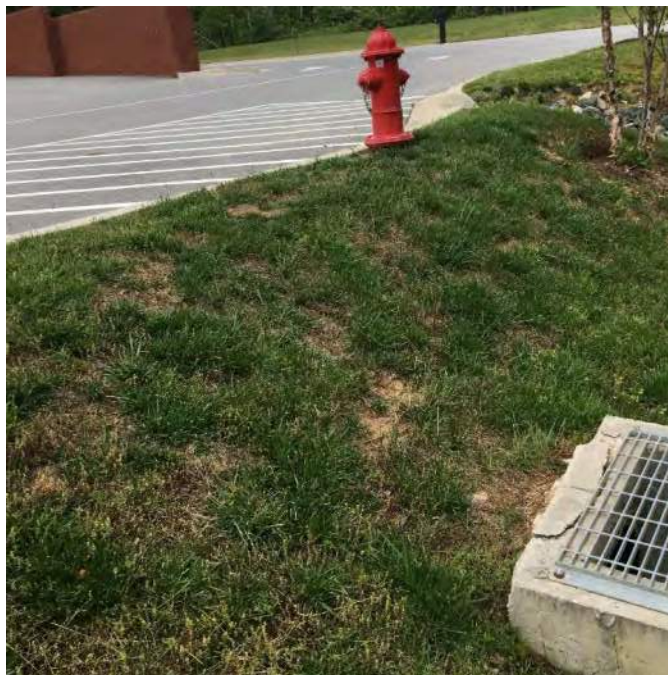
Embankment Erosion B

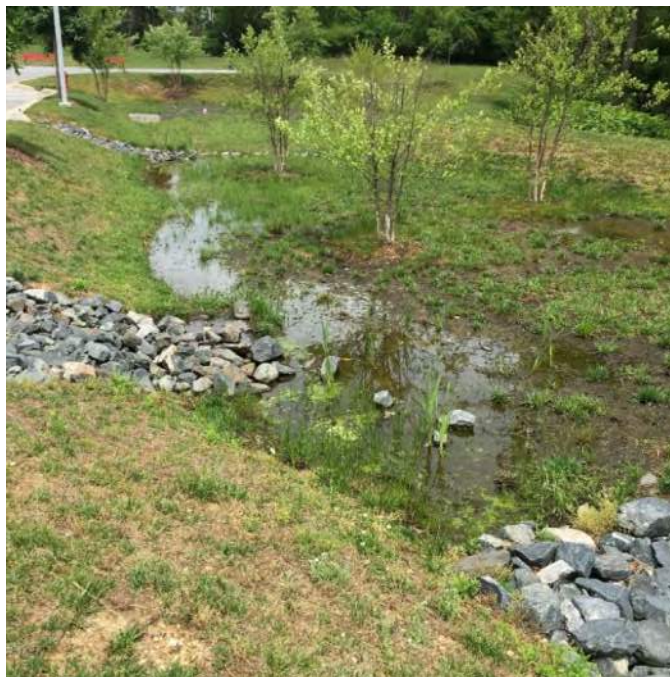
Ponding North Forebay

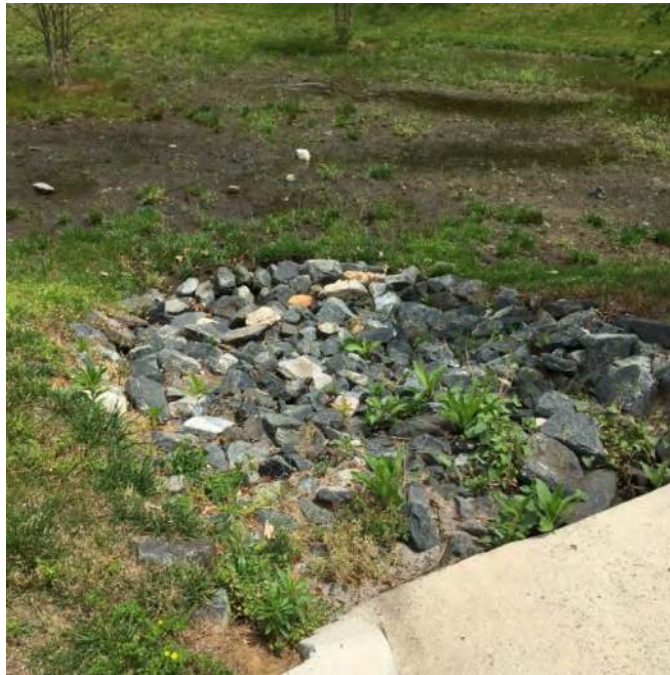
Erosion Vegetation Inflow

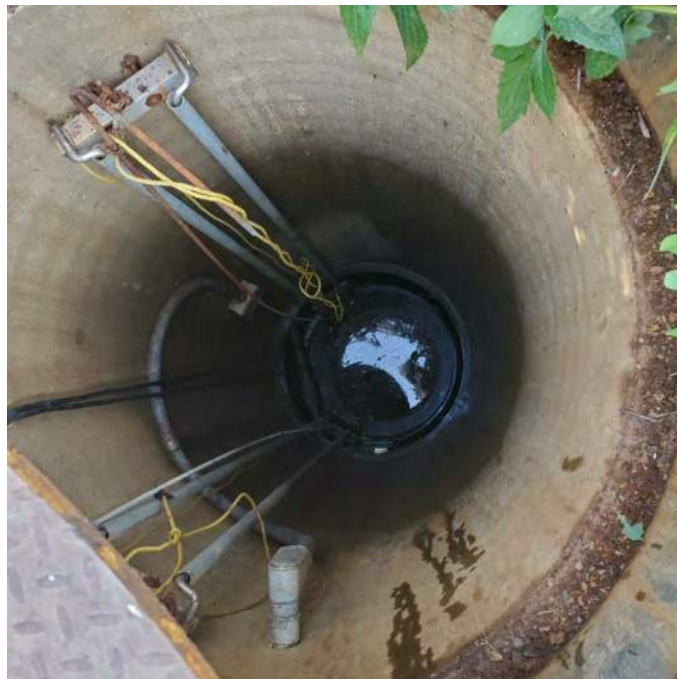
Overall Photo

Date of Inspection:	July 15, 2021, 2:45 PM	Inspector Initials	SAL, BC
BMP ID	UMCP19BMP0082	Inspection Firm	MES
BMP Type:	Rainwater Harvesting	Underground BMP?	Yes
BMP Status:	Pass	Overall Inspection Comment	4 feet of ponding within structure. Uncertain if this is designed depth or ponding.
Maintenance Level:	Routine maintenance

- **BMP Access** - Poor
- **Debris & Sediment** - Good
- **Vegetation** – N/A
- **BMP Contamination** - Good
- **General Site Conditions Comments:** Single entrance manhole without access ladder, 4 of standing water within facility
- **Inflow Condition** – Not rated
- **Inflow Comments:** Unable to access inflow due to standing water
- **Forebay** – N/A
- **Conveyance Stability** - Good
- **Downstream Condition** – Good
- **Downstream Condition Comments:**

Install manual drain controls for building maintenance, install access ladder

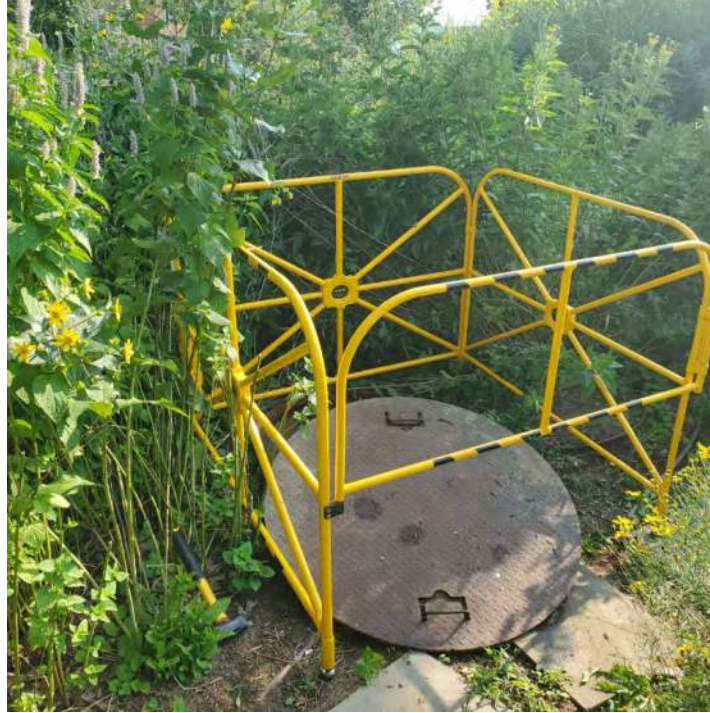
Entrance

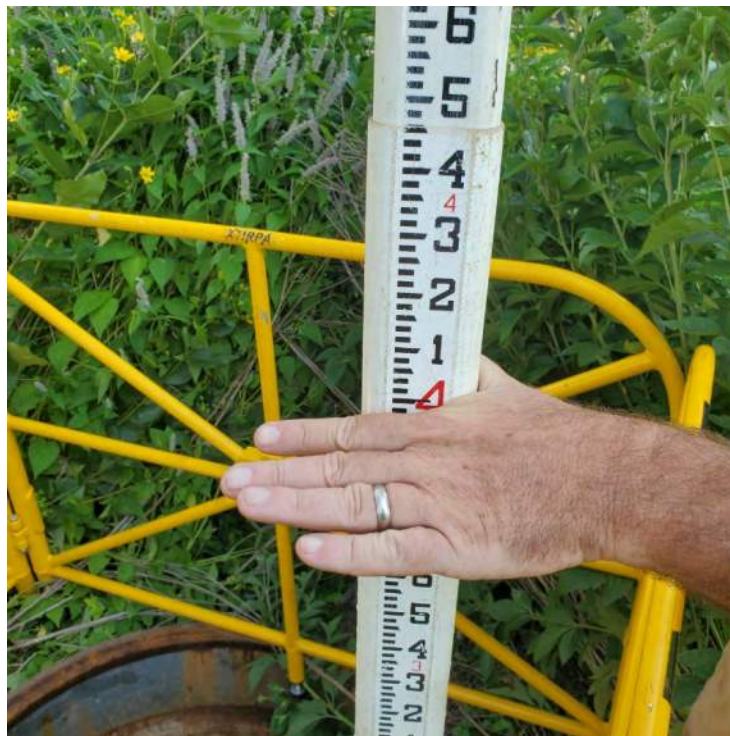
Ponding Depth

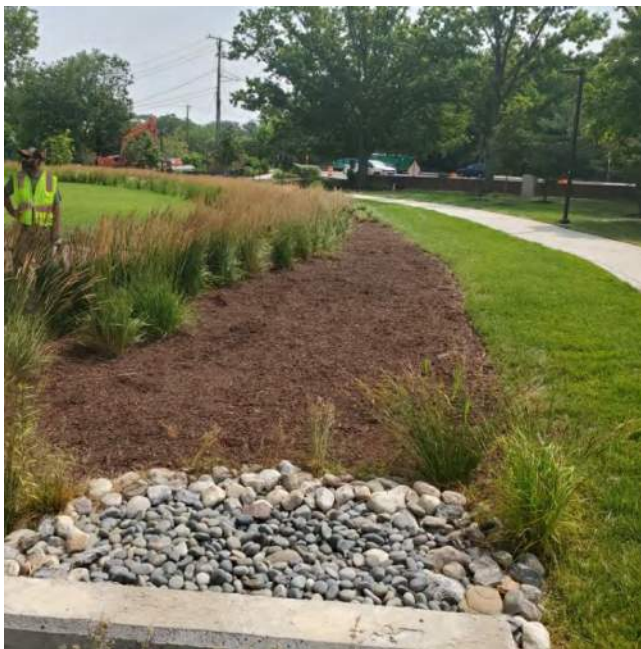
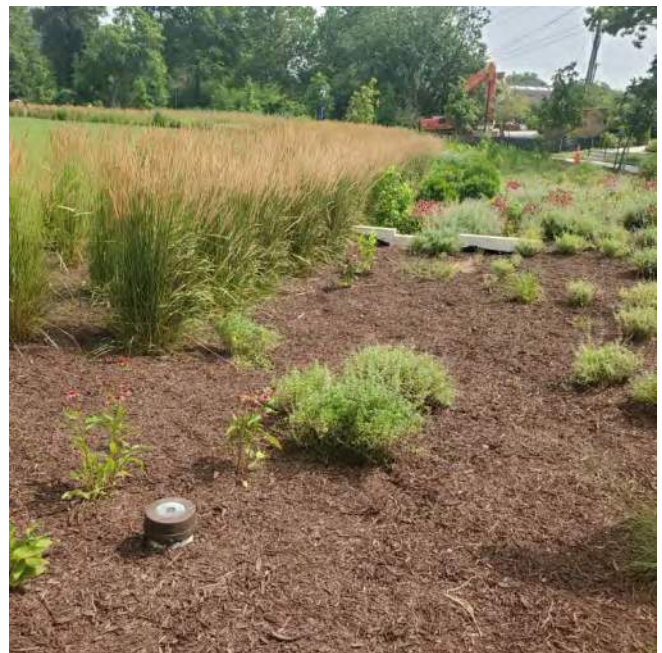
Overall Photo

Date of Inspection:	July 15, 2021 10:45 AM	Inspector Initials	SAL, BC, OKB, DCH
BMP ID	UMCP20BMP0243	Inspection Firm	MES
BMP Type:	Bioswale	Underground BMP?	No
BMP Status:	Pass	Overall Inspection Comment	Overgrown vegetation at overflow structure and downstream
Maintenance Level:	Minor maintenance

Maintenance & Remediation Recommendations – Control vegetation to ensure control structure does not become clogged

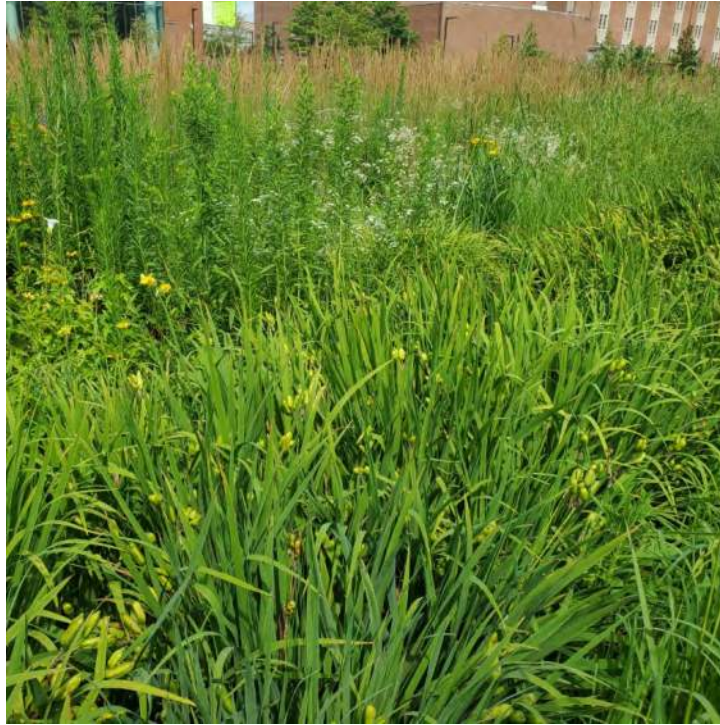
- **BMP Access** - Good
- **Debris & Sediment** - Good
- **Vegetation** – Fair
- **BMP Contamination** - Good
- **General Site Conditions Comments:** Overgrown vegetation at control structure
- **Inflow Condition** – Good
- **Forebay** – N/A
- **Conveyance Stability** - Good
- **Downstream Condition** – N/A

Overgrown Vegetation

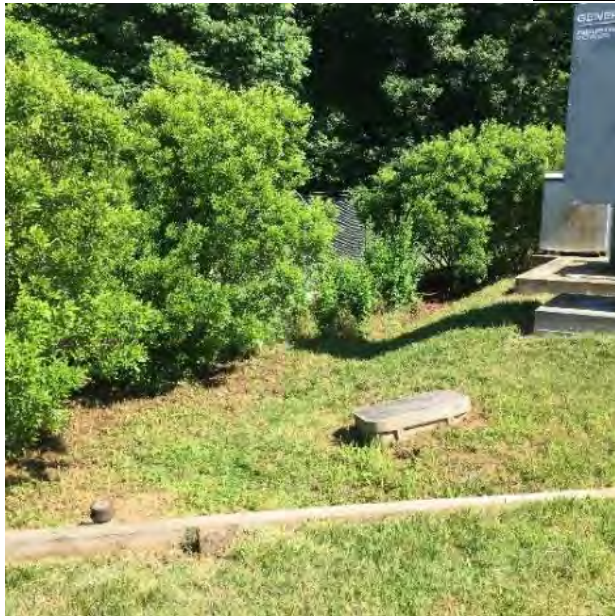
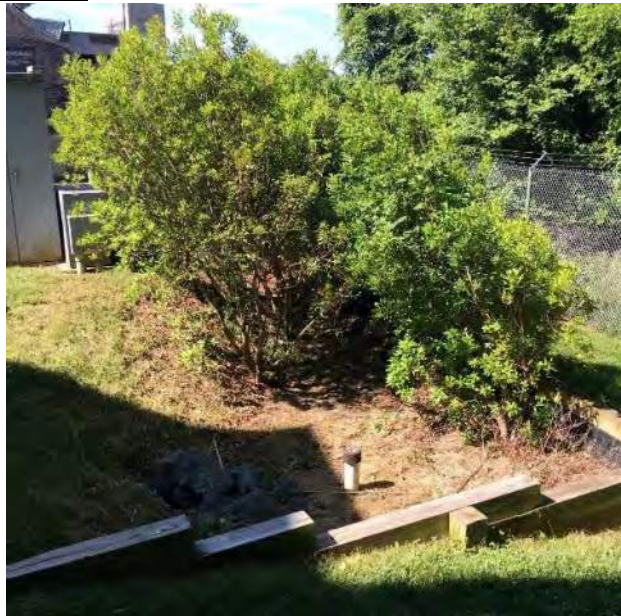
Overall Photo

Date of Inspection:	June 1, 2021, 10:00 AM	Inspector Initials	KR, DH
BMP ID	UMCP19BMP0042	Inspection Firm	MES
BMP Type:	Micro-bioretentation	Underground BMP?	No
BMP Status:	Pass	Overall Inspection Comment	Bare areas within conveyance. Minor erosion and sediment accumulation at south inflow. Minor vegetation growth outfall riprap.
Maintenance Level:	Minor Maintenance (Use of Hand Equipment for Repairs)

Remove vegetation outfall riprap. Remulch bare areas conveyance. Regrade south inflow. Trim vegetation and remove leafy debris from basin.

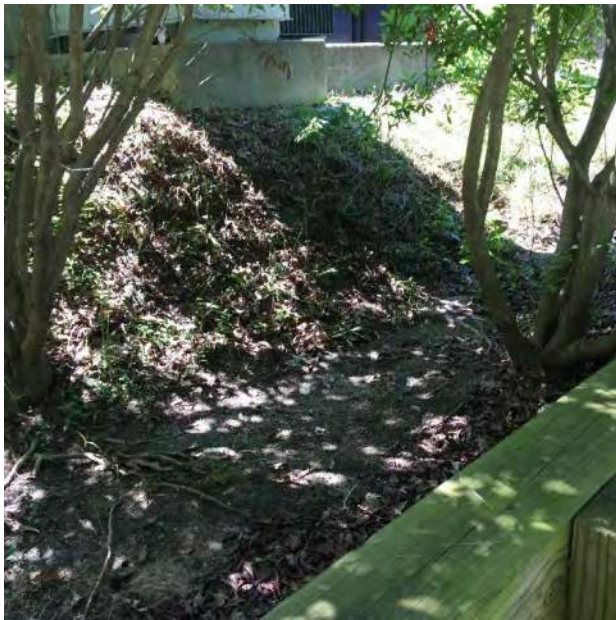
Erosion Conveyance

- **BMP Access** - Good
- **Debris & Sediment** - Fair
- **Vegetation** - Good
- **BMP Contamination** - Good
- **Other Repair Items** - Minor leafy debris accumulation within conveyance.
- **General Site Conditions Comments:**
- **Inflow Condition** - Fair
- **Inflow Comments:** Minor erosion and sediment accumulation south inflow.
- **Forebay** – N/A
- **Conveyance Stability** - Fair
- **Downstream Condition** – Good
- **Downstream Condition Comments:** Downstream not accessible
- **Other Repair Items:** Bare areas within conveyance.

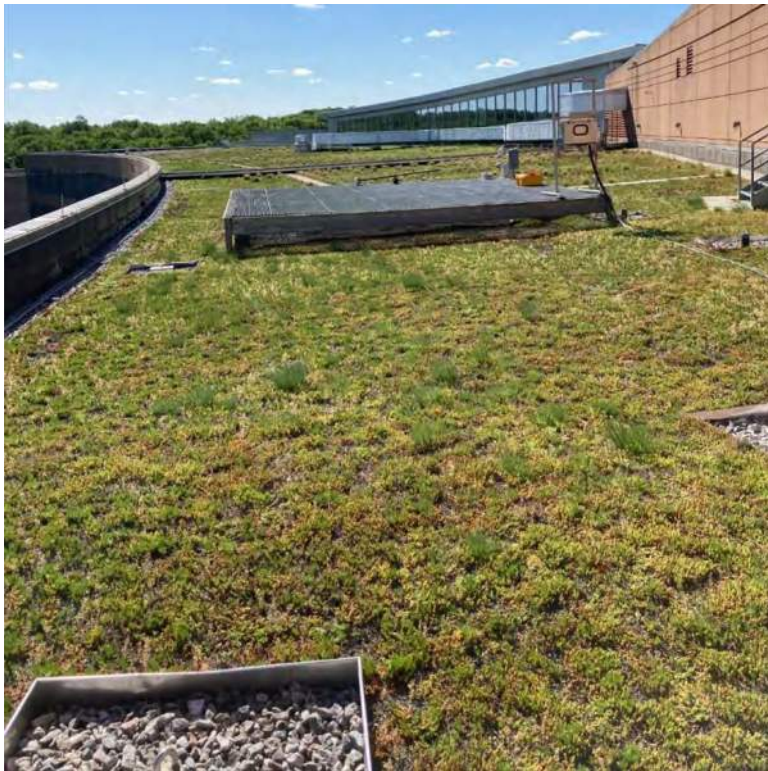
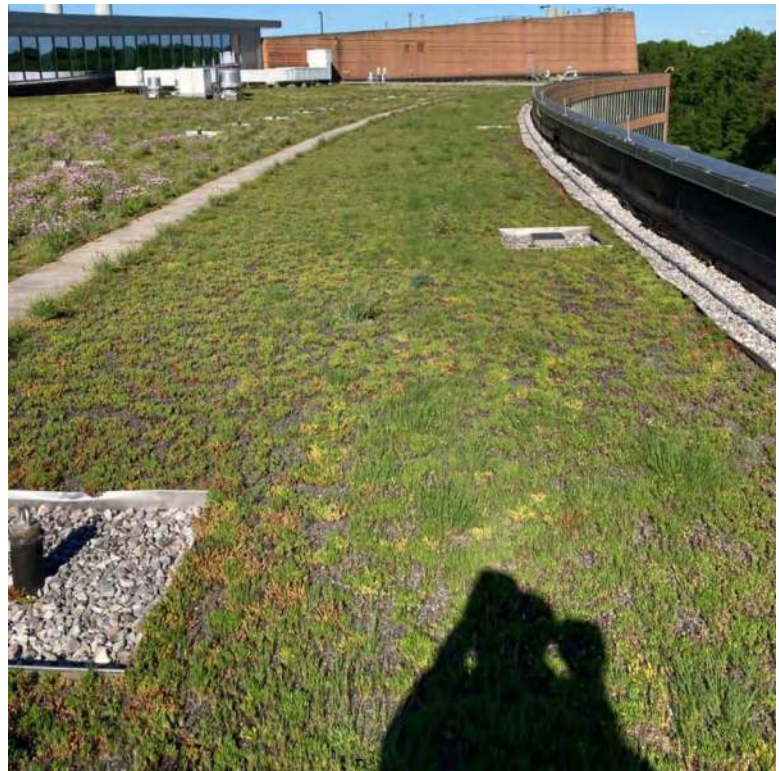
Overall Photo

Date of Inspection:	May 6, 2021	Inspector Initials	BC,KR
BMP ID	UMCP20BMP0273	Inspection Firm	MES
BMP Type:	Green Roof - Extensive	Underground BMP?	No
BMP Status:	Pass	Overall Inspection Comment	Overall BMP in good condition. Minor bare areas.
Maintenance Level:	Minor Maintenance

Continue routine maintenance. Establish vegetation within bare areas.

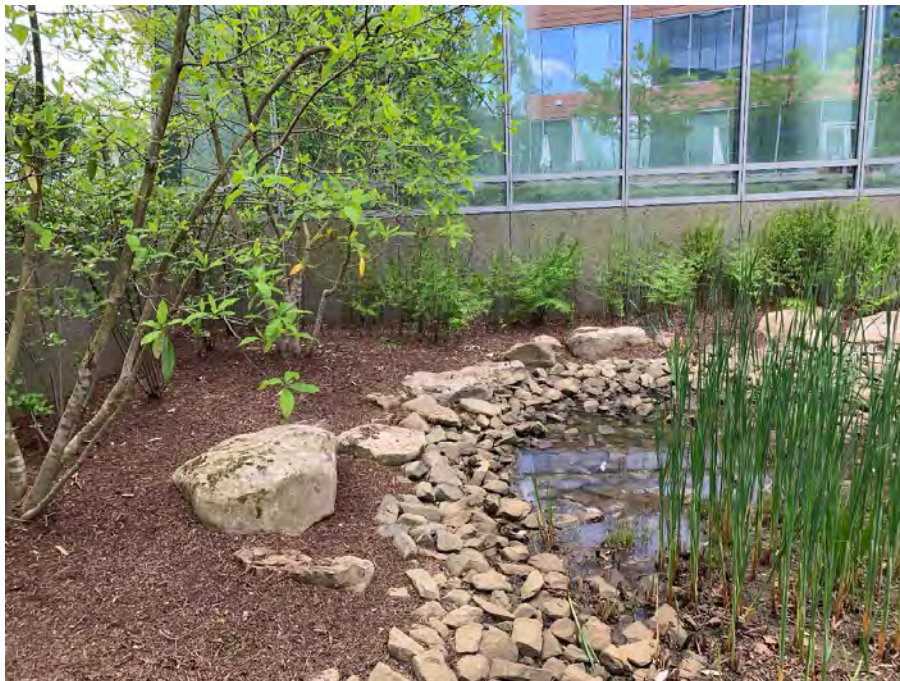
Excessive Ponding

- **Ponding** - Poor / **Water Depth** – 0.5 ft
- **Treatment Area Comments:** Rip rap of basin holding water
- **Other Repair Items:** Remove sediment and debris. Vacuum/flush cleanout
- **Low Flow Orifice** - N/A
- **Outlet / Control Structure** - Good
- **Other Repair Items** – Remove woody vegetation around riser
- **Control Structure Comments:**
- **Principal Spillway** – Good
- **Spillway Outfall** – Good

Remove invasives, flush/vacuum cleanout, remove riprap and sediment, replace media/riprap if needed

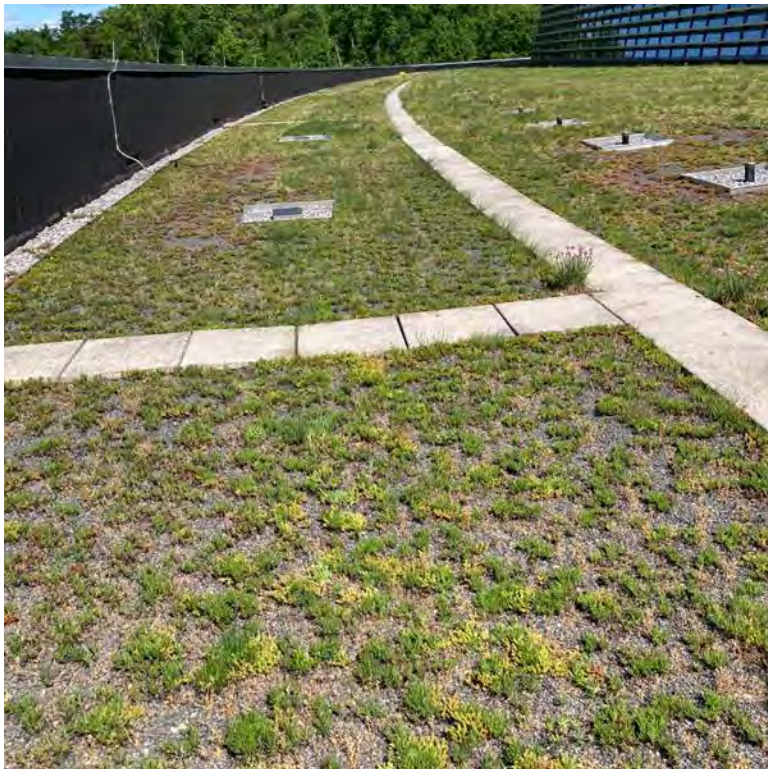
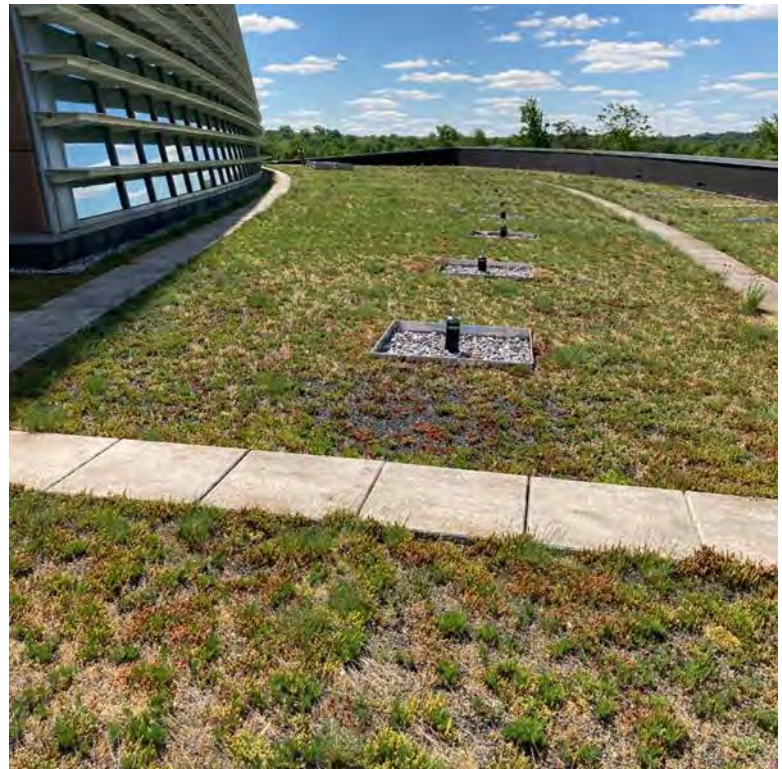
Overall Photo

Date of Inspection:	May 6, 2021	Inspector Initials	BC,KR
BMP ID	UMCP20BMP0275	Inspection Firm	MES
BMP Type:	Green Roof - Extensive	Underground BMP?	No
BMP Status:	Pass	Overall Inspection Comment	Overall BMP in good condition. Several large areas with minimal vegetation growth.
Maintenance Level:	Minor Maintenance

Continue routine maintenance. Establish vegetation within bare areas.

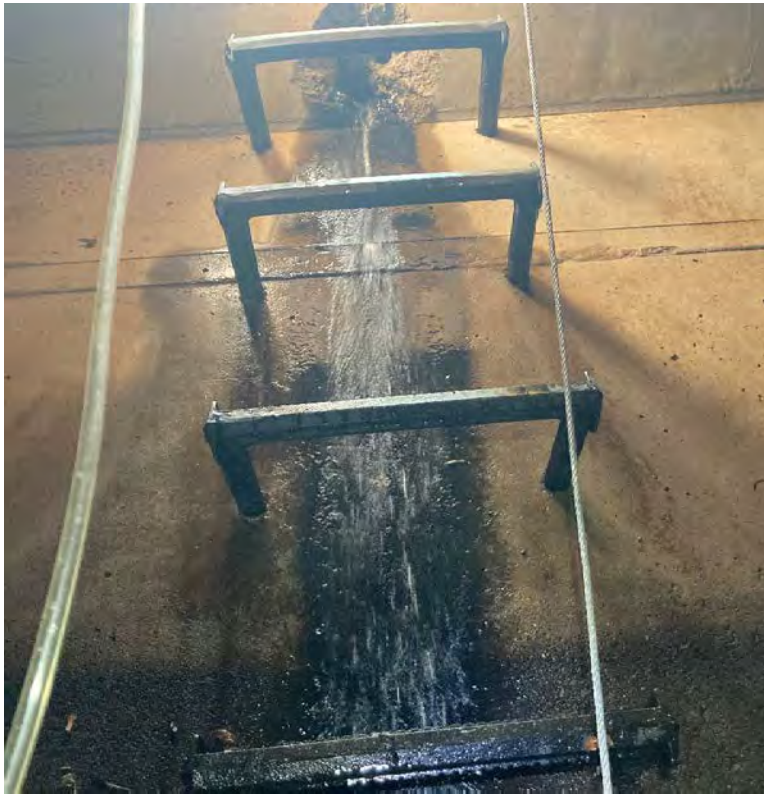
Observed flow

Date of Inspection:	June 17, 2021, 10:48 AM	Inspector Initials	DH, BC, GS
BMP ID	UMCP20BMP0277	Inspection Firm	MES
BMP Type:	Rainwater Harvesting	Underground BMP?	Yes
BMP Status:	Pass	Overall Inspection Comment	Unknown inflow during dry weather conditions
Maintenance Level:	Routine maintenance

Investigate source of dry weather flow to determine if source is illicit discharge or is compromising facility

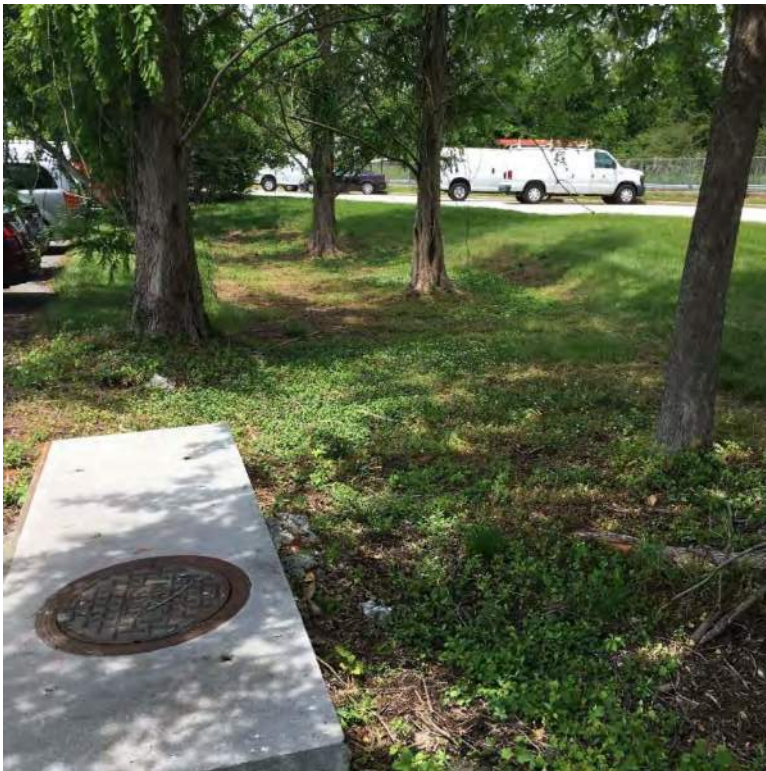
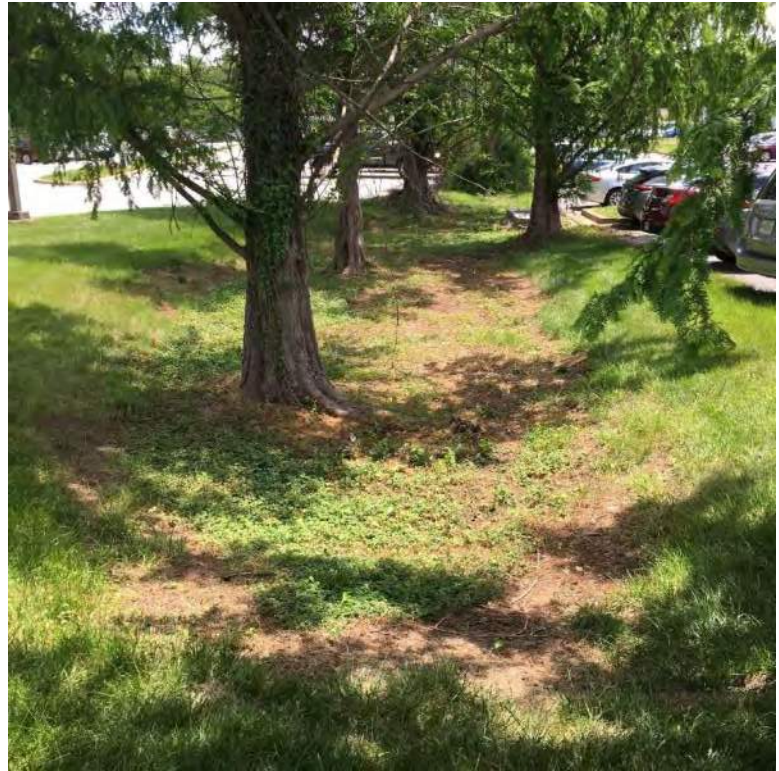
Overall Photo

Date of Inspection:	June 1, 2021, 12:43PM	Inspector Initials	KR, DH
BMP ID	UMCP20BMP0280	Inspection Firm	MES
BMP Type:	Micro-bioretentation	Underground BMP?	No
BMP Status:	Fail	Overall Inspection Comment	Minor sediment and debris at inflows. Minor bare areas in basin. Grading within basin reducing storage capacity.
Maintenance Level:	Major Maintenance

- **BMP Access** - Good
- **Debris & Sediment** - Fair
- **Vegetation** - Good
- **BMP Contamination** - Good
- **General Site Conditions Comments:**
- **Inflow Condition** - Good
- **Inflow Comments:** Minor sediment and debris at inflows.
- **Forebay** – N/A
- **Conveyance Stability** - Good
- **Downstream Condition** – Not rated
- **Downstream Condition Comments:** Downstream not accessible

Remove sediment and debris from inflows. Seed bare areas in basin. Excavate/regrade basin to restore storage capacity.

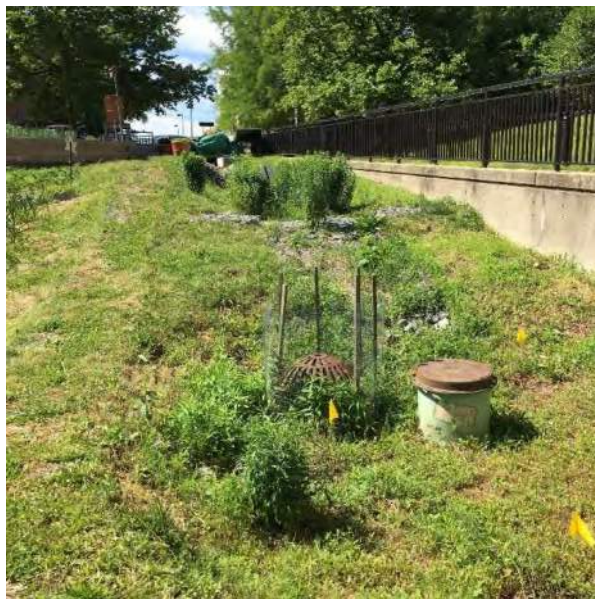
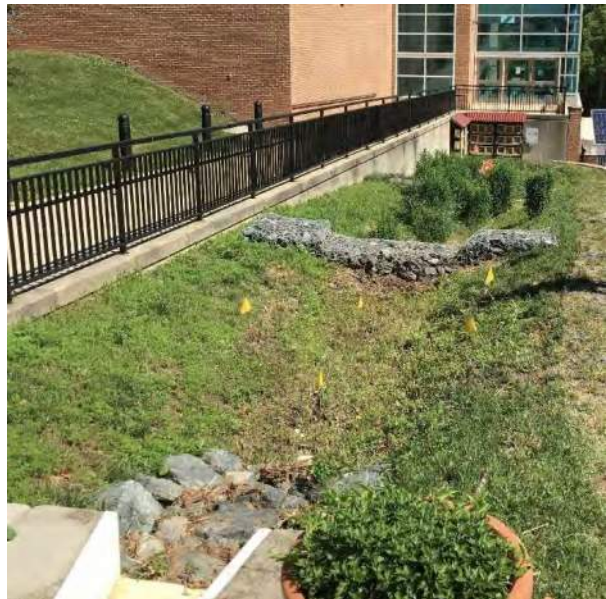
Overall Photo

Date of Inspection:	June 1, 2021, 10:31 AM	Inspector Initials	KR, DH
BMP ID	UMCP19BMP0076	Inspection Firm	MES
BMP Type:	Bioretention	Underground BMP?	No
BMP Status:	Pass	Overall Inspection Comment	Minor bare areas within basin. Minor debris and vegetation inflow riprap after second check dam.
Maintenance Level:	Minor Maintenance (Use of Hand Equipment for Repairs)

Remove debris from riprap. Trim vegetation. Mulch bare areas.

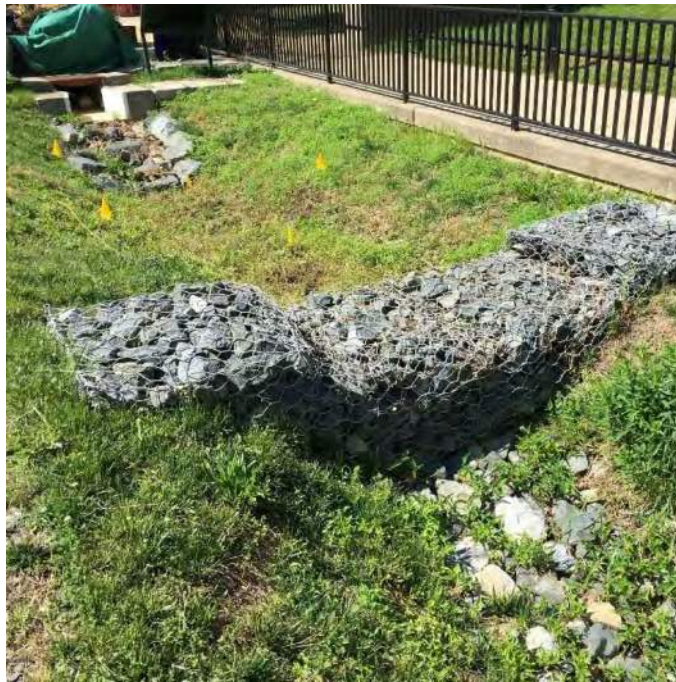
Inflow

- **BMP Access** - Good
- **Debris & Sediment** - Good
- **Vegetation** - Good
- **BMP Contamination** - Good
- **General Site Conditions Comments:**
- **Inflow Condition** - Fair
- **Inflow Comments:** Minor debris and vegetation inflow riprap.
- **Forebay** – N/A
- **Conveyance Stability** - Good
- **Downstream Condition** – N/A
- **Downstream Condition Comments:** Could not access downstream

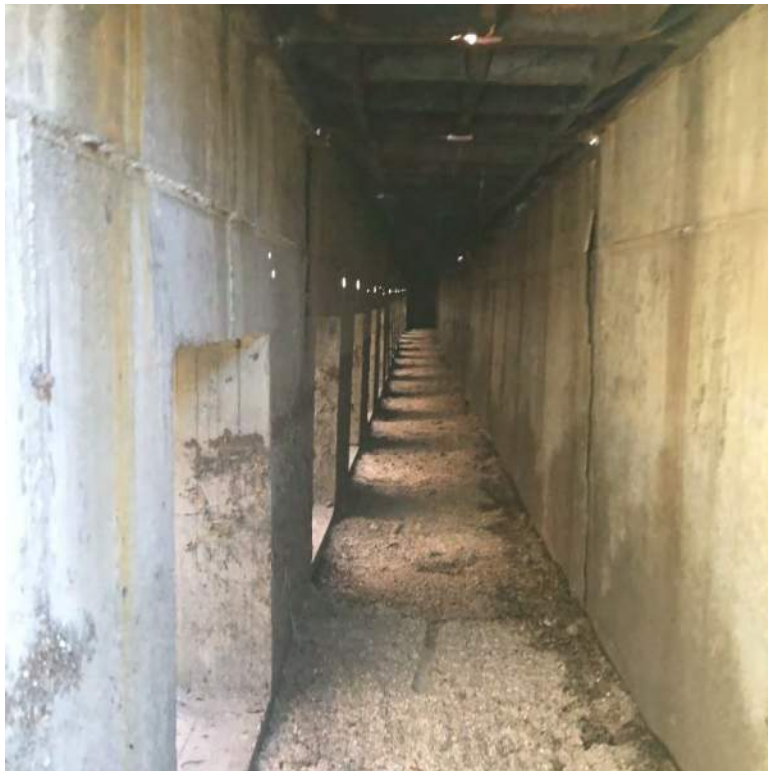
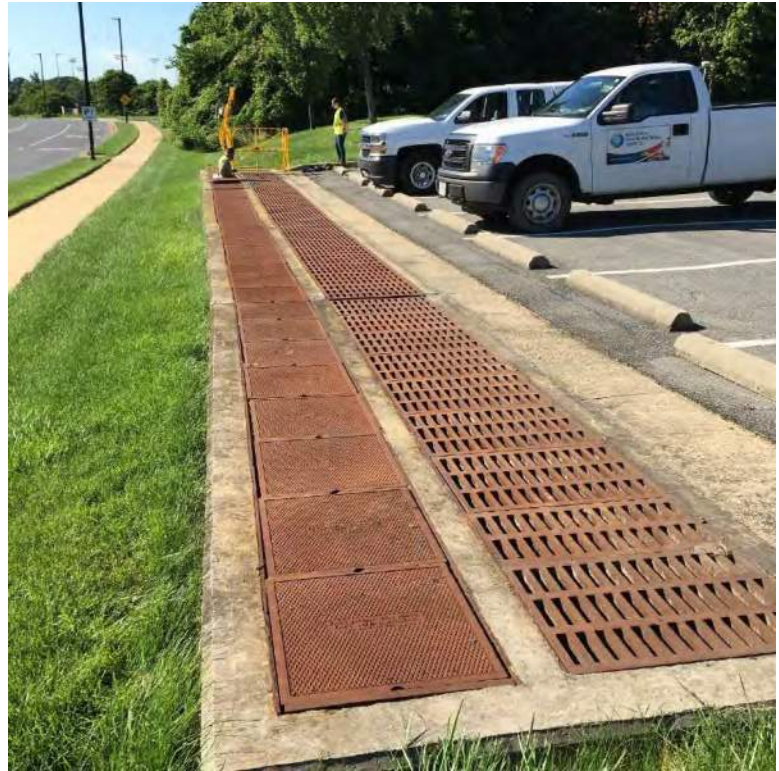
Overall Photo

Date of Inspection:	June 17, 2021, 9:07AM	Inspector Initials	DH, BC, GS
BMP ID	UMCP19BMP0108	Inspection Firm	MES
BMP Type:	Underground Filter	Underground BMP?	Yes
BMP Status:	Pass	Overall Inspection Comment	BMP in good condition, Minor erosion on the outside of BMP, Displaced iron slab above sand filter
Maintenance Level:	Minor Maintenance (Use of Hand Equipment for Repairs)

Repair erosion at side on BMP.
