University of Maryland, College Park
National Pollutant Discharge Elimination
System MS4 Phase II
FY2021 Annual Report
General Discharge Permit #13-SF-5501

Task 2: Findings and Recommendations Report

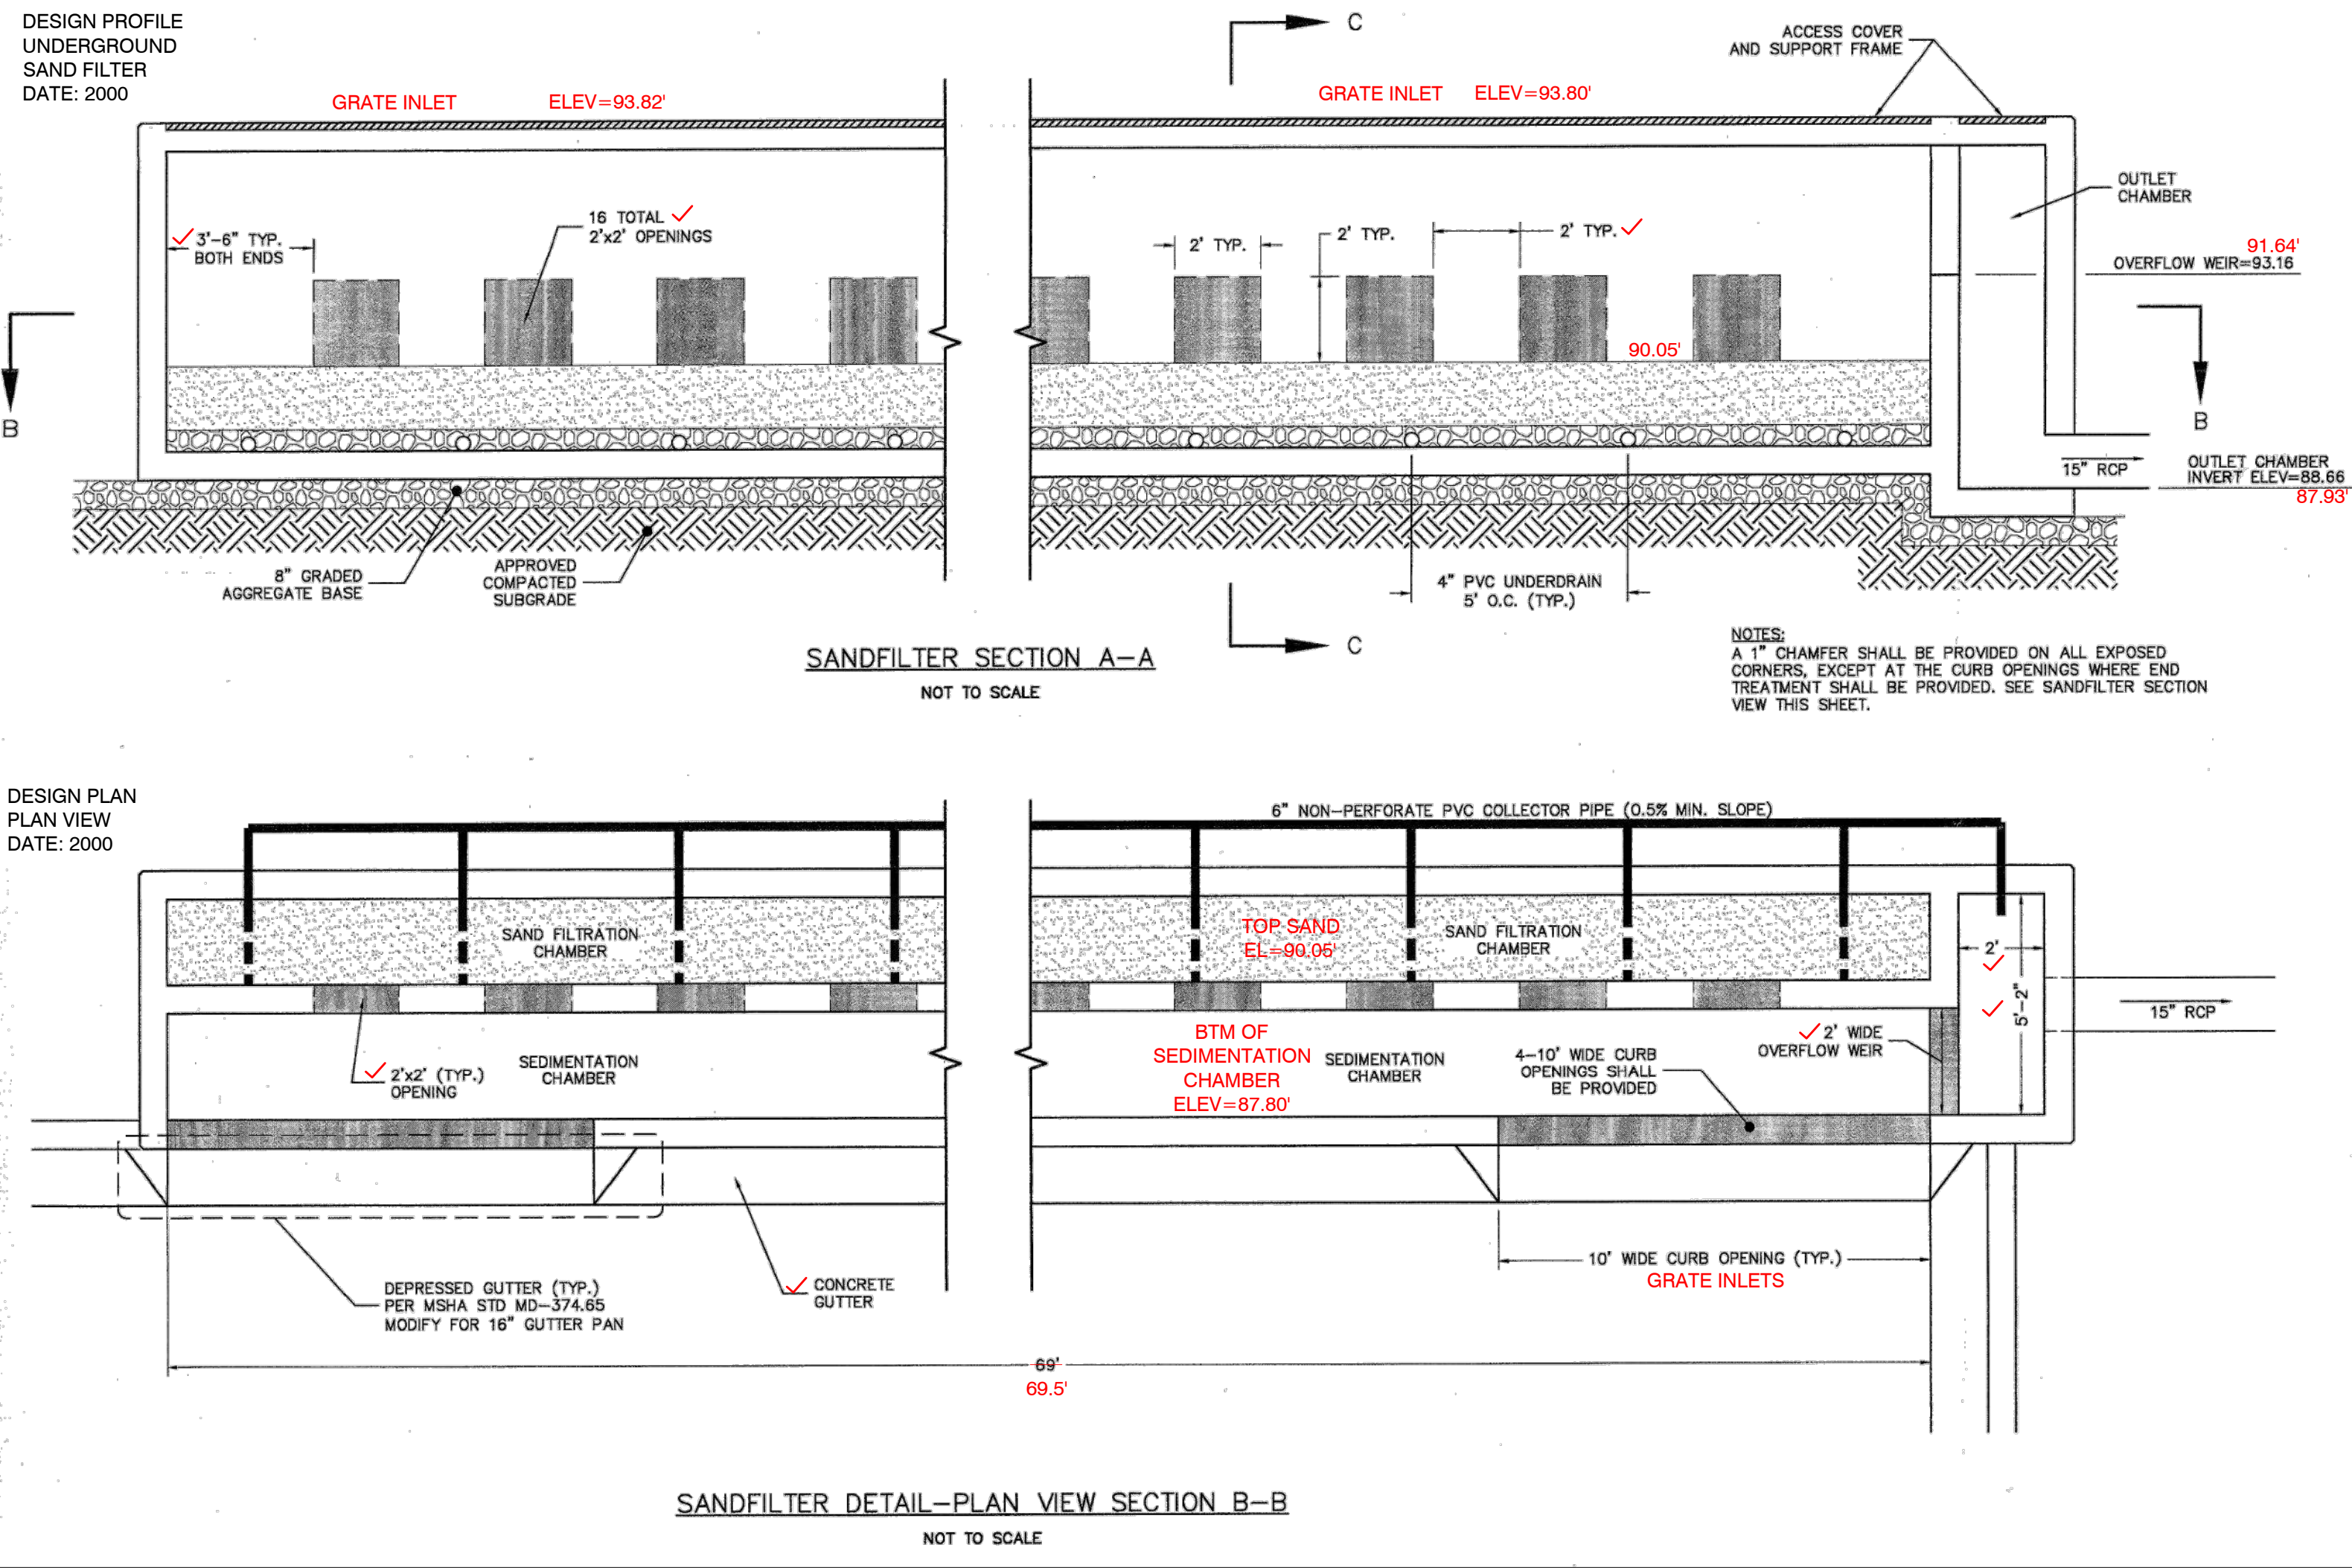
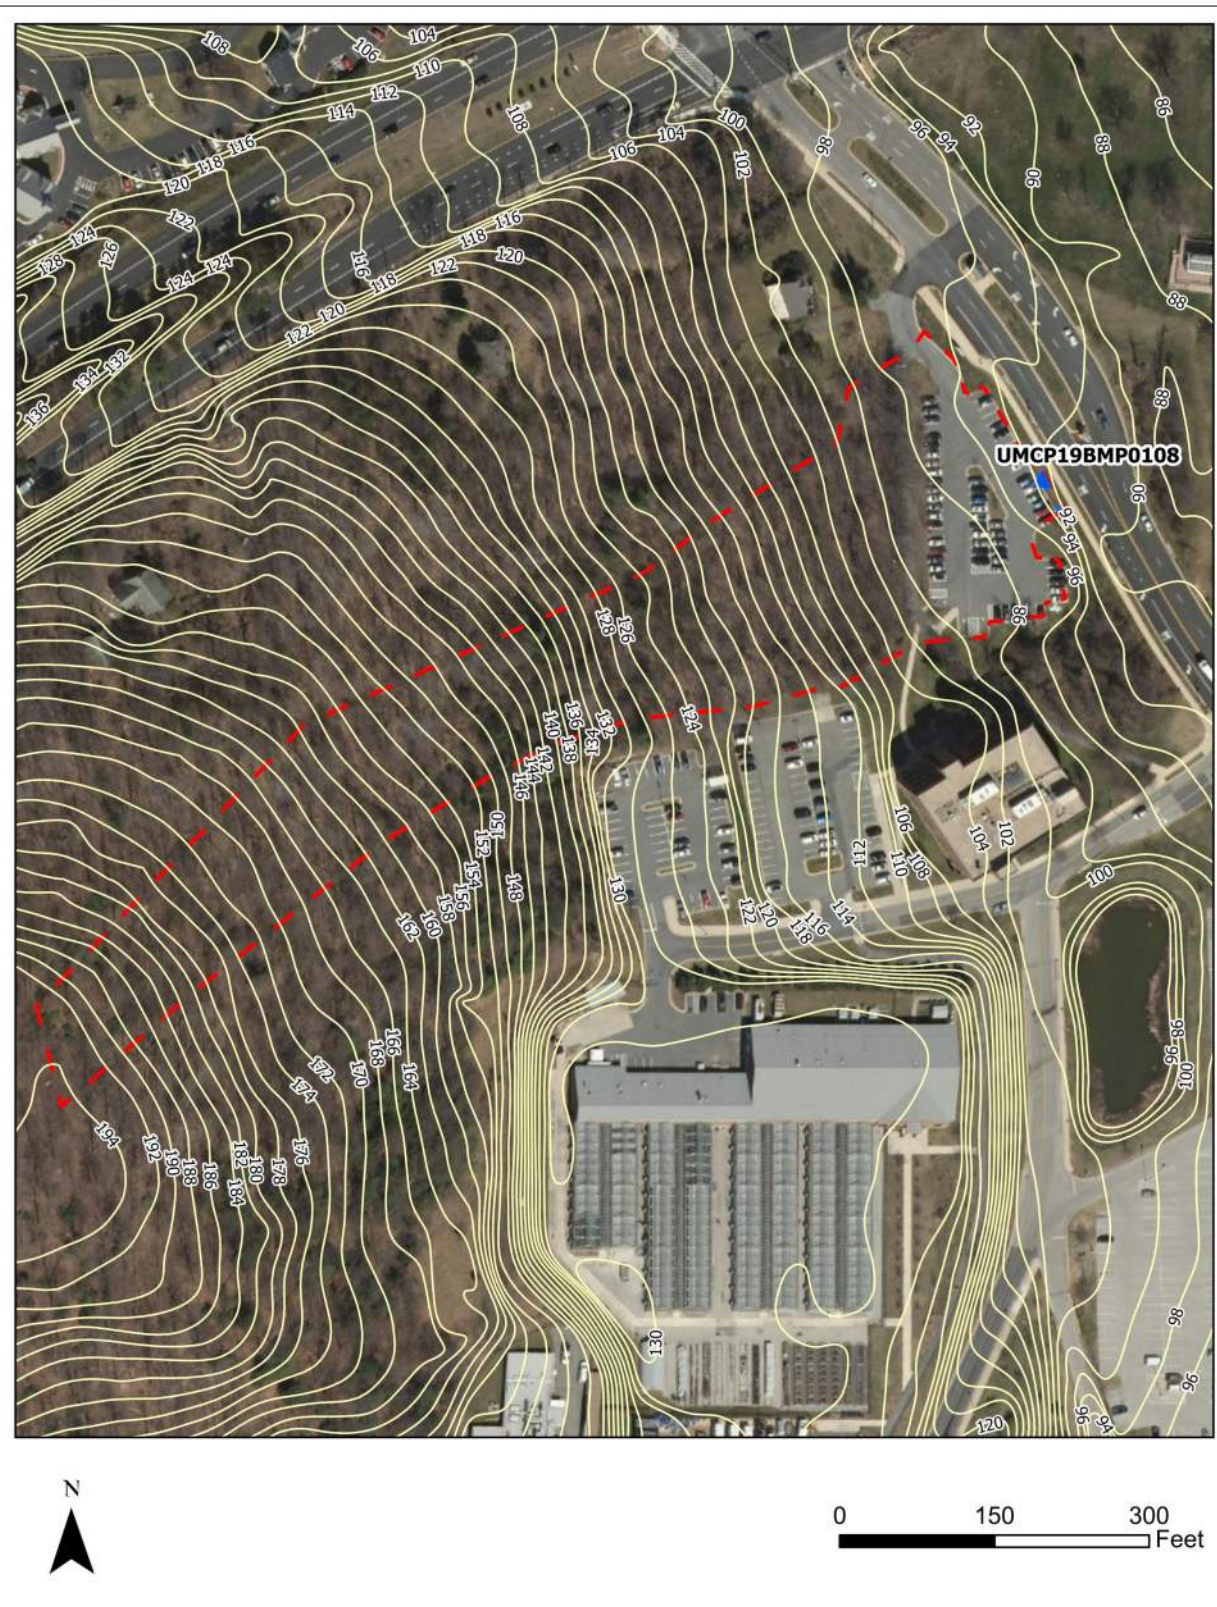
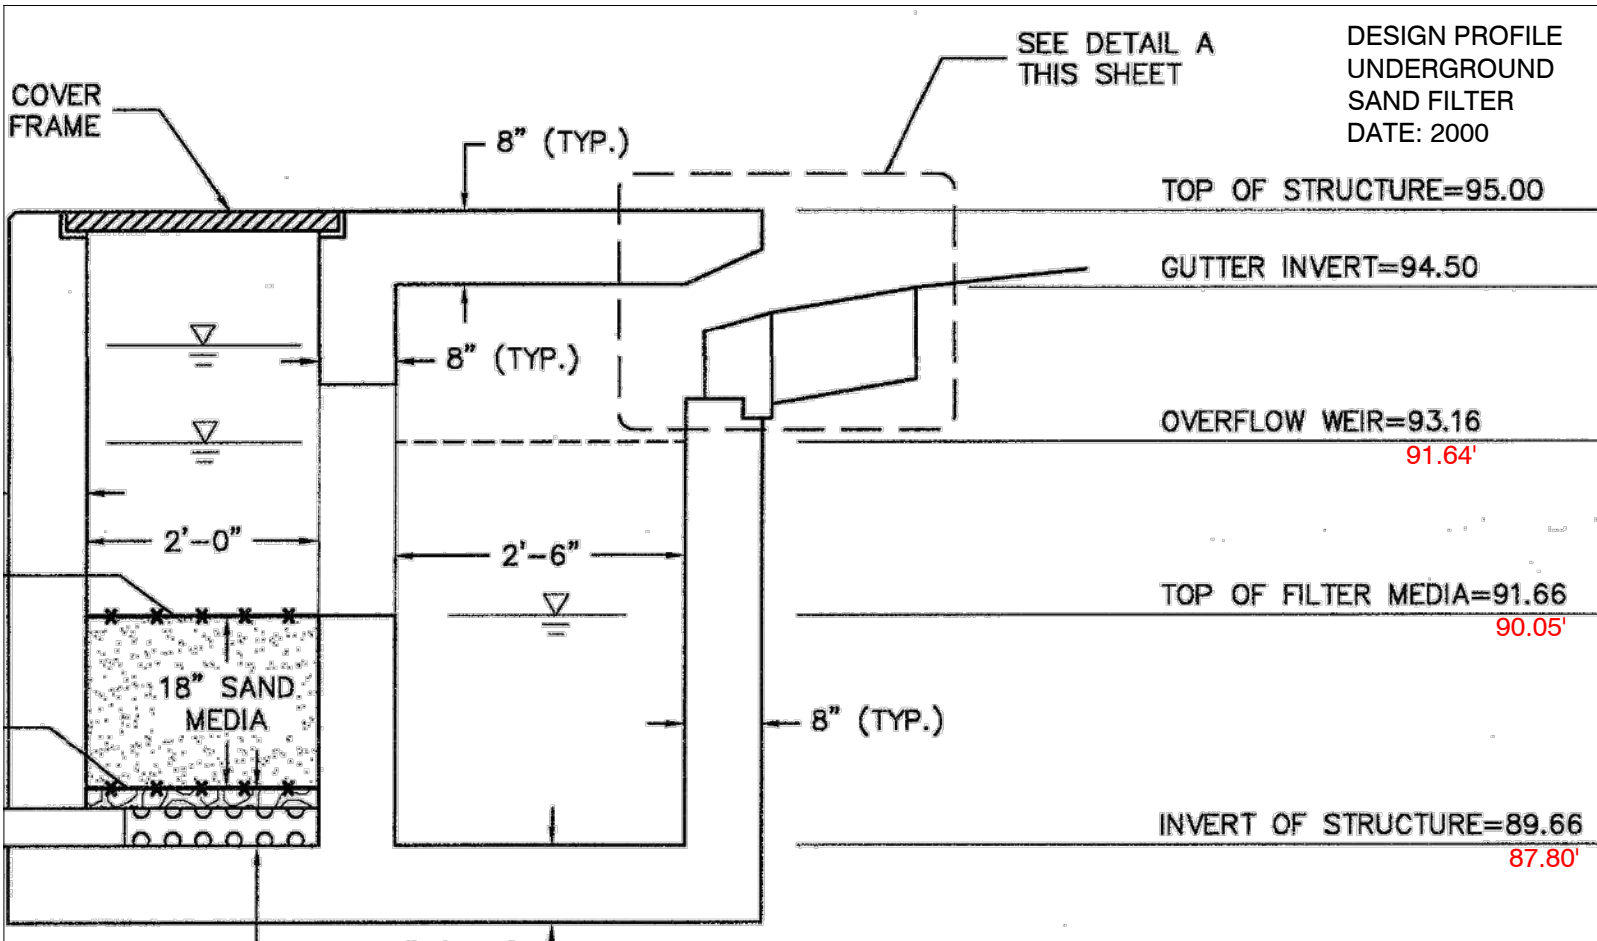
BMP FIELD VERIFICATION WORKSHEET
UMCP19BMP0108 - UNDERGROUND SAND FILTER - 00-SF-0275
CHESAPEAKE LOT (LOT P2)
COLLEGE PARK, MD 20740 - UMCP
GEOSPATIAL & ENGINEERING DIVISION
259 Najoles Road - Millersville, Maryland 21108 - Office: 410-729-8200 - Fax: 410-729-8340

Date of Inspection:	June 17, 2021, 9:07AM	Inspector Initials	DH, BC, GS
BMP ID	UMCP19BMP0108	Inspection Firm	MES
BMP Type:	Underground Filter	Underground BMP?	Yes
BMP Status:	Pass	Overall Inspection Comment	BMP in good condition, Minor erosion on the outside of BMP, Displaced iron slab above sand filter
Maintenance Level:	Minor Maintenance (Use of Hand Equipment for Repairs)

PROJECT NAME: Chesapeake Parking Lot East		MDE NO: UMCP19BMP0108
BMP VERIFICATION DATA FOR FILTERS (Sand Filters and Bioretetion)		
FEATURE	DESIGN	SURVEY
FOREBAY AREA (SQUARE FEET)	172.5	173.75
FOREBAY VOLUME (CUBIC FEET)	603.75	667.2
FILTER BED SURFACE AREA (SQUARE FEET)	138	139
FILTER BED SURFACE ELEVATION (FEET)	91.66	90.05
FILTER INLET PIPE SIZE/INVERT ELEVATION	93.16	91.64
OUTLET PIPE (UNDERDRAIN) SIZE/INVERT ELEVATION	4"/89.66'	4"/ 87.93'
THICKNESS OF FILTER MEDIA (FEET)	1.5	NFV
PLACEMENT OF GEOTEXTILE	around aggregate layer	NFV
PLANTINGS	none	none
COMPOSITION OF FILTER MEDIA	washed sand	✓
WATER QUALITY DEPTH (FEET)	1.5	1.59
NFV = NOT FIELD VERIFIED

Repair erosion at side on BMP.

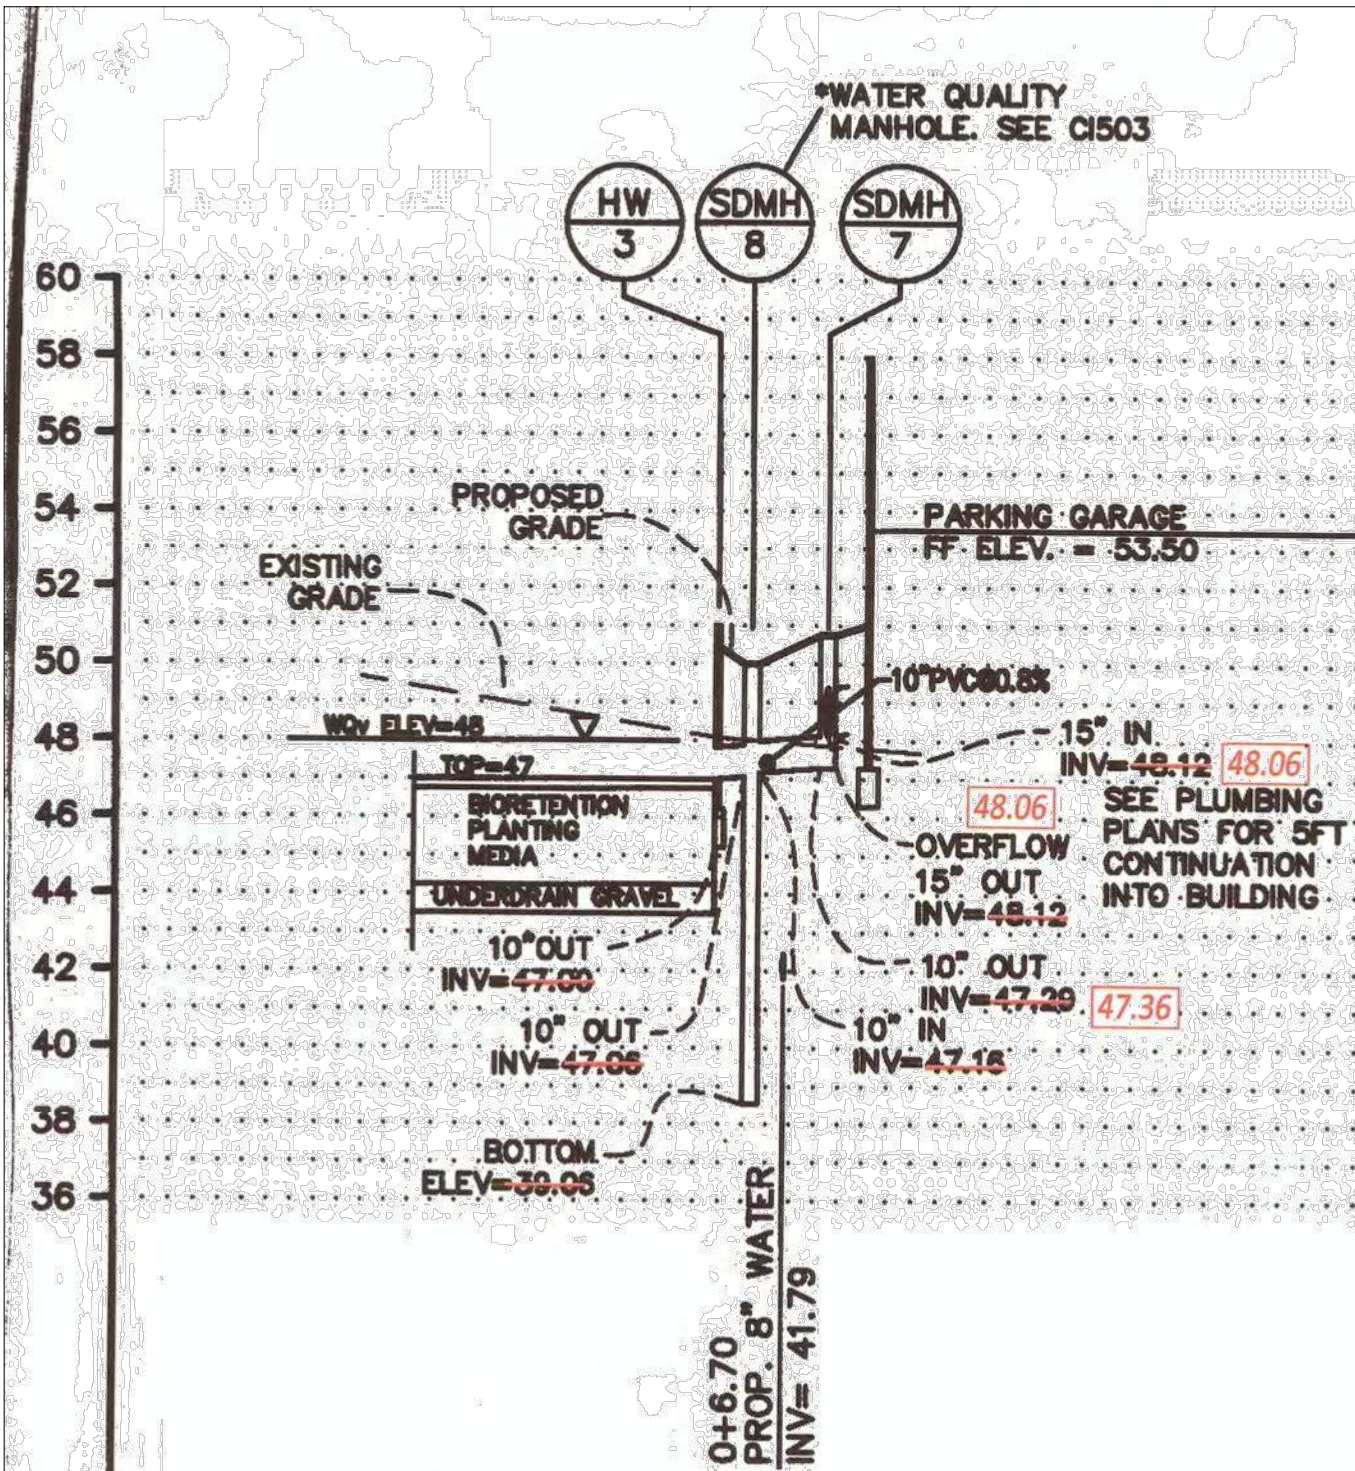
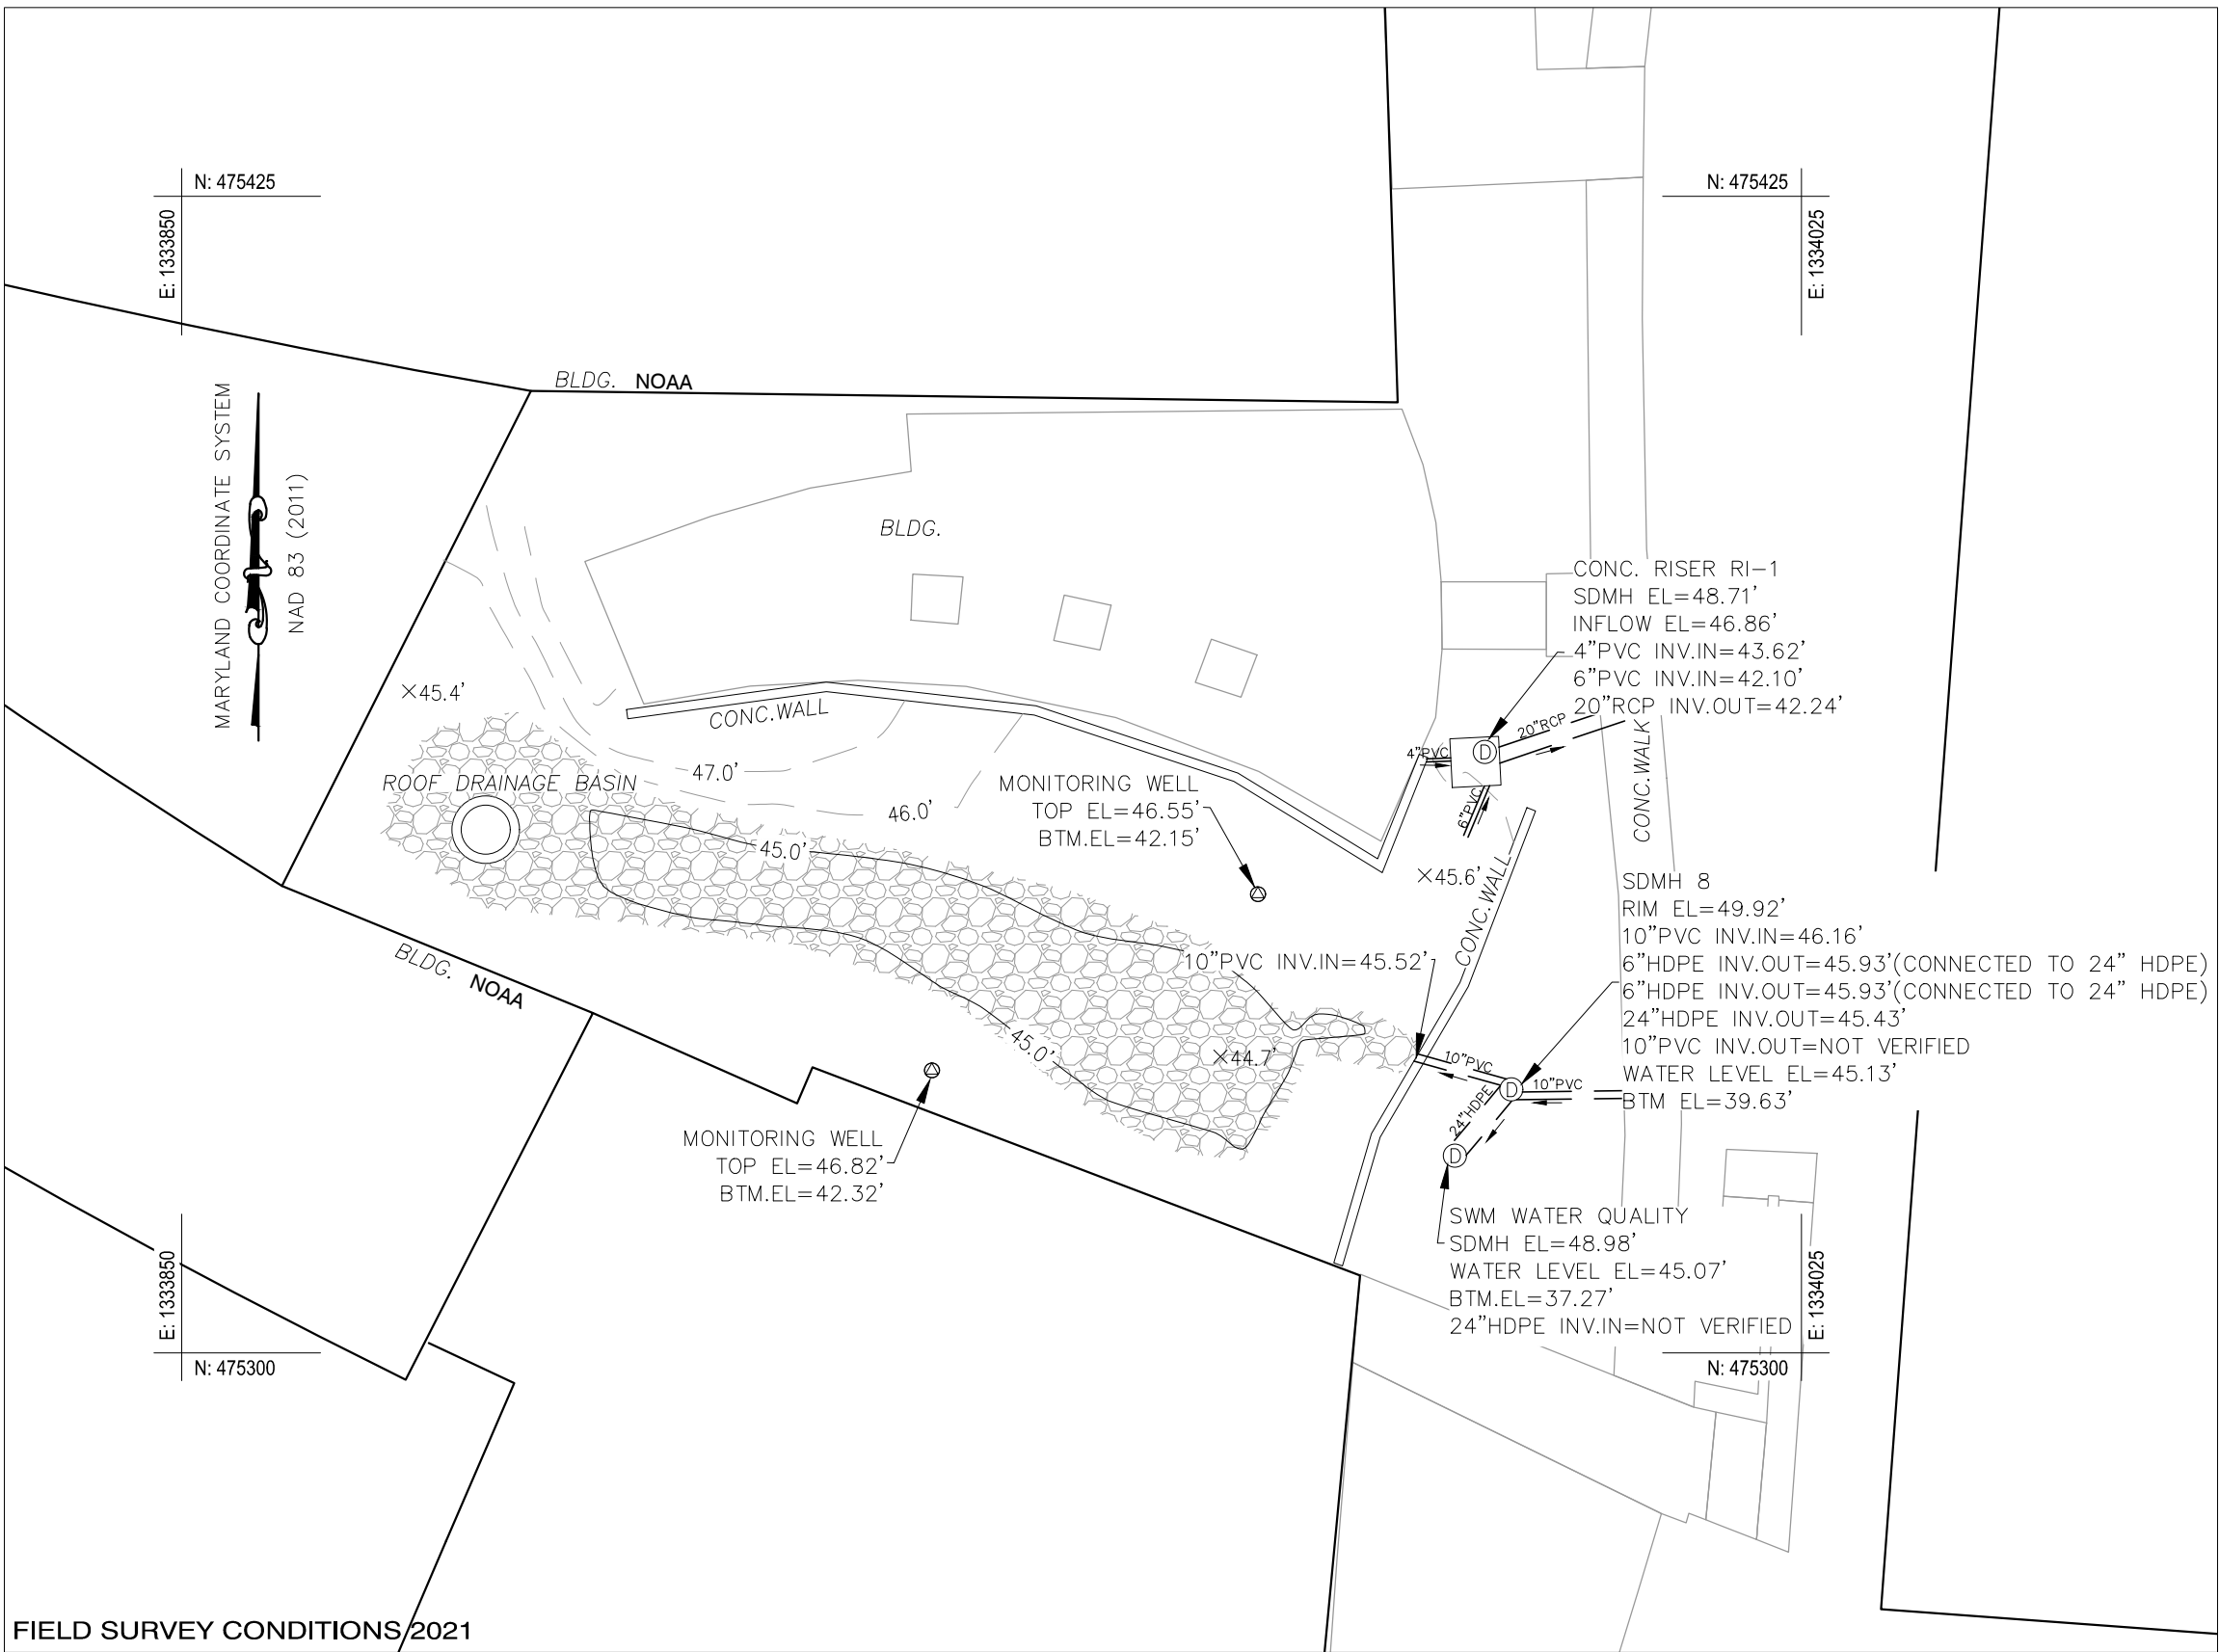
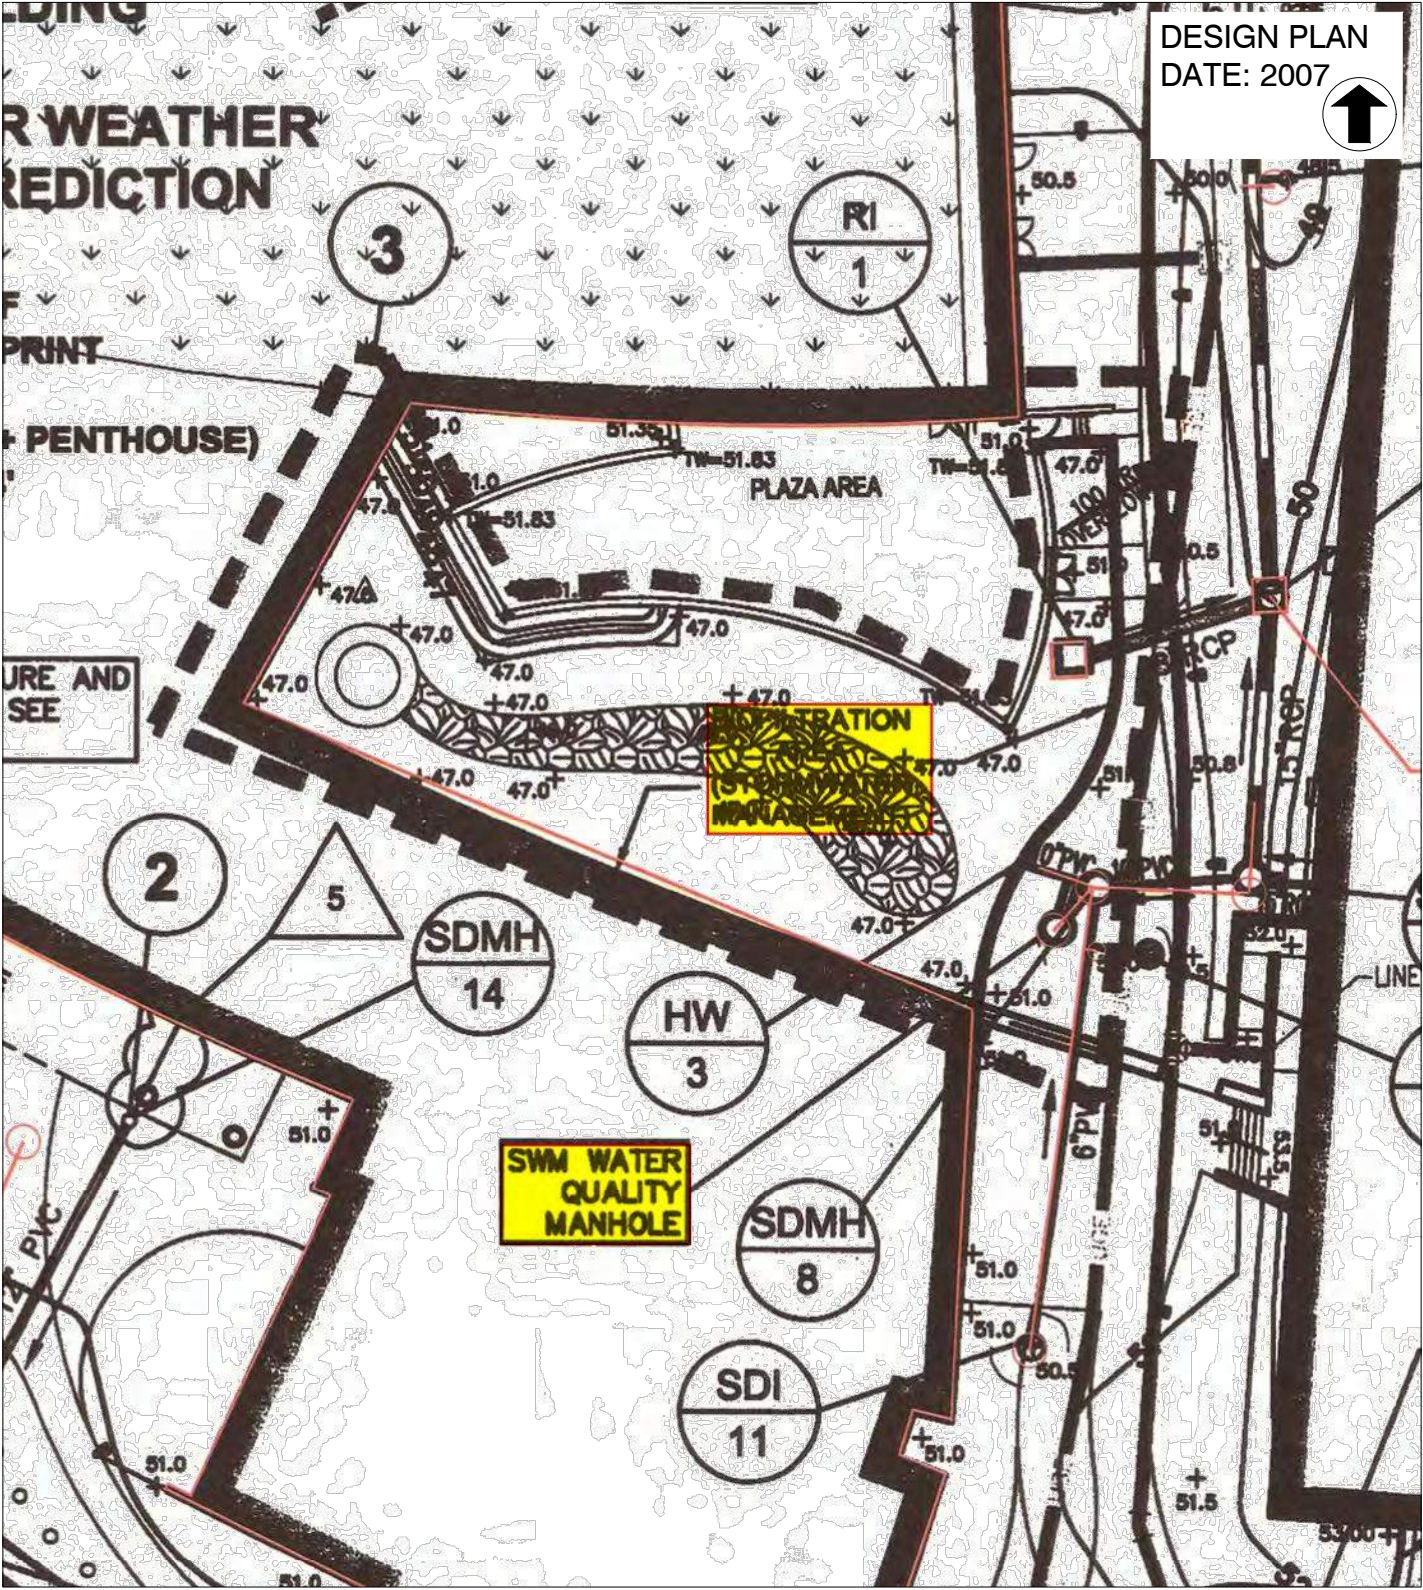
BMP FIELD VERIFICATION WORKSHEET
UMCP19BMP0274 & UMCP19BMP0278 - BIoretention & WQ MANHOLE
NOAA - CENTER FOR WEATHER AND CLIMATE PREDICTION
COLLEGE PARK, MD 20740 - UMCP
GEOSPATIAL & ENGINEERING DIVISION
259 Najoles Road - Millersville, Maryland 21108 - Office: 410-729-8200 - Fax: 410-729-8340

BMP Summary Table					
BMP ID	WQ _c (cubic feet)	PE (in)	Total Drainage Area (ac.)	Total Impervious Area (ac.)	Impervious Area Credit (ac.)
UMCP20BMP0274	4,347	0.92	1.62	1.35	0*
UMCP20BMP0278	73	0	0.98	0.96	0**
*BMP MUST BE IN PASSING CONDITION TO RECEIVE CREDIT					
**WATER QUALITY MANHOLES DO NOT RECEIVE WATER QUALITY TREATMENT CREDIT

PROJECT NAME: NOAA Bioretention		MDE NO: UMCP20BMP0274	
BMP VERIFICATION DATA FOR FILTERS (Sand Filters and Bioretention)			
FEATURE	DESIGN	SURVEY	
FOREBAY AREA (SQUARE FEET)	N/A	N/A	
FOREBAY VOLUME (CUBIC FEET)	N/A	N/A	
FILTER BED SURFACE AREA (SQUARE FEET)	1,108	1,678	
FILTER BED SURFACE ELEVATION (FEET)	47	45	
FILTER INLET PIPE SIZE/INVERT ELEVATION	NA/48"	NA/46.86'	
OUTLET PIPE (UNDERDRAIN) SIZE/INVERT ELEVATION	NA/43.5'	6"/42.10'	
THICKNESS OF FILTER MEDIA (FEET)	2.5	NFV	
PLACEMENT OF GEOTEXTILE	N/A	NFV	
PLANTINGS	N/A	✓	
COMPOSITION OF FILTER MEDIA	N/A	NFV	
WATER QUALITY DEPTH (FEET)	1	1.86	
WATER QUALITY SURFACE AREA (SQUARE FEET)	4,487	4,842	
NFV = NOT FIELD VERIFIED

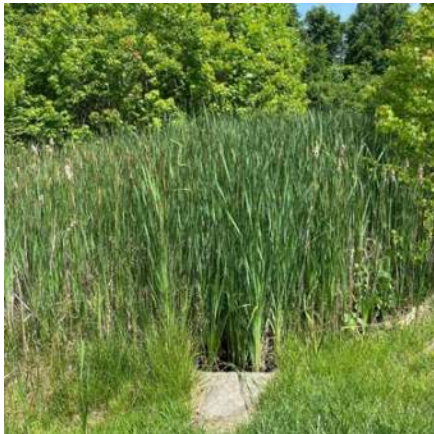
Figure 2. Overgrown vegetation

Both facilities were excessively overgrown with vegetation, as shown in Figure 2, making accessibility to Swale B and the control structure difficult. Vegetation within the southern portion of Swale A was better maintained. There was a significant amount of cattail growth and ponding within both facilities. The excess

- 1.) Trim/remove overgrown vegetation within each swale.
- 2.) Remove tree at control structure.
- 3.) Replace low flow & trash rack.
- 4.) Repair damage to control structure concrete (if needed after tree removal).
- 5.) Excavate and regrade swales to restore 8' swale bottom and proper slope along the channel length.
- 6.) Reestablish grass within swale bottoms and on slopes.
- 7.) Stabilize erosion along slope at southern Swale A inflow with soil and seed.
- 8.) Stabilize erosion along parking lot edge. Ensure smooth seam where slope and asphalt meet to prevent future erosion.
- 9.) Remove and replace existing inflow pipe at higher elevation from stormceptor at southern Swale A.
- 10.) Repair asphalt damaged by pipe replacement.
- 11.) Install concrete retaining wall.

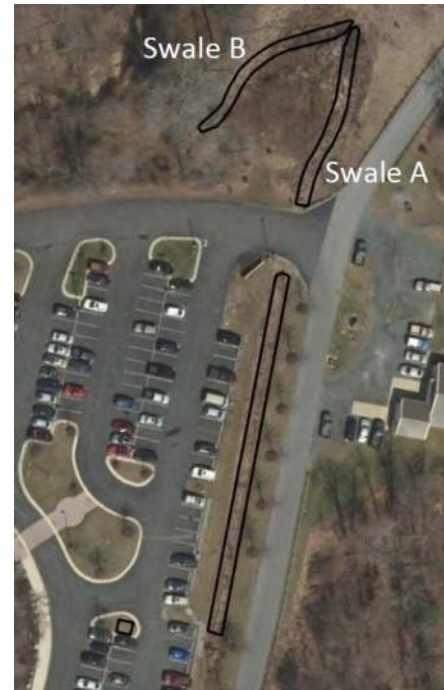
The two facilities, shown in Figure 1, are grass swales located north and east of the Laboratory for Telecommunication Sciences parking lot. Swale A (SWF066) receives runoff from 2.43 acres of impervious within a 4.75-acre drainage area, and Swale B (SWF065) receives runoff from 0.22 acres of impervious within a 0.50-acre drainage area. Stormwater enters both facilities through sheetflow. Swale A also receives concentrated flow from a stormceptor on the south end of the swale. The stormceptor acts as pretreatment for a portion of the runoff from the parking lot. Pretreatment is also achieved through a stone diaphragm that runs the northeastern perimeter of the lower section of Swale A. There is a control structure where the two swales meet. The control structure is a concrete structure with a perforated PVC

Figure 1. Overall aerial view

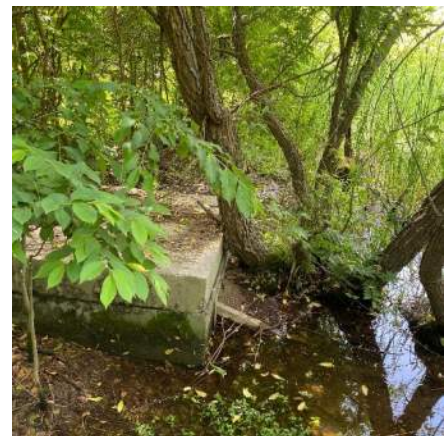
ponding is being caused by a clogged low flow. There was a significant amount of accumulated muck around the control structure. Additionally, there is a large tree at the control structure which has compromised the trash rack and low flow, shown in Figure 3. The principal spillway and outfall were not accessed at the time of inspection.

Figure 3. Tree growth at control structure

2. Remove Tree
3. Replace low flow and trash rack
4. Repair concrete (if needed after tree removal)

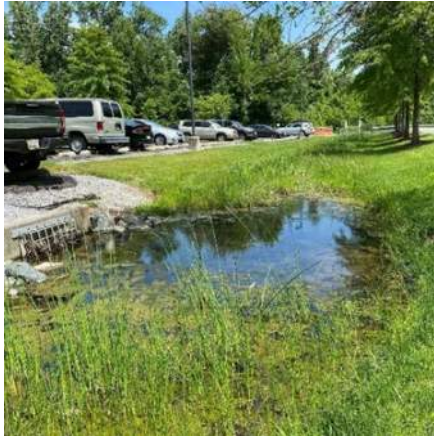
The clogged low flow has caused water to pond throughout the entirety of both swales, forming a small pool at the south inflow to Swale A shown in Figure 4. The grading within the southern section of Swale A is also contributing to the observed ponding at the inflow. The trash rack for the southern inflow was partially clogged with leafy debris. Additionally, Figure 5 shows erosion was observed along the edge of the

Figure 4. Ponding at Swale A south inflow

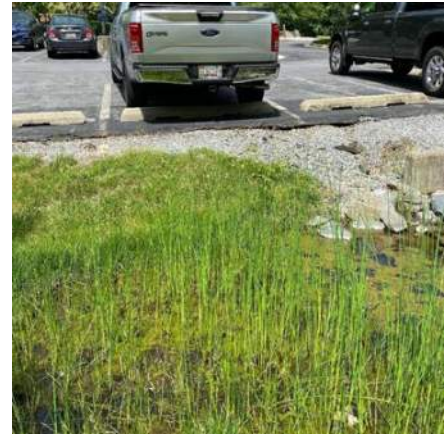
parking lot and on the slope of the swale where sheetflow from the parking lot enters Swale A by the southern inflow. Swale B was observed to have channeling within the conveyance as well as accumulation of vegetative debris.

Figure 5. Erosion along parking lot

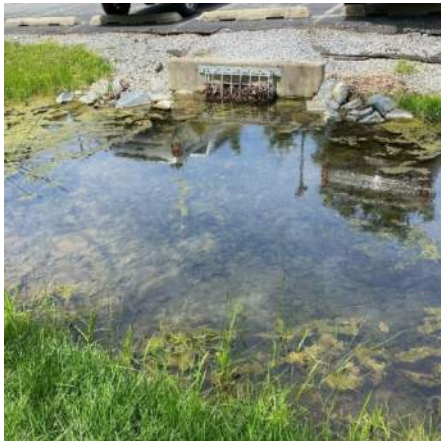
However, the accumulation of sediment has altered the grading from the original design. Grass swales should have a bottom width of no more than 8 feet, with side slopes at a recommended ratio of 3:1 and never to exceed a ratio of 2:1. Survey determined the swales meet the side slope criteria, but the bottom of the swale is no longer defined. The bottom width of Swale A is approximately 10 feet, and Swale B 11 feet, exceeding the allowable maximum design width. Additionally, as mentioned previously, grading within the southern section of Swale A is contributing to the ponding observed at the southern inflow.

Figure 6. Ponding at Swale A south inflow and parking lot

In addition to the bottom of Swale A exceeding the maximum design width, the geometric slope of the swale is relatively flat. The slope of the southern portion of Swale A is approximately 0.27%. There is no minimum slope needed according to the MDE Design manual, but due to the continuous ponding in Swale A, it is assumed that the swale does not have adequate positive drainage to convey water through the facility in order for it to not hold water past the maximum 48 hour retention period.

approximately 260', so a fall of 2.6' would be needed in order to have a 1% slope and promote positive flow. To address this, MES is proposing to reset the inflow pipe from the stormceptor to a higher downstream invert of 92.31 instead of it's designed invert of 90.92, which allows for a 1% slope within the pipe. This will allow for enough room to re-grade the swale to achieve a slope 0.85%, which is much more desirable for a swale of this length, and as close to a 1% slope as the site constraints allow. A potential obstacle to this proposal, shown in Figure 6, is that there does not appear to be much room for cover over the pipe in the parking lot. This is an aspect that would need to be further investigated if this option is chosen, especially since the pipe would be 1.39 feet higher than current conditions show. A planning level grading concept was drafted in the Concept Plan for resetting the pipe and re-grading the

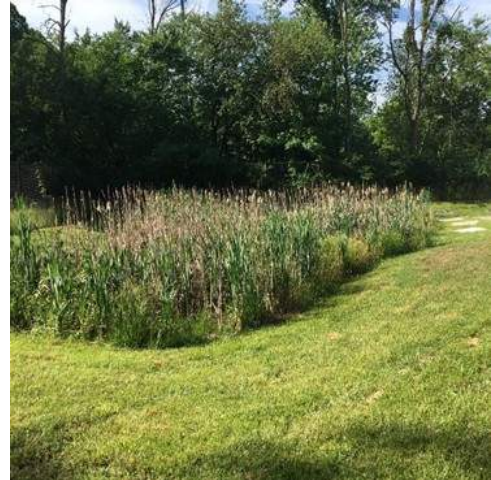
The facility, shown in Figure 1, is a pond that receives runoff from 1.17 acres of impervious within a 1.32-acre drainage area. Stormwater enters the facility through sheetflow on the southwestern side of the facility. This inflow has riprap protection to ensure nonerosive flow into the facility. Additionally, according to design concentrated flow from an oil grit separator is introduced on the west side of the facility. However, this inflow pipe was not confirmed in the field due to likely being submerged. The pond does not have a control structure. An earth spillway on the east side of the pond controls the water elevation within the pond. Overflow from the pond enters a dry swale (SWF026) which will eventually outfall to a small tributary leading to Paint Branch Creek. Upon inspection, the facility was determined to be failing and requires major maintenance.

Figure 1. Overall view from west

Figure 2 shows excessive vegetation growth within the inflow riprap protection. Additionally, as demonstrated in Figure 1 the basin was overrun with cattail growth, reducing the storage capacity of the

- 1.) Remove vegetation from inflow riprap protection.
- 2.) Excavate basin to remove cattails and restore pond bottom to 67'.
- 3.) Ensure inflow pipe from parking inlet is located and opening is clear of obstruction.
- 4.) Regrade slopes at 3:1 grade. Seed and stabilize as needed.

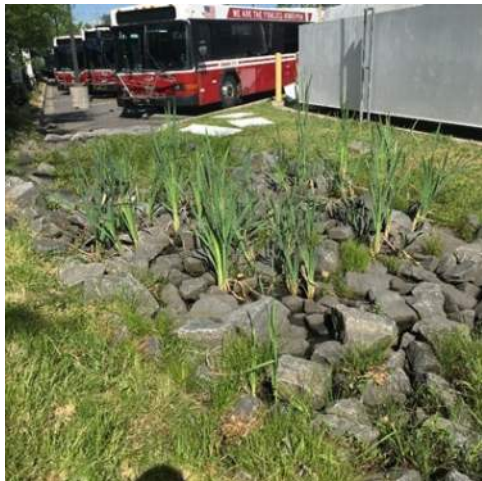
Figure 2. Vegetation growth inflow riprap

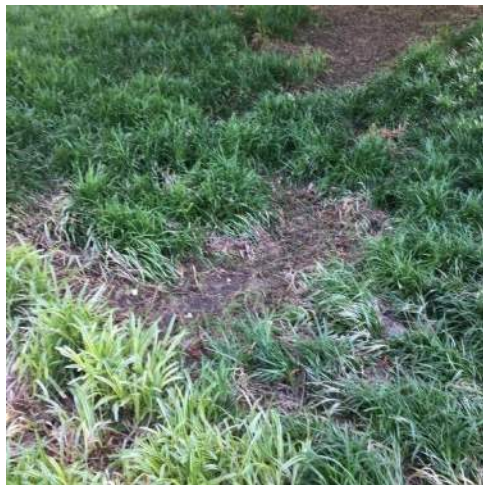
Figure 2. Erosion at inflow

Figure 2 shows minor bare areas within the basin of the facility. Additionally, MES observed a bare area leading into the facility on the east slope, as shown in Figure 3. It

- 1.) Add 3" of filter media and 2-3" of mulch to raise basin bottom to 70.5' to restore ponding to the designed 1' depth. Existing vegetation will need to be removed prior to media and mulch installation.
- 2.) Install new vegetation within bottom of basin. MES recommends incorporating shrub plantings.
- 3.) Seed/mulch bare area on slope.
- 4.) Trim vegetation as needed.

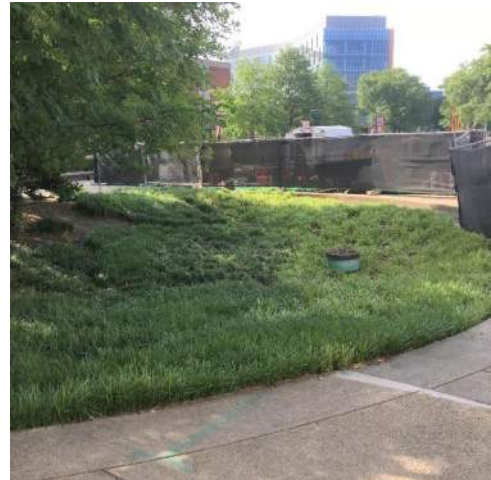
The facility, shown in Figure 1, is a micro-bioretention that receives runoff from 0.10 acres of impervious within a 0.17-acre drainage area. Stormwater enters the facility through sheetflow at the north and west regions of the facility. There is a gravel curtain at the inflow that acts as a spreader to ensure nonerosive flow into the facility. The control structure

Figure 1. Overall view from west

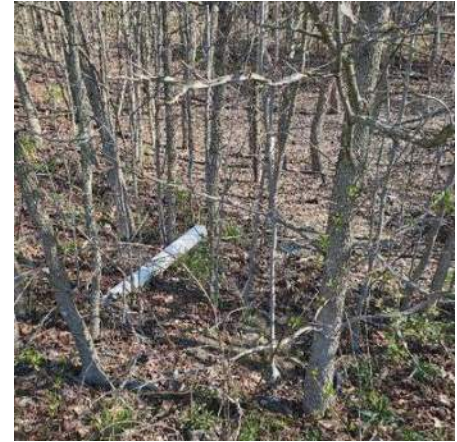
Finally, there is erosion around the 4" PVC inflow to the facility, shown in Figure 4, which should be repaired and stabilized with seed and matting.

Figure 4. Overgrown vegetation at outfall

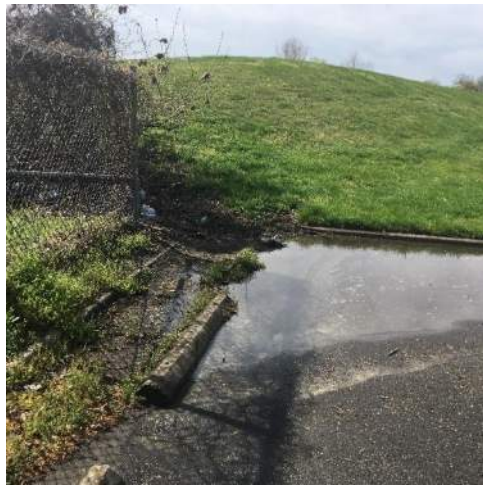
Ponding was observed at both inflows within the parking lot due to accumulated sediment prohibiting proper flow into the facility, shown in Figure 2. Displaced riprap, accumulated debris and overgrown vegetation were also observed at both inflows, as demonstrated in Figure 3. The basin of the pond was dry although indicated by design to hold a permanent pool. It is suspected that this may be attributed to the minimized flow to the pond due to the blocked inflows. The drainage area to the facility is much smaller than the MDE recommendation of 10 acres but is assumed to qualify as a pocket pond which ponding is partially facilitated by a locally high ground water table. Figure 4 shows vegetation growth and sediment accumulation within the pond basin, with more heavily overgrown vegetation along the basin slopes and around the control structure. Tree

Figure 2. Ponding southern inflow

- 1.) Remove sediment & debris from curb cut inflow openings. Ensure grading facilitates flow into facility. Regrade as needed.
- 2.) Remove overgrown vegetation & debris from both inflow protection. Replace displaced riprap.
- 3.) Remove unplanned vegetation, accumulated sediment & debris from pond basin.
- 4.) Excavate basin to restore to 1' ponding. Regrade as needed.
- 5.) Trim overgrown vegetation on pond slopes and around control structure.
- 6.) Grade slopes to ensure maximum ratio of 3:1.
- 7.) Remove woody growth from embankment, within 15' of embankment toe, and within 25' of principal spillway structure.
- 8.) Trim vegetation at outfall. Replace displaced outfall protection as needed.

1. Remove sediment & debris at curb cut. Regrade as needed.

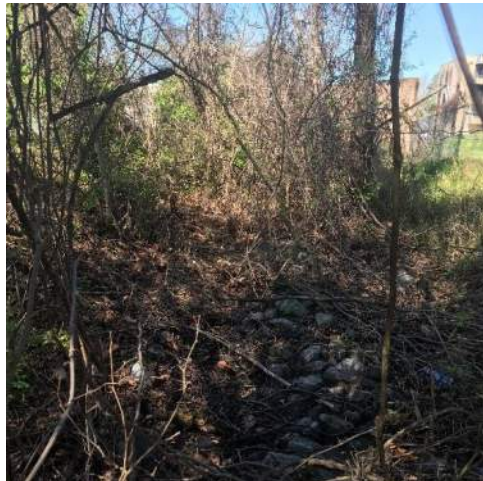
Figure 3. Northwest inflow channel

2. Remove overgrown vegetation & debris. Replace displaced riprap.

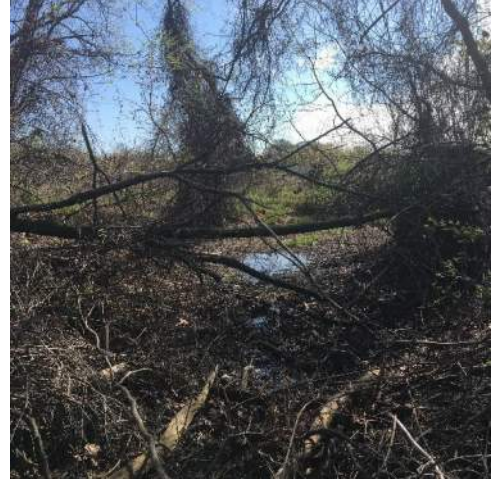
The facility, shown in Figure 1, is a wet pond that receives runoff from 1.06 acres of impervious within a 1.99-acre drainage area. The pond is fenced off with an opening at the southern end which MES used for access to the facility. Stormwater enters the facility through curb cuts at the northwest and southeast regions of the parking lot. The control structure is a 15" concrete culvert pipe that outfalls to a channel leading to Paint Branch Creek. Upon inspection, the

Figure 1. Overall view from northwest inflow channel

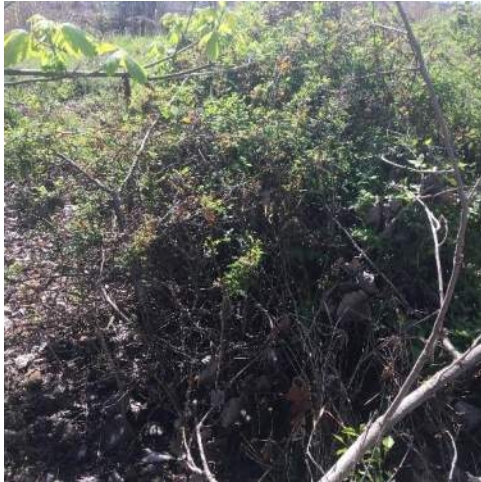
and downstream condition were in poor condition due to overgrown vegetation as shown in Figure 5.

Figure 5. Overgrown vegetation at outfall

8. Trim vegetation. Replace displaced riprap as needed
