University of Maryland, College Park  
National Pollutant Discharge Elimination  
System MS4 Phase II  
FY2023 Annual Report  
General Discharge Permit #13-SF-5501

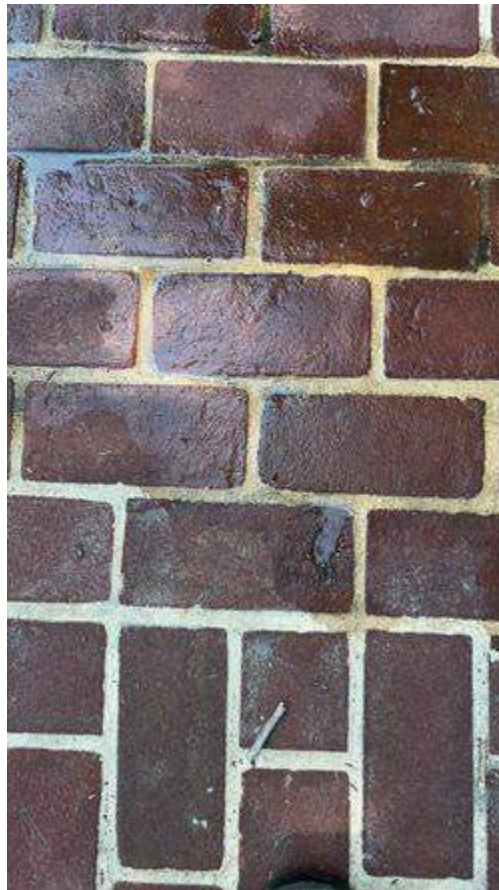
Photo Showing Permeable Pavers Have Been Grouted

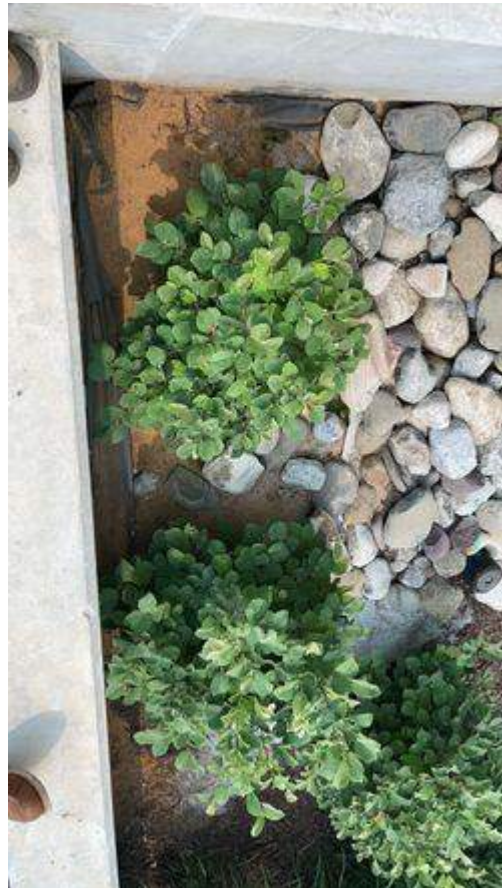
- **BMP Access** - Good
- **Debris & Sediment** - Fair
- **Vegetation** - Good
- **BMP Contamination** - Fair
- **General Site Conditions Comments:** Heavy sedimentation around Inflow.

Sedimentation at inflow:
