University of Maryland, College Park  
National Pollutant Discharge Elimination  
System MS4 Phase II  
FY2024 Annual Report  
General Discharge Permit #13-SF-5501

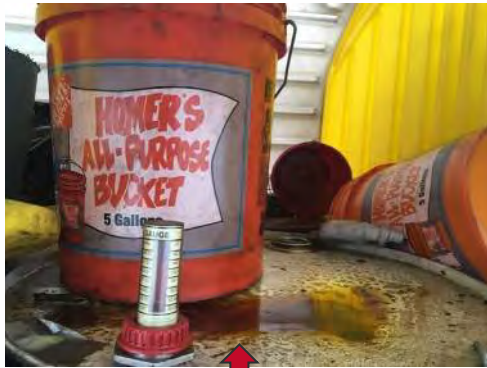
Spillage

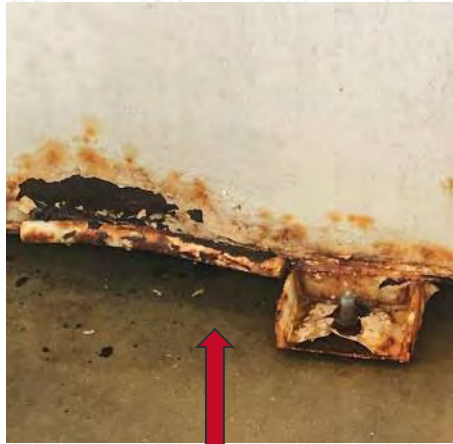
Severely rusted and pitting occurring

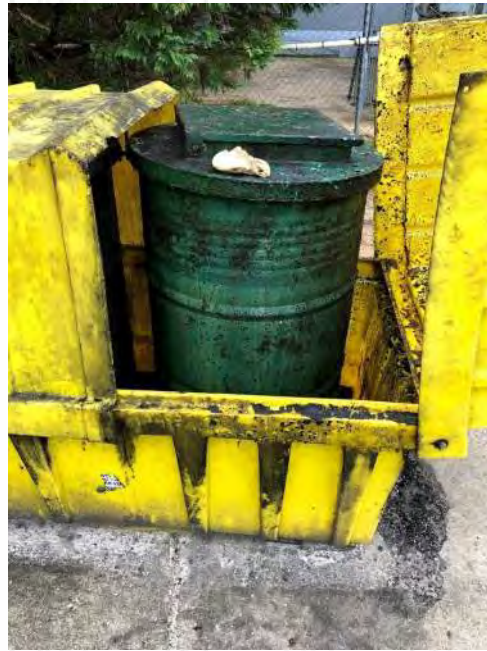
Containment not closed, spillage, no spill kit, no signage.

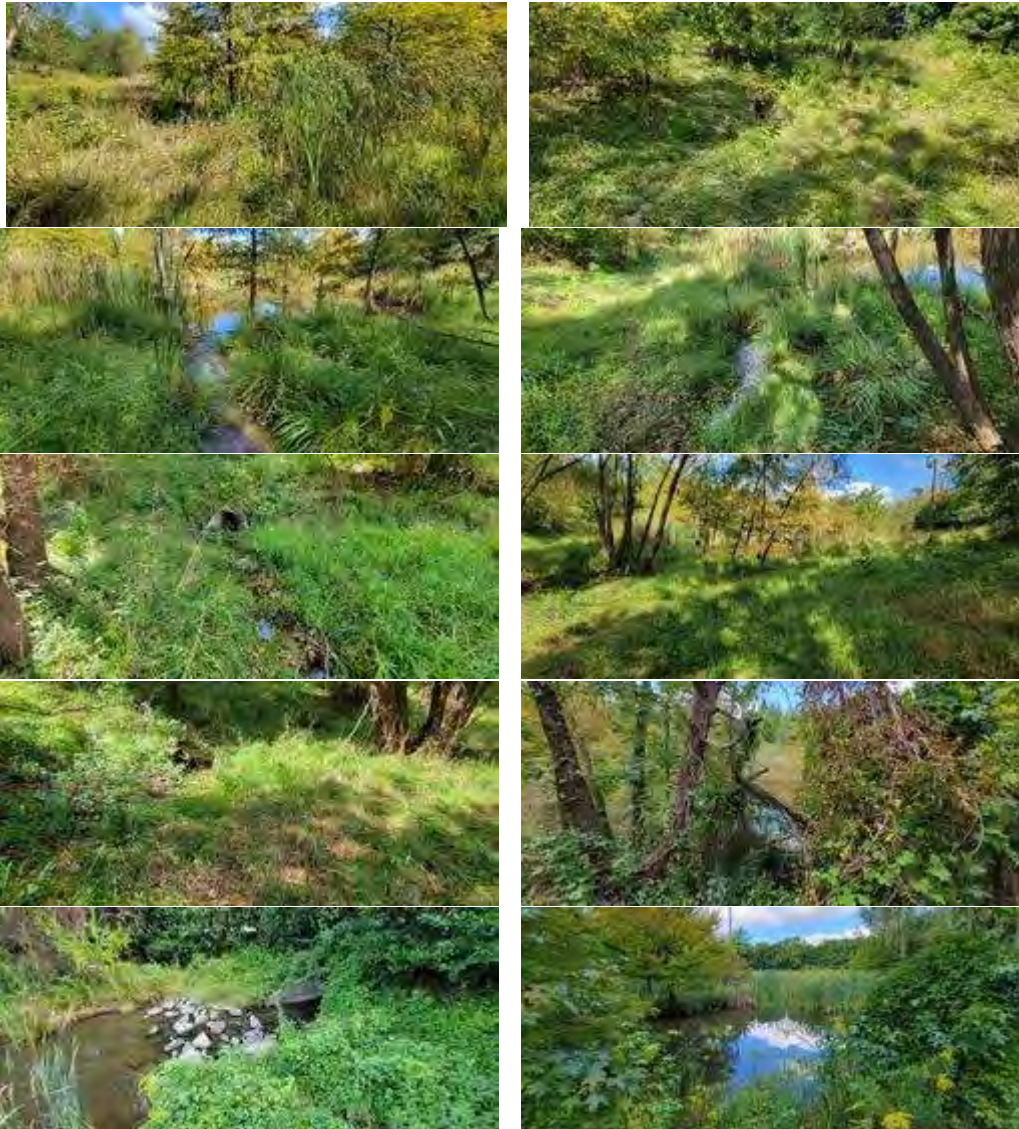
- **BMP Access** - Fair
- **Debris & Sediment** - Good
- **Vegetation** - Good
- **BMP Contamination** - Good
- **General Site Conditions Comments:** Southern inlets and channel are overgrown. Access around facility is overgrown. Riser not immediately Visakhapatnam

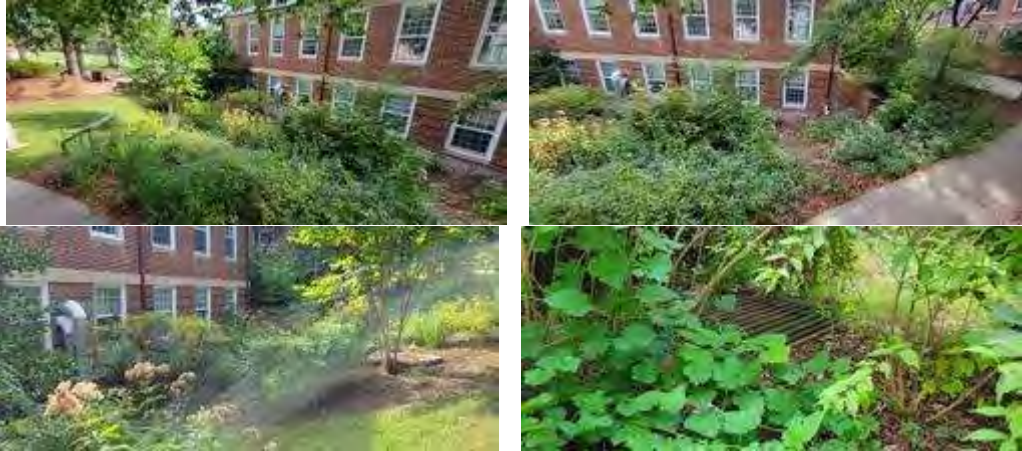
- **BMP Access** - Good
- **Debris & Sediment** - Good
- **Vegetation** - Good
- **BMP Contamination** - Good
- **General Site Conditions Comments:** Good access to facility. Appropriate vegetation, no weed pressure. Overflow is clear

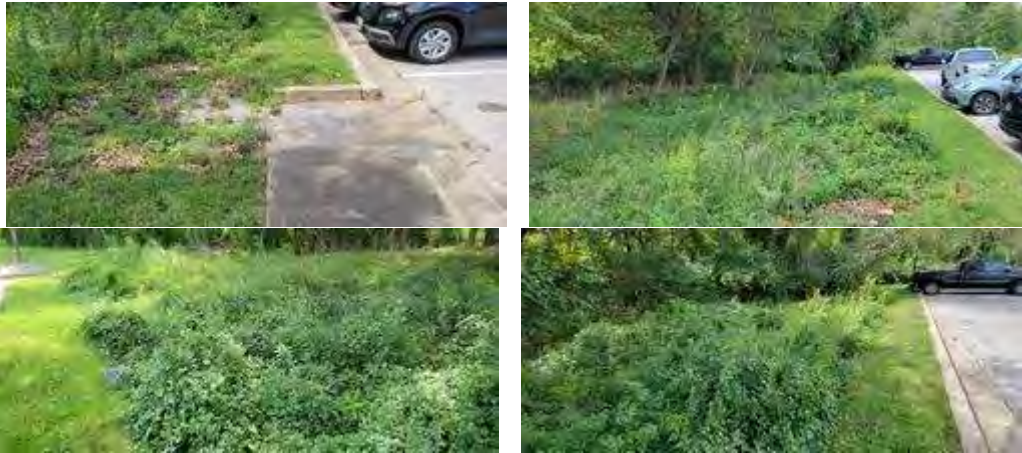
<b>Date of Inspection:</b>	September 21, 2023 12:09 PM	<b>Inspector Initials:</b>	MMC
<b>BMP ID:</b>	UMCP19BMP0027	<b>Inspection Firm:</b>	UMD
<b>BMP Type:</b>	Bioretention	<b>Underground BMP?</b>	No
<b>BMP Status</b>	Pass	<b>Overall Inspection Comment:</b>	
<b>Maintenance Level</b>	Minor Maintenance (Use of Hand Equipment for Repairs)

- **BMP Access** - Good
- **Debris & Sediment** - Fair
- **Vegetation** - Fair
- **BMP Contamination** - Fair
- **General Site Conditions Comments:** Some debris at inlet. Full vegetation, but naturalized with native and non native volunteer plants

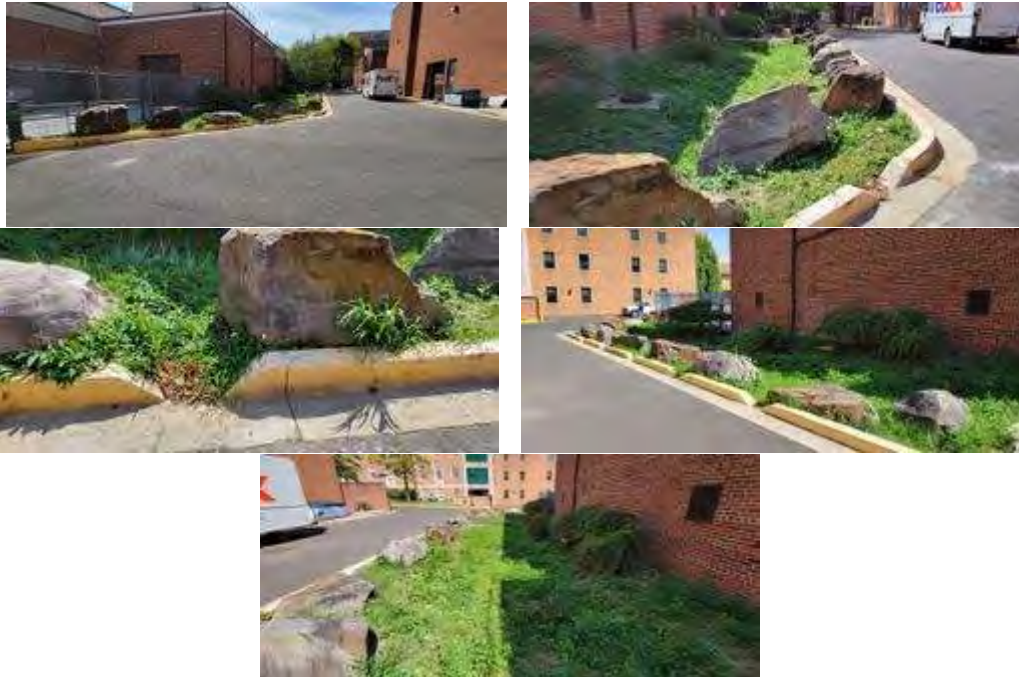
<b>Date of Inspection:</b>	September 21, 2023 11:32 AM	<b>Inspector Initials:</b>	MMC
<b>BMP ID:</b>	UMCP19BMP0039	<b>Inspection Firm:</b>	UMD
<b>BMP Type:</b>	Bioretention	<b>Underground BMP?</b>	No
<b>BMP Status</b>	Pass	<b>Overall Inspection Comment:</b>	
<b>Maintenance Level</b>	Minor Maintenance (Use of Hand Equipment for Repairs)

- **BMP Access** - Good
- **Debris & Sediment** - Good
- **Vegetation** - Fair
- **BMP Contamination** - Fair
- **General Site Conditions Comments:** There is vegetative coverage, but mostly invasive and undesirable weeds. Some curb cuts are partly blocked by weeds and debris. One Boulder has moved and needs to be repositioned.

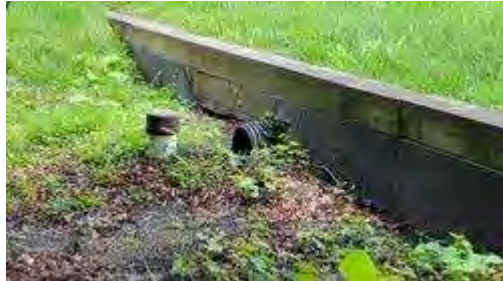
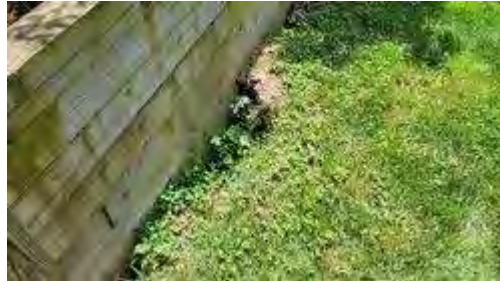
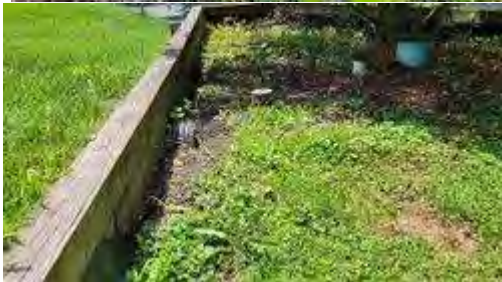
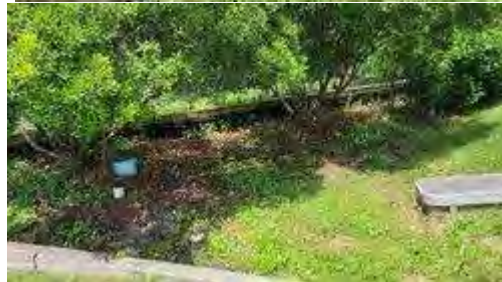
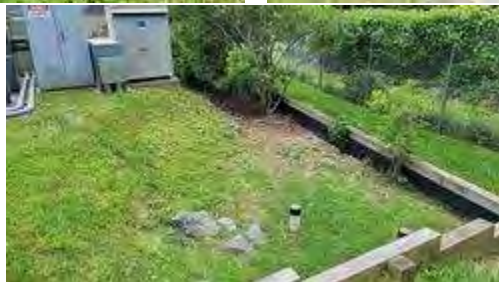
<b>Date of Inspection:</b>	June 11, 2024 1:05 PM	<b>Inspector Initials:</b>	MMC
<b>BMP ID:</b>	UMCP19BMP0042	<b>Inspection Firm:</b>	UMD
<b>BMP Type:</b>	Micro-Bioretenion	<b>Underground BMP?</b>	No
<b>BMP Status</b>	Pass	<b>Overall Inspection Comment:</b>	
<b>Maintenance Level</b>	Minor Maintenance (Use of Hand Equipment for Repairs)

- **BMP Access** - Good
- **Debris & Sediment** - Good
- **Vegetation** - Fair
- **BMP Contamination** - Good
- **General Site Conditions Comments:** Shrub layer is good, understory and ground cover needs attention.

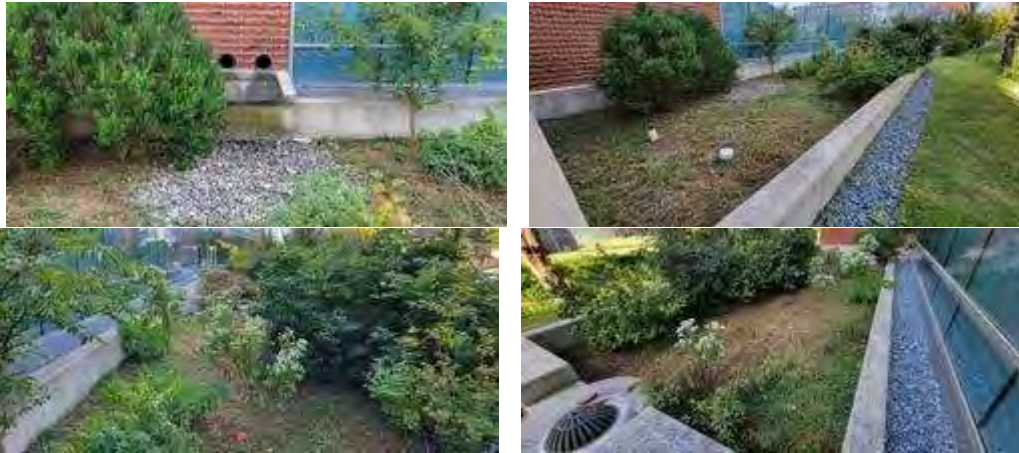
- **BMP Access** - Good
- **Debris & Sediment** - Good
- **Vegetation** - Fair
- **BMP Contamination** - Good
- **General Site Conditions Comments:** Vegetation present, but lower growing plant layer is missing and being replaced by grass and weeds

Replant following the plant schedule as needed

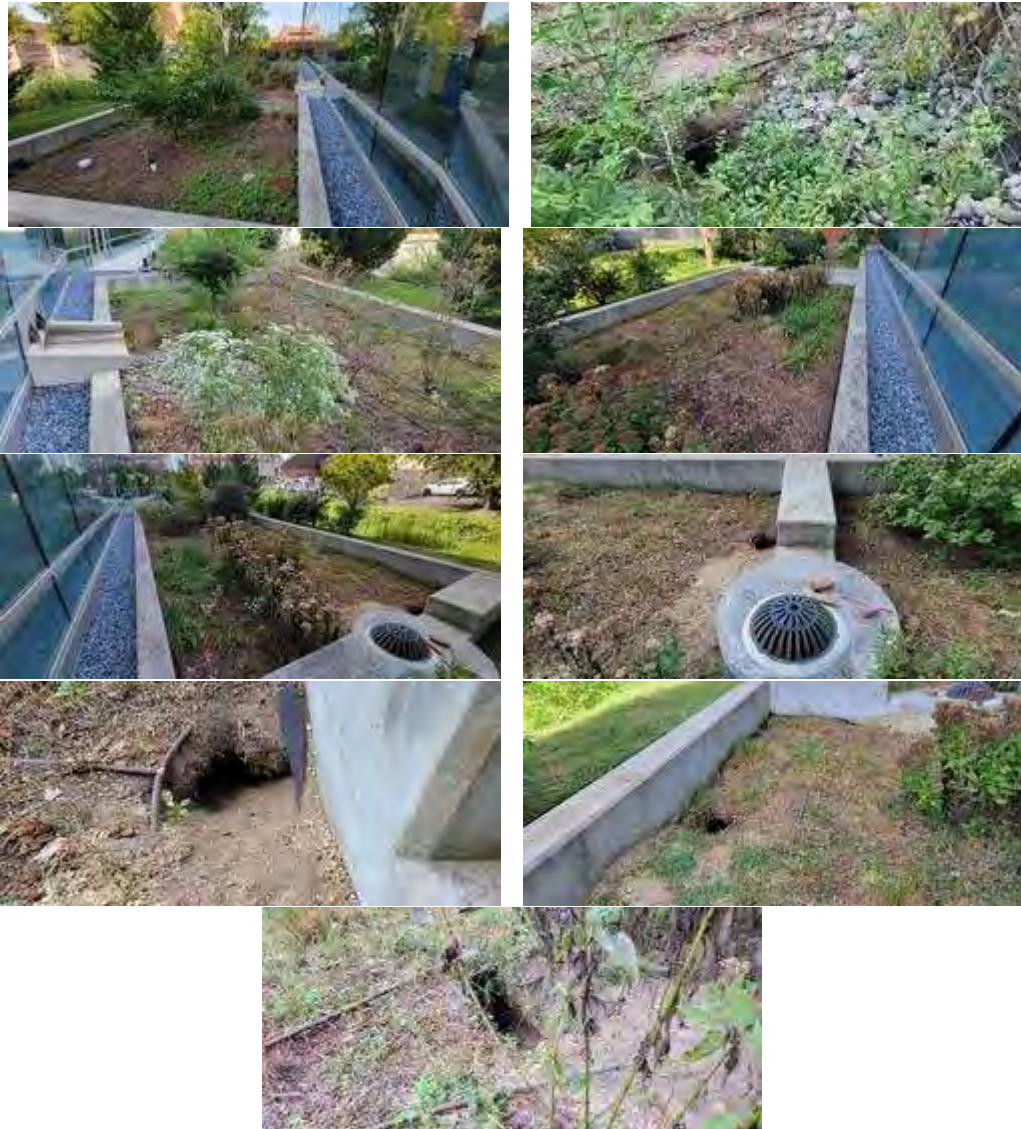
- **BMP Access** - Good
- **Debris & Sediment** - Good
- **Vegetation** - Fair
- **BMP Contamination** - Good
- **General Site Conditions Comments:** Perennial shrubs present, but lower growing plants are absent and being replaced with weed. Holes present which appear to be from burrowing animals

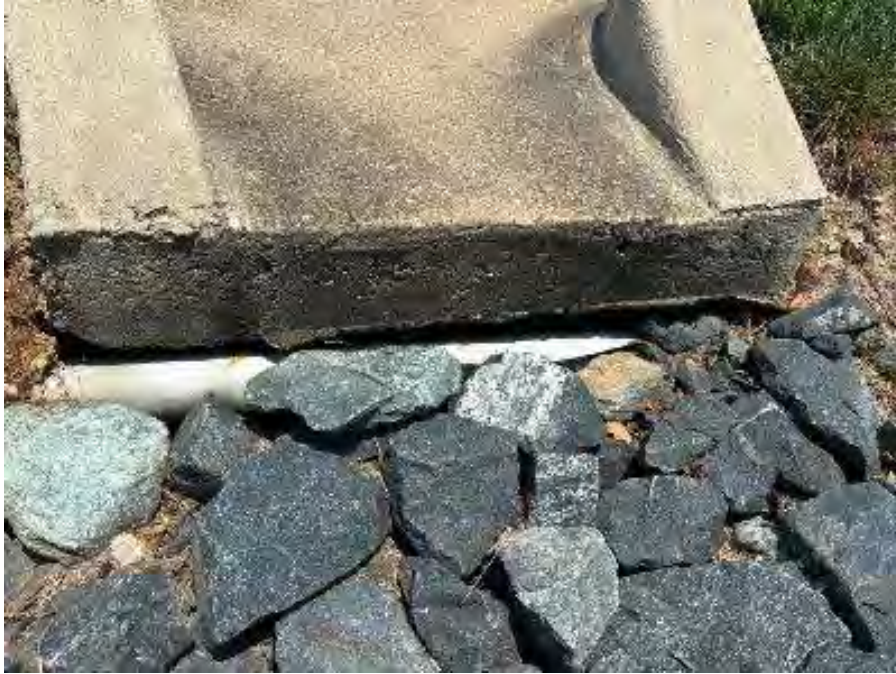
Exposed Pipe at Inflow

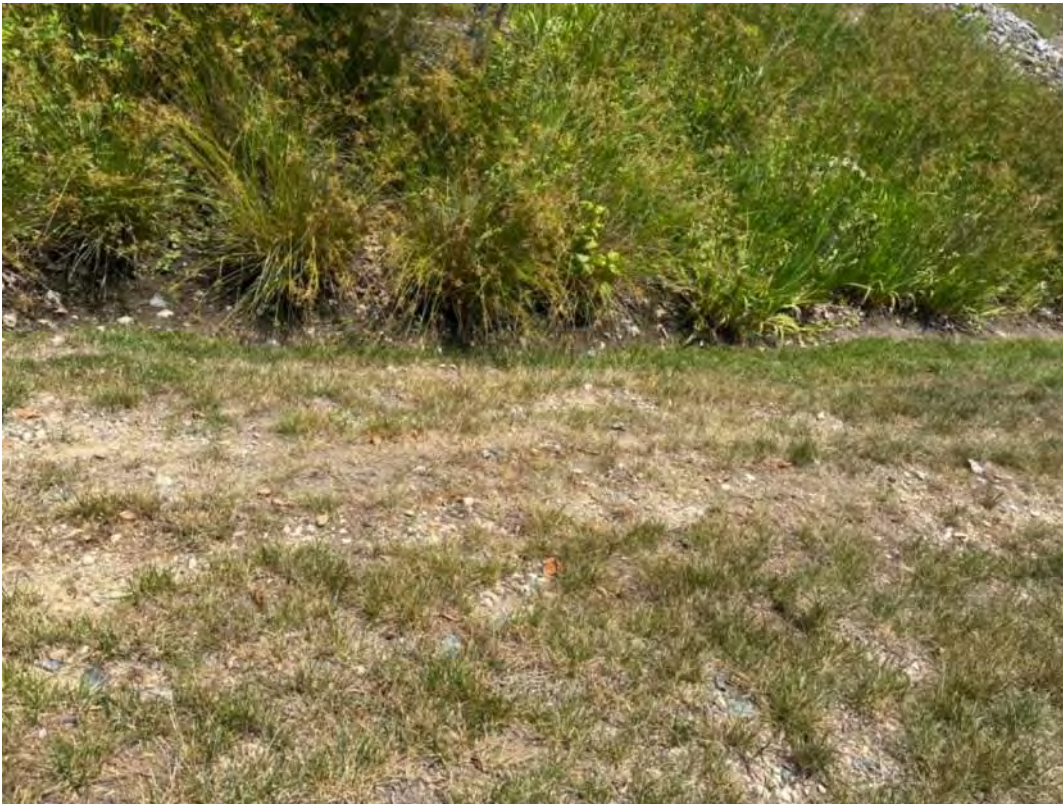
<b>Date of Inspection:</b>	June 17, 2024 1:18 PM	<b>Inspector Initials:</b>	SK, TG
<b>BMP ID:</b>	UMCP20BMP0259	<b>Inspection Firm:</b>	UMD
<b>BMP Type:</b>	Submerged Gravel Wetland	<b>Underground BMP?</b>	No
<b>BMP Status</b>	Pass	<b>Overall Inspection Comment:</b>	BMP in good condition. Stabilize erosion on embankment
<b>Maintenance Level</b>	Minor Maintenance (Use of Hand Equipment for Repairs)

Erosion Occurring to Embankment

Minor maintenance. Reseed bare spots on embankment.

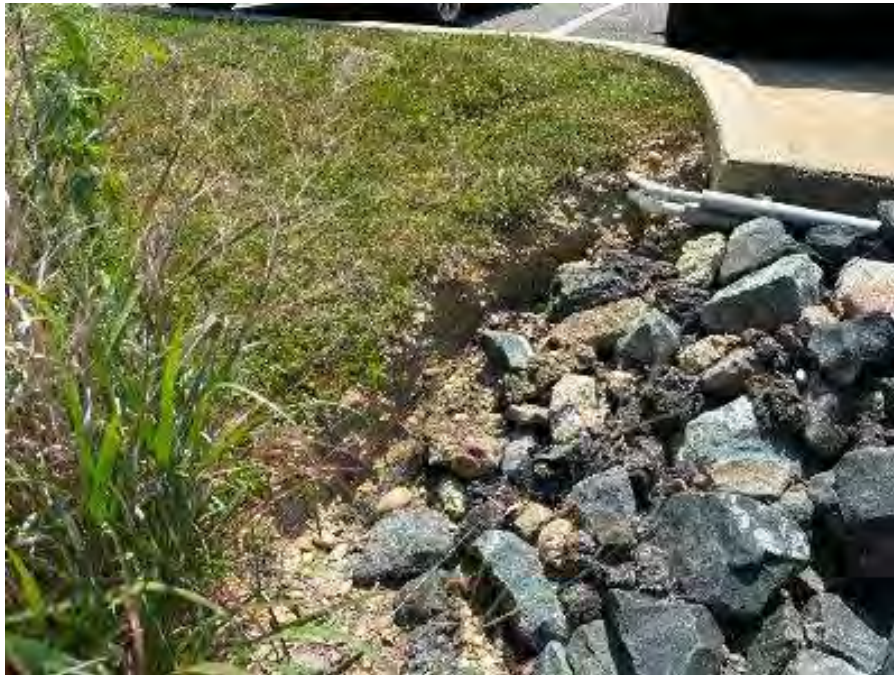
- **Inflow Condition** - Poor
- **Forebay** - N/A

Erosion Occurring to Inflow

Minor maintenance. Repair erosion around inflow

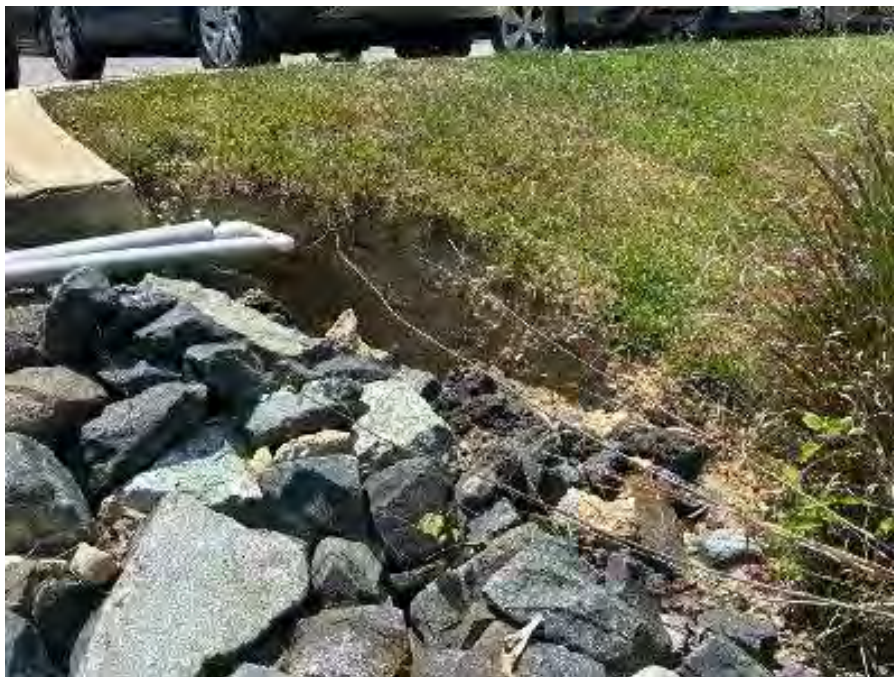
Erosion Occurring to Inflow

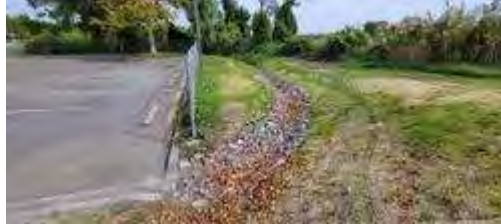
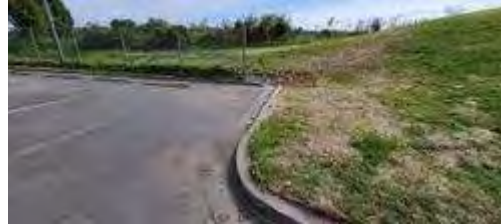
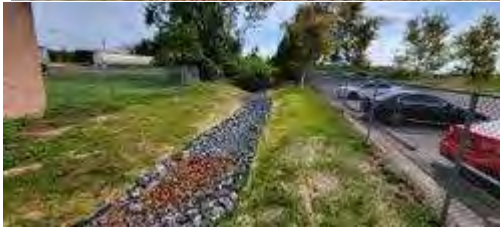
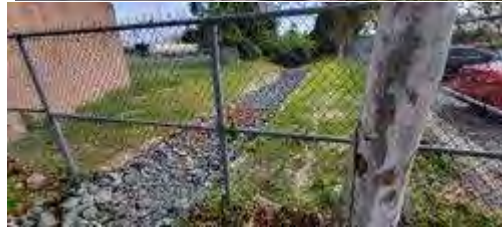
- **BMP Access** - Fair
- **Debris & Sediment** - Good
- **Vegetation** - Good
- **BMP Contamination** - Good
- **General Site Conditions Comments:** Wetland restrictions don't allow for complete clearing, but flow path of water is unobstructed

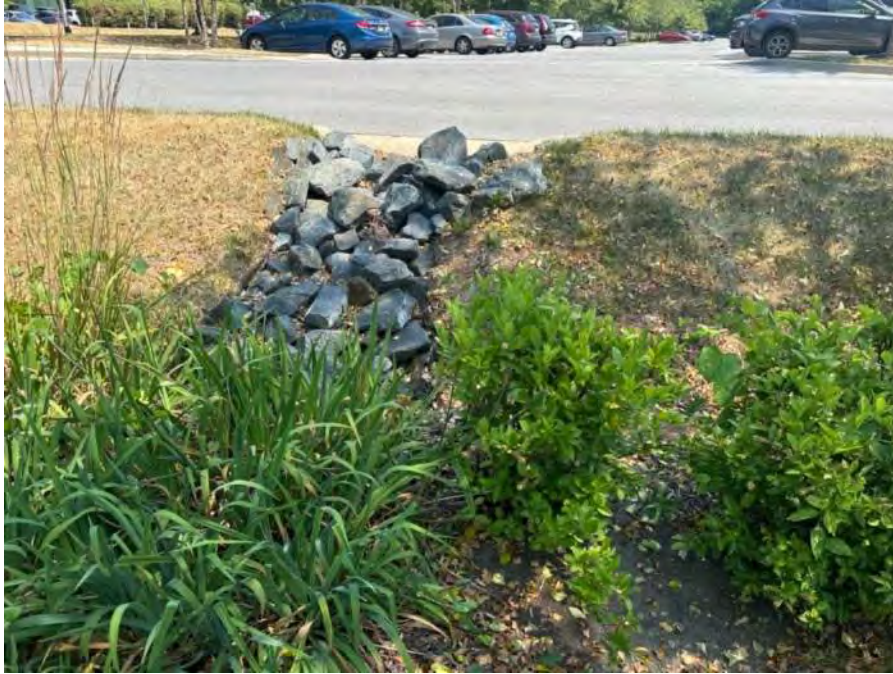
Vegetation Obstructing Inflow

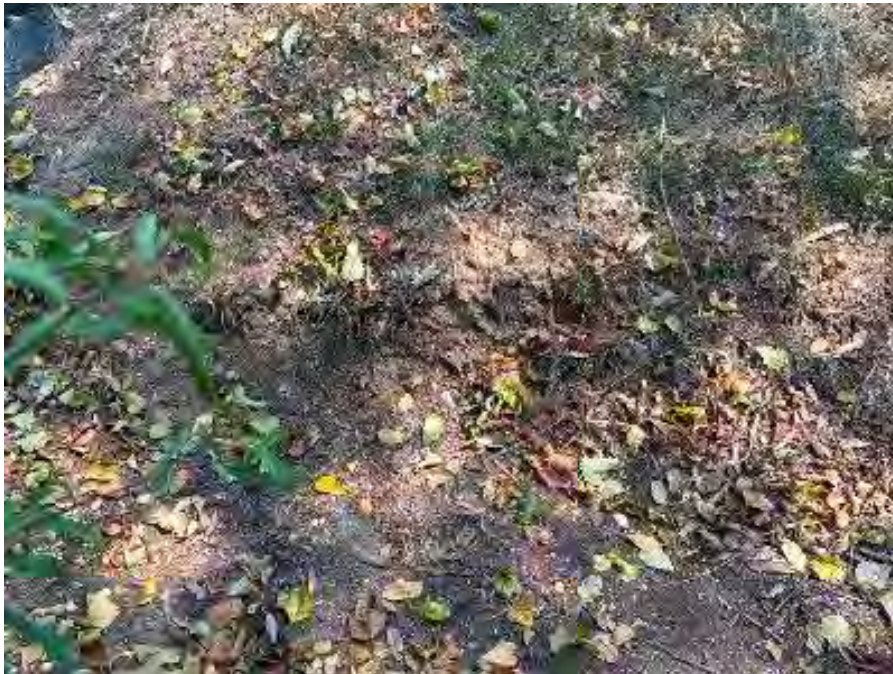
Slight Erosion Occurring to Embankment

Minor maintenance. Reseed bare spots on embankment

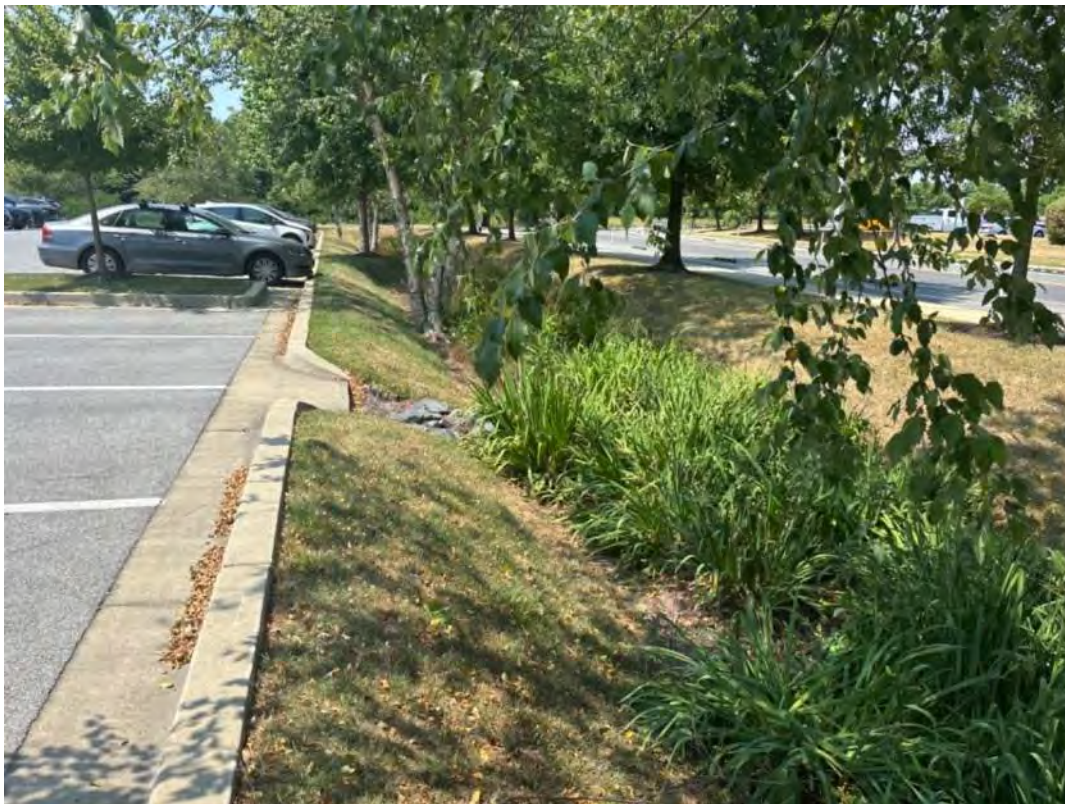
<b>Date of Inspection:</b>	June 17, 2024 11:20 AM	<b>Inspector Initials:</b>	SK, TG
<b>BMP ID:</b>	UMCP20BMP0269	<b>Inspection Firm:</b>	UMD
<b>BMP Type:</b>	Micro-Bioretenion	<b>Underground BMP?</b>	No
<b>BMP Status</b>	Pass	<b>Overall Inspection</b>	BMP in good condition. Inflow needs repairing
<b>Maintenance Level</b>	Minor Maintenance (Use of Hand Equipment for Repairs)	<b>Comment:</b>

Minor maintenance. Repair inflow

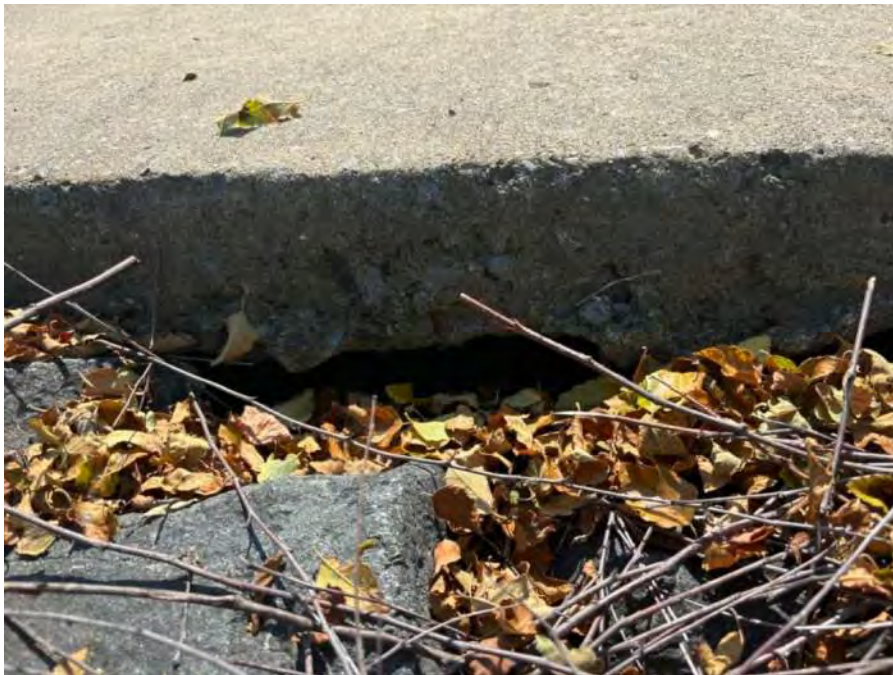
- **Inflow Condition** - Fair
- **Forebay** - N/A

Erosion Occurring to Inflow

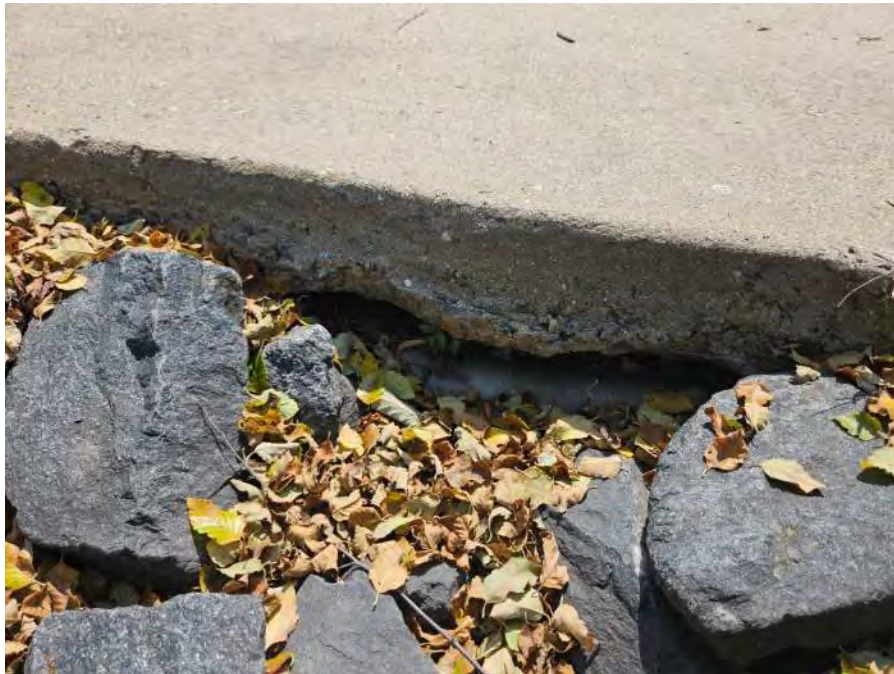
<b>Date of Inspection:</b>	June 17, 2024 11:25 AM	<b>Inspector Initials:</b>	SK,TG
<b>BMP ID:</b>	UMCP20BMP0270	<b>Inspection Firm:</b>	UMD
<b>BMP Type:</b>	Micro-Bioretenion	<b>Underground BMP?</b>	No
<b>BMP Status</b>	Pass	<b>Overall Inspection</b>	BMP in good condition, inflow needs repairing
<b>Maintenance Level</b>	Minor Maintenance (Use of Hand Equipment for Repairs)	<b>Comment:</b>

- **Inflow Condition** - Fair
- **Forebay** - N/A

Erosion Occurring to Inflow

Minor maintenance. Repair inflow

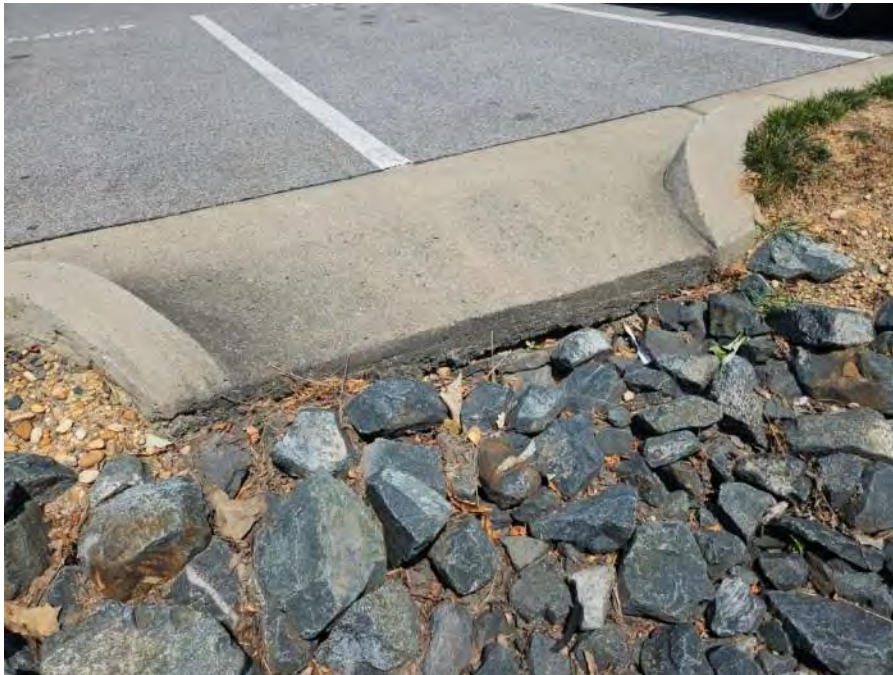
<b>Date of Inspection:</b>	June 17, 2024 11:36 AM	<b>Inspector Initials:</b>	SK,TG
<b>BMP ID:</b>	UMCP20BMP0272	<b>Inspection Firm:</b>	UMD
<b>BMP Type:</b>	Submerged Gravel Wetland	<b>Underground BMP?</b>	No
<b>BMP Status</b>	Pass	<b>Overall Inspection Comment:</b>	Bmp in good condition, inflows have minor erosion/cracking
<b>Maintenance Level</b>	Minor Maintenance (Use of Hand Equipment for Repairs)

Erosion Occurring to Inflow

Minor maintenance. Repair inflows

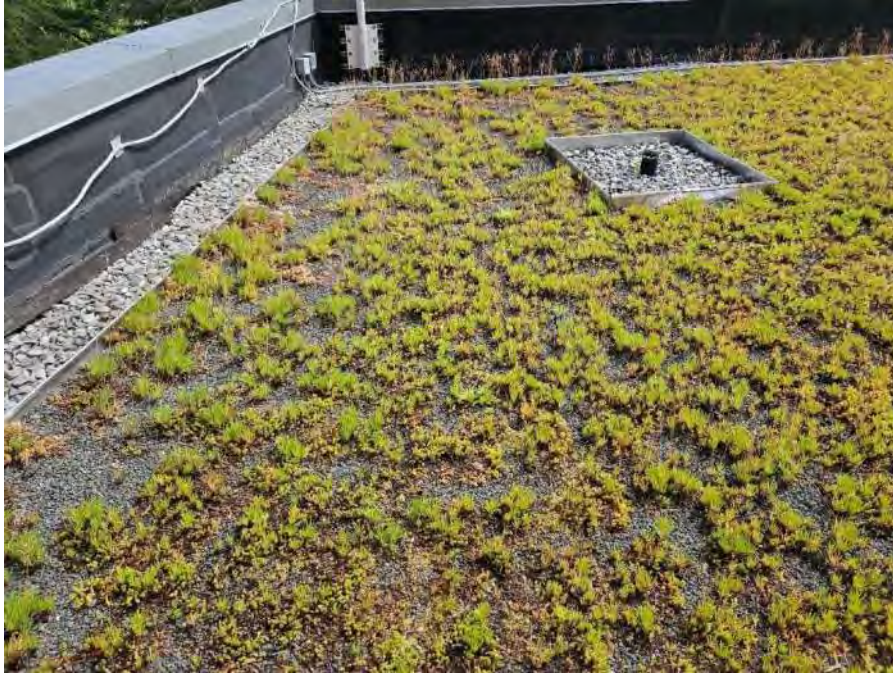
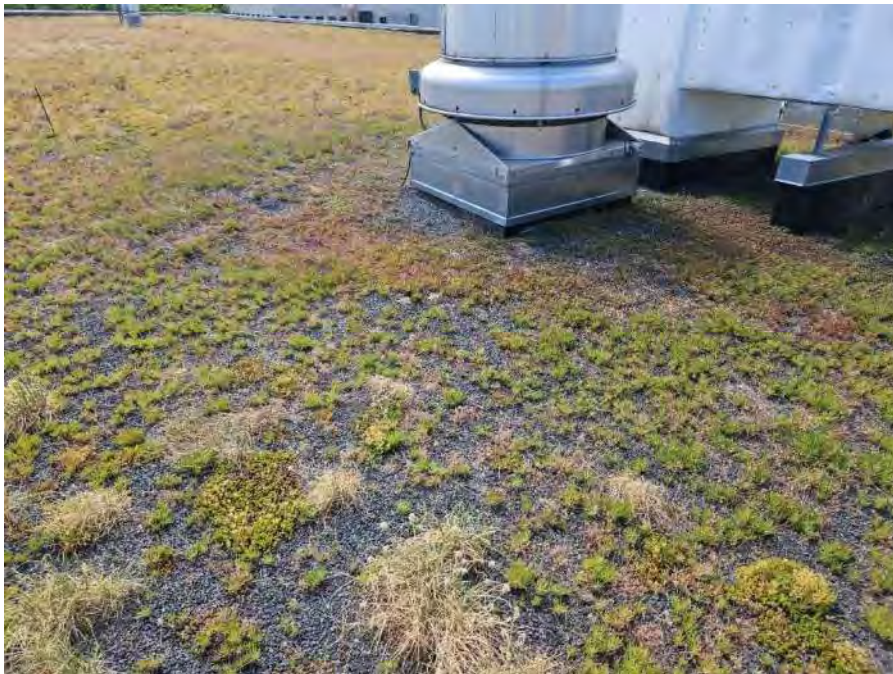
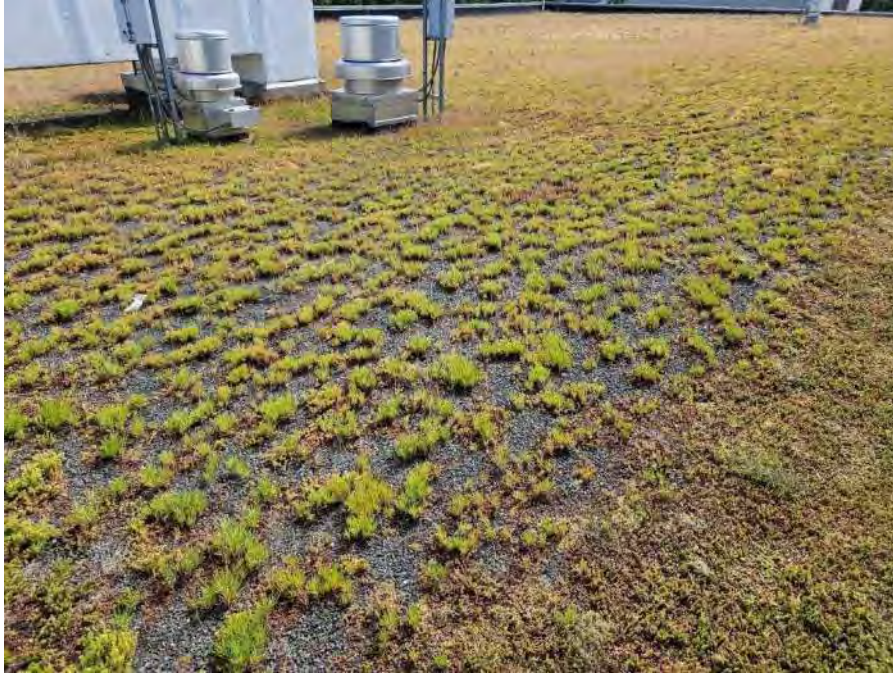
<b>Date of Inspection:</b>	June 28, 2024 10:04 AM	<b>Inspector Initials:</b>	SK,PP
<b>BMP ID:</b>	UMCP20BMP0273	<b>Inspection Firm:</b>	UMD
<b>BMP Type:</b>	Green Roof - Extensive	<b>Underground BMP?</b>	No
<b>BMP Status</b>	Pass	<b>Overall Inspection Comment:</b>	BMP in good condition, minor bare spots
<b>Maintenance Level</b>	Minor Maintenance (Use of Hand Equipment for Repairs)

Minor bare areas

Reseed bare spots

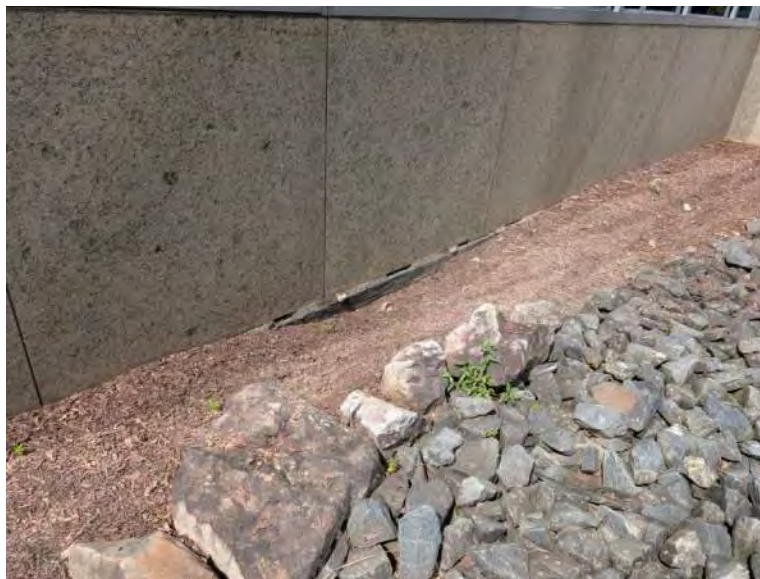
<b>Date of Inspection:</b>	June 26, 2024 3:18 PM	<b>Inspector Initials:</b>	SAL,BTWS
<b>BMP ID:</b>	UMCP20BMP0274	<b>Inspection Firm:</b>	MES
<b>BMP Type:</b>	Bioretention	<b>Underground BMP?</b>	No
<b>BMP Status</b>	Pass	<b>Overall Inspection</b>	Minor erosion at building from waterfall inflow, Cattails growth in Riprap
<b>Maintenance Level</b>	Minor Maintenance (Use of Hand Equipment for Repairs)	<b>Comment:</b>

Erosion at building

Repair Erosion at building. Ensure drainage to waterfall inflow. Monitor cattail growth in riprap.

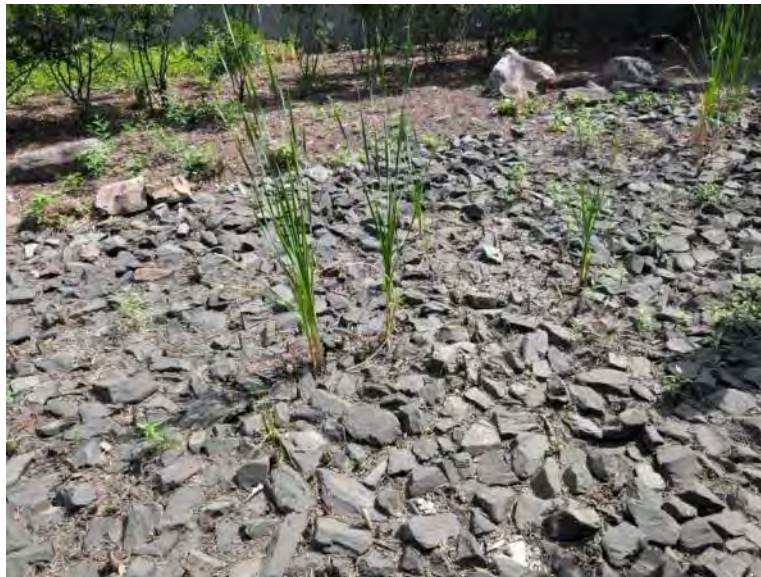
- **BMP Access** - Fair
- **Debris & Sediment** - Good
- **Vegetation** - Fair
- **BMP Contamination** - Good
- **General Site Conditions Comments:** Aquatic Vegetation growing in riprap

Vegetation growth in riprap

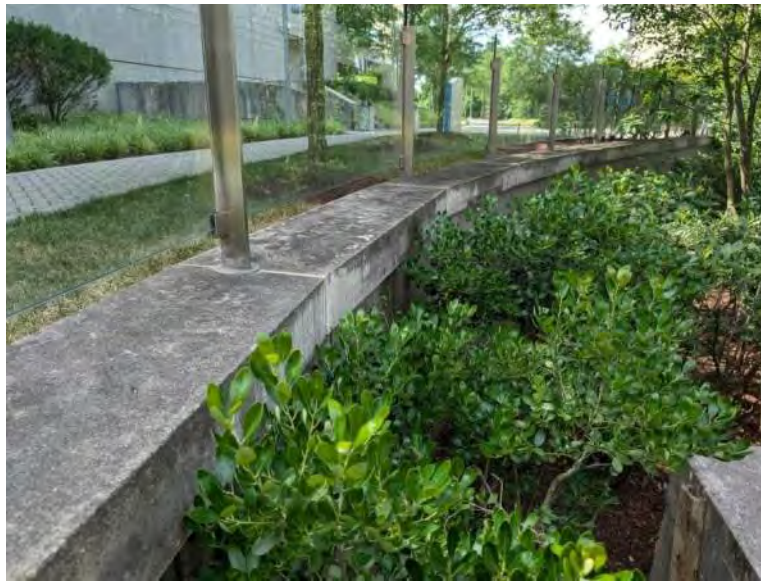
Upstream Overgrown Vegetation/Bridge over bioretention

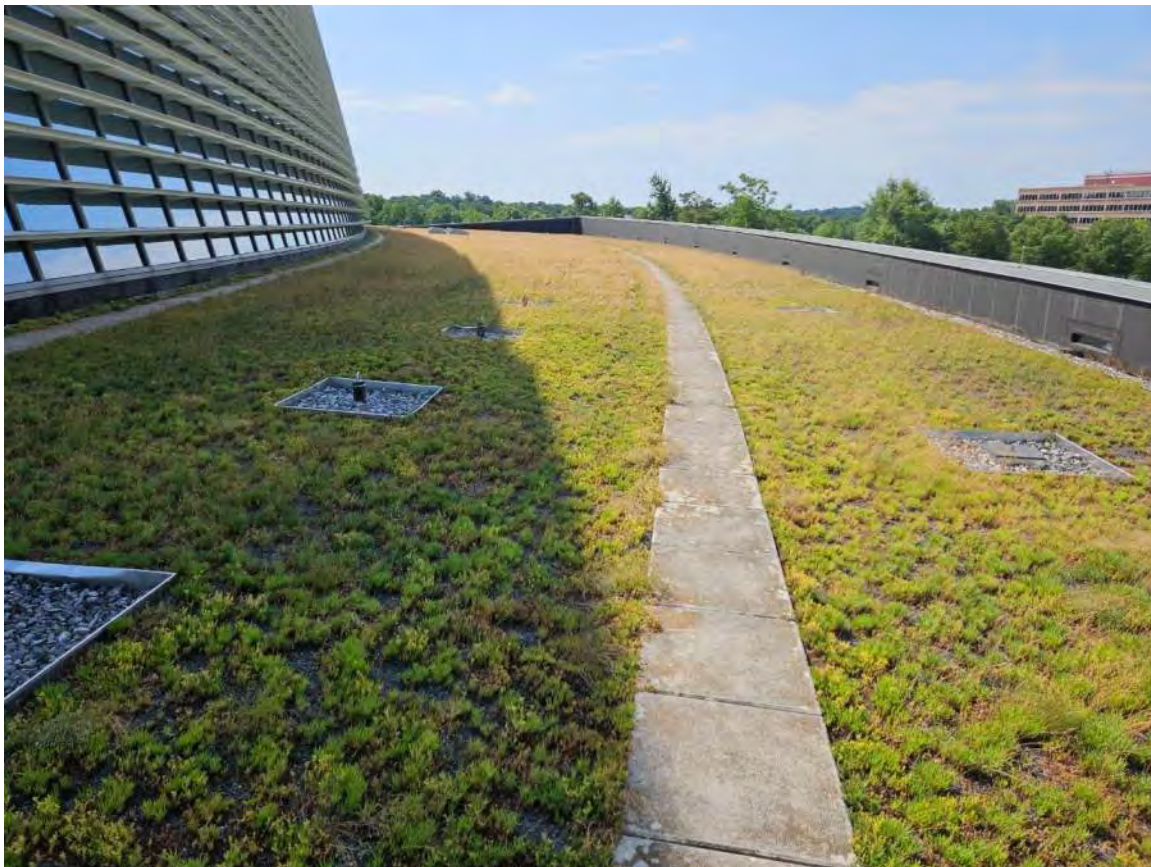
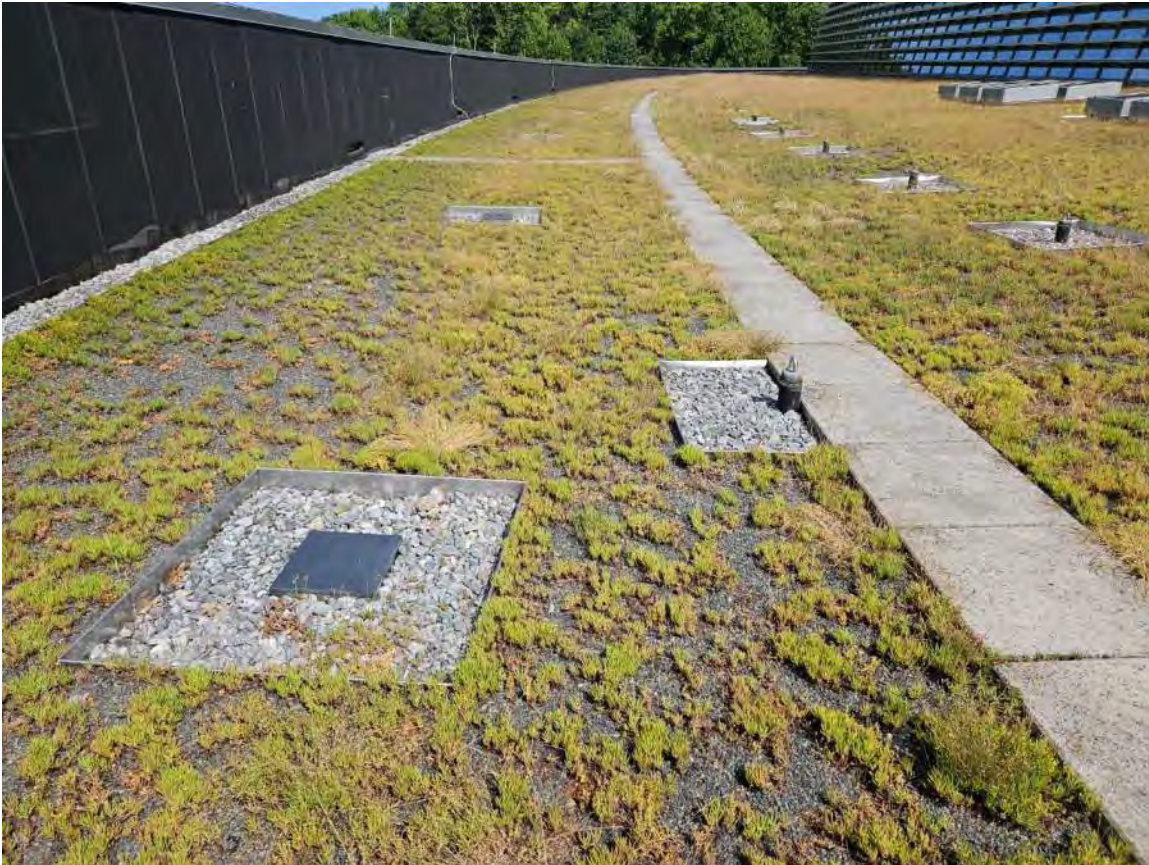
<b>Date of Inspection:</b>	June 28, 2024 10:19 AM	<b>Inspector Initials:</b>	SK,TG
<b>BMP ID:</b>	UMCP20BMP0275	<b>Inspection Firm:</b>	UMD
<b>BMP Type:</b>	Green Roof - Extensive	<b>Underground BMP?</b>	No
<b>BMP Status</b>	Pass	<b>Overall Inspection Comment:</b>	BMP in good condition. Replant bare areas.
<b>Maintenance Level</b>	Minor Maintenance (Use of Hand Equipment for Repairs)

Overall in good condition. Replant bare areas.

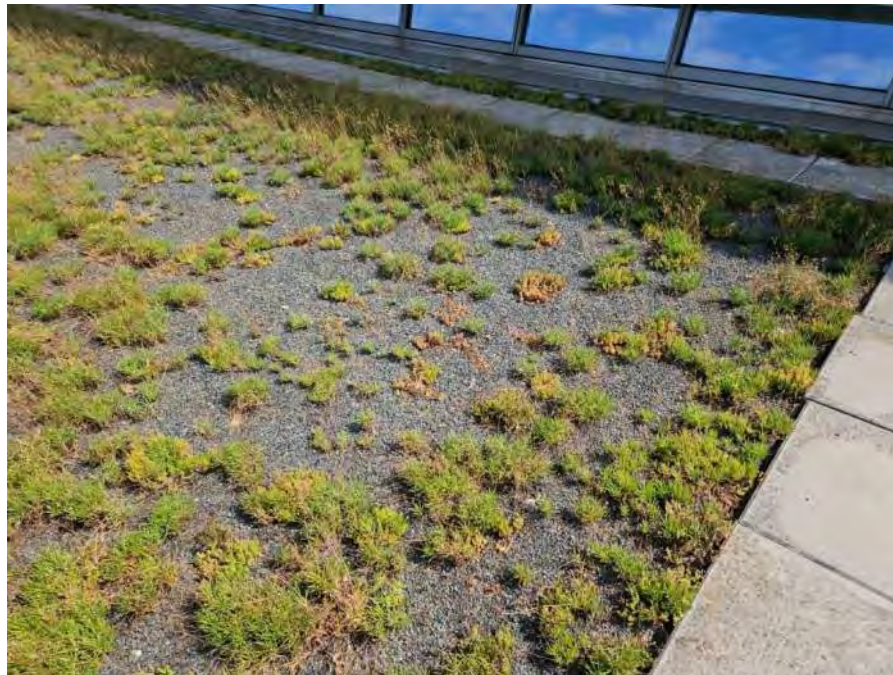
Minor bare areas

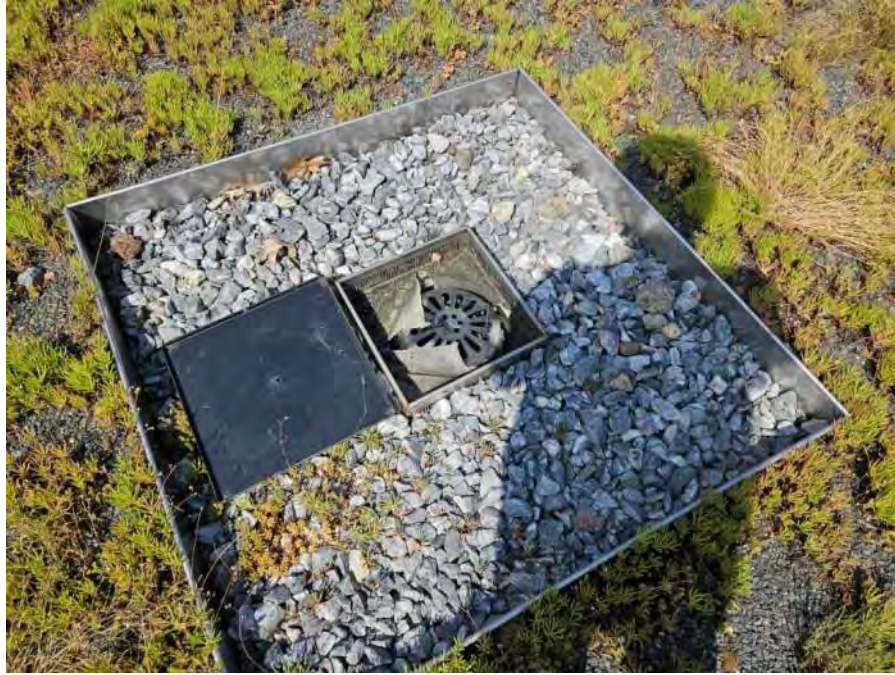
Bare areas

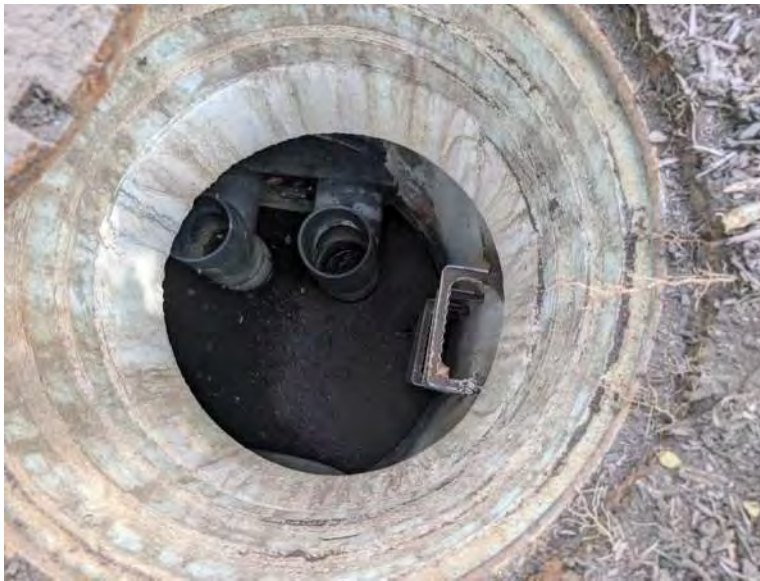
<b>Date of Inspection:</b>	June 26, 2024 8:39 AM	<b>Inspector Initials:</b>	SAL,BTWS
<b>BMP ID:</b>	UMCP20BMP0276	<b>Inspection Firm:</b>	MES
<b>BMP Type:</b>	Oil Grit Separator	<b>Underground BMP?</b>	Yes
<b>BMP Status</b>	Fail	<b>Overall Inspection Comment:</b>	4' of Sediment/Mud within Facility
<b>Maintenance Level</b>	Major Maintenance (Use of Heavy Machinery for Repairs)

- **BMP Access** - Fair
- **Debris & Sediment** - Poor
- **Vegetation** - N/A
- **BMP Contamination** - Good
- **General Site Conditions Comments:** 4' sediment and mud within facility.

Clear sediment from facility to allow for continued filtration

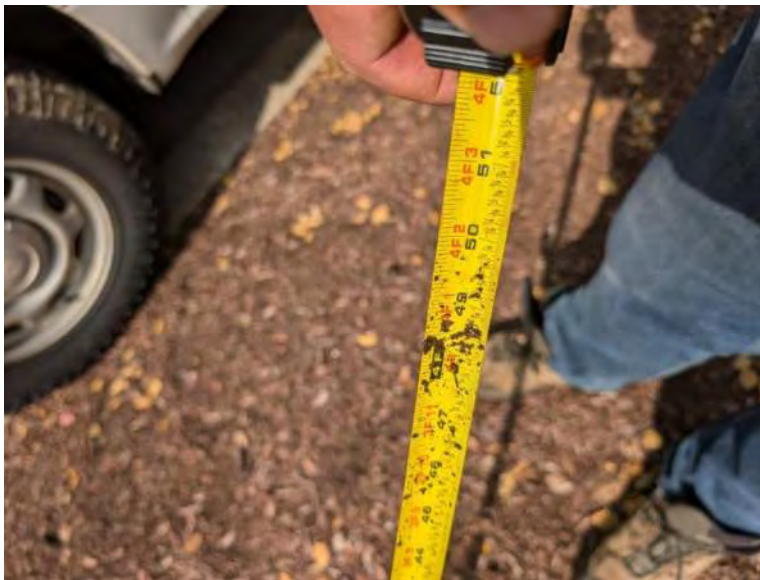
Measured 4ft of sediment accumulation

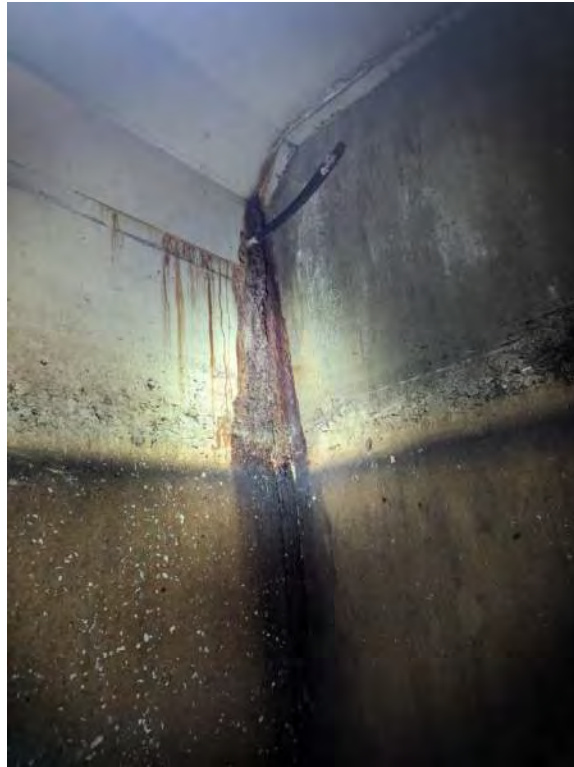
Discoloration on structure wall
