University of Maryland, College Park  
National Pollutant Discharge Elimination  
System MS4 Phase II  
FY2024 Annual Report  
General Discharge Permit #13-SF-5501

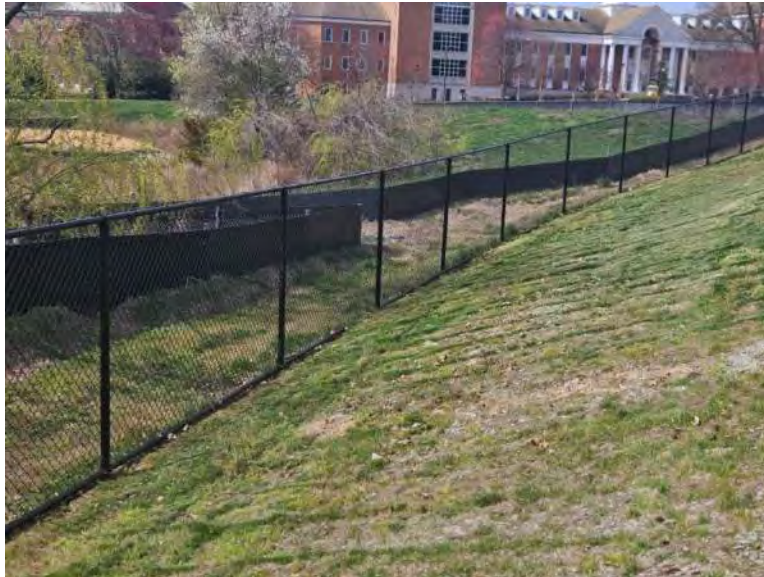
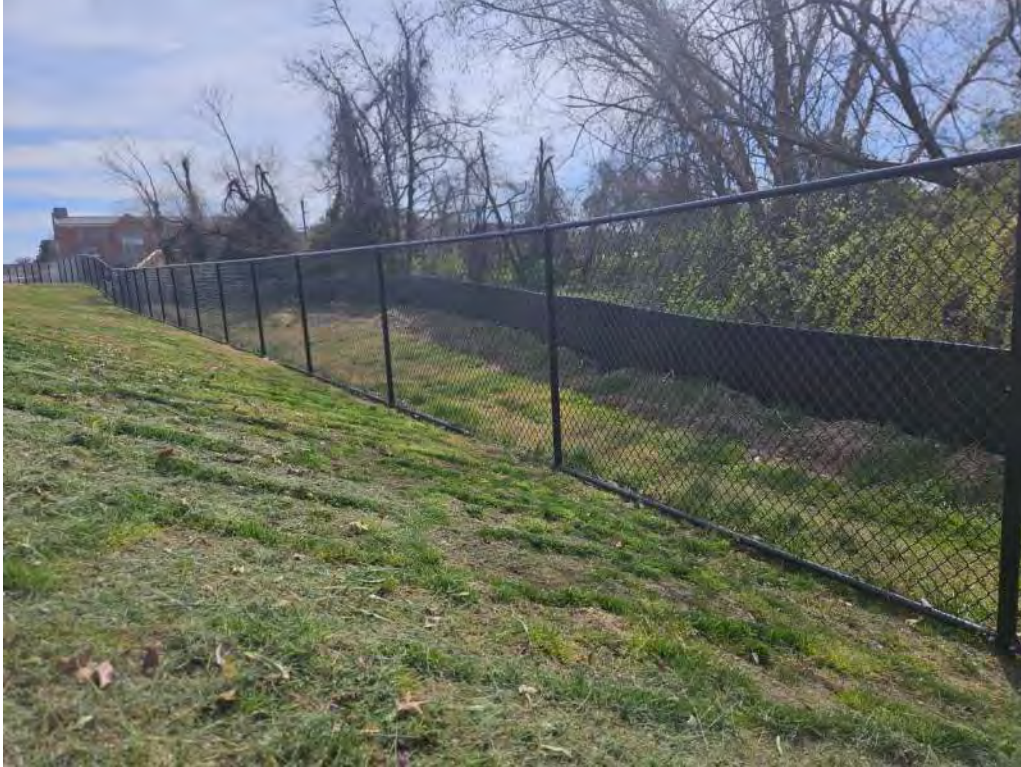
<b>Date of Inspection:</b>	March 26, 2024 12:50 PM	<b>Inspector Initials:</b>	PP,SK
<b>BMP ID:</b>	UMCP23BMP0326	<b>Inspection Firm:</b>	UMD
<b>BMP Type:</b>	Bio-Swale	<b>Underground BMP?</b>	No
<b>BMP Status</b>	Pass	<b>Overall Inspection Comment:</b>	BMP in good condition. Recommend adding more grass seed
<b>Maintenance Level</b>	Routine Maintenance

Continue routine maintenance. Recommend adding more grass seed.

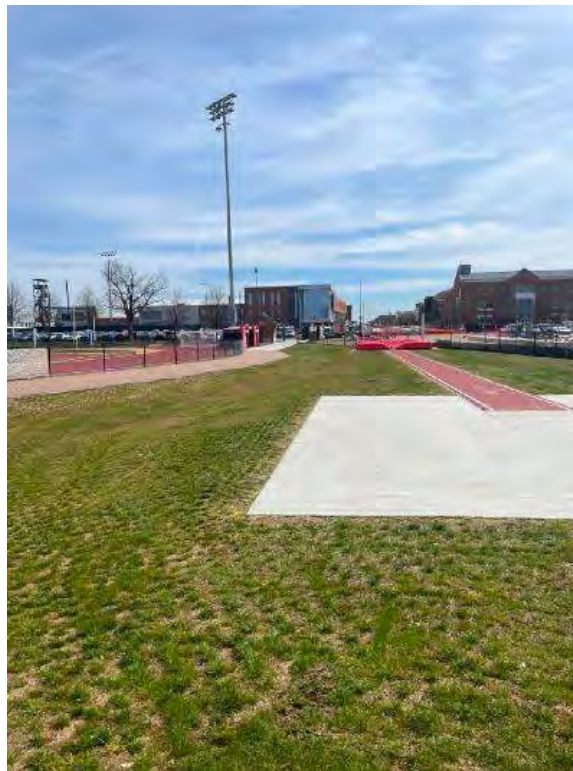
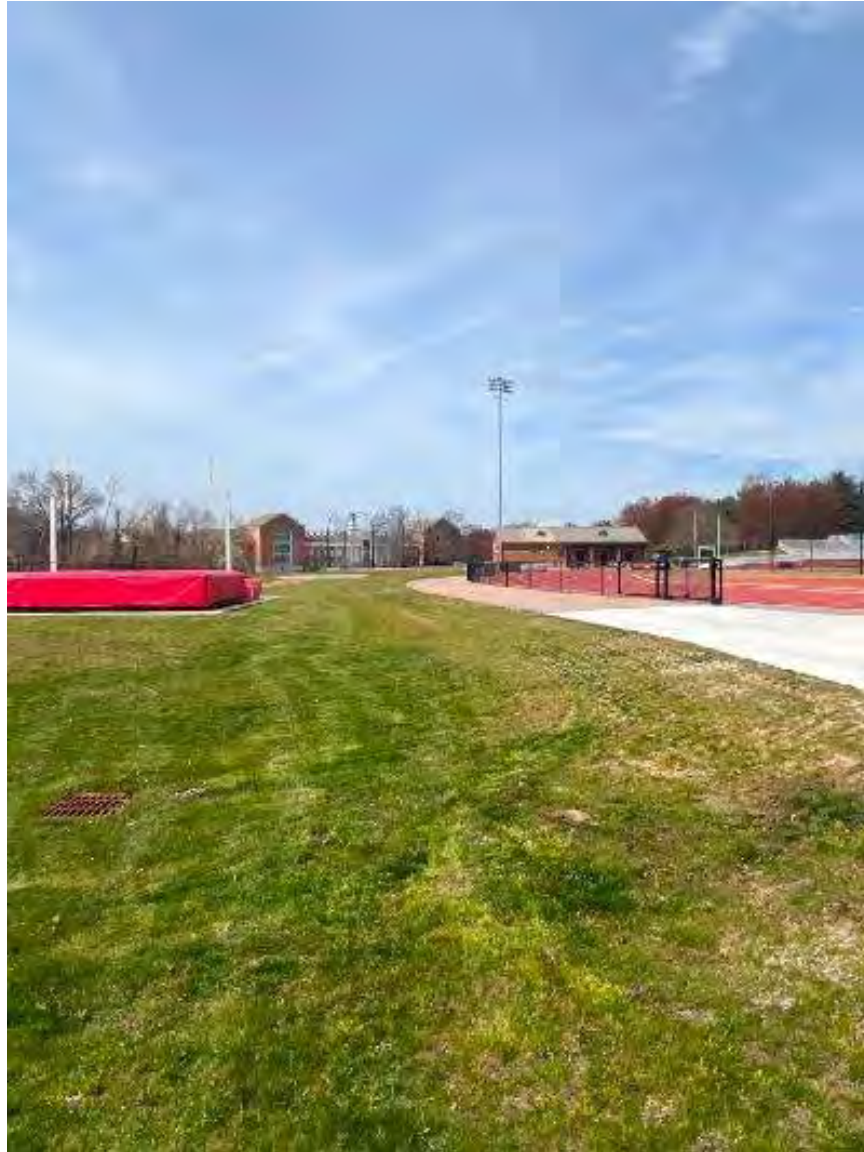
<b>Date of Inspection:</b>	March 27, 2024 11:52 AM	<b>Inspector Initials:</b>	PP,SK
<b>BMP ID:</b>	UMCP23BMP0327	<b>Inspection Firm:</b>	UMD
<b>BMP Type:</b>	Disconnection of Non-Rooftop Runoff	<b>Underground BMP?</b>	No
<b>BMP Status</b>	Pass	<b>Overall Inspection Comment:</b>	BMP in good condition. Recommend adding more grass seed
<b>Maintenance Level</b>	Routine Maintenance

Recommend adding more grass seed. Continue routine maintenance

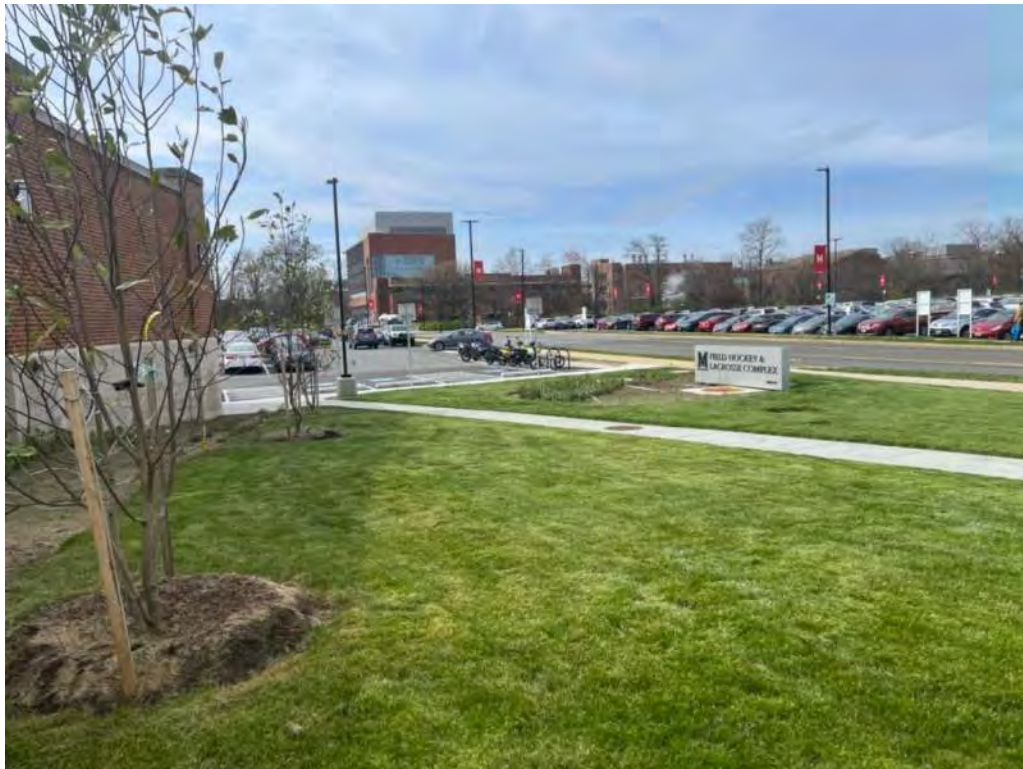
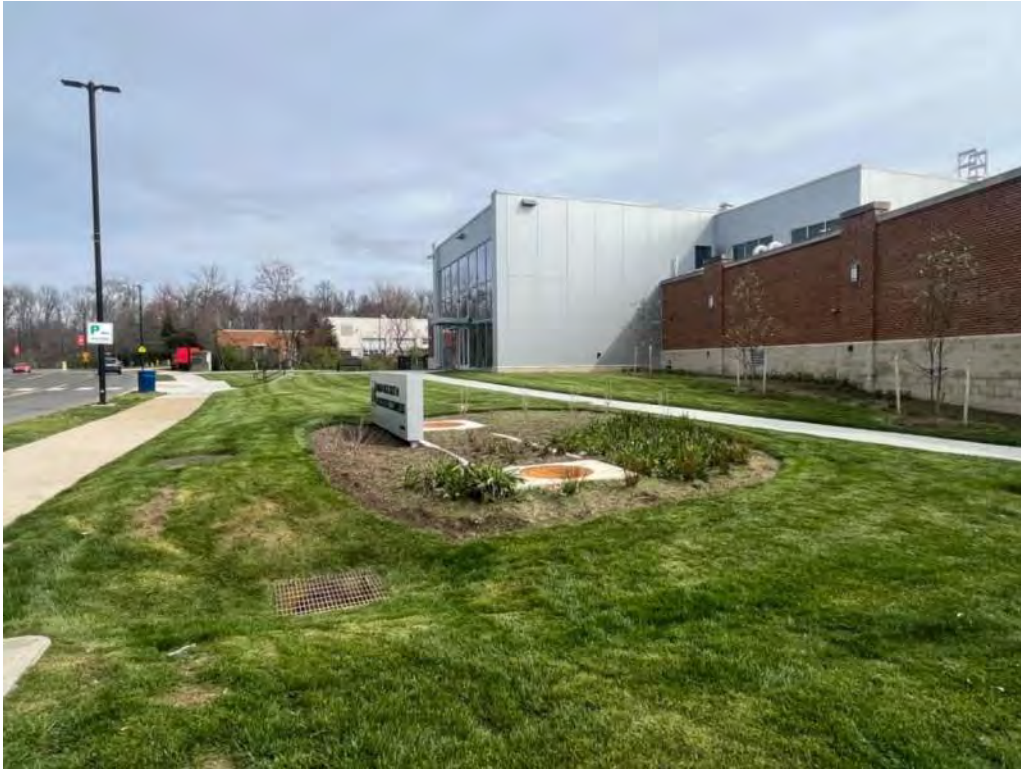
<b>Date of Inspection:</b>	March 26, 2024 4:08 PM	<b>Inspector Initials:</b>	PP,SK
<b>BMP ID:</b>	UMCP23BMP0328	<b>Inspection Firm:</b>	UMD
<b>BMP Type:</b>	Micro-Bioretenion	<b>Underground BMP?</b>	No
<b>BMP Status</b>	Pass	<b>Overall Inspection Comment:</b>	BMP has active water flow
<b>Maintenance Level</b>	Minor Maintenance

Monitor ponding and source of flow

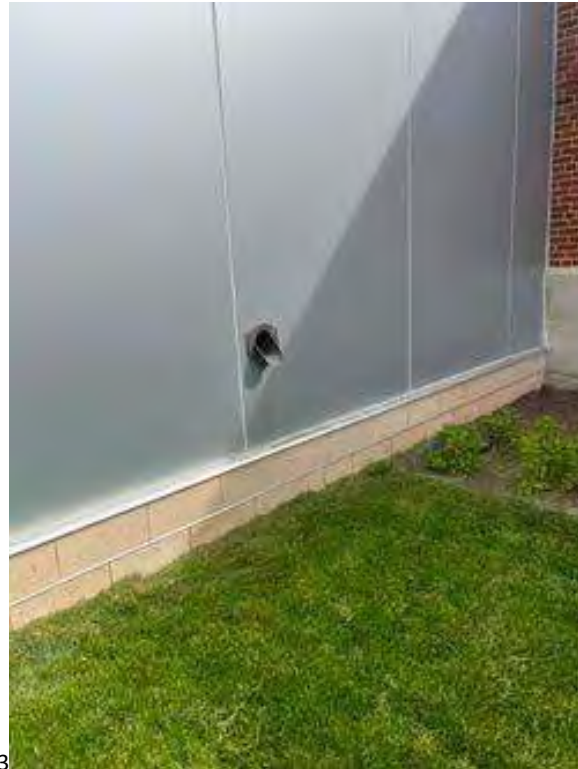
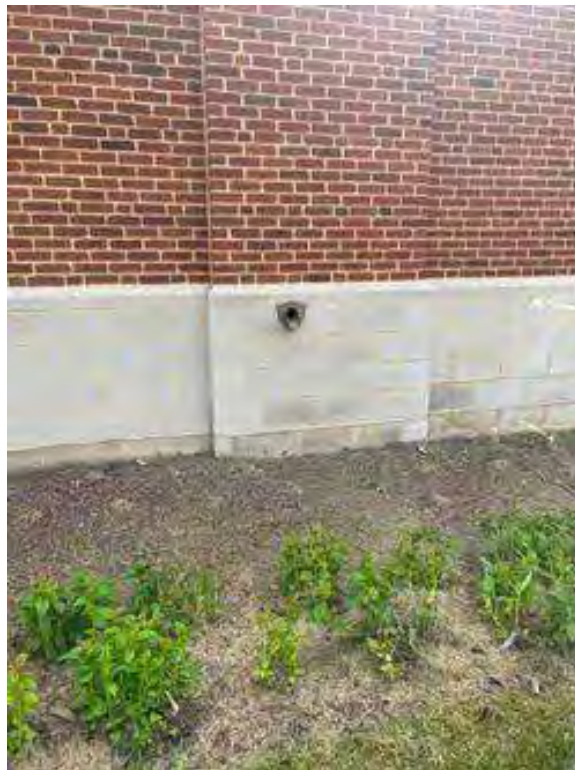
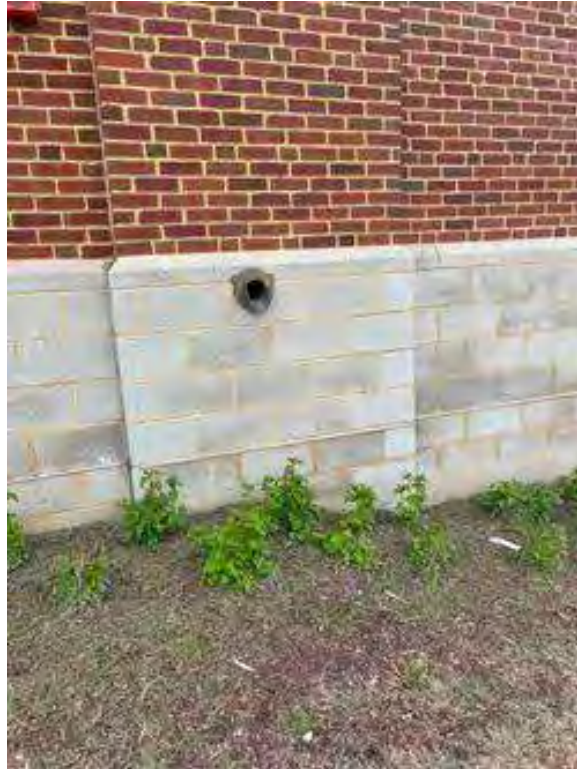
- **Inflow Condition** - Poor
- **Forebay** - N/A

**BMP Status** - Fail

Inlet

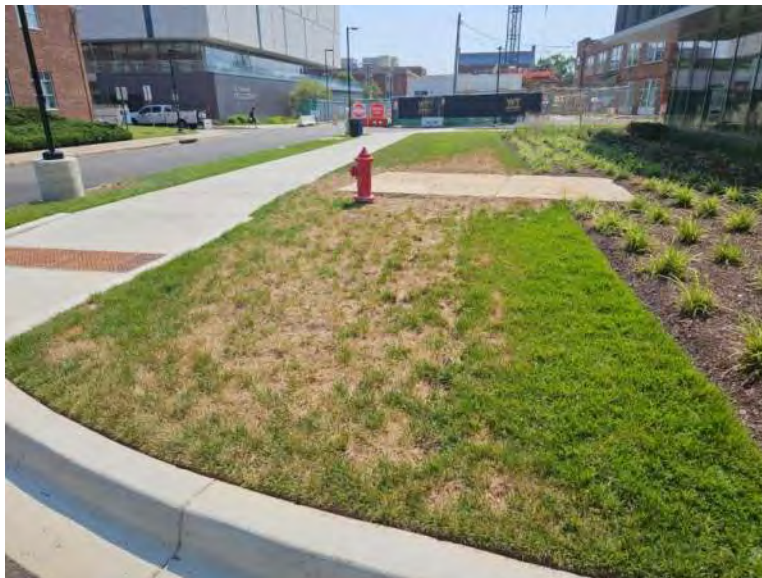
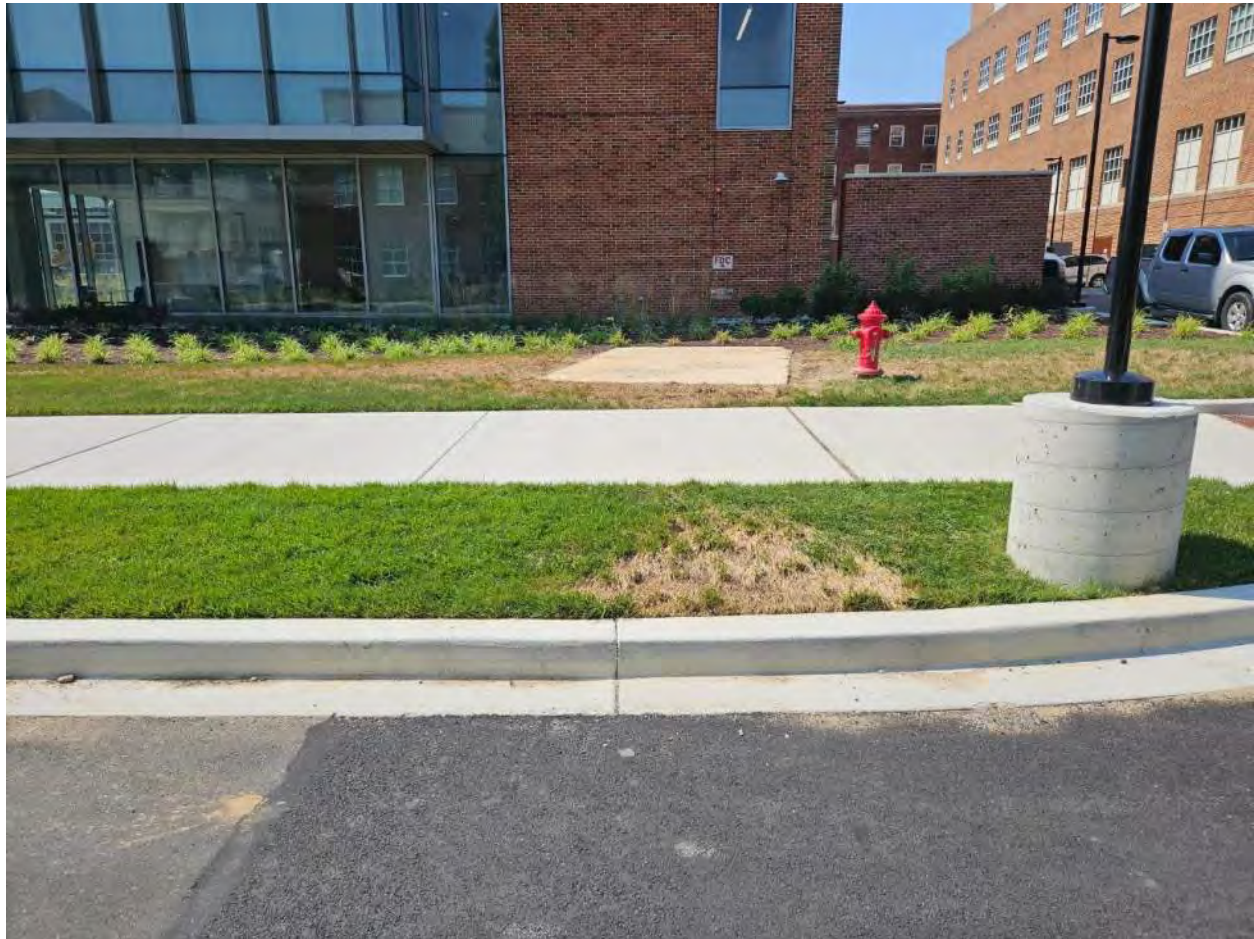
<b>Date of Inspection:</b>	June 17, 2024 10:37 AM	<b>Inspector Initials:</b>	SK,TG
<b>BMP ID:</b>	UMCP23BMP0330	<b>Inspection Firm:</b>	UMD
<b>BMP Type:</b>	Disconnection of Non-Rooftop Runoff	<b>Underground BMP?</b>	No
<b>BMP Status</b>	Pass	<b>Overall Inspection Comment:</b>	Repair erosion on grassy area
<b>Maintenance Level</b>	Minor Maintenance (Use of Hand Equipment for Repairs)

Erosion Affecting Grassy Area

Minor Maintenance

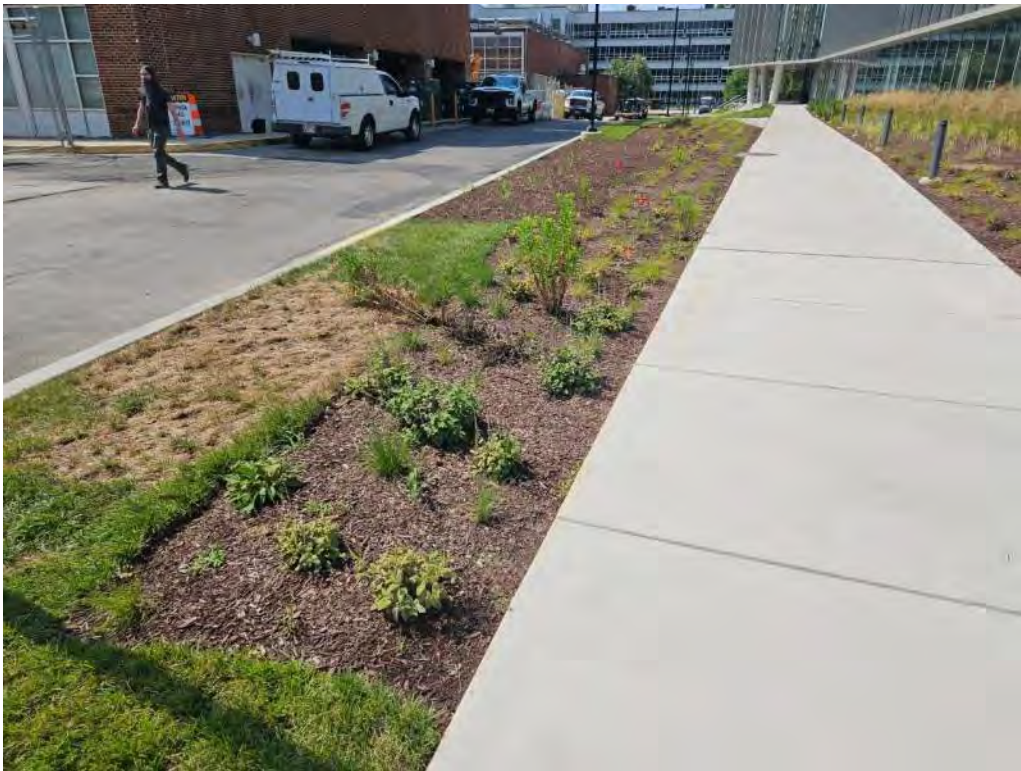
### Overall Photo

<b>Date of Inspection:</b>	June 17, 2024 10:31 AM	<b>Inspector Initials:</b>	SK,TG
<b>BMP ID:</b>	UMCP23BMP0331	<b>Inspection Firm:</b>	UMD
<b>BMP Type:</b>	Disconnection of Non-Rooftop Runoff	<b>Underground BMP?</b>	No
<b>BMP Status</b>	Pass	<b>Overall Inspection Comment:</b>	BMP in good condition
<b>Maintenance Level</b>	Routine Maintenance (Only needs Routine Maintenance)

**Maintenance & Remediation Recommendations** – Continue Routine Maintenance
