University of Maryland, College Park
National Pollutant Discharge Elimination
System MS4 Phase II
FY2025 Annual Report
General Discharge Permit #13-SF-5501

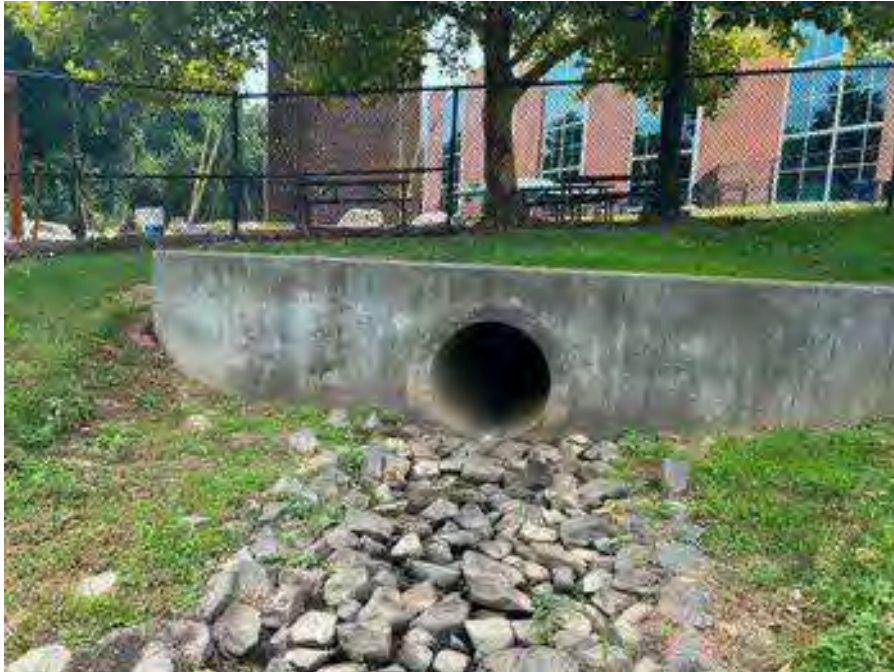
Principal Spillway Overall

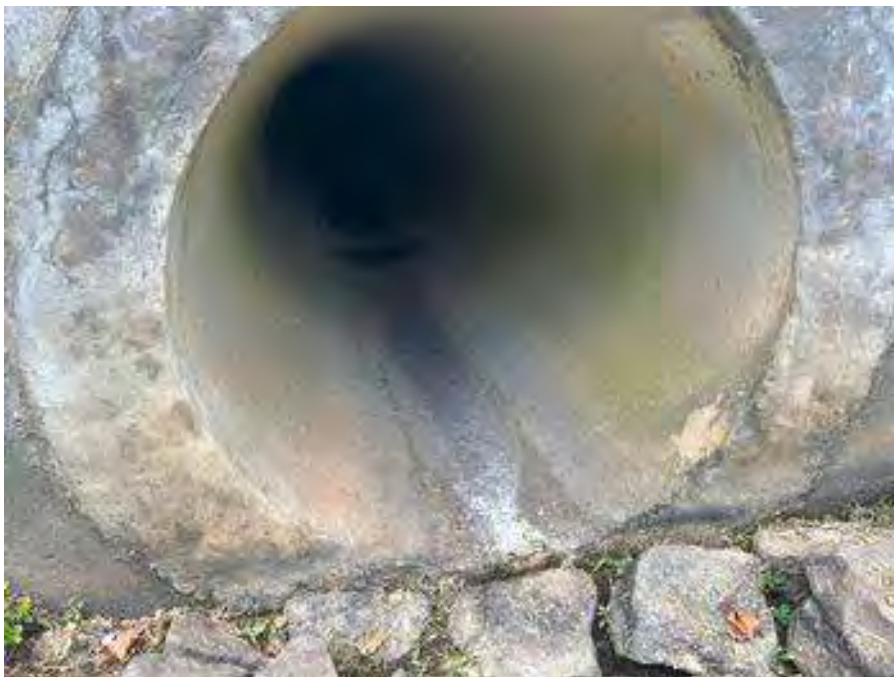
Principal Spillway Close Up

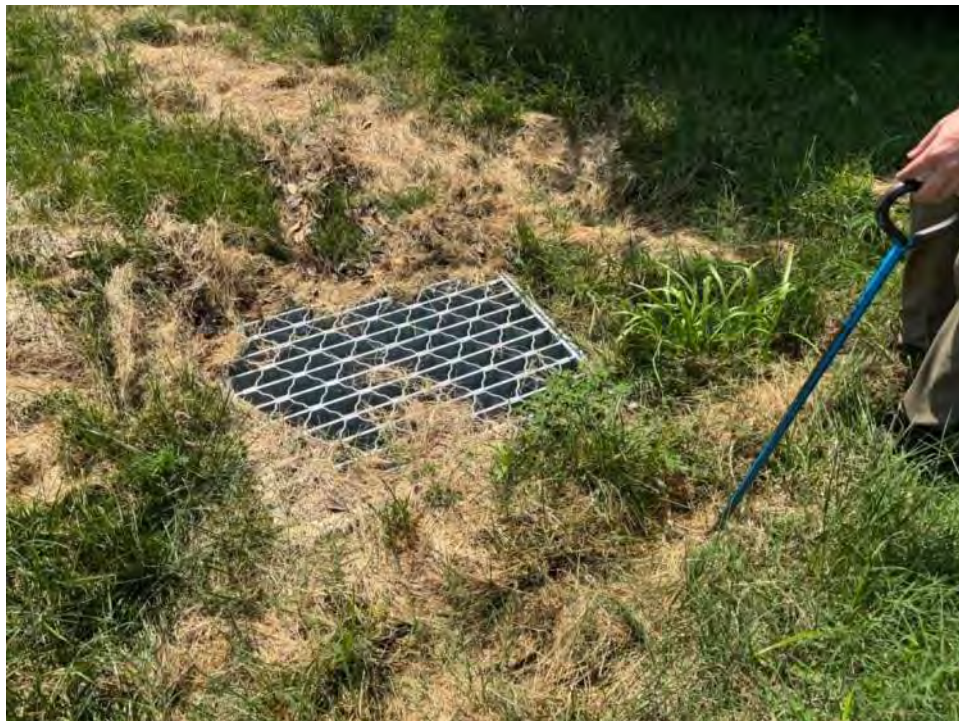
Small hole forming around control structure

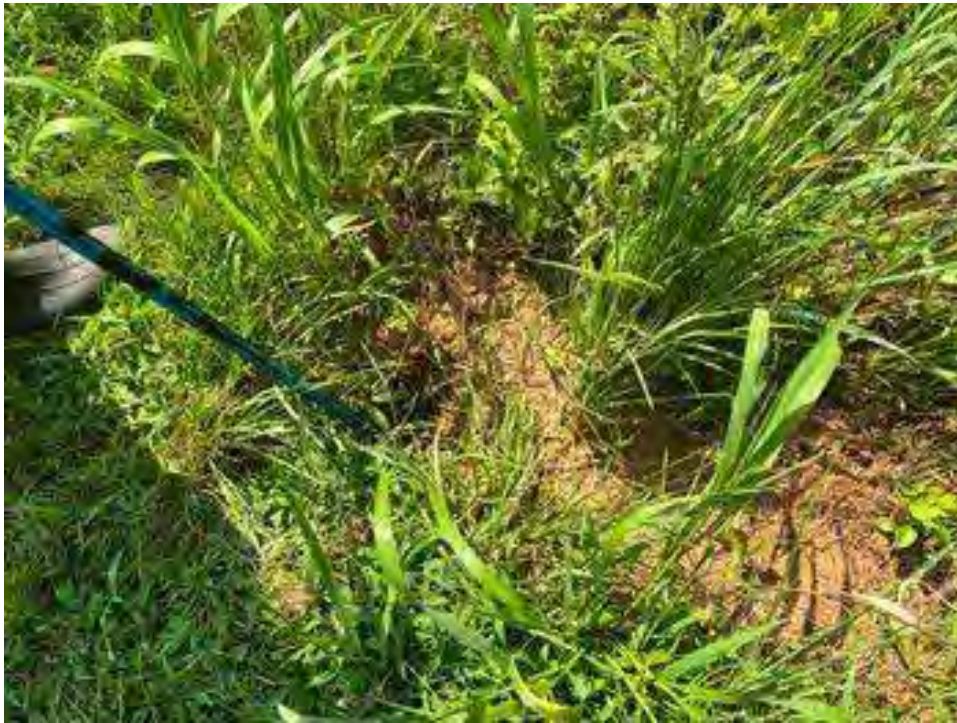
Small eroded channel on berm

Clear overgrowth from pond berm and clear cattails from treatment area, fix small eroded channel on north side of berm

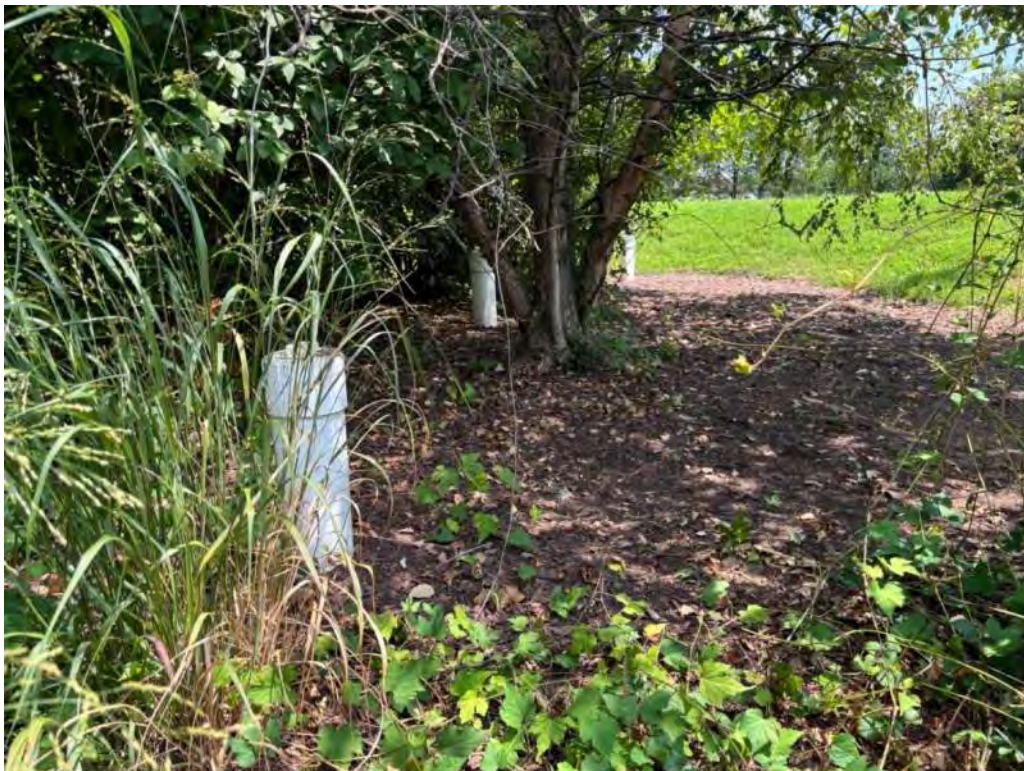
Debris in basin

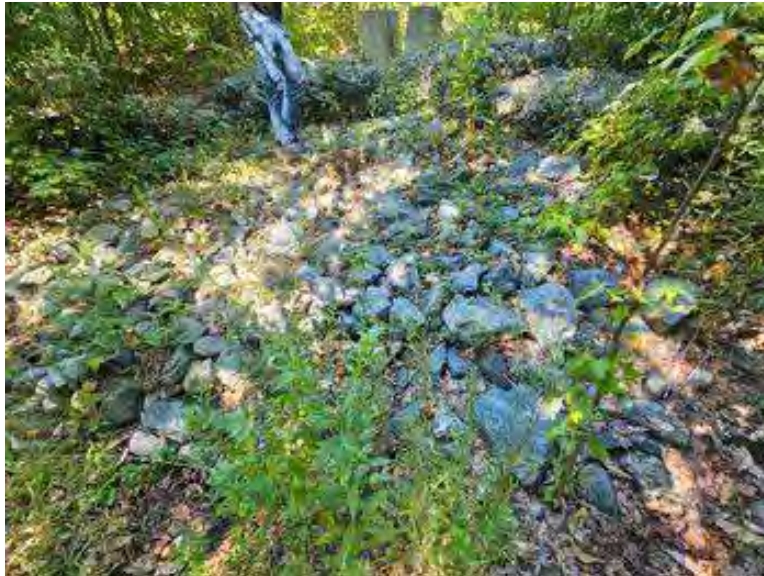
Outfall. Minor vegetation and debris.

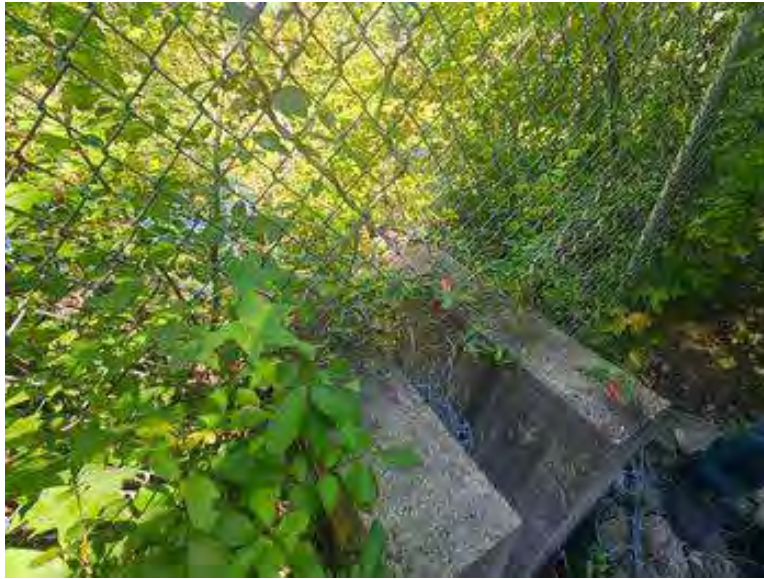
Tree growth on embankment.

Remove Woody Vegetation from embankment

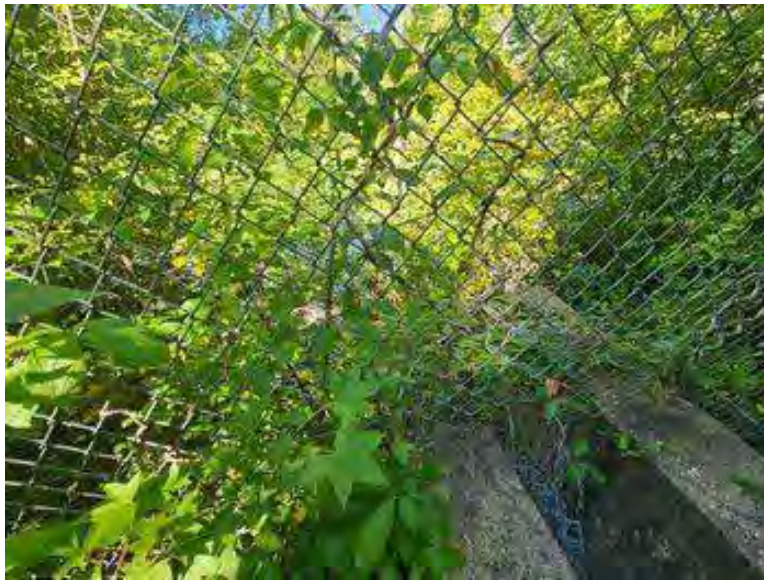
Tree growth on embankment.

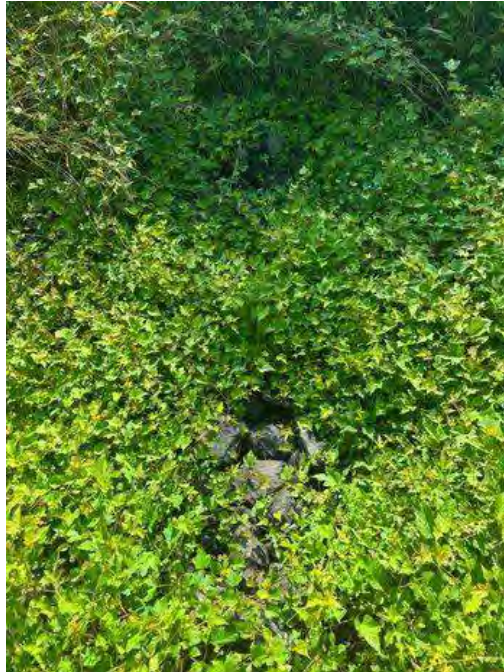
- **BMP Access** - Good
- **Debris & Sediment** - Good
- **Vegetation** - Fair
- **BMP Contamination** - Good
- **General Site Conditions Comments:** Slightly overgrown with grassy vegetation

Overgrown Rip Rap Close Up

Remove unwanted vegetation. Locate and reinspect control structure following maintenance.

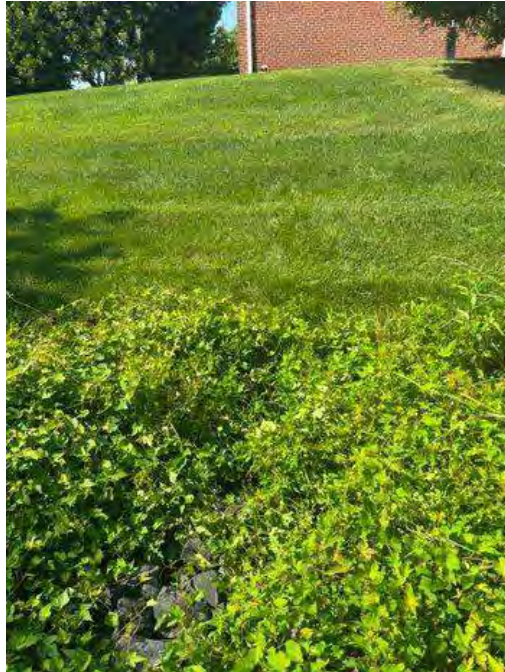
Overgrown Rip Rap

Remove unplanned vegetation. Trim planned vegetation. Locate & reinspect control structure following maintenance.

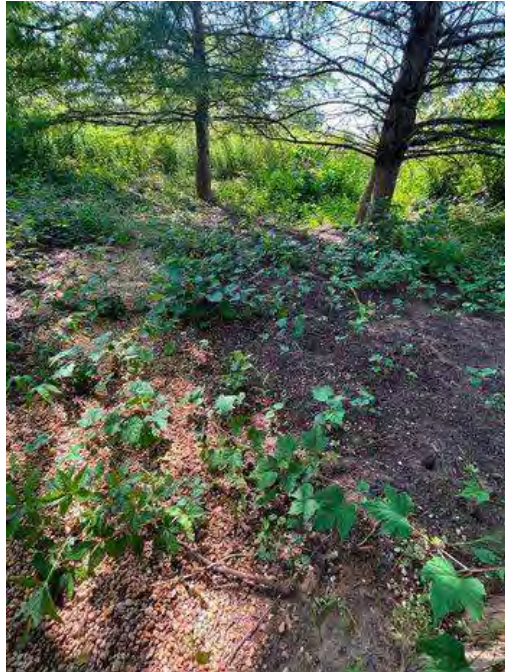
- **BMP Access** - Fair
- **Debris & Sediment** - Good
- **Vegetation** - Good
- **BMP Contamination** - Good
- **General Site Conditions Comments:** Bare spots in treatment basin, good inflow, control structure not located

Bare Spots in Treatment Basin 1

Remove unwanted vegetation and trim planned vegetation. Locate & reinspect control structure following maintenance.

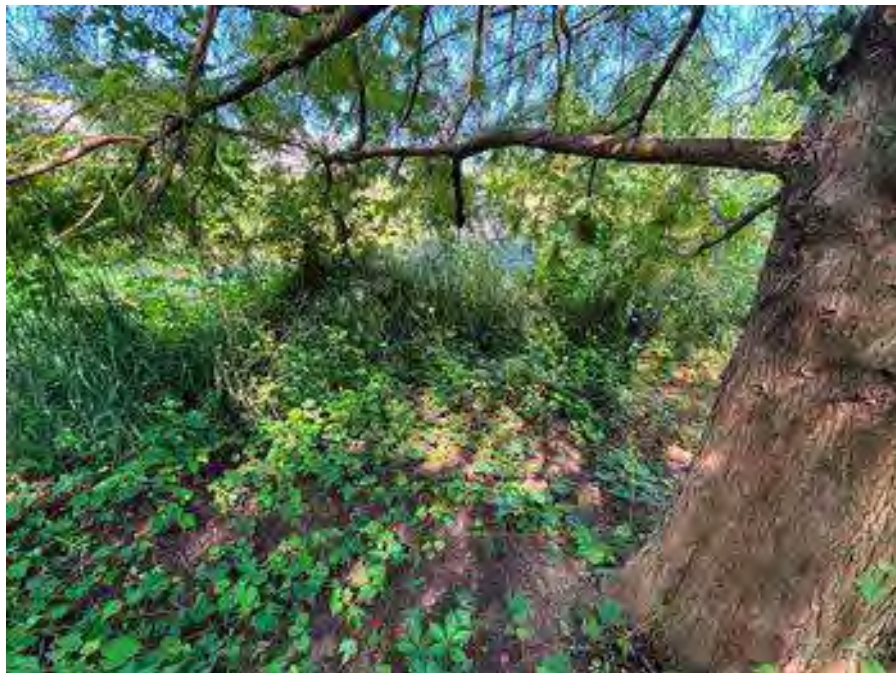
Bare Spots in Treatment Basin 2

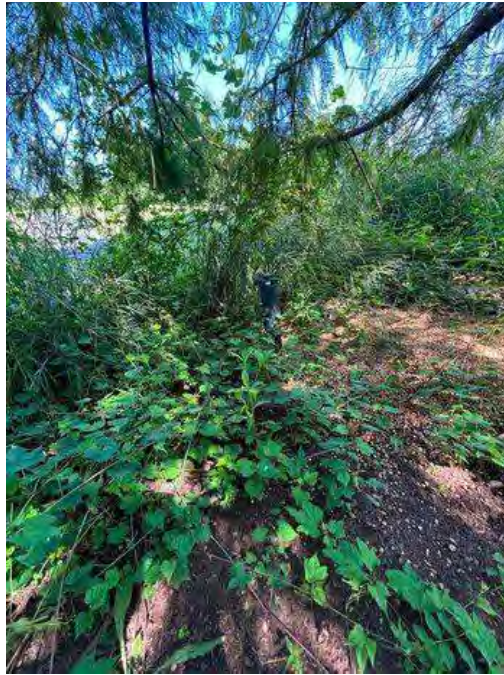
Bare Spots in Treatment Basin 3

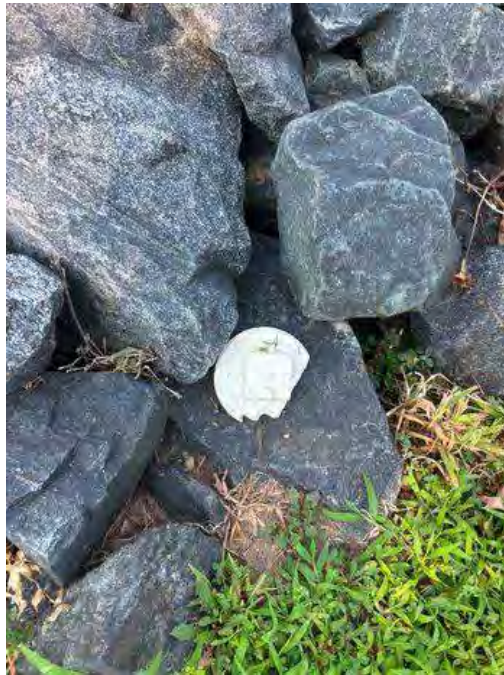
Debris in Discharge Area Close Up

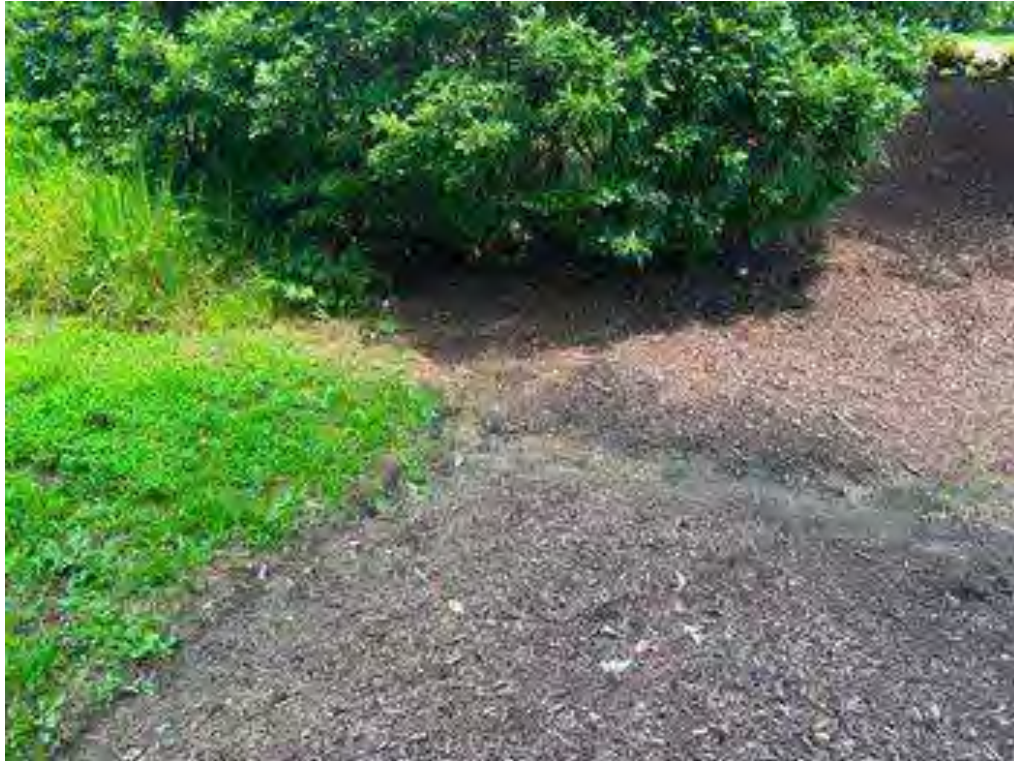
Minor sediment erosion at inflow

Re-mulch and monitor sediment deposits in inflow channel and upper treatment area, put caps on observation wells

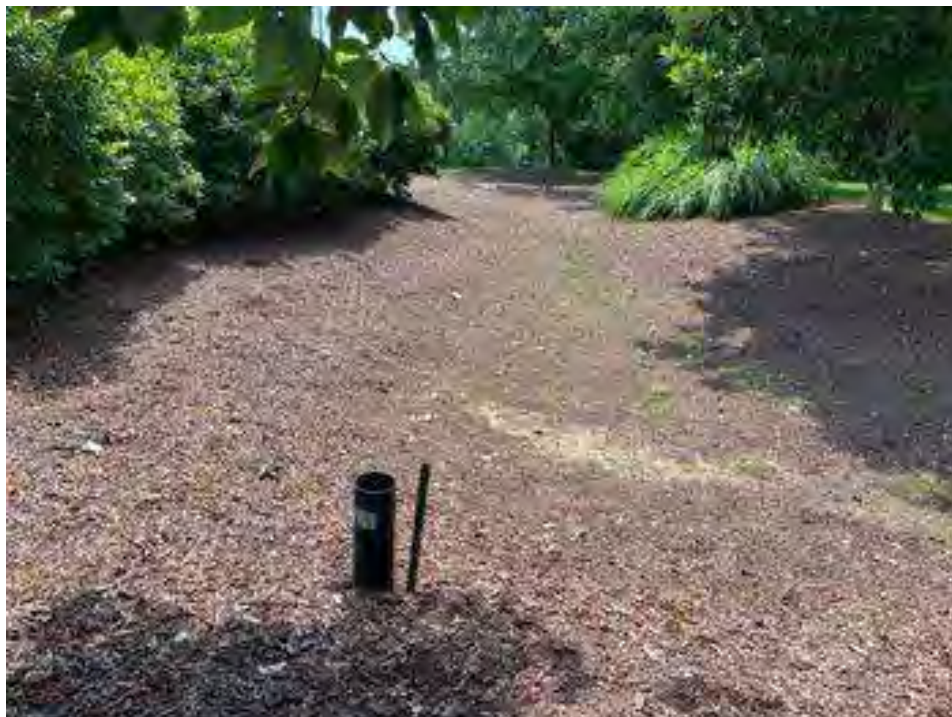
Minor sediment erosion at upper treatment basin

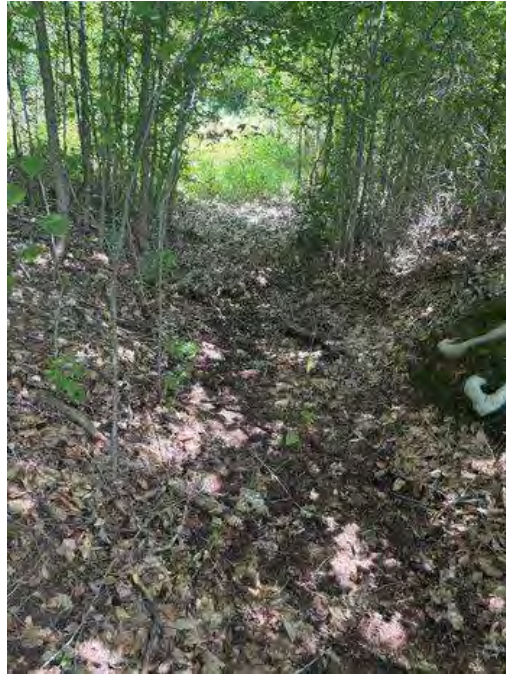
- **BMP Access** - Fair
- **Debris & Sediment** - Good
- **Vegetation** - Fair
- **BMP Contamination** - Good
- **General Site Conditions Comments:** Excess vegetation made access of structures difficult

Inflow Channel with Minor Erosion

Trim back vegetation, stabilize and reseed erosion at inflow channel. Locate & reinspect structures following maintenance.

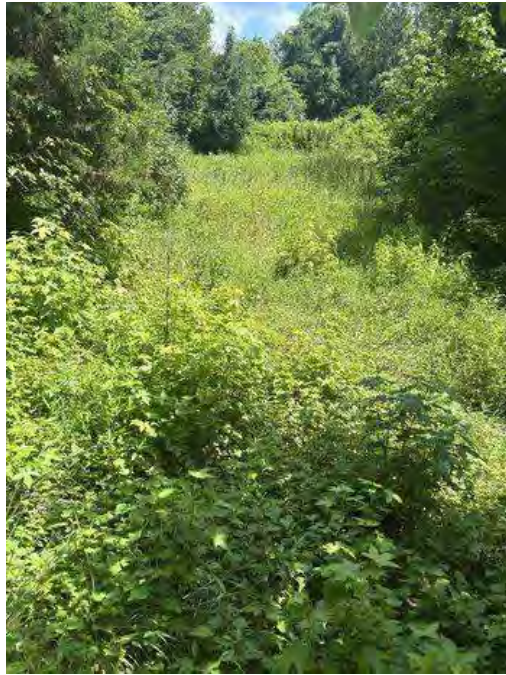
Overgrown Vegetation in Treatment Area

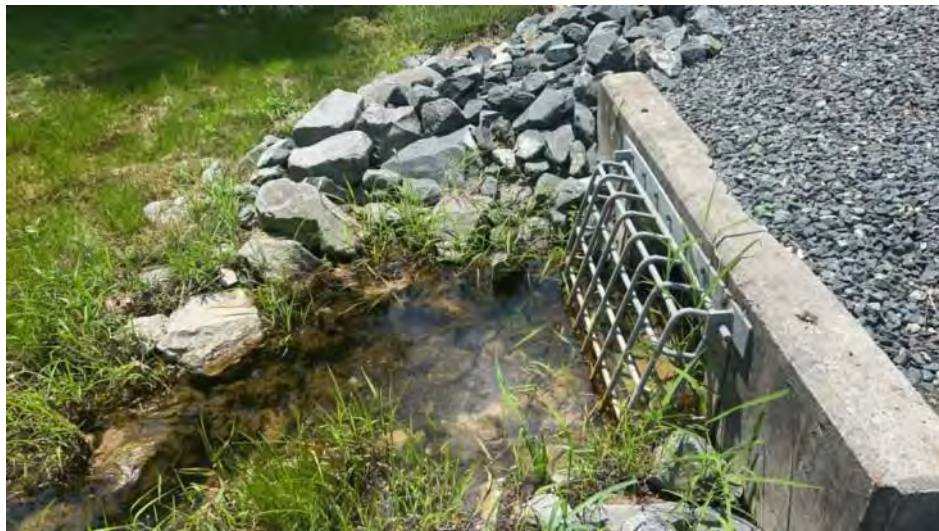
Trash Rack with Ponding

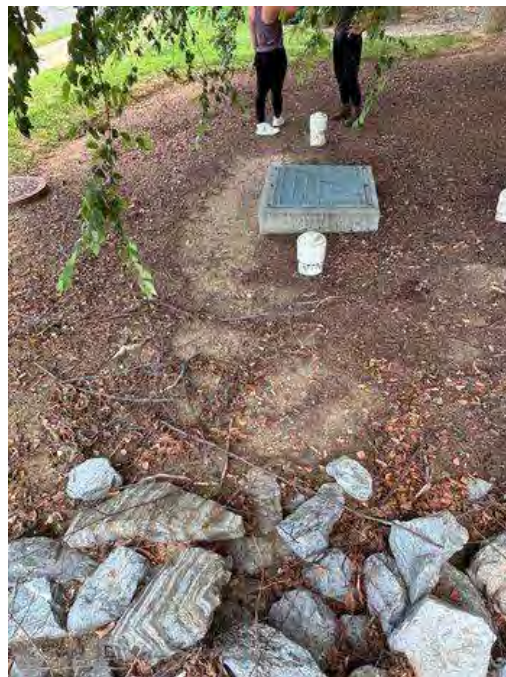
Control Structure Overall and Minor Erosion

Clean out control structure, remove excess sediment, remulch as needed

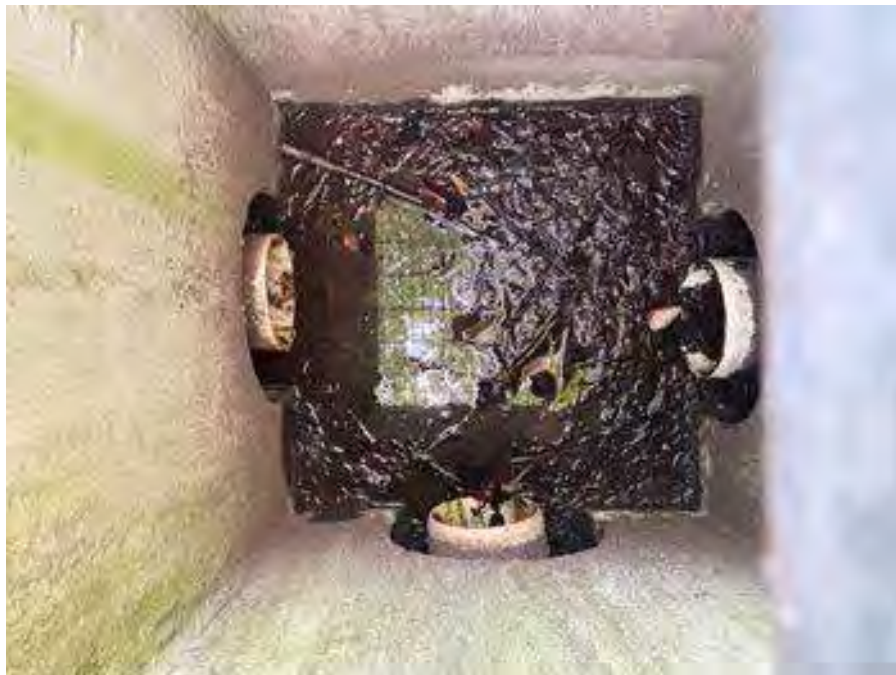
Control Structure Interior with Debris Buildup

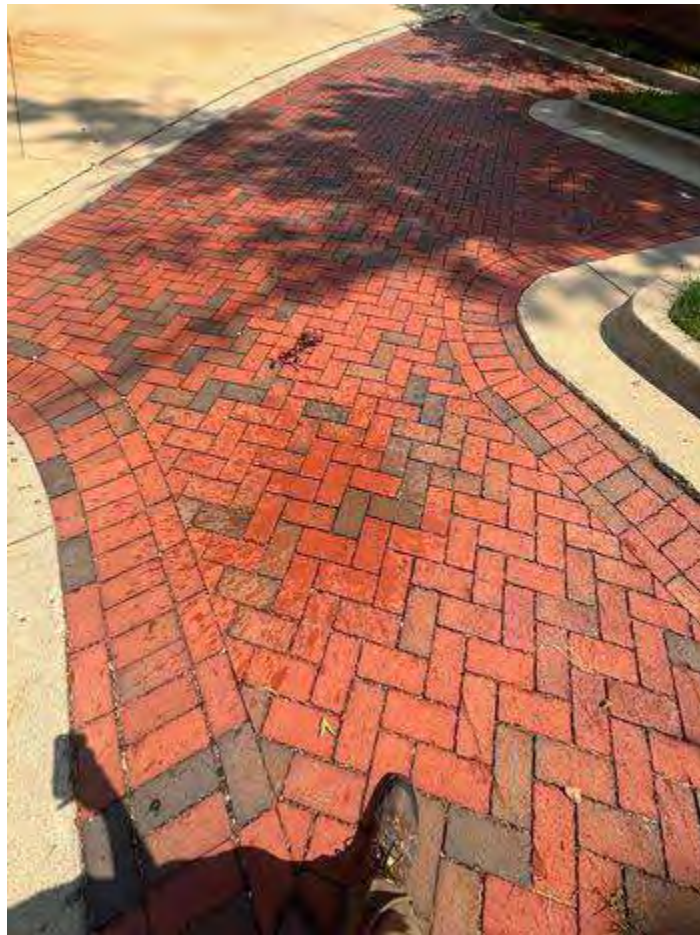
Water permeating into surface

Continue routine maintenance

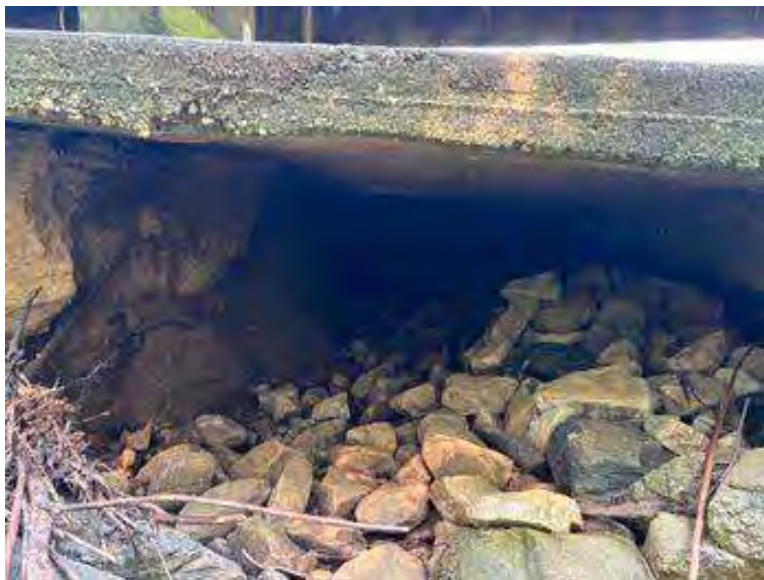
Collapsed concrete spillway

Repair collapsed concrete embankment, remove woody vegetation on and within buffer of embankment, clean out sedimented west side of pond

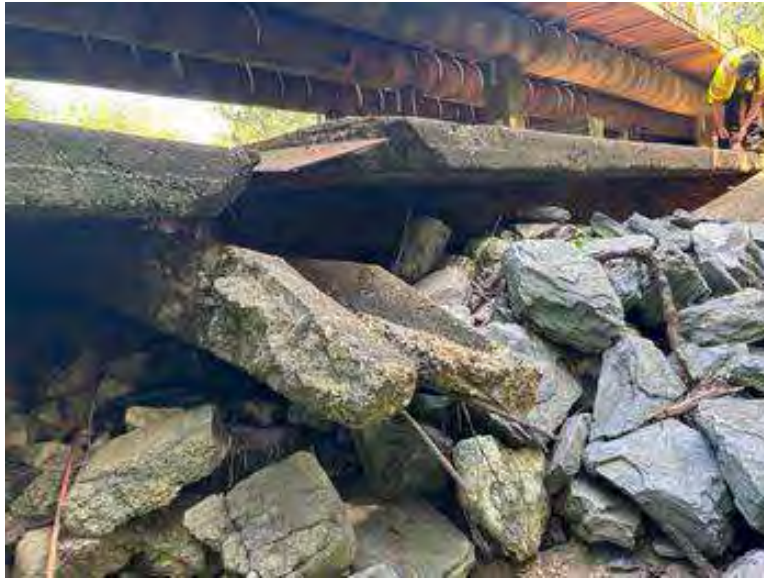
Stone fill beneath collapsed concrete spillway

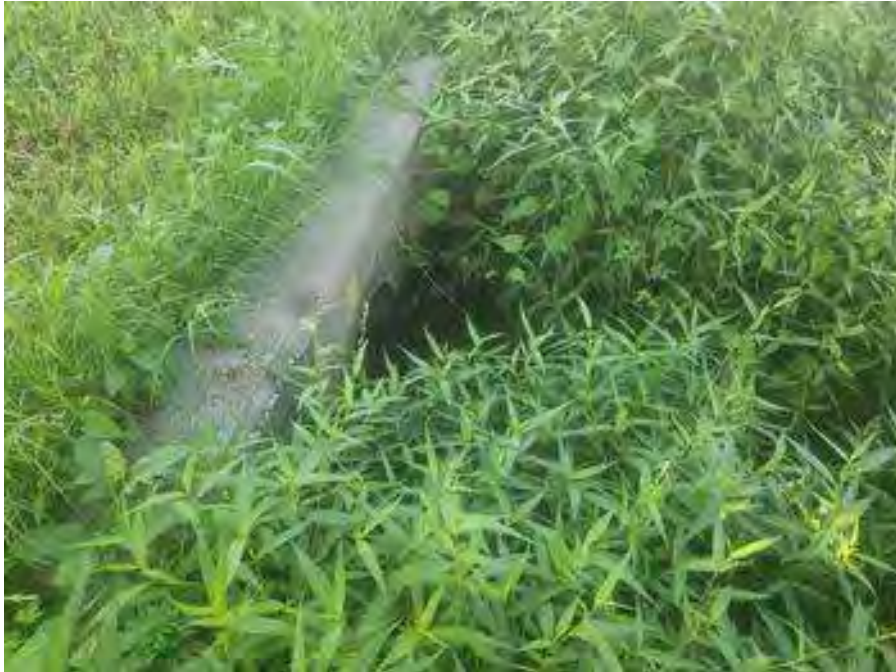
Inflow with Overgrown Vegetation

Remove invasive cattails, phragmites, and princess tree (tree on northernmost part of treatment area).

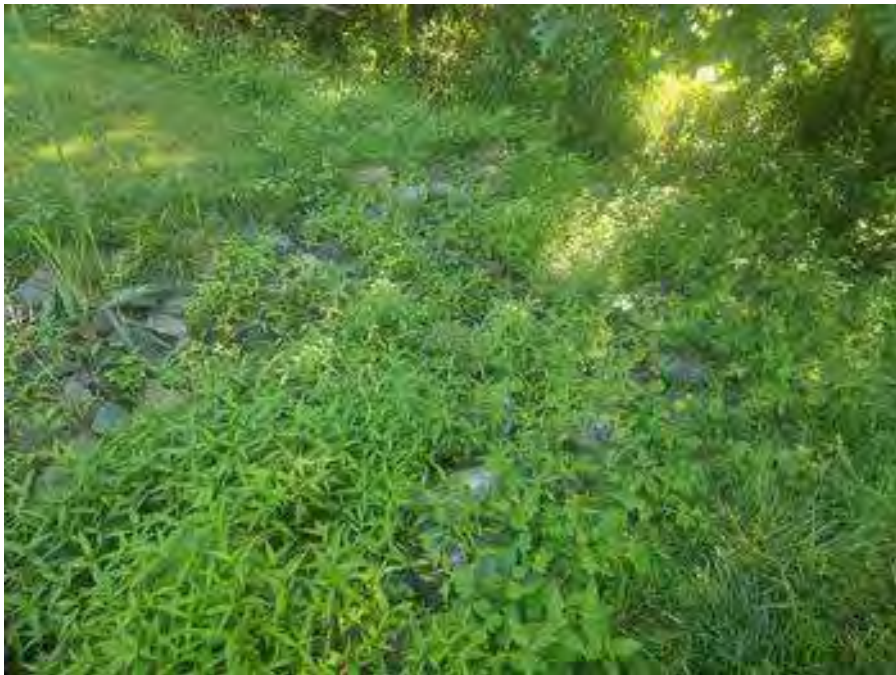
Overgrown Vegetation in Rip Rap

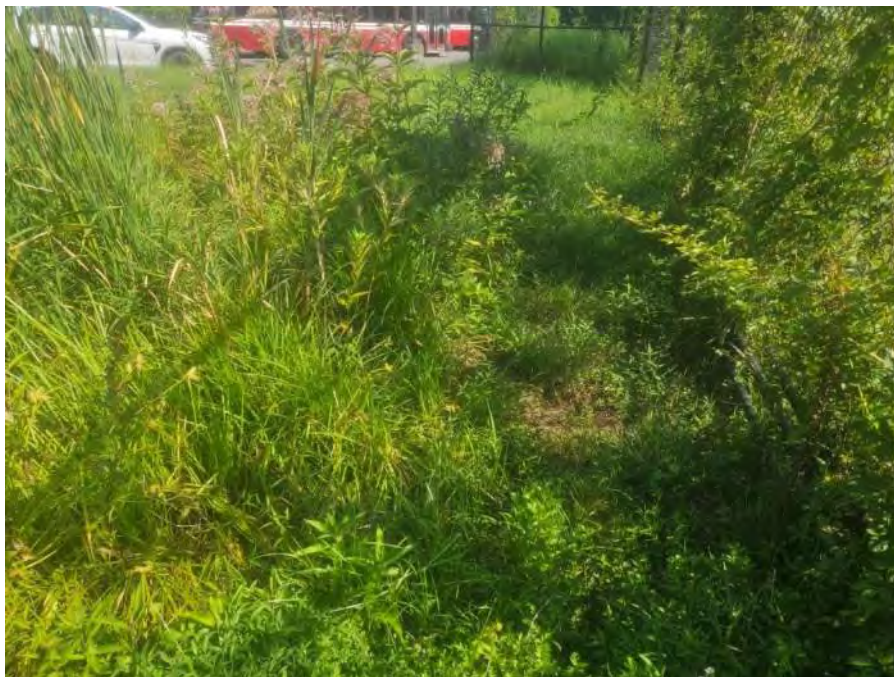
Principal Spillway with Erosion

Repair erosion at principal spillway, remove invasive cattails

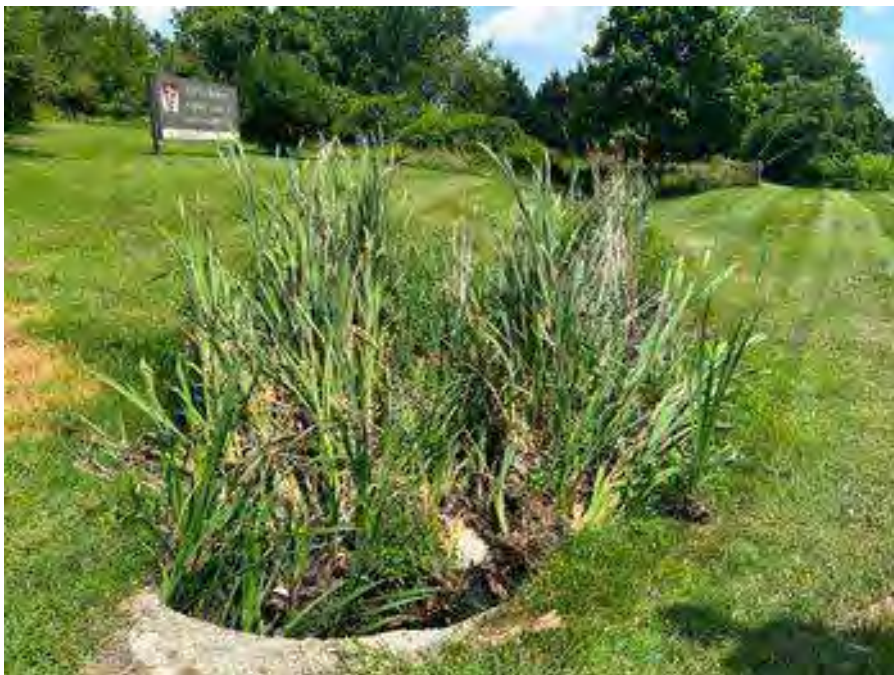
Overgrown Vegetation Blocking Inflow

Clear out overgrown herbaceous vegetation blocking inflow and remove plastic bottle obstructing low flow

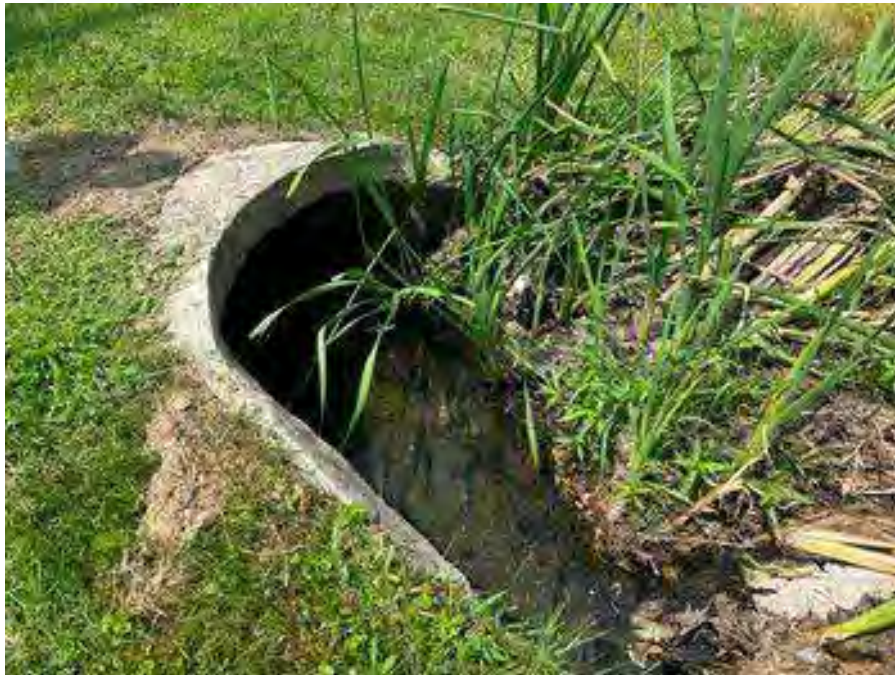
Inflow Close Up with Overgrown Vegetation

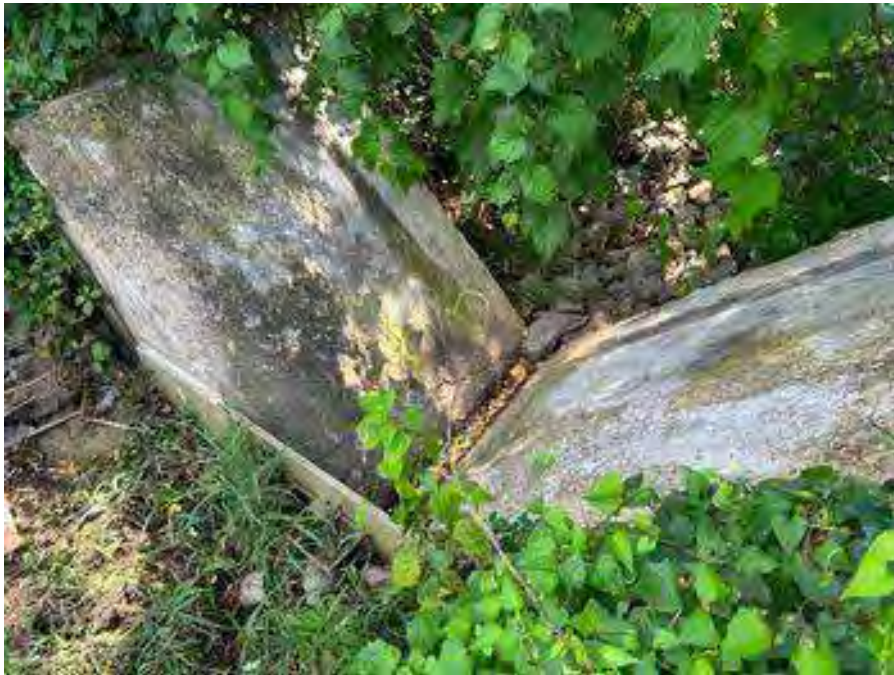
Control Structure with Low Flow Orifice Blockage

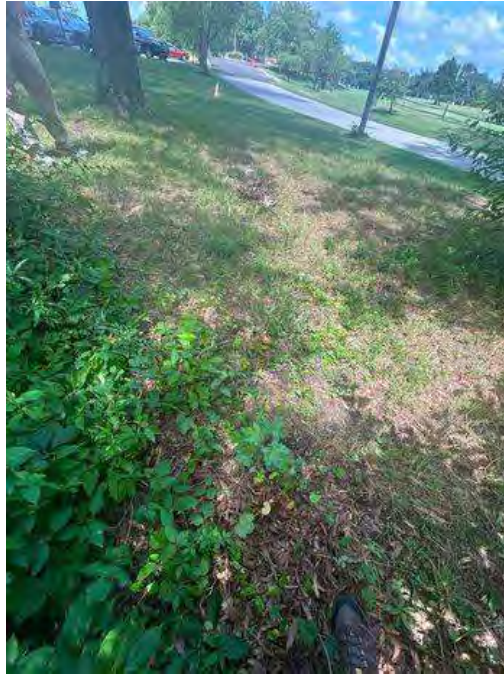
Collapsed Inflow Pipe with Discharge to Treatment Area

Repair major erosion near upstream embankment, clear vegetation to locate control structure, repair inflow pipe

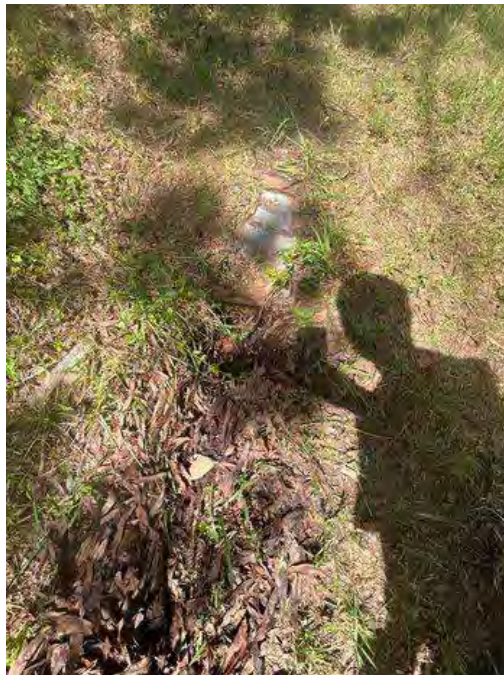
Collapsed Inflow Pipe Close Up

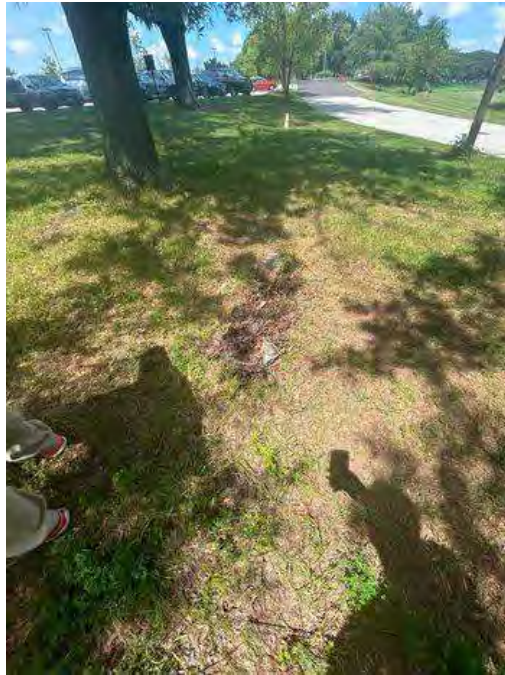
Collapsed Inflow Pipe Overall

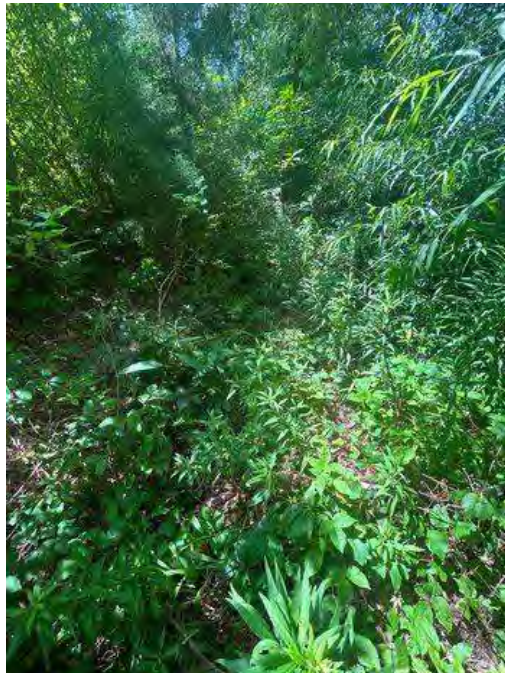
Erosion in Treatment Area

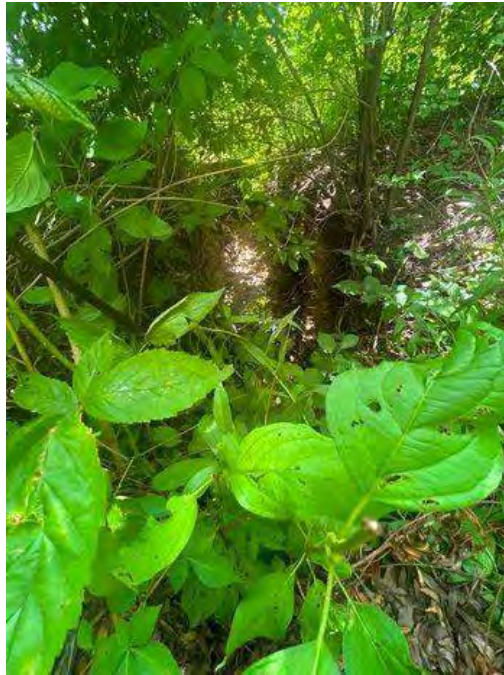
Eroded Channel Near Outfall 1

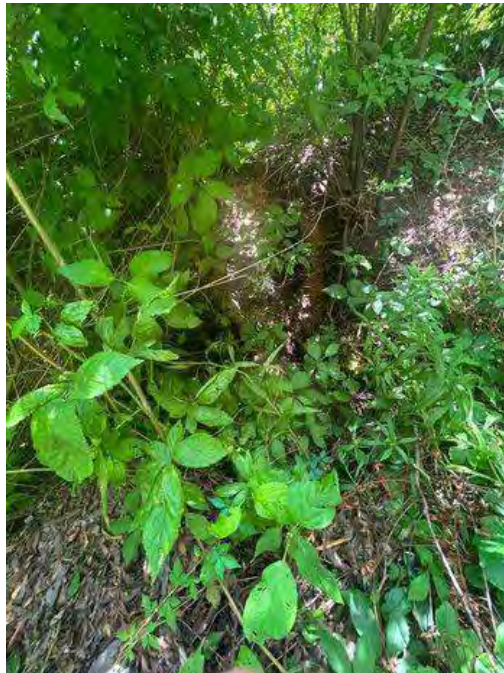
Eroded Channel Near Outfall 2

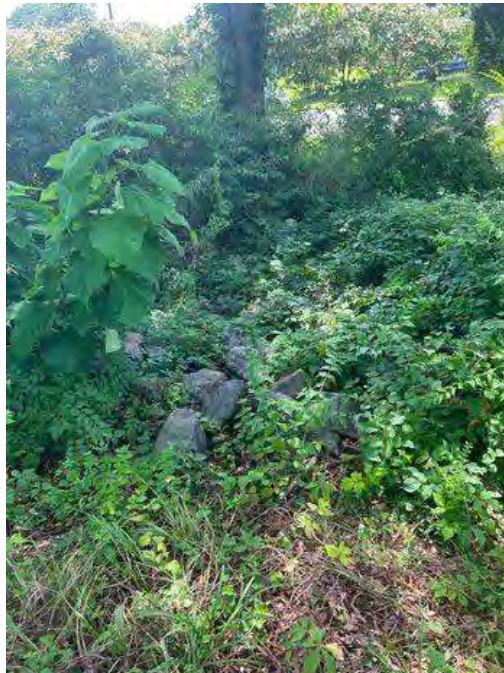
Overgrown Rip Rap

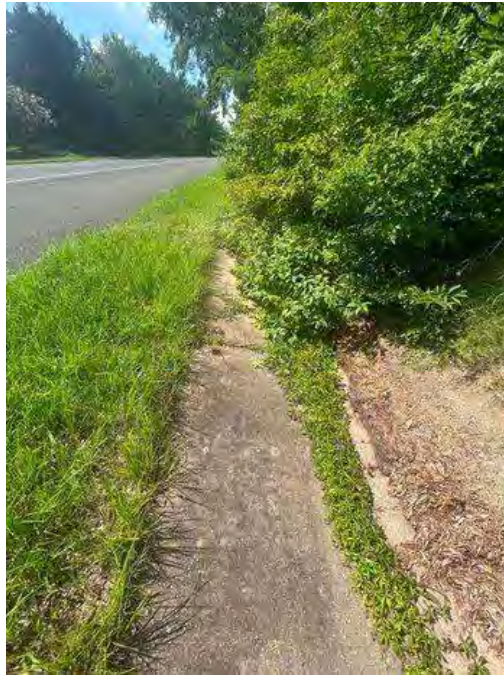
Cracked Outfall Entrance

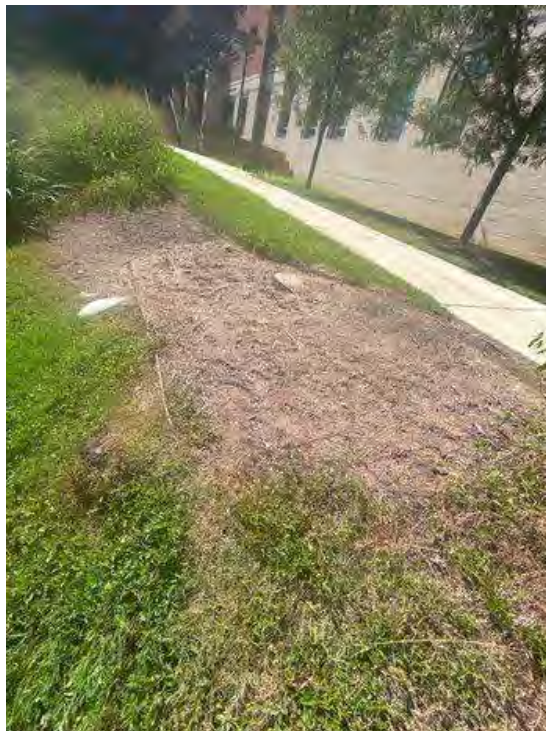
- **BMP Access** - Good
- **Debris & Sediment** - Good
- **Vegetation** - Fair
- **BMP Contamination** - Good
- **General Site Conditions Comments:** Bare patches and mild erosion on embankment and north berm

Bare area on slope

Stabilize and reseed/remulch embankment/berms, repair inflow pipe

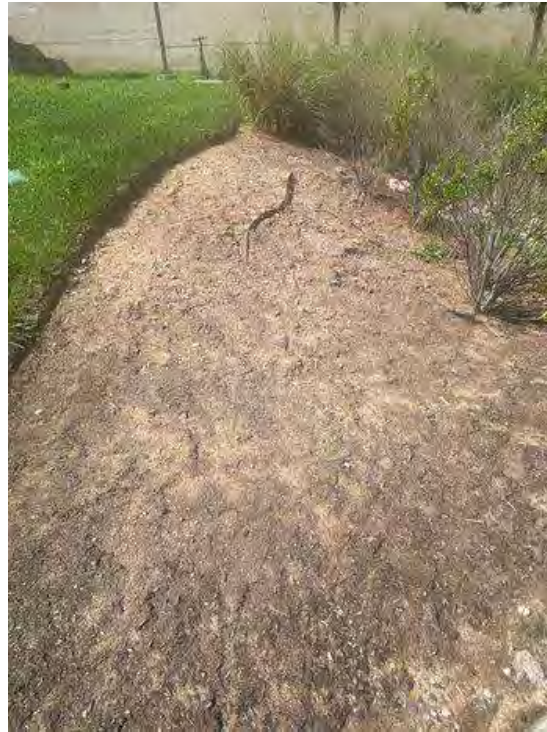
Bare area on slope

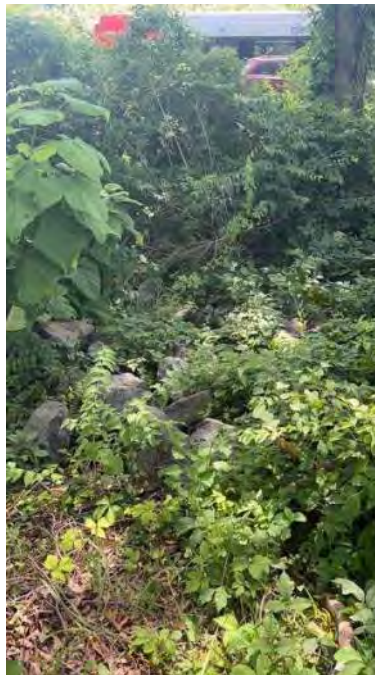
Overgrown Rip Rap 1

Remove some vegetation/poison ivy, remove debris at parking lot inflow

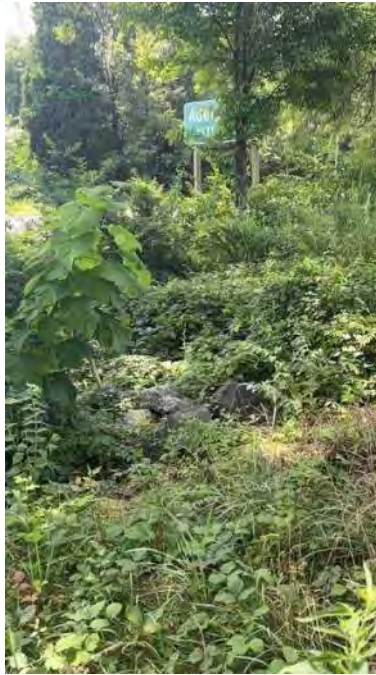
Overgrown Rip Rap 2

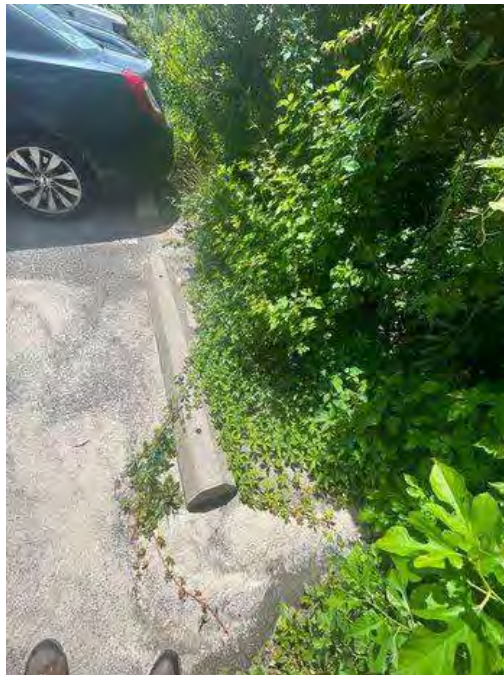
Minor Sediment Buildup in Sheet Inflow 1

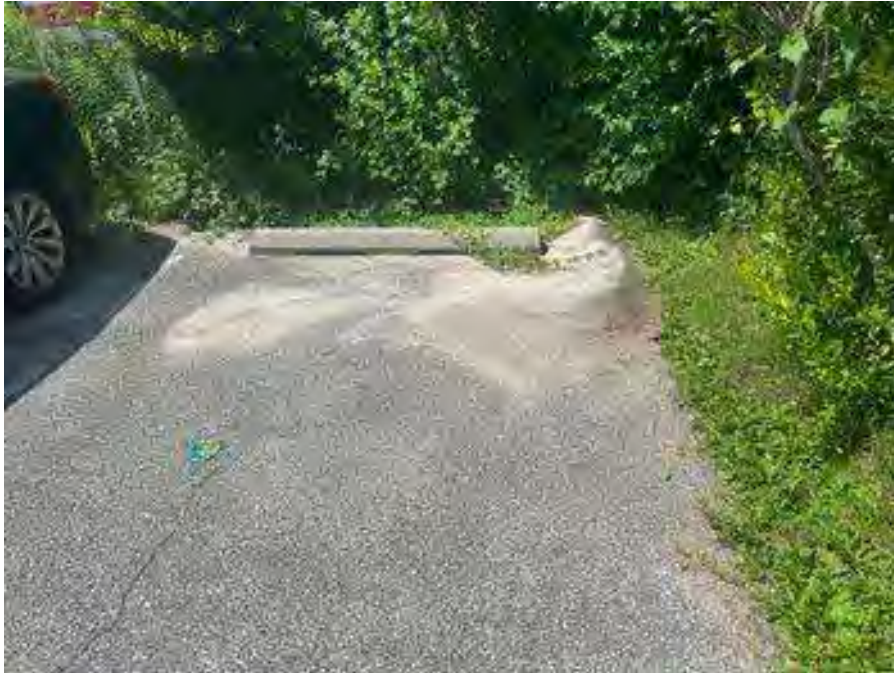
Minor Sediment Buildup in Sheet Inflow 2

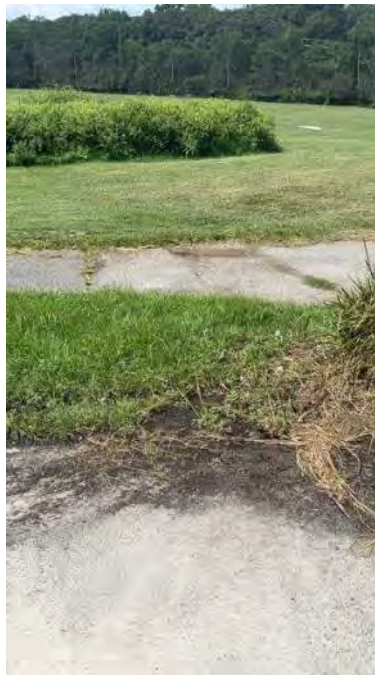
Sediment Buildup Near Rain Garden

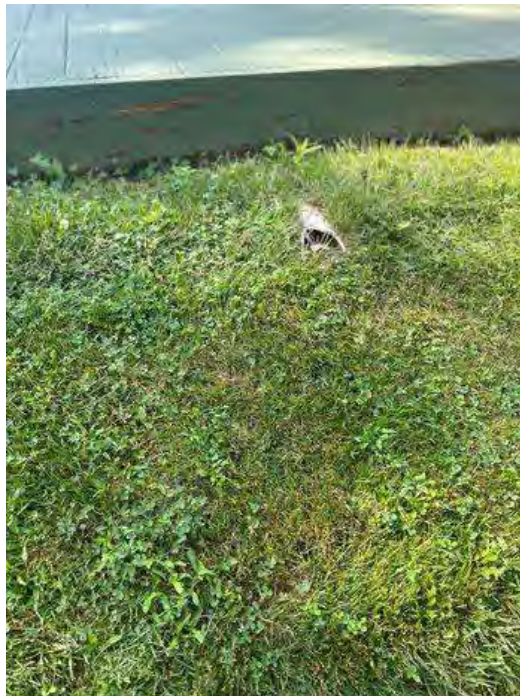
Broken inflow 1 pipe

Fill erosion on berm, fix broken inflow pipe

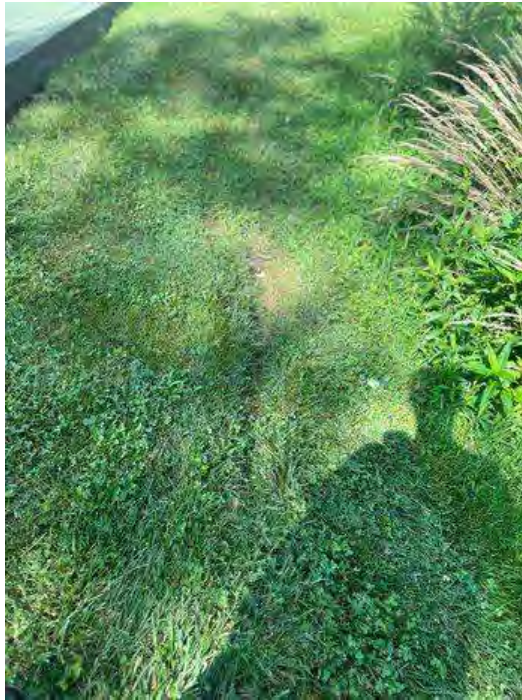
Erosion on south berm

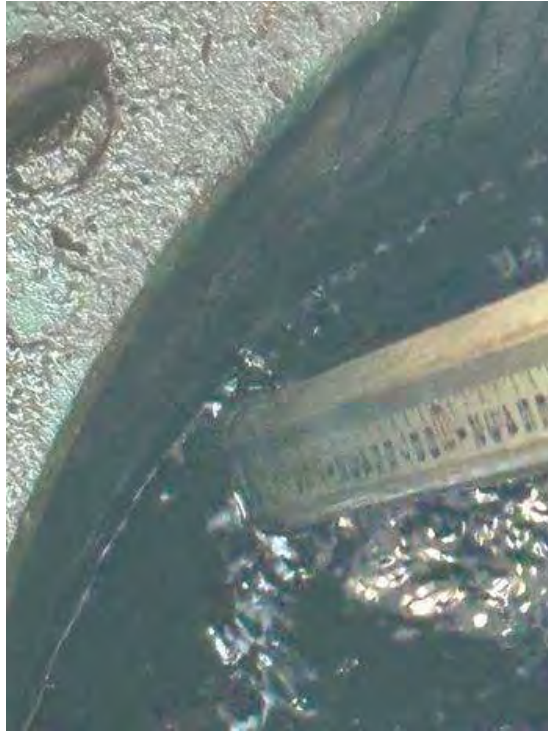
Water surface within stormceptor
