University of Maryland, College Park
National Pollutant Discharge Elimination
System MS4 Phase II
FY2025 Annual Report
General Discharge Permit #13-SF-5501

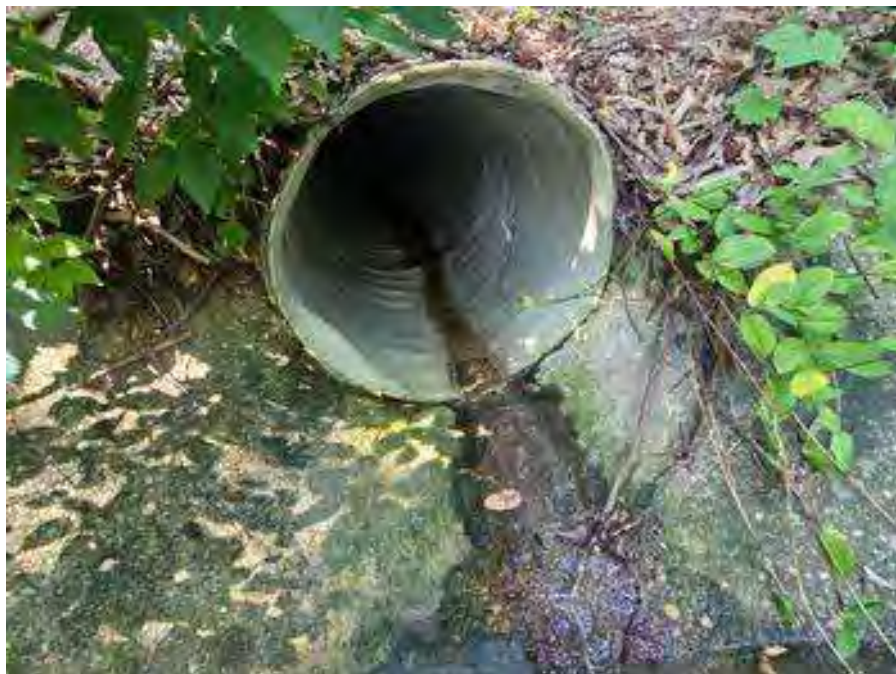
Inflow 1 with Active dry weather flow Close Up

Investigate source of dry weather flow and eliminate.

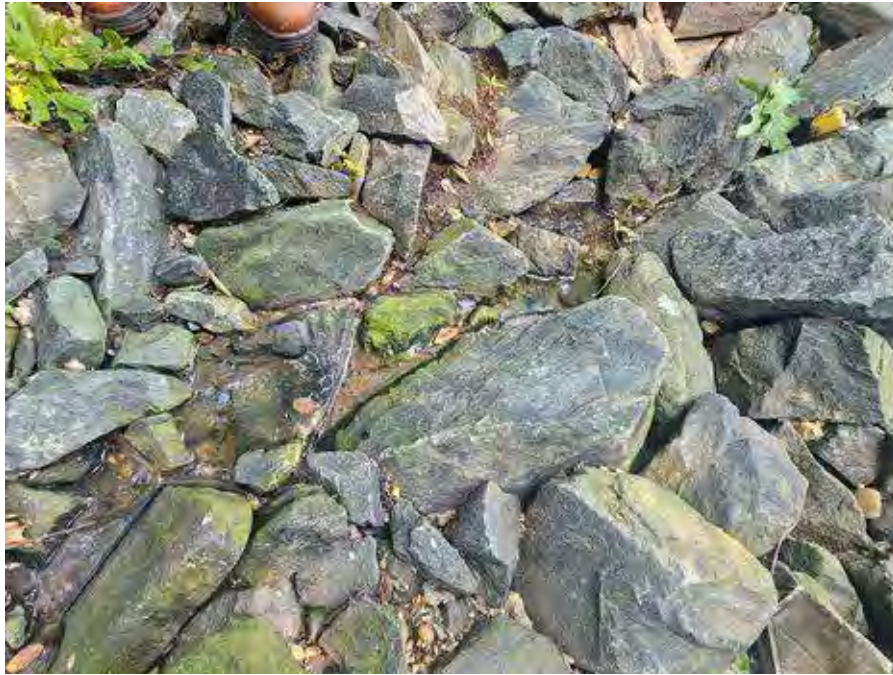
Dry weather flow Close Up in Inflow 1 Rip Rap

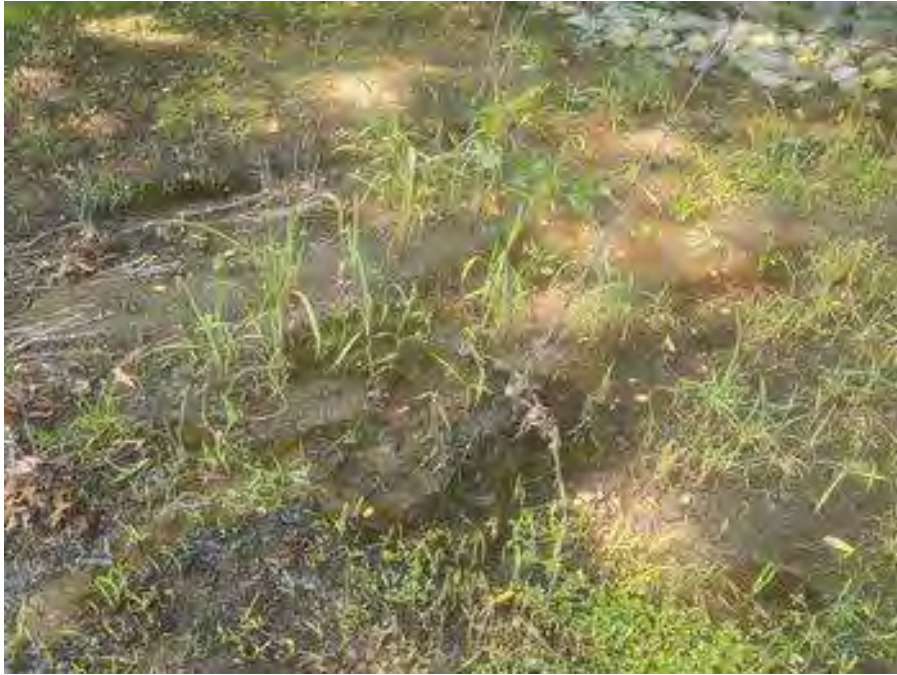
Upper Treatment Area with Ponding

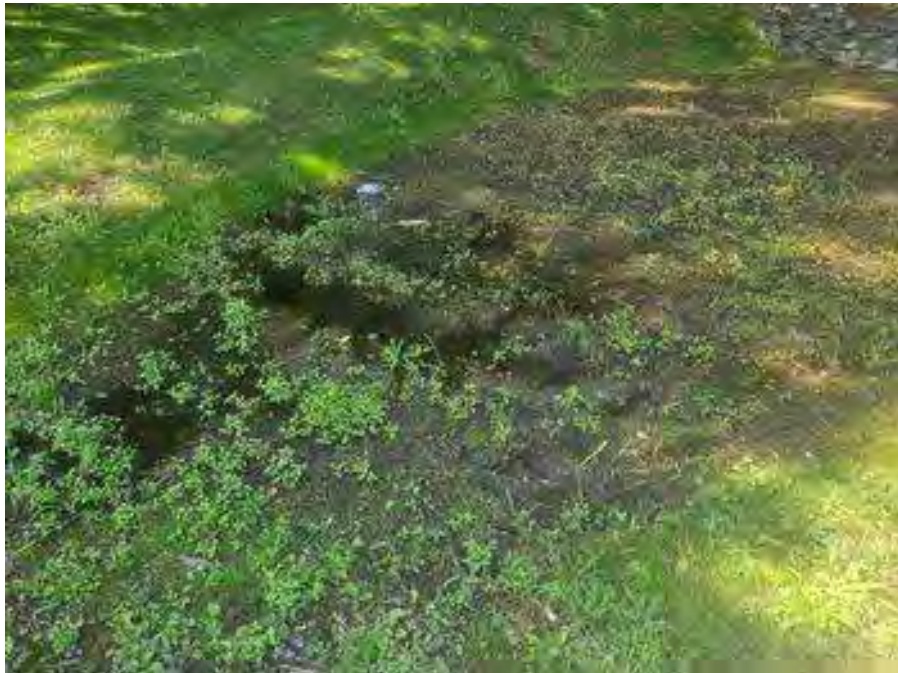
Lower Treatment area with Ponding

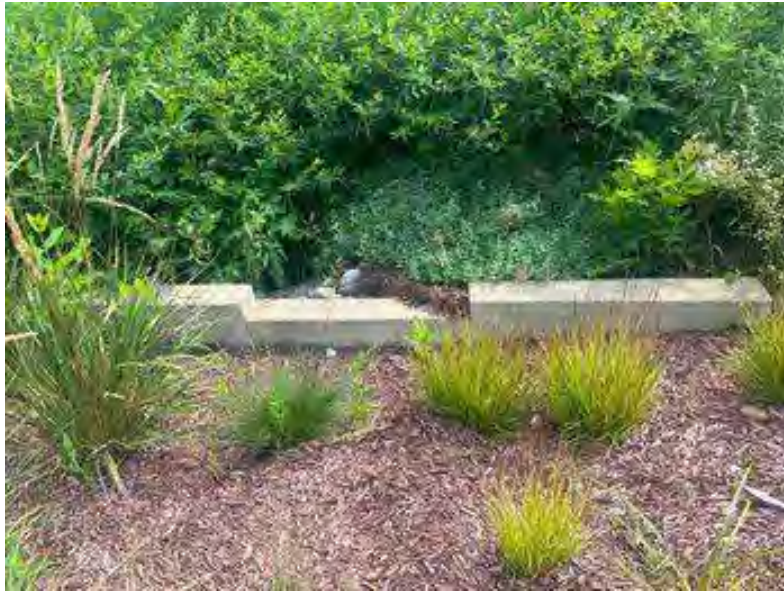
Weir wall from forebay

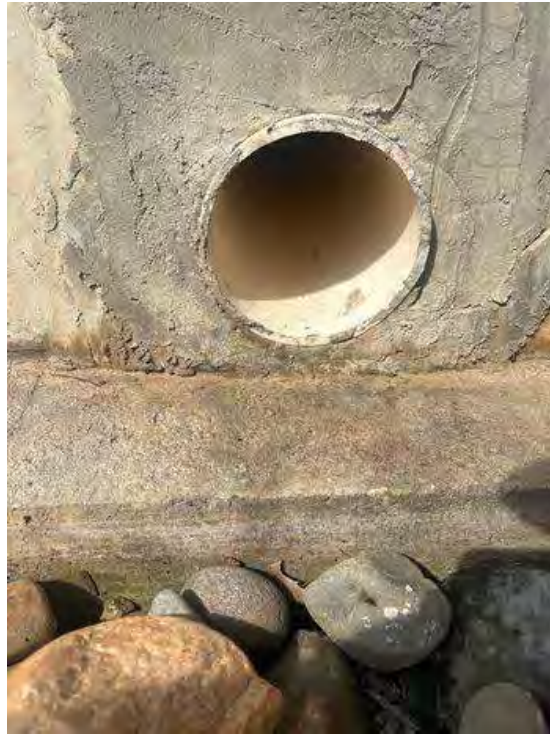
Pipe at inflow

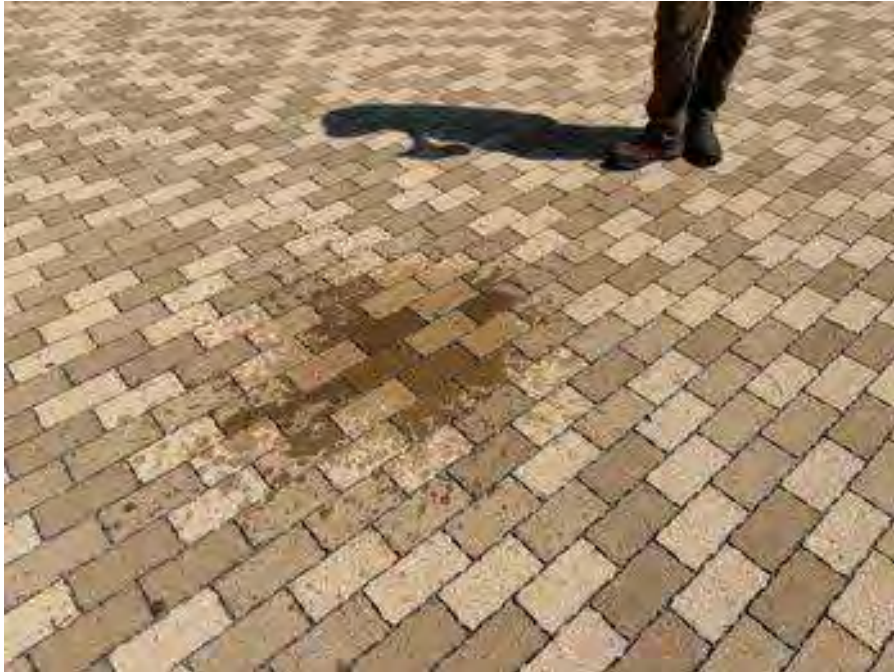
Water test flows into pervious surface

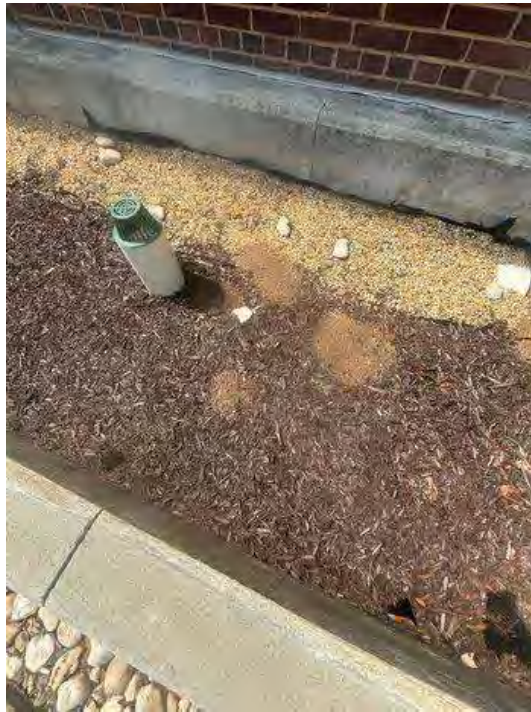
Monitoring well with emergency spillway and dirt piles in treatment basin

Plant if necessary, remove excess sediment from animals

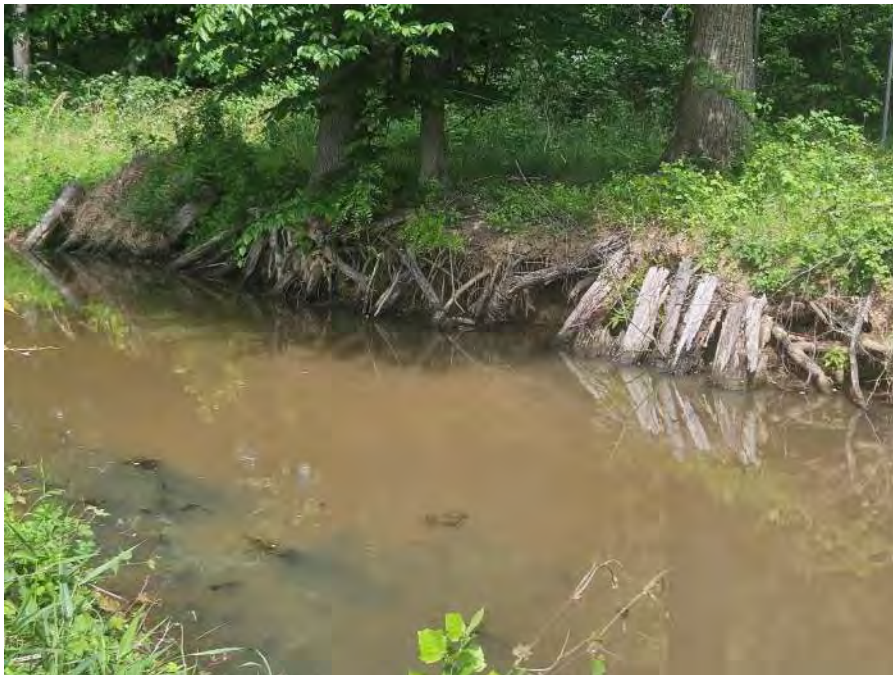
- **BMP Access** - Good
- **Debris & Sediment** - Good
- **Vegetation** - Good
- **BMP Contamination** - Good
- **General Site Conditions Comments:** Some erosion on the northern bank

Erosion along Northern Bank

Remove Fallen Trees from Stream and Repair Erosion

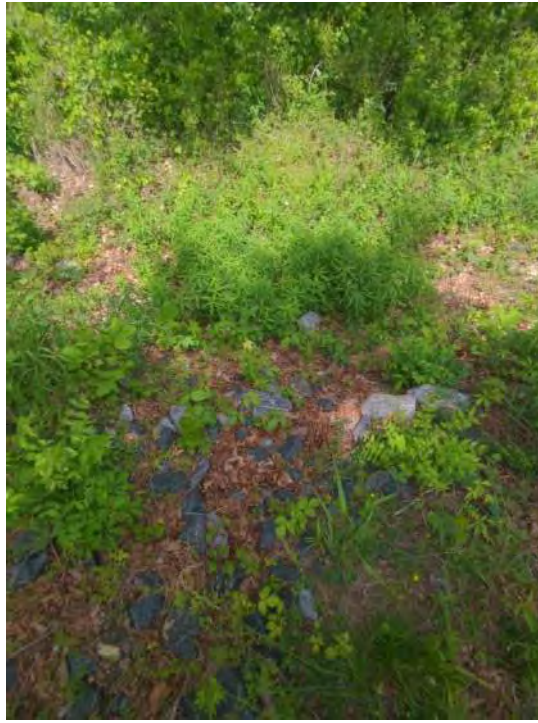
Debris in Channel

Clear Debris and Invasive Vegetation

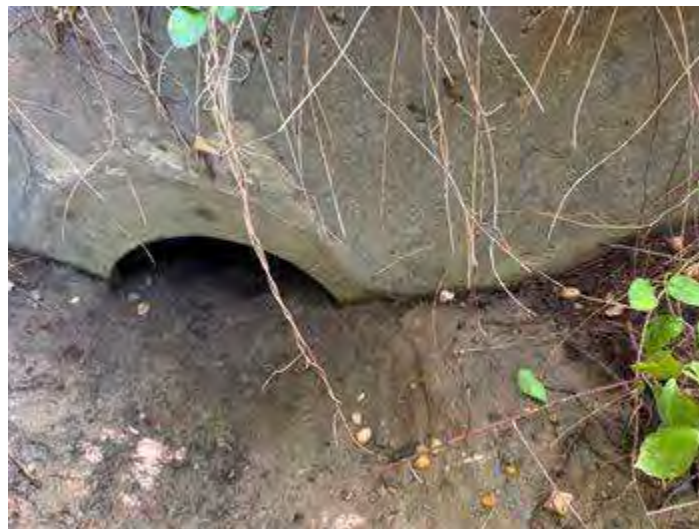
Clogged outflowing pipe

Clear sediment and overgrowth from outfall and rip rap, clear out overgrowth from treatment area

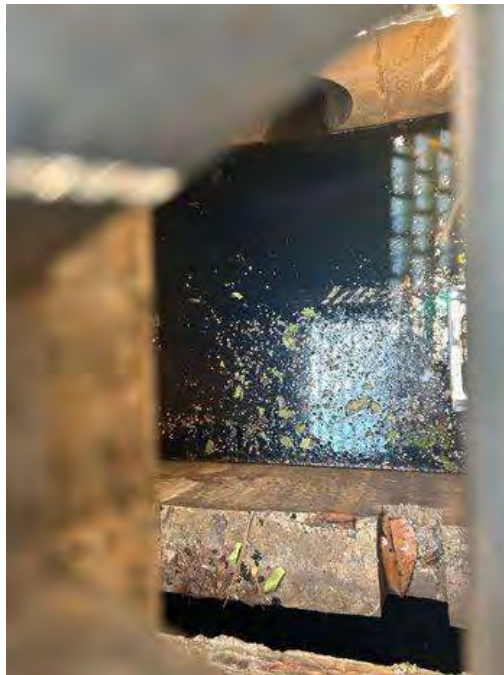
- **BMP Access** - Good
- **Debris & Sediment** - Good
- **Vegetation** - N/A
- **BMP Contamination** - Good
- **General Site Conditions Comments:** Minor algal growth in principal spillway

Spillway and Minor Algal Growth B

Monitor algal growth in principal spillway
