University of Maryland, College Park  
National Pollutant Discharge Elimination  
System MS4 Phase II  
FY2023 Annual Report  
General Discharge Permit #13-SF-5501

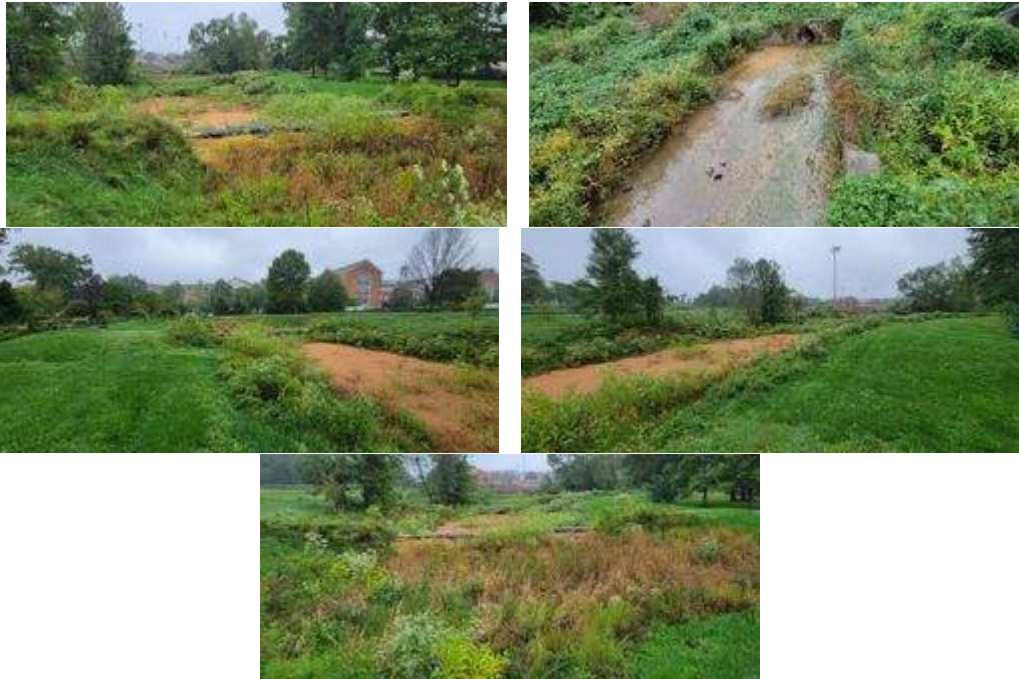
- **BMP Access** - Good
- **Debris & Sediment** - Fair
- **Vegetation** - Fair
- **BMP Contamination** - Fair
- **General Site Conditions Comments:** Good vegetation, along with weed growth in pretreatment and sand filter

Regrade and smooth rutting and reseed

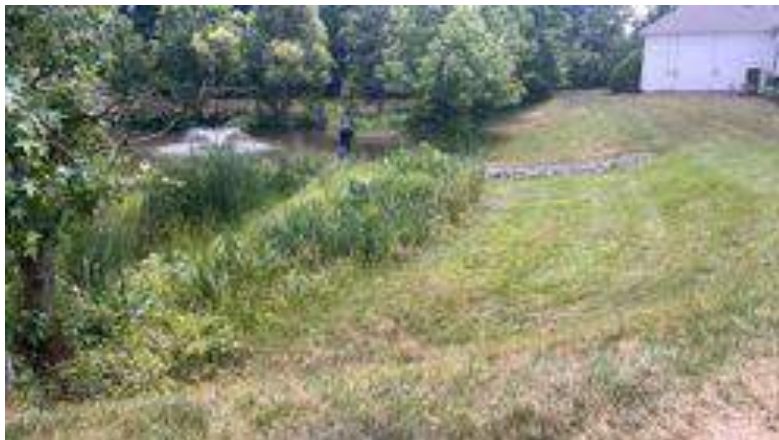
**Contamination at NW Inflow**

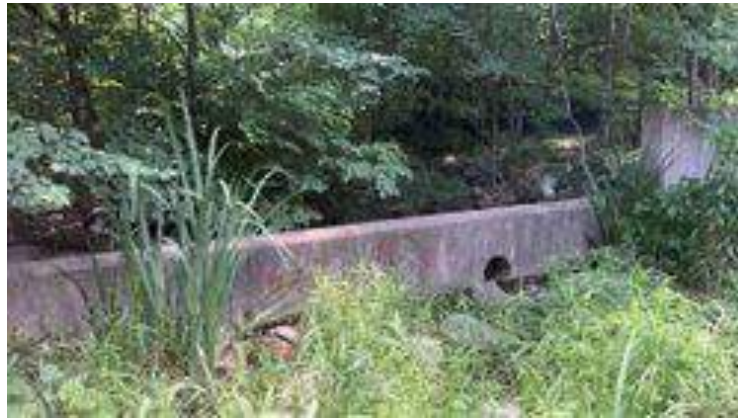
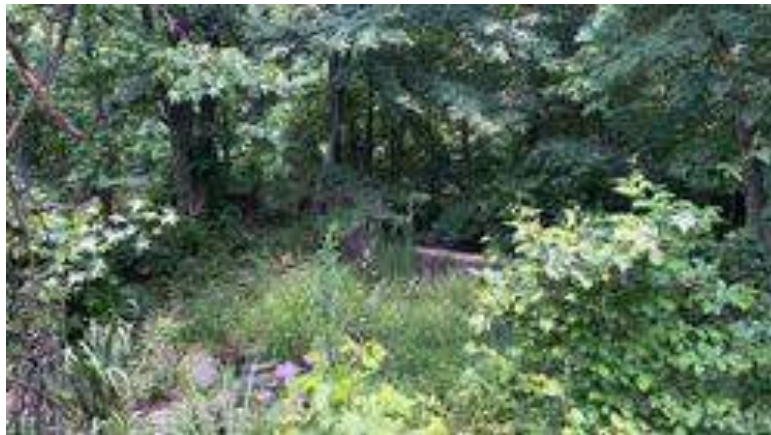
**SW Forebay conveyance instability**

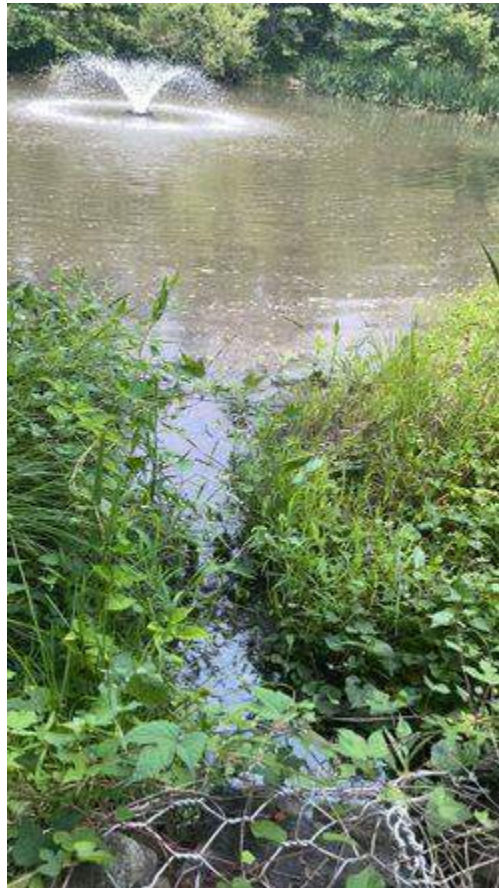
**Woody vegetation growth in gabion basket of SW forebay**

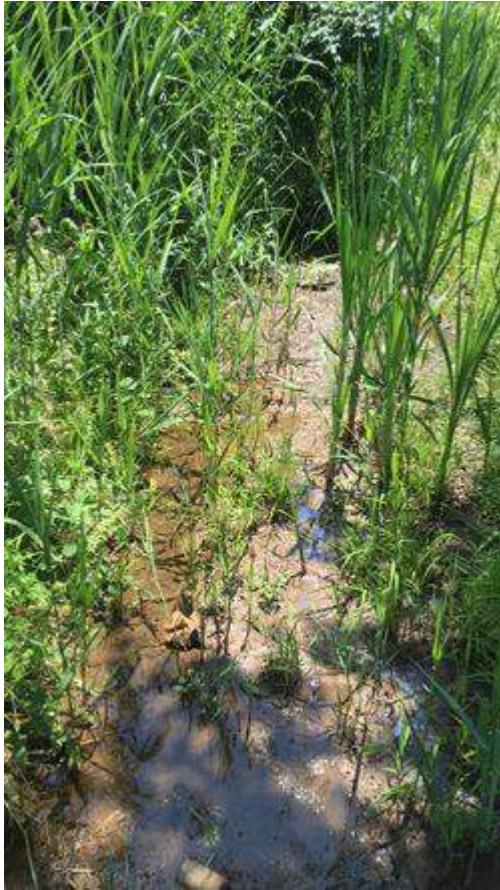
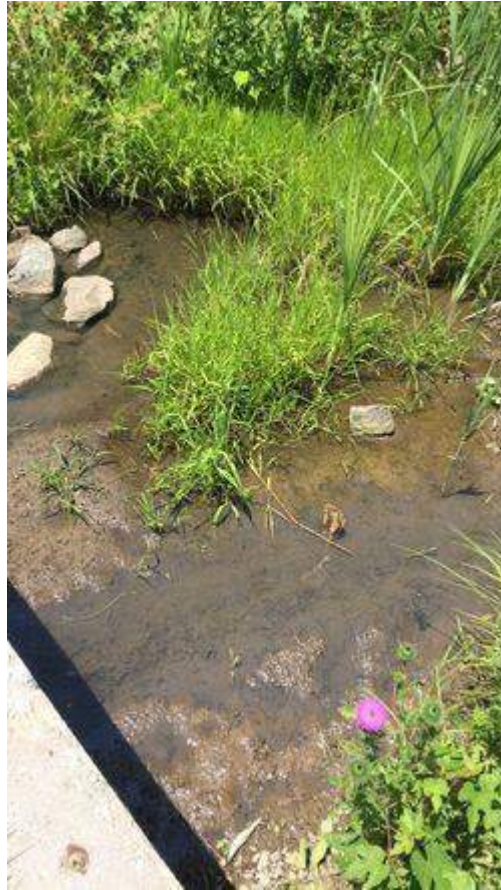
### Excessive Sedimentation Near Outfall

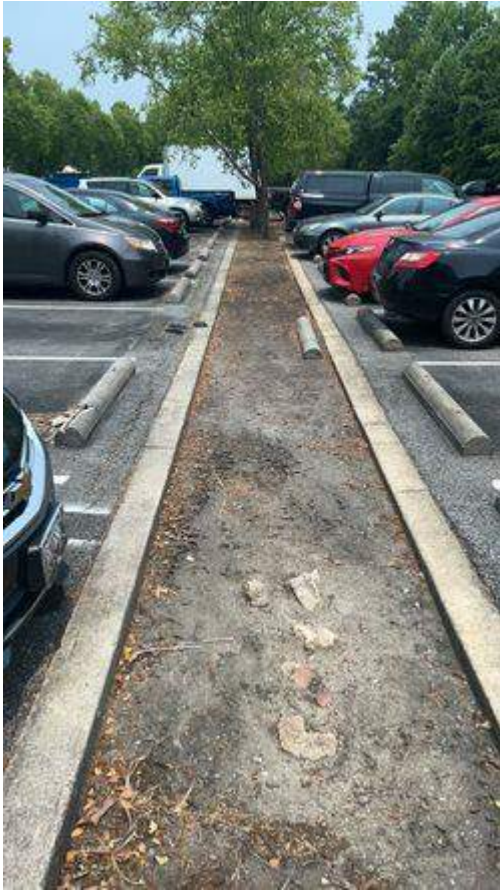
Overall photo showing sediment buildup and lack of mulch.

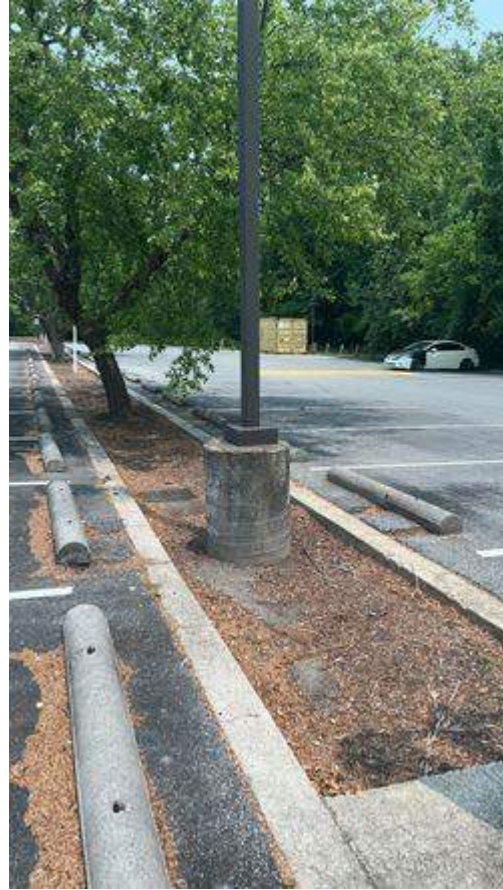
Overall photo showing sediment accumulation.

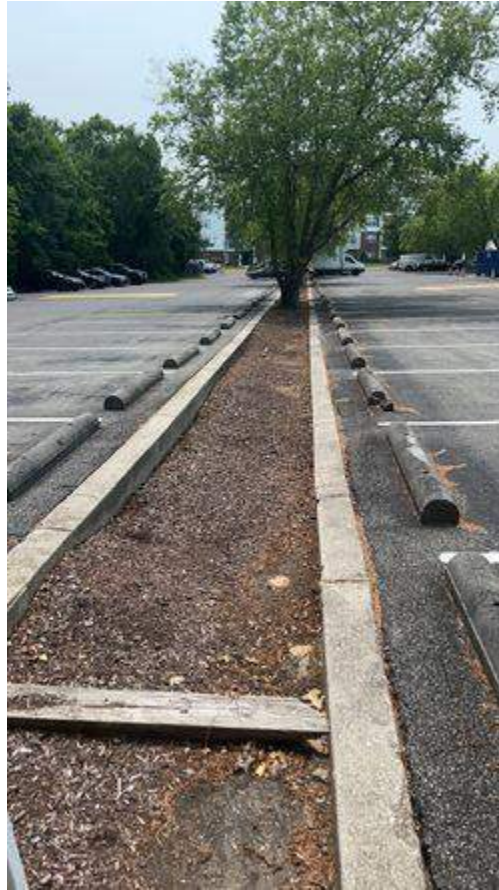
Overall photo showing sediment accumulation and bare areas.

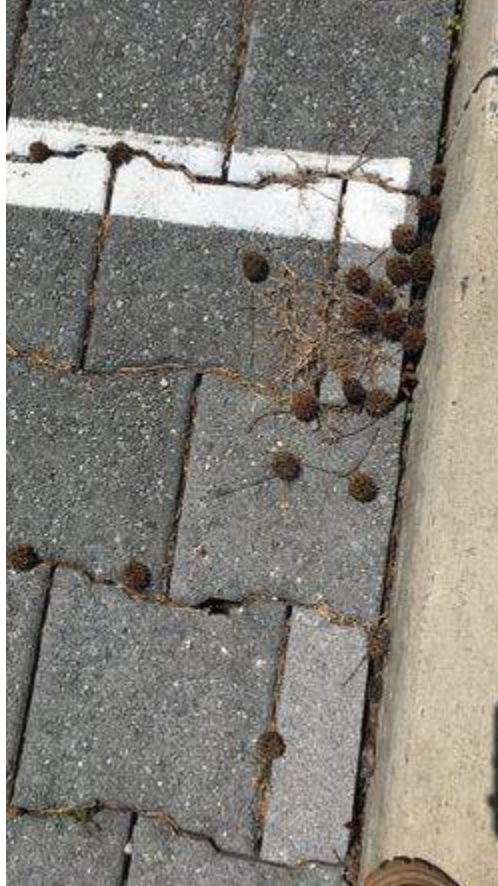
Routine Cleaning and Maintenance Needed

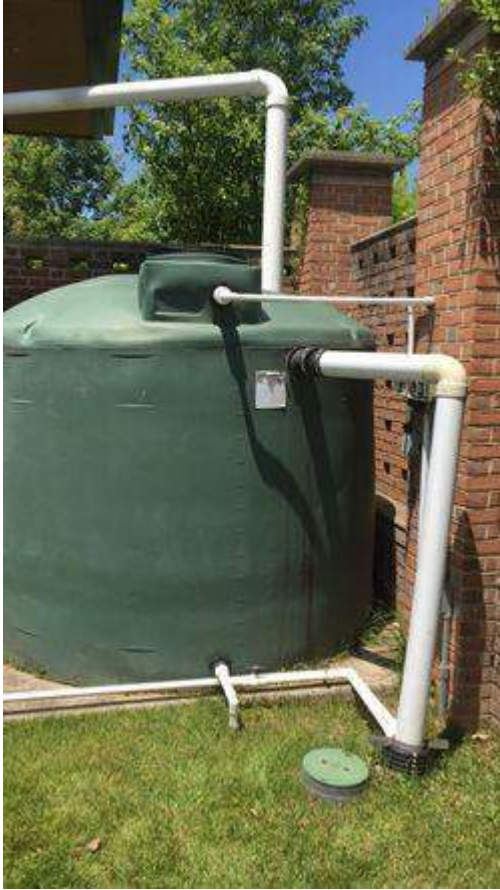
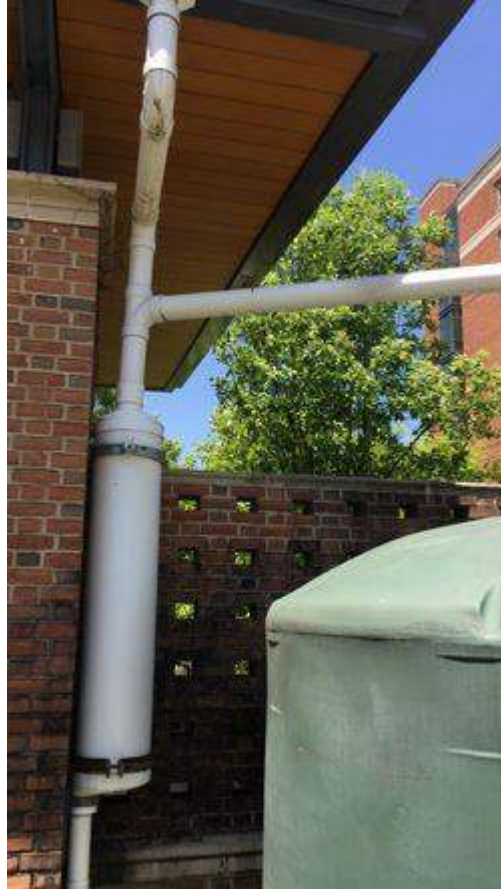
Overall Condition

Date of Inspection:	May 31, 2023 12:47 PM	Inspector Initials:	BFB/TPR
BMP ID:	UMCP19BMP0083	Inspection Firm:	MES
BMP Type:	Rainwater Harvesting	Underground BMP?	No
BMP Status	Pass	Overall Inspection Comment:	Minor cracking on downspout connection
Maintenance Level	Minor Maintenance (Use of Hand Equipment for Repairs)

Repair cracked PVC connection

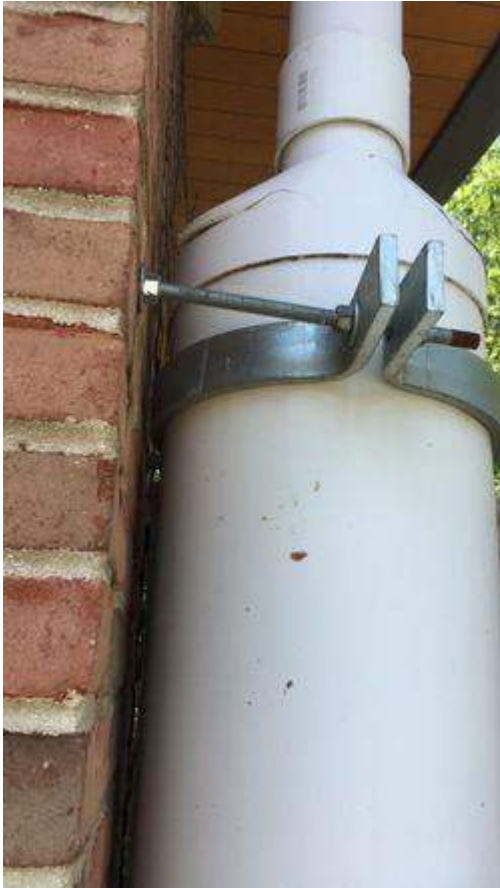
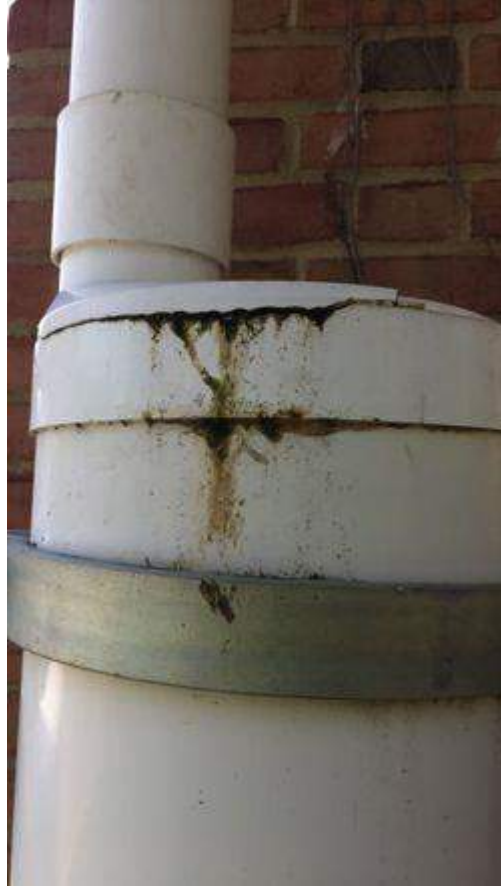
Downspout Condition

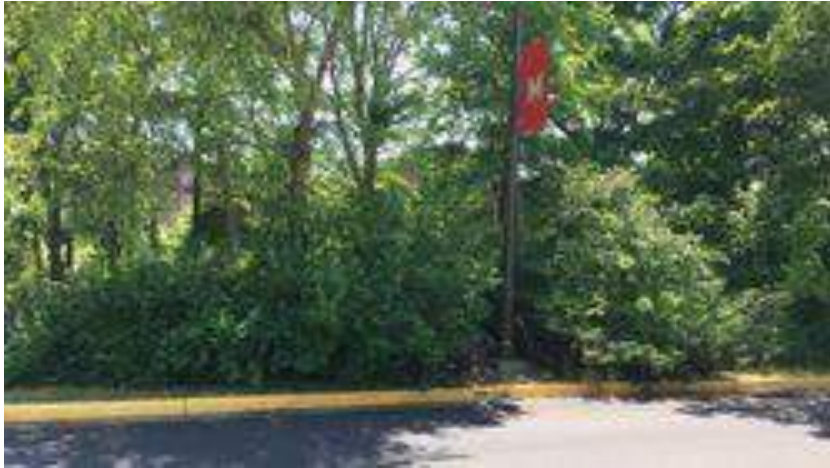
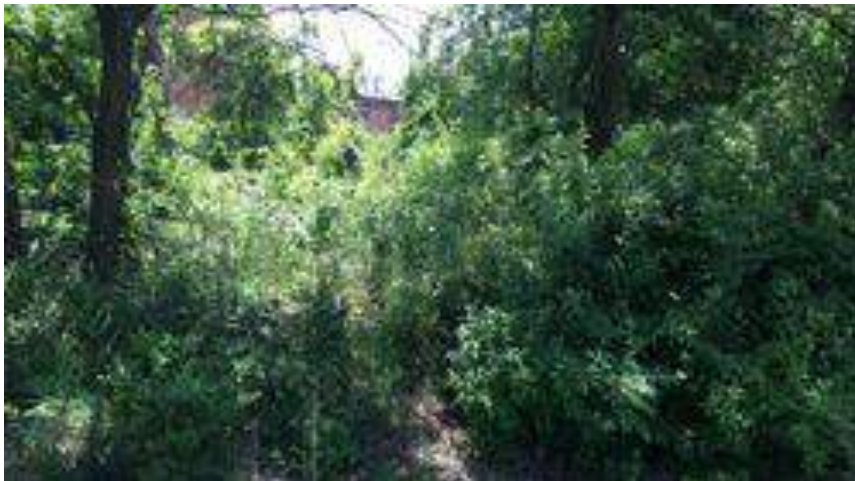
**Overall:**

- **BMP Access** - Fair
- **Debris & Sediment** - Fair
- **Vegetation** - Poor
- **BMP Contamination** - Good
- **General Site Conditions Comments:** Completely overgrown and high sediment build up

**Maintenance & Remediation Recommendations** – Clear sediment and debris. Remove unplanned and invasive vegetation.

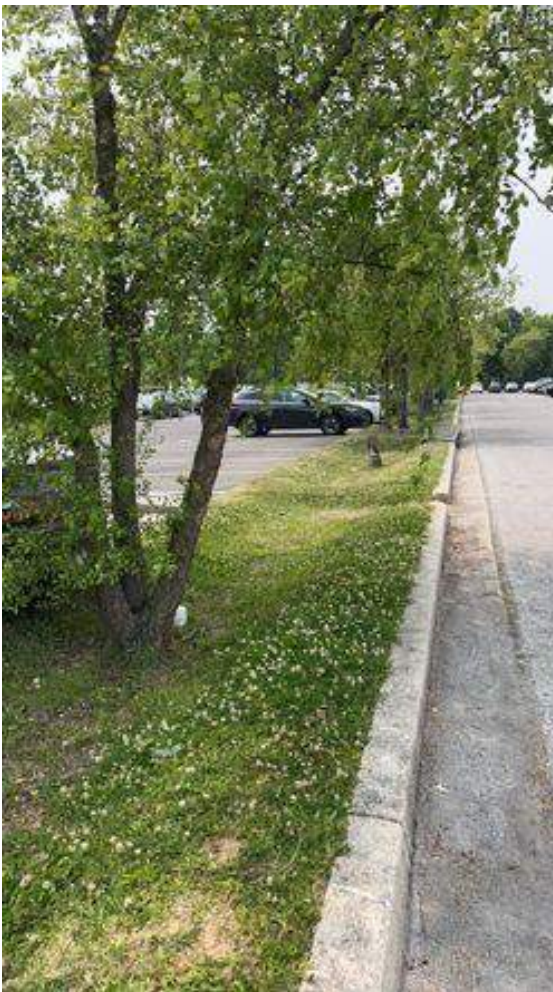
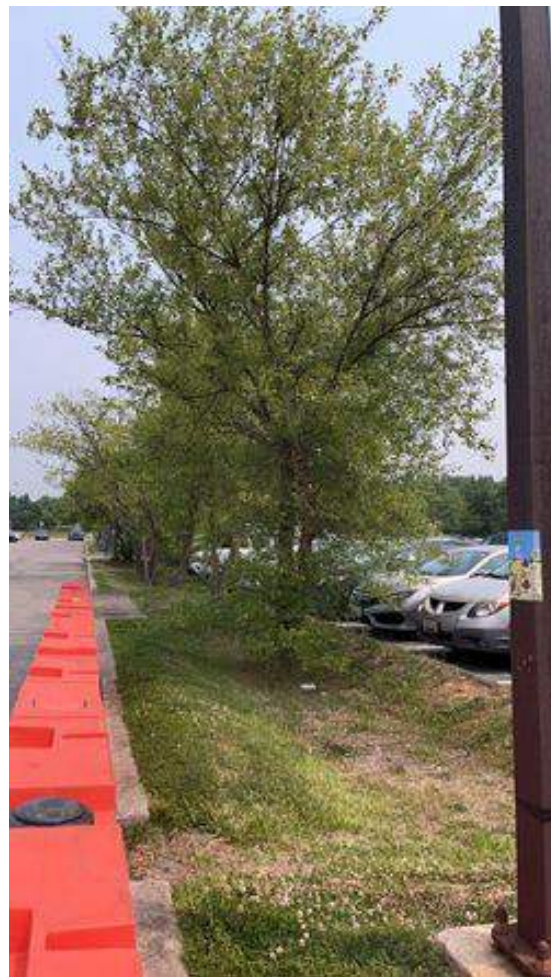
**Overall Photos:**

- **BMP Access** - Good
- **Debris & Sediment** - Fair
- **Vegetation** - Fair
- **BMP Contamination** - Good
- **General Site Conditions Comments:** Bmp not in good condition. Several inlets are collapsing, sedimentation and debris in conveyance basin.

- **Downstream Condition** - N/A
- **Downstream Condition Comment** - Bare spots in basin, debris and sedimentation.

Replace inlets, regrade all basins, remove sediment from all inflows.

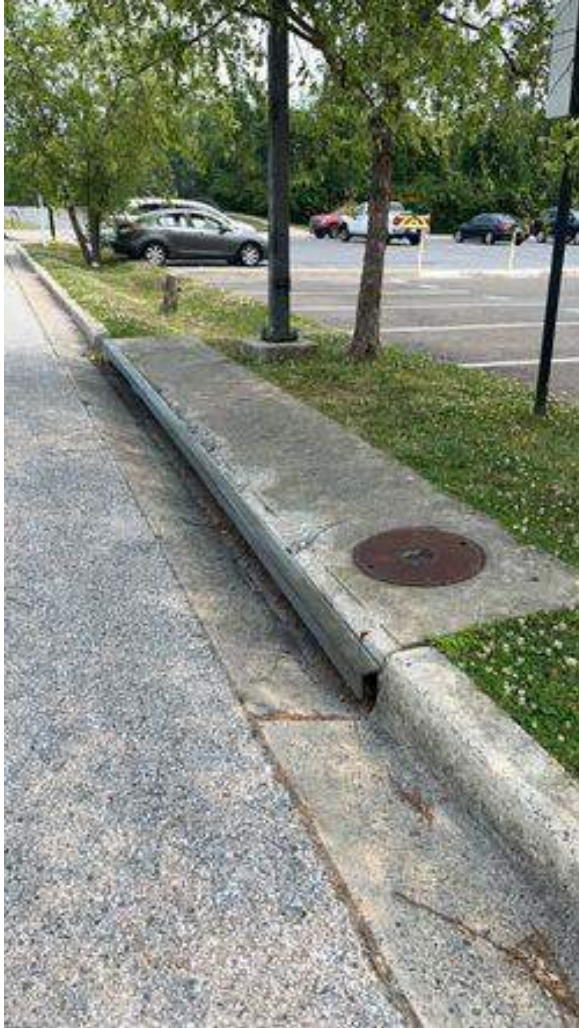
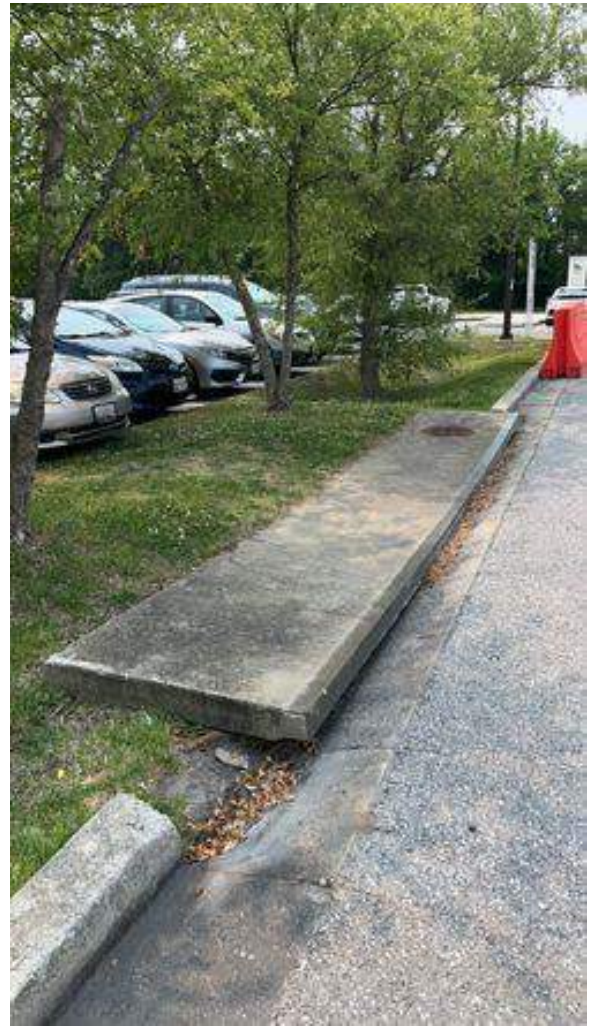
**Storm Drain 1 and 3**

- **Inflow Condition** – Poor
- **Inflow Comments** - Inflows are collapsing.
- **Forebay** - N/A

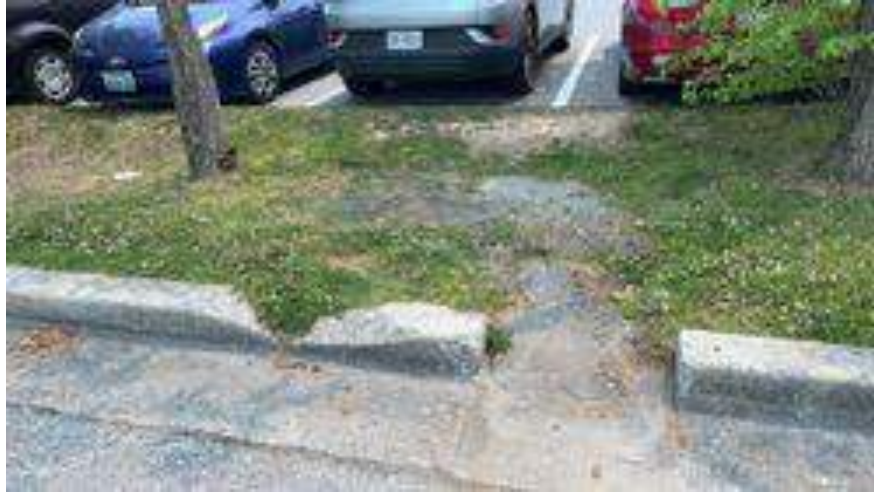
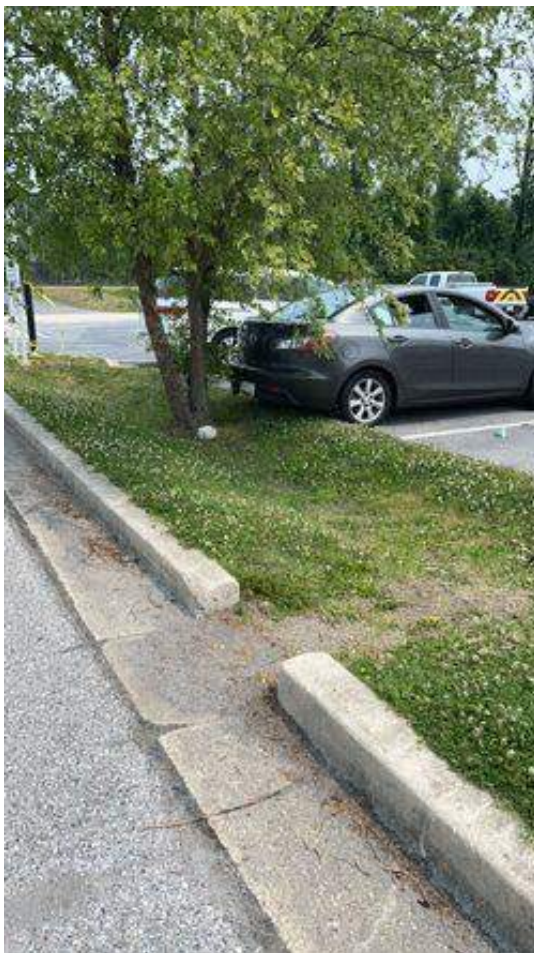
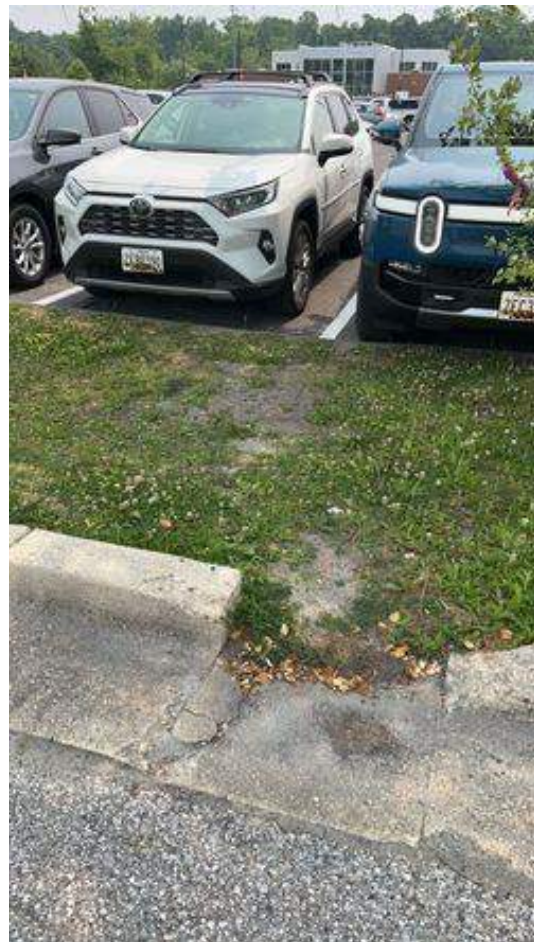
**Inlet structures with sediment accumulation:**

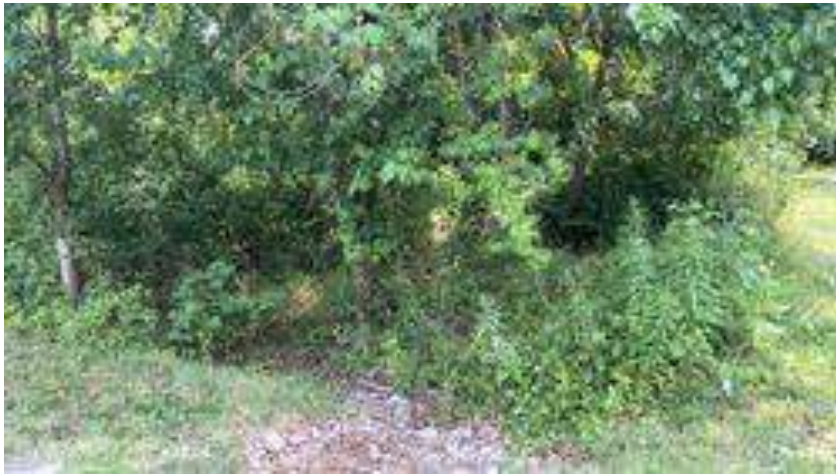
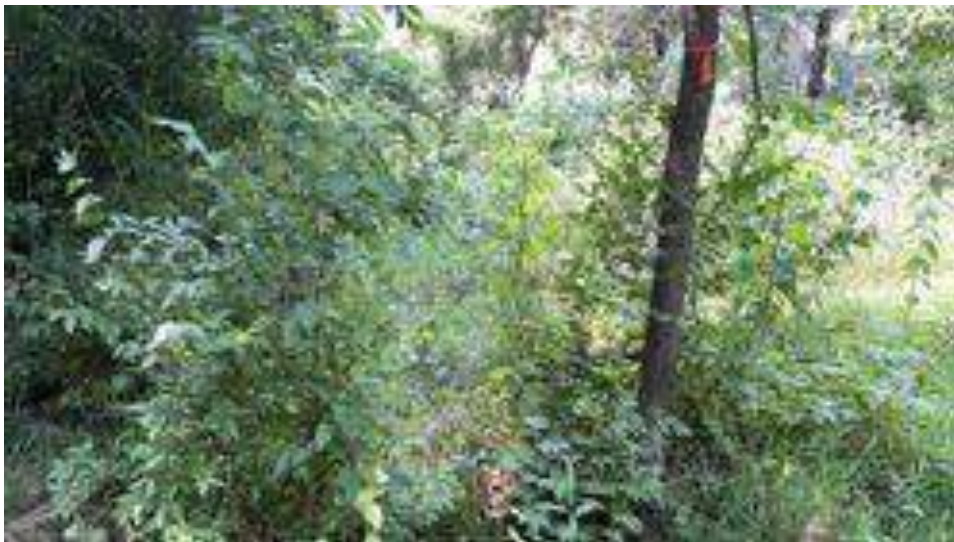
**Overall Photos:**

- **BMP Access** - Fair
- **Debris & Sediment** - Poor
- **Vegetation** - Poor
- **BMP Contamination** - N/A
- **General Site Conditions Comments:** Completely overgrown, cannot identify features, major vegetation and removal required.

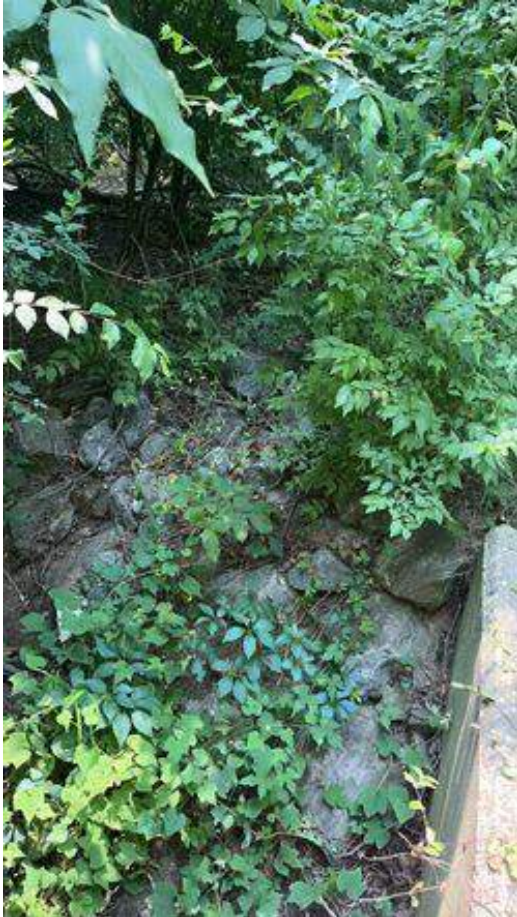
**Vegetation at Outfall:**

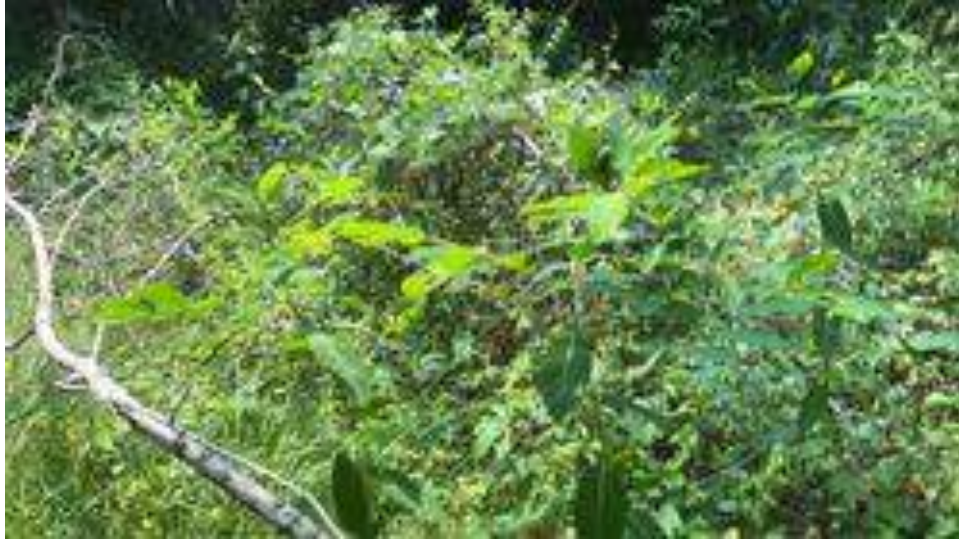
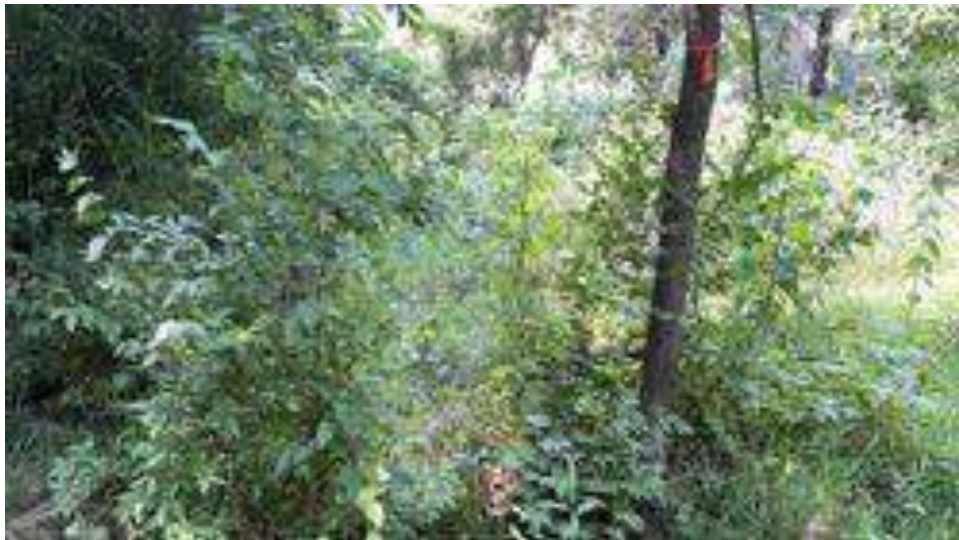
**Vegetation in Treatment Area:**

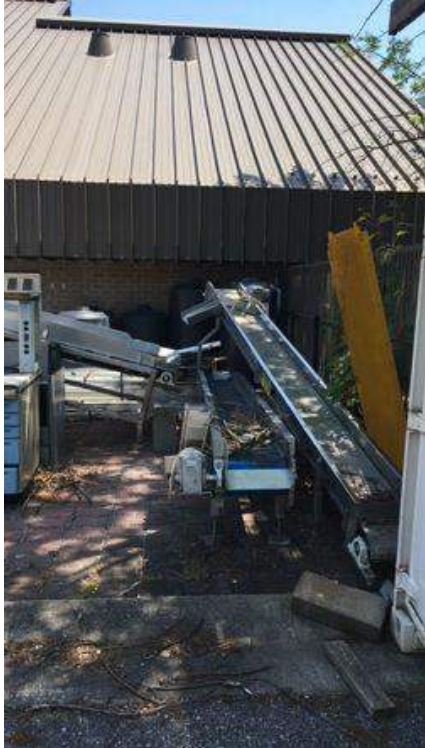
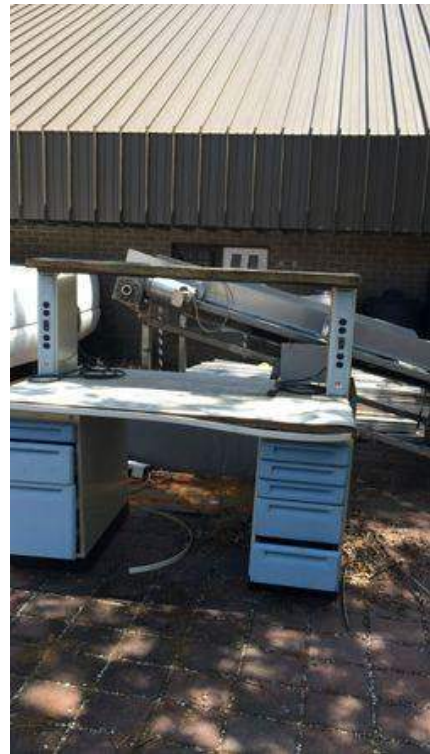
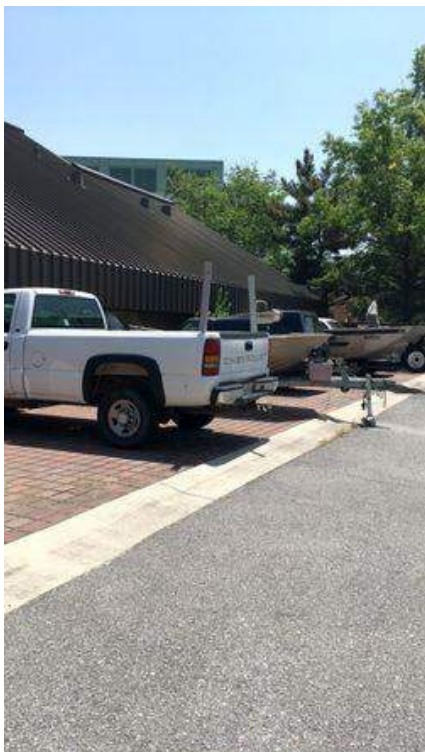
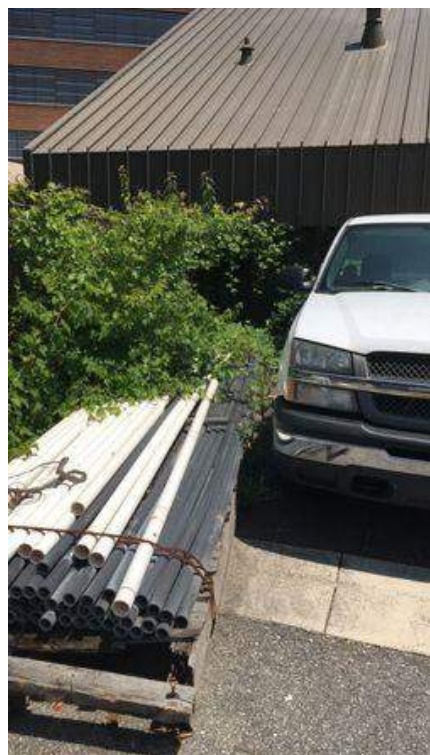
**Objects blocking pavement:**

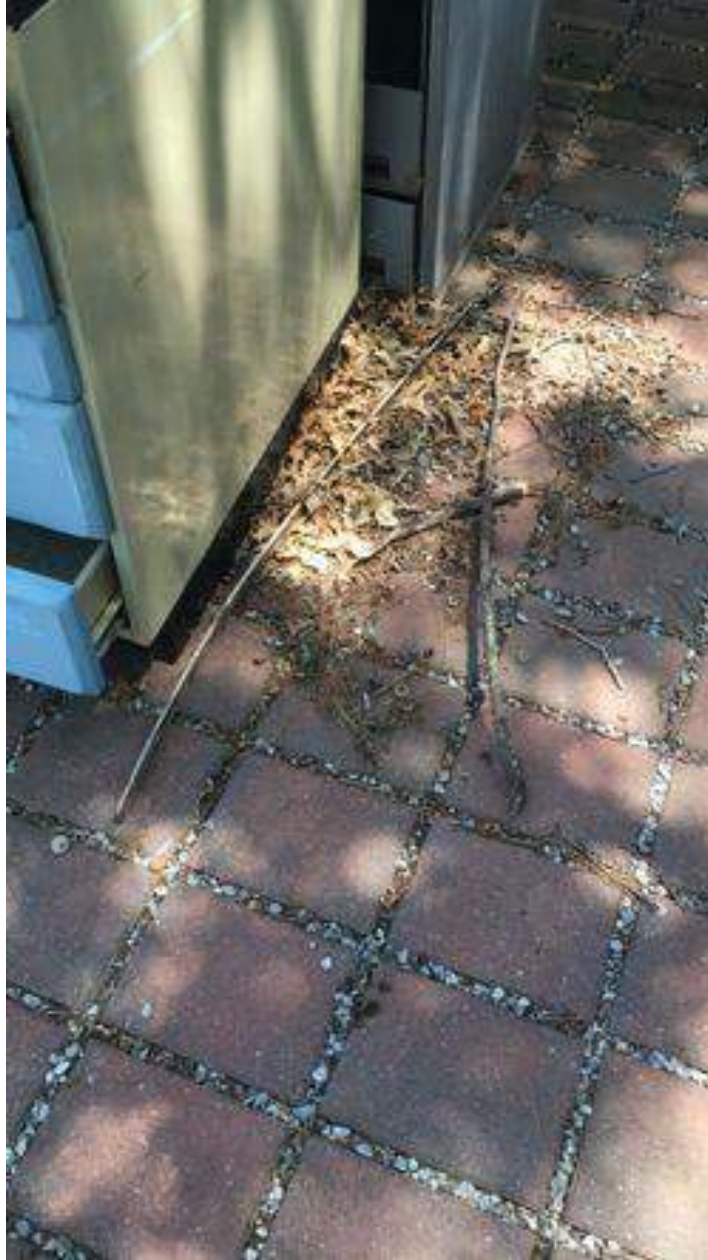
**Buildup of debris:**

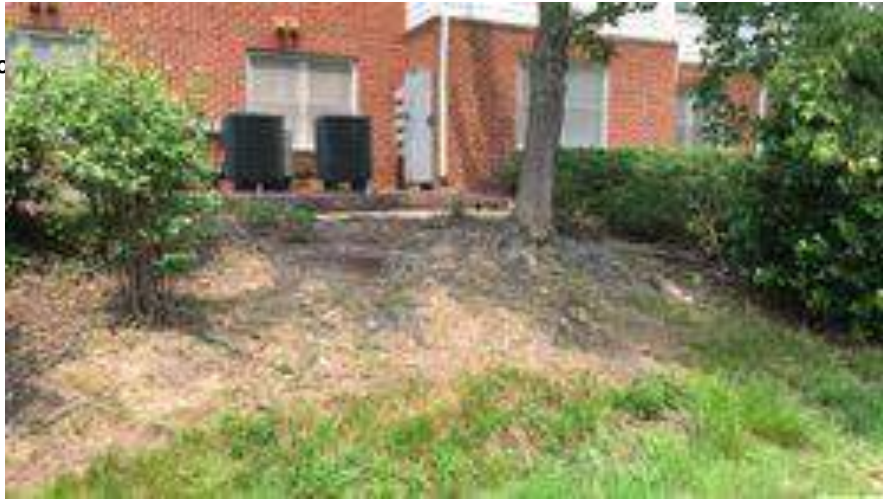
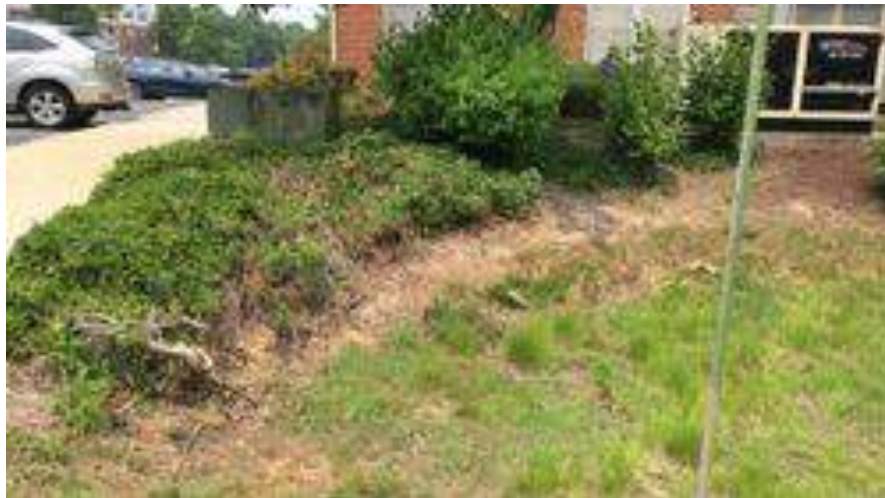
Bare patches c

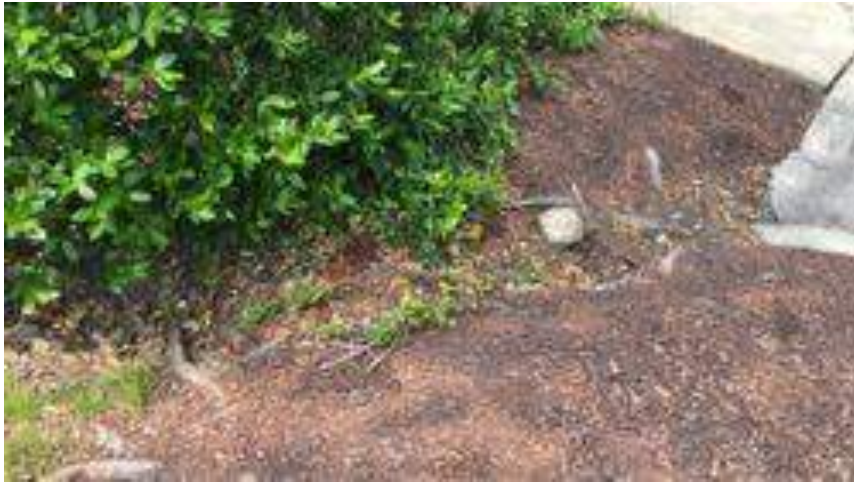
**Moderate Erosion at NE inflow:**

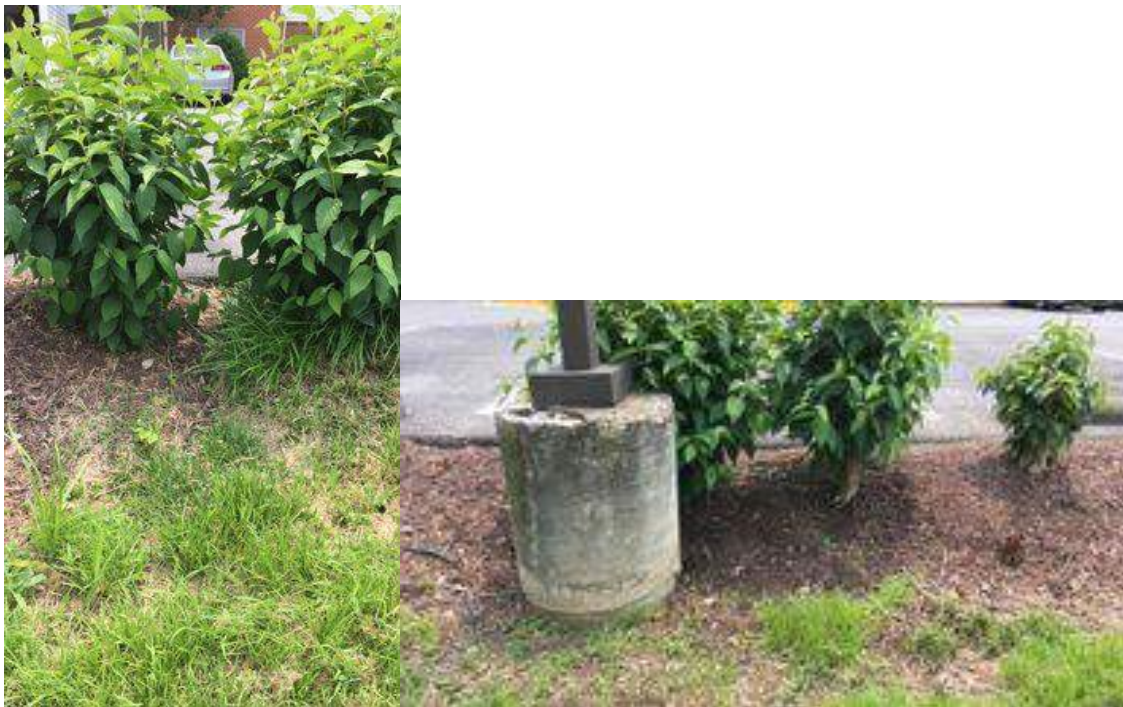
**Mild erosion on S bank**

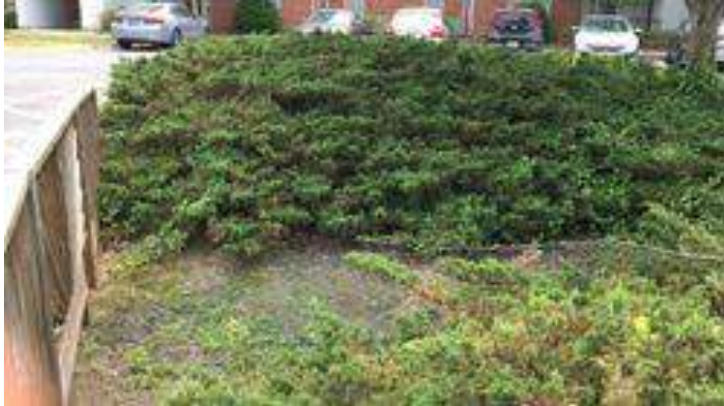
**Bare area in SW basin**

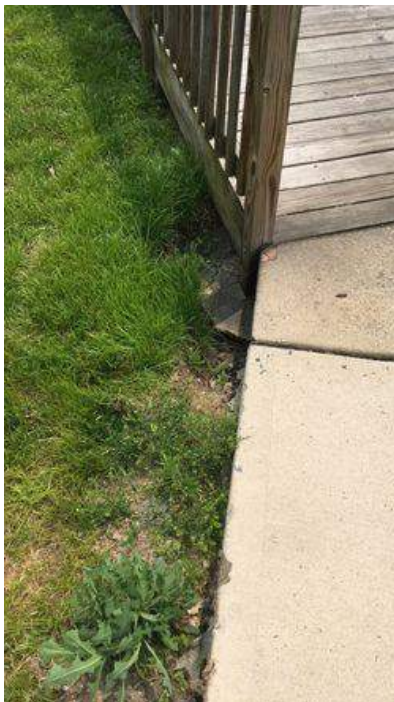
**Gully forming around food of bridge from sheet flow from sidewalk**

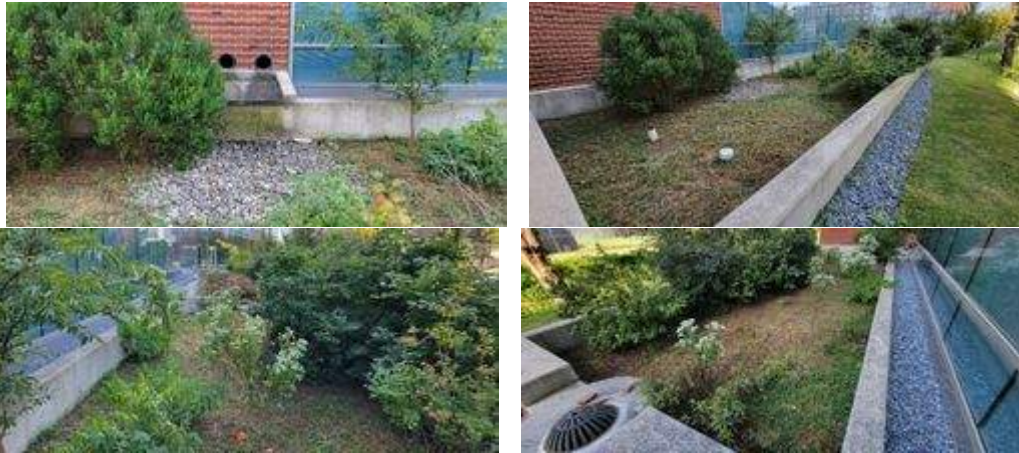
- **BMP Access** - Good
- **Debris & Sediment** - Good
- **Vegetation** - Fair
- **BMP Contamination** - Good
- **General Site Conditions Comments:** Vegetation present, but lower growing plant layer is missing and being replaced by grass and weeds

Replant following the plant schedule as needed

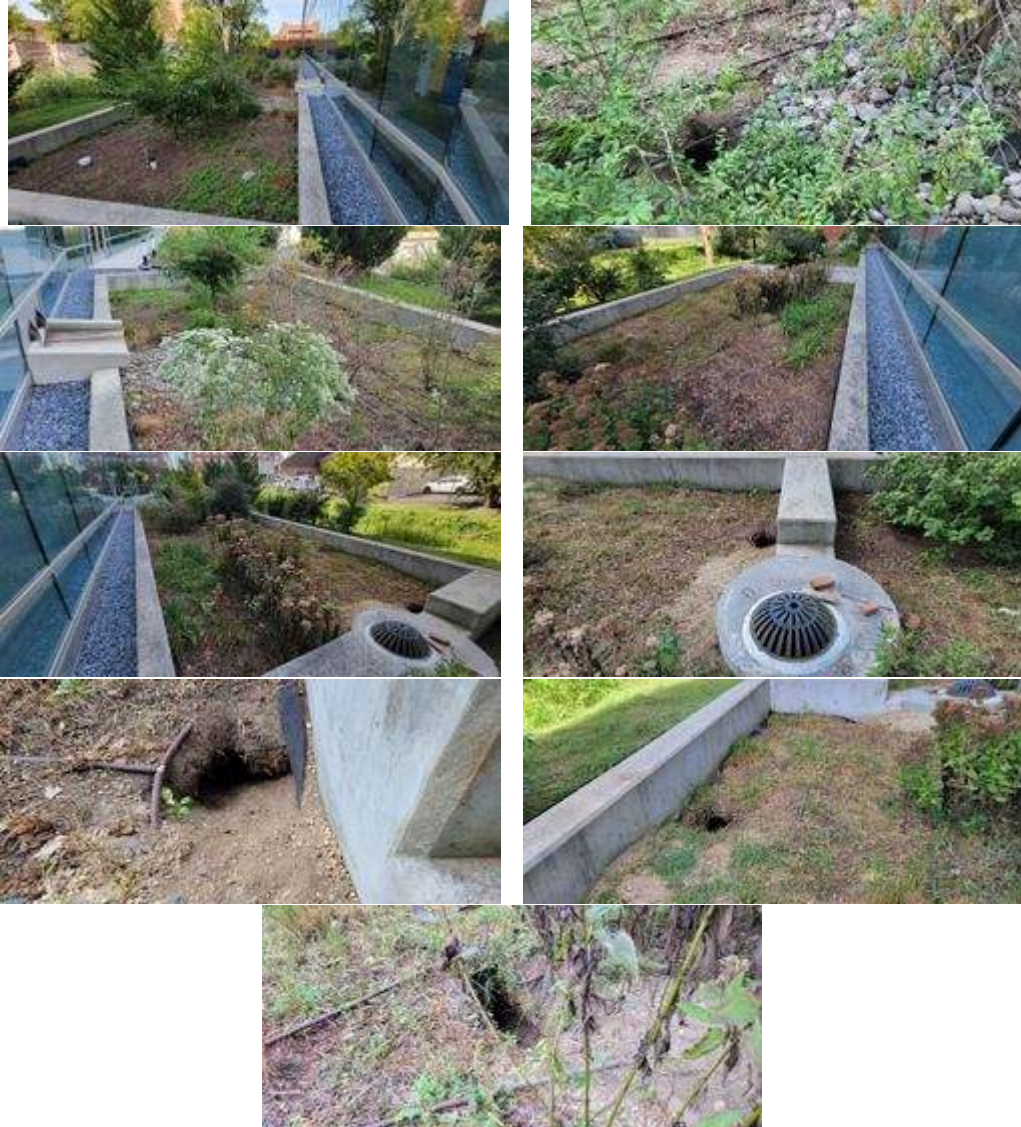
- **BMP Access** - Good
- **Debris & Sediment** - Good
- **Vegetation** - Fair
- **BMP Contamination** - Good
- **General Site Conditions Comments:** Perennial shrubs present, but lower growing plants are absent and being replaced with weed. Holes present which appear to be from burrowing animals
