University of Maryland, College Park  
National Pollutant Discharge Elimination  
System MS4 Phase II  
FY2023 Annual Report  
General Discharge Permit #13-SF-5501

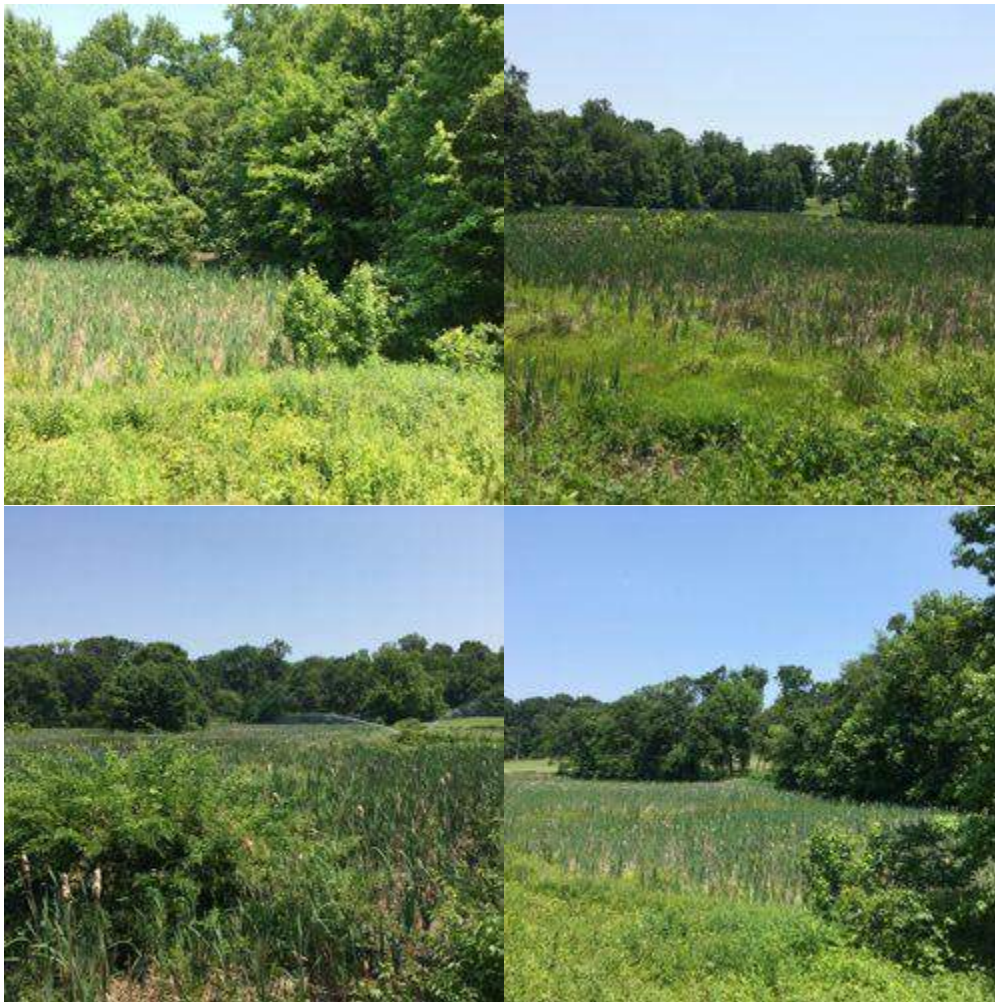
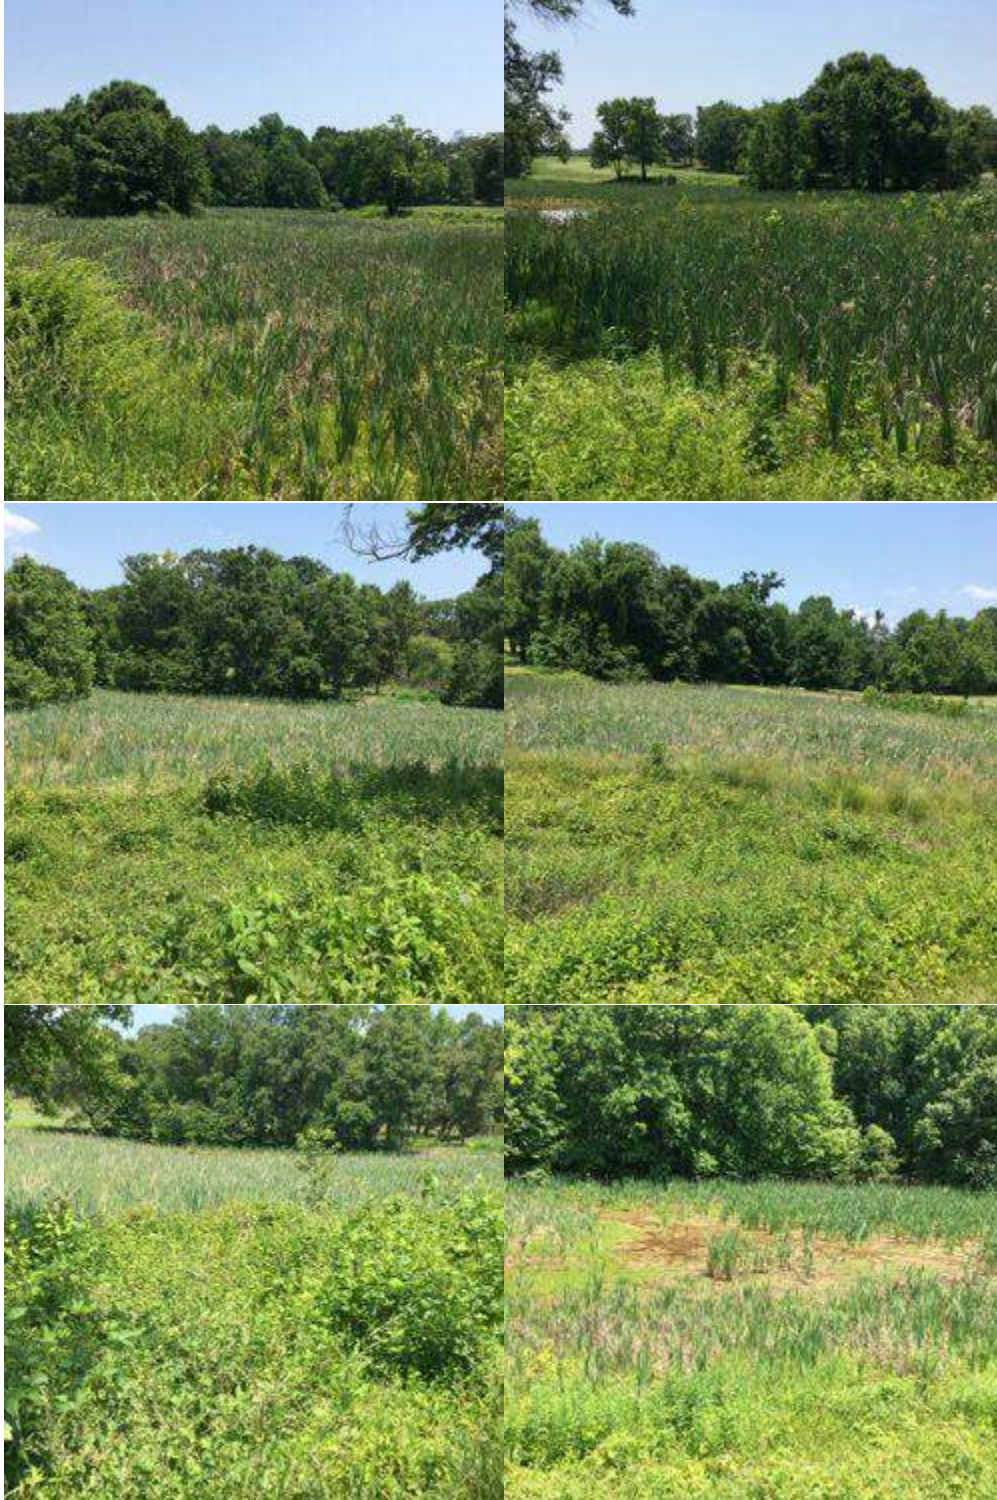
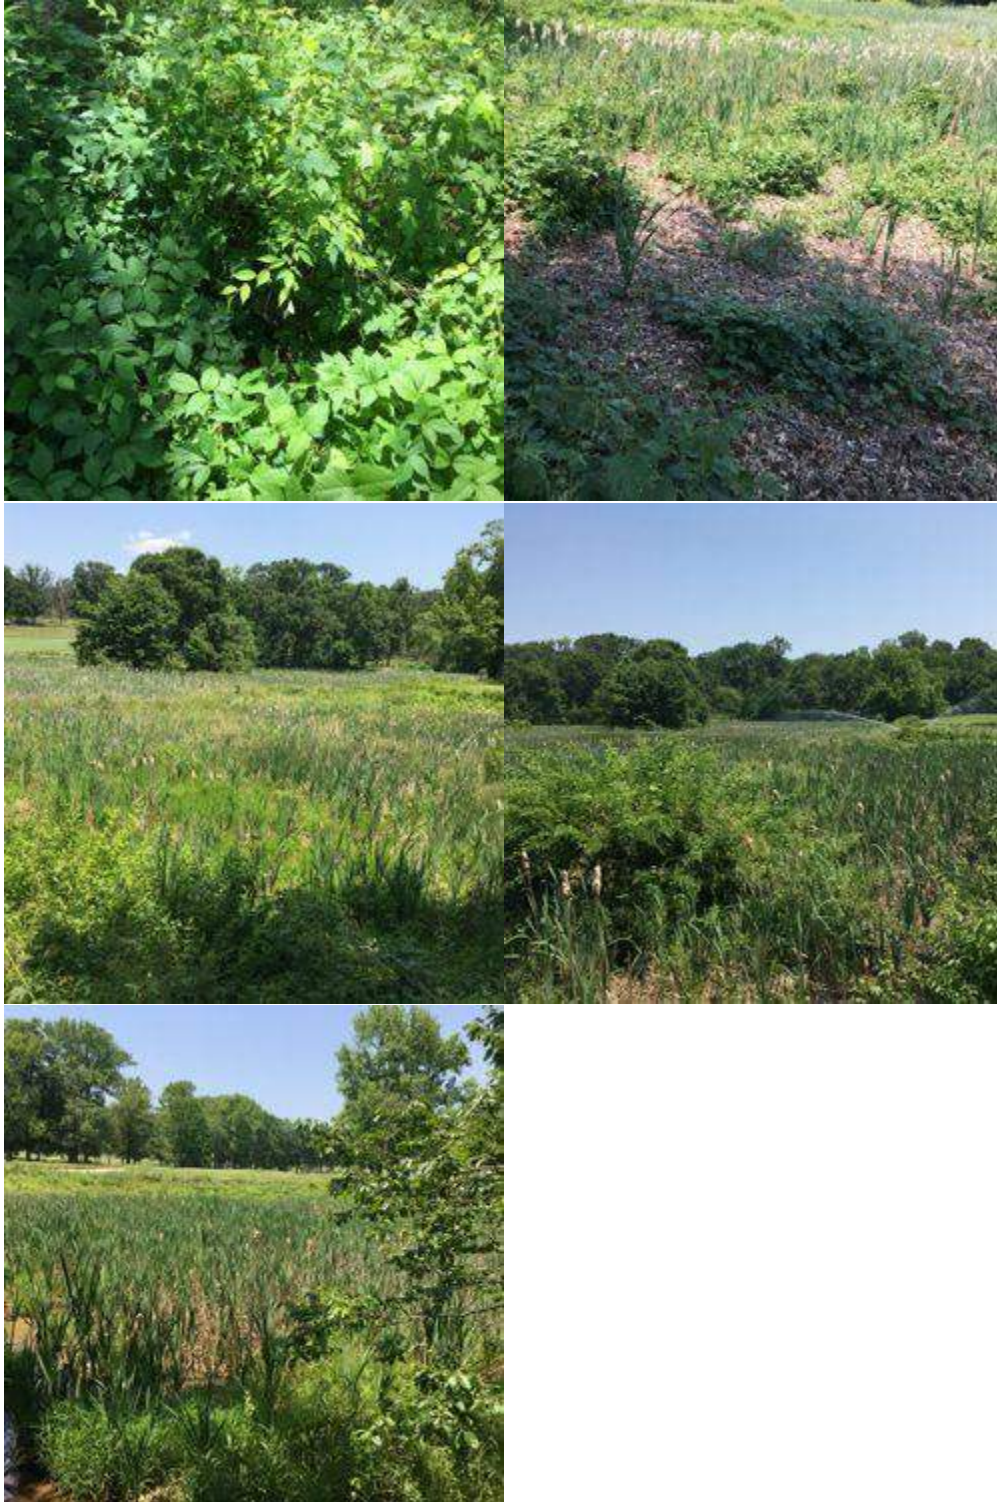
- **BMP Access** - Good
- **Debris & Sediment** - Poor
- **Vegetation** - Poor
- **BMP Contamination** - Good
- **General Site Conditions Comments:** Cattail growth throughout facility, significant sediment accumulation within facility

Dredge facility, rebuild control structure, repair downstream condition, repair inflows.

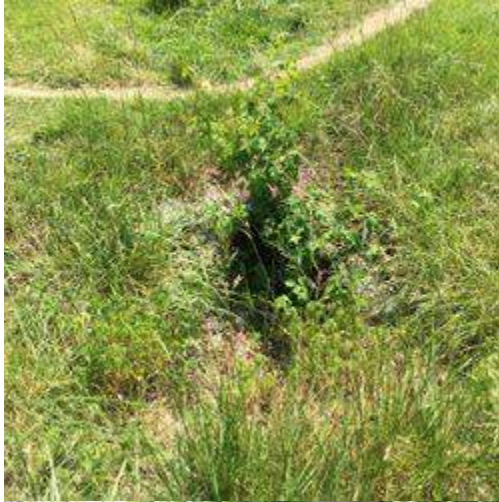
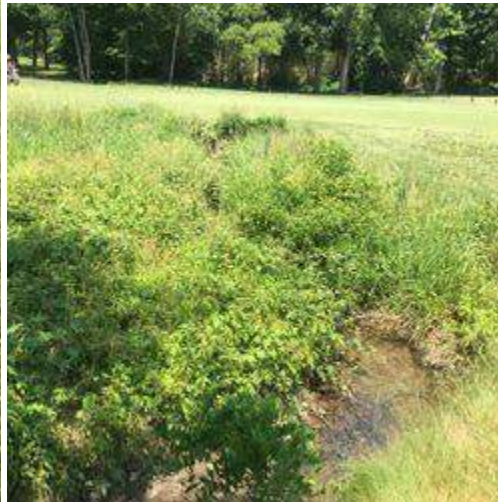
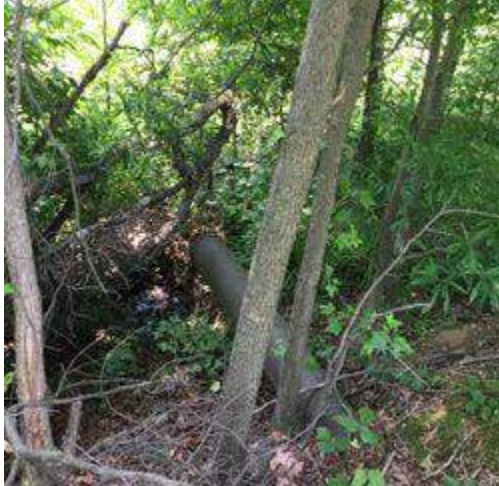
- **Inflow Condition** - Poor
- **Forebay** - N/A

**Erosion at Inflows :**

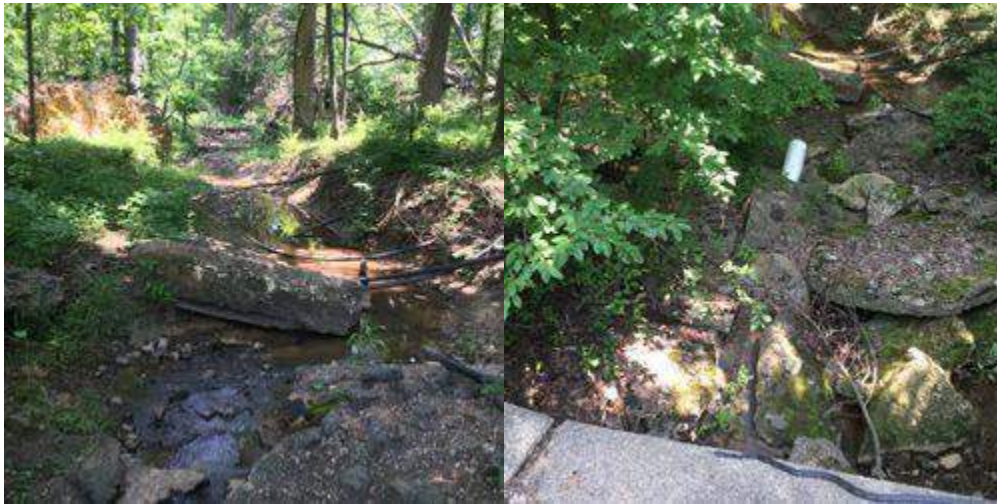
- **Spillway Outfall** - Poor
- **Downstream Condition** - Poor

**Downstream Condition:**

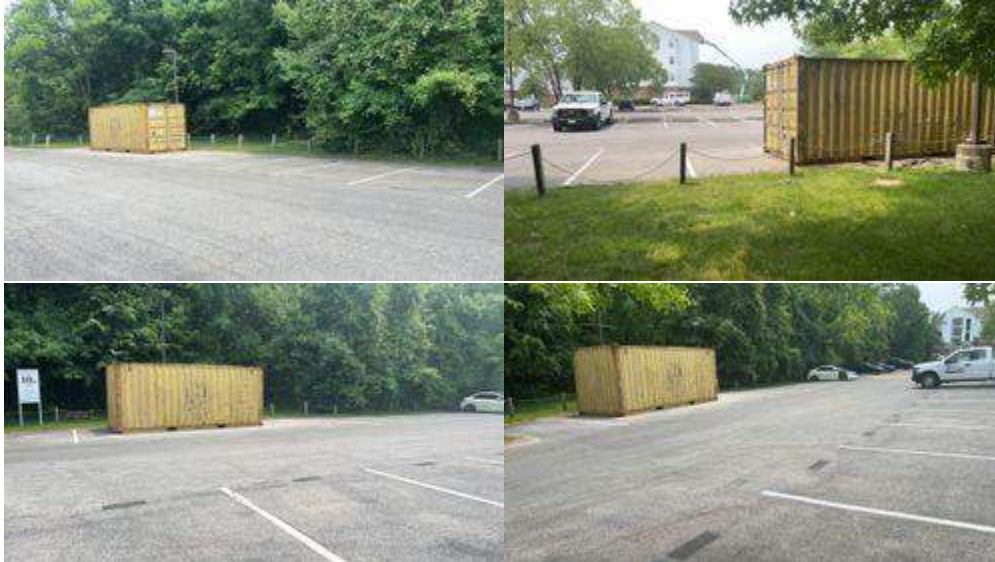
**Photos showing the storage container blocking the inflow**

Move storage container.

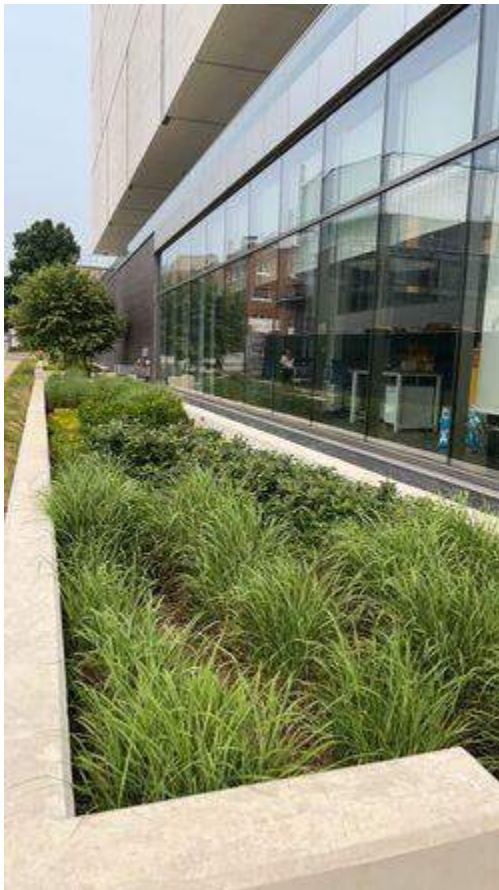
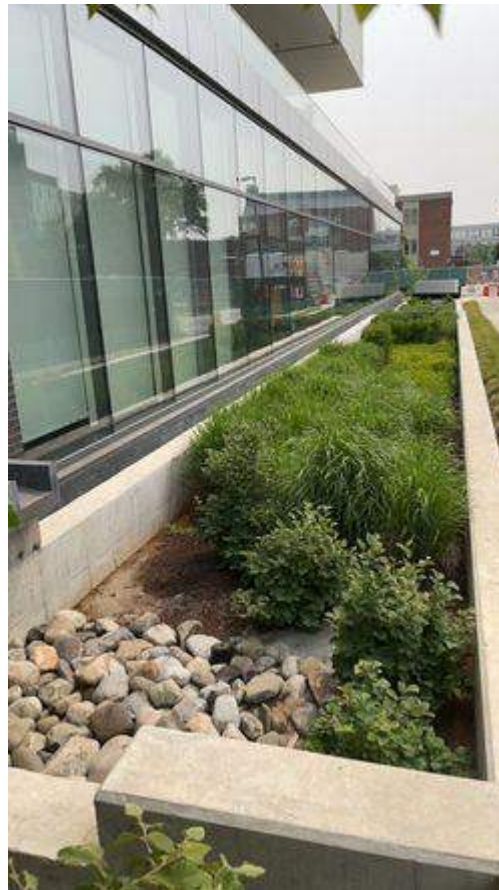
Overall Photos:

- **BMP Access** - Good
- **Debris & Sediment** - Fair
- **Vegetation** - Good
- **BMP Contamination** - Fair
- **General Site Conditions Comments:** Heavy sedimentation around Inflow.

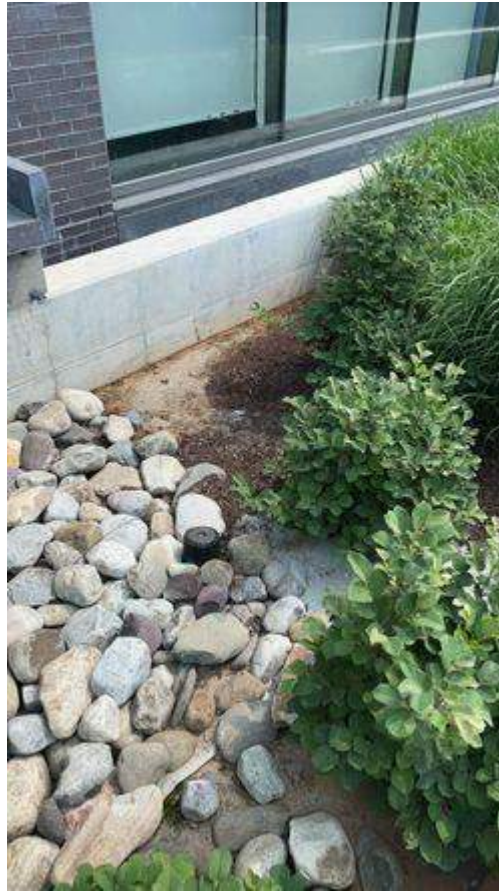
Sedimentation around inflow:

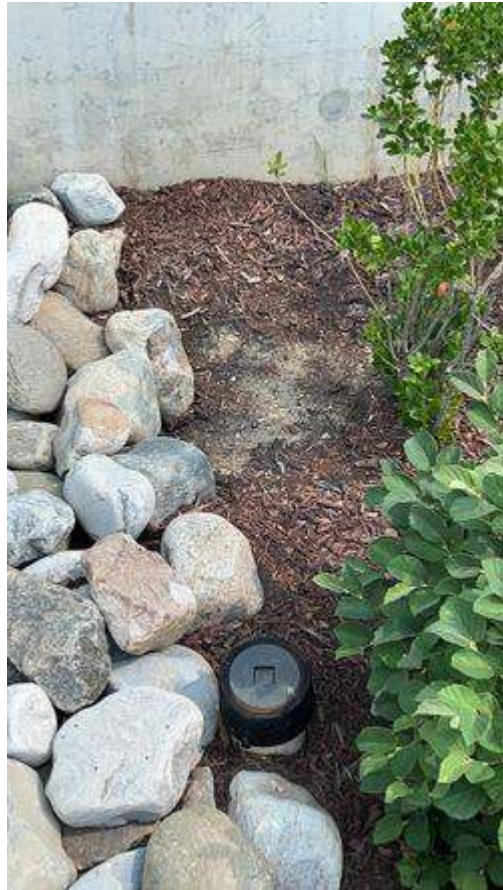
Bare patch next to inflow:

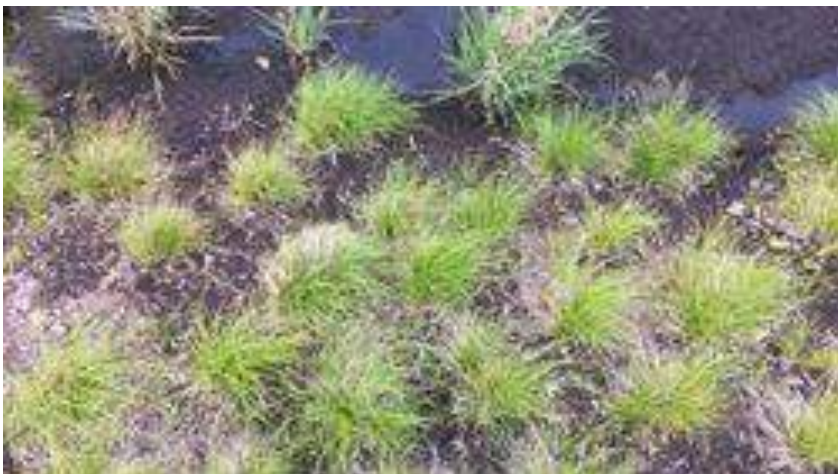
Pooling water at inflow:

**Maintenance & Remediation Recommendations**- Fix broken inflow pipe. Investigate and remediate ponding.

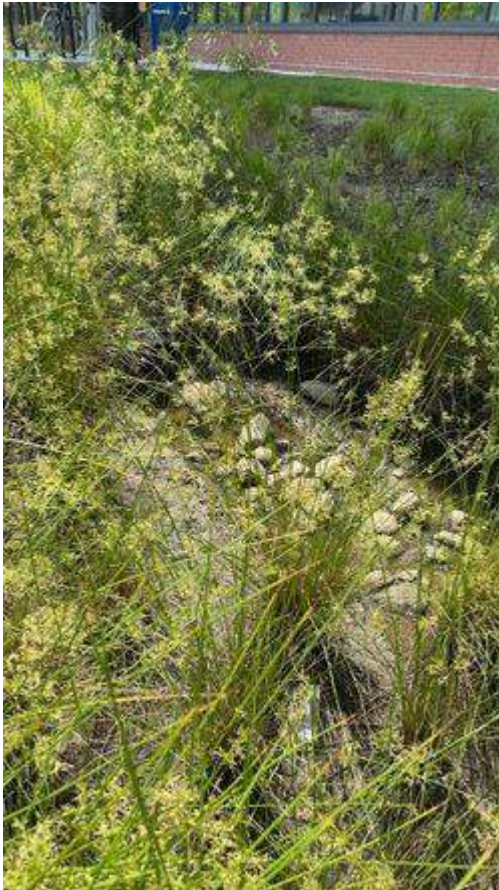
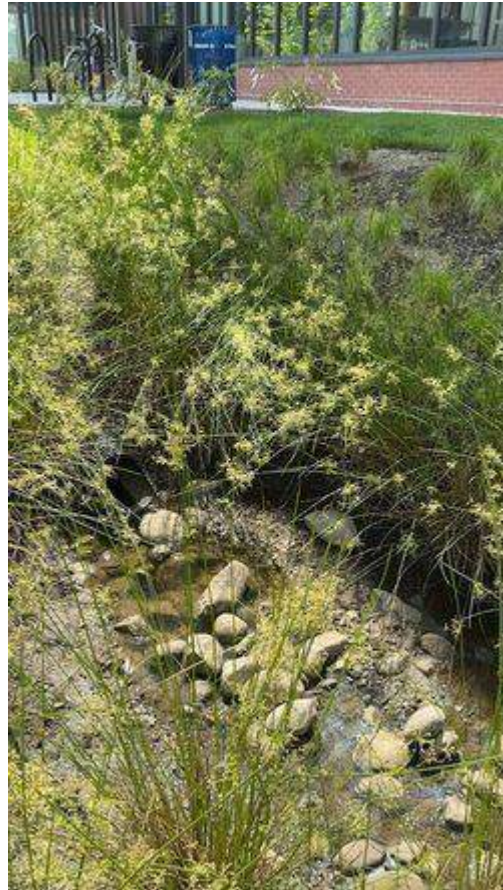
Inflow:

- **Inflow Condition** - Fair
- **Forebay** – N/A

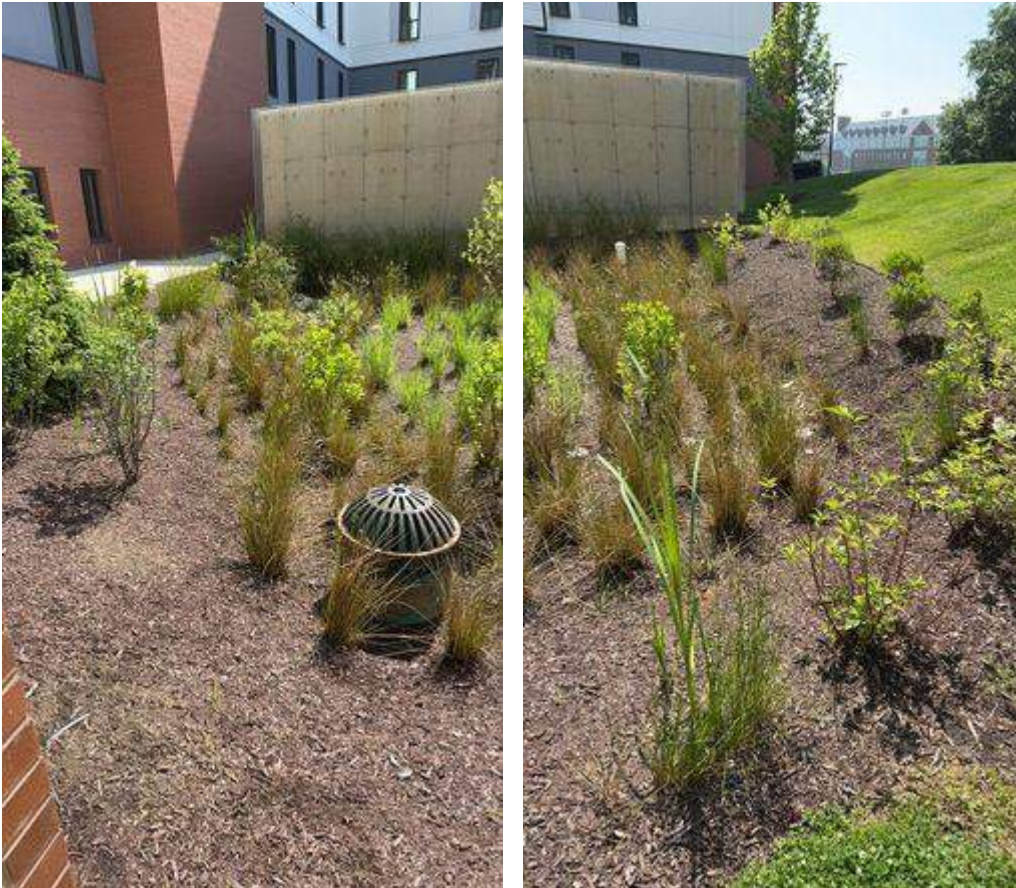
Overall Photos:

- **BMP Access** - Poor
- **Debris & Sediment** - Fair
- **Vegetation** - Good
- **BMP Contamination** - Fair
- **General Site Conditions Comments:** Trash in treatment area

**Maintenance & Remediation Recommendations** - Continue with Routine Maintenance.

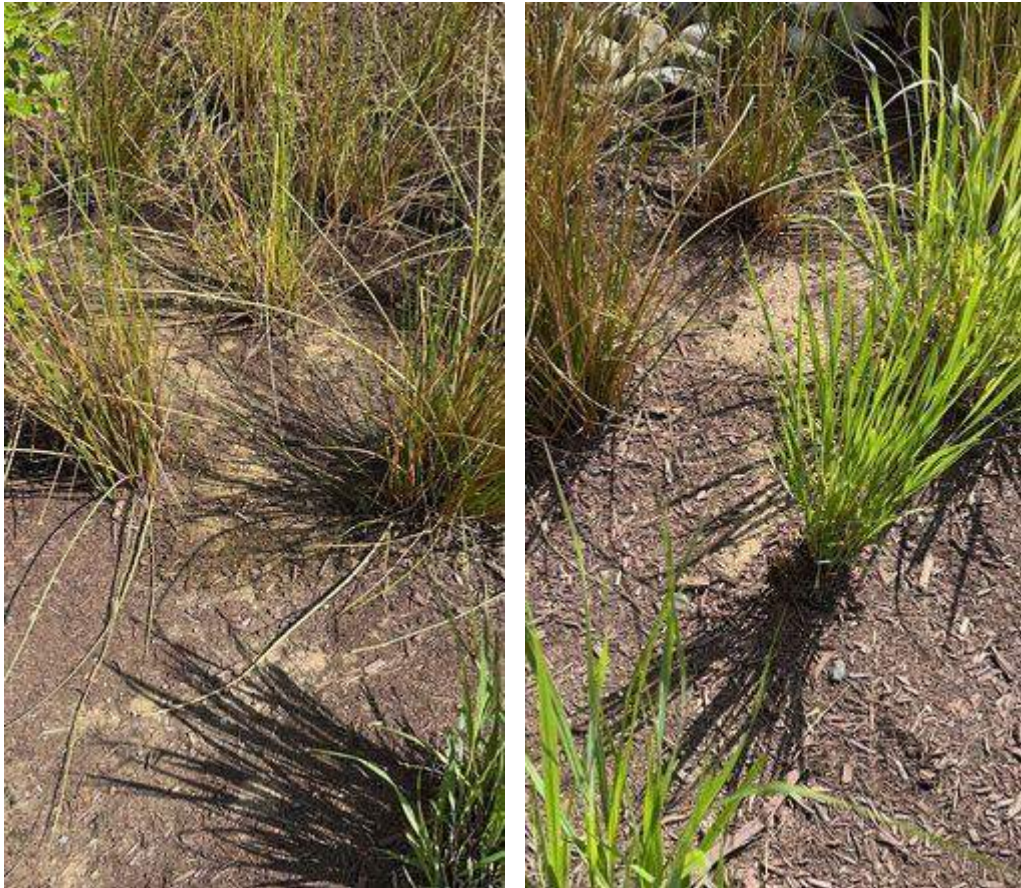
Sediment in Treatment Area:

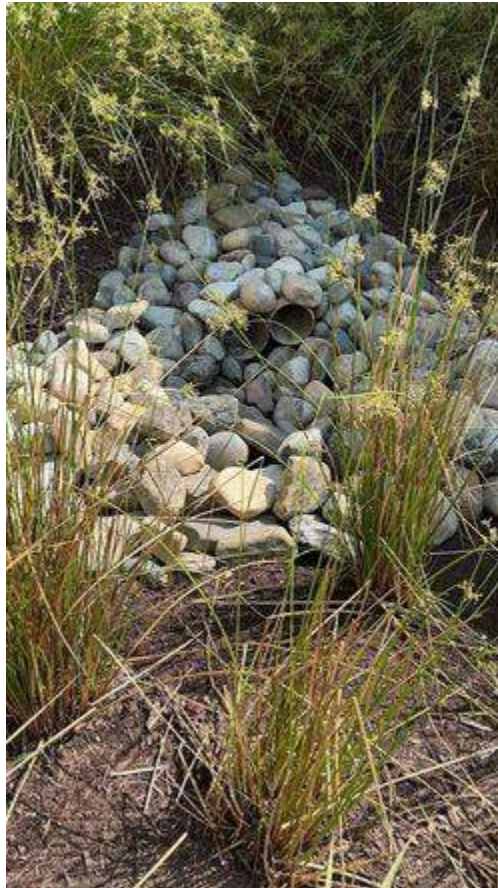
Inflow:

- **Inflow Condition** - Good
- **Forebay** – N/A

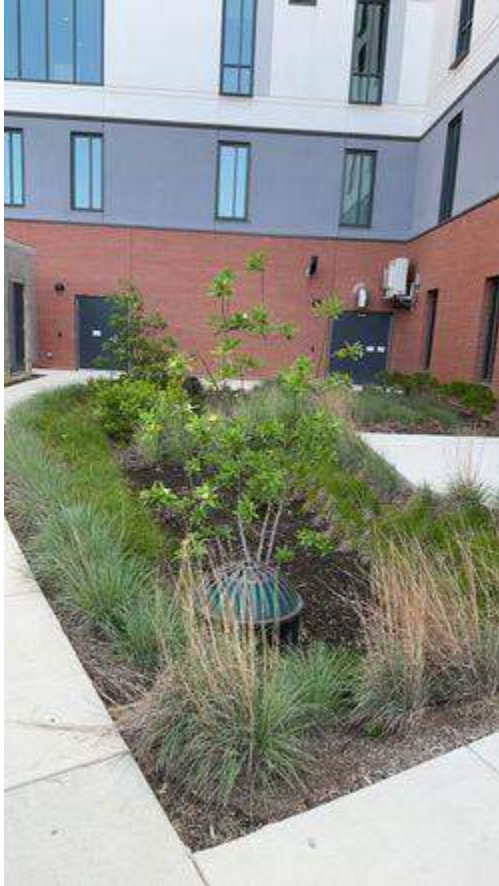
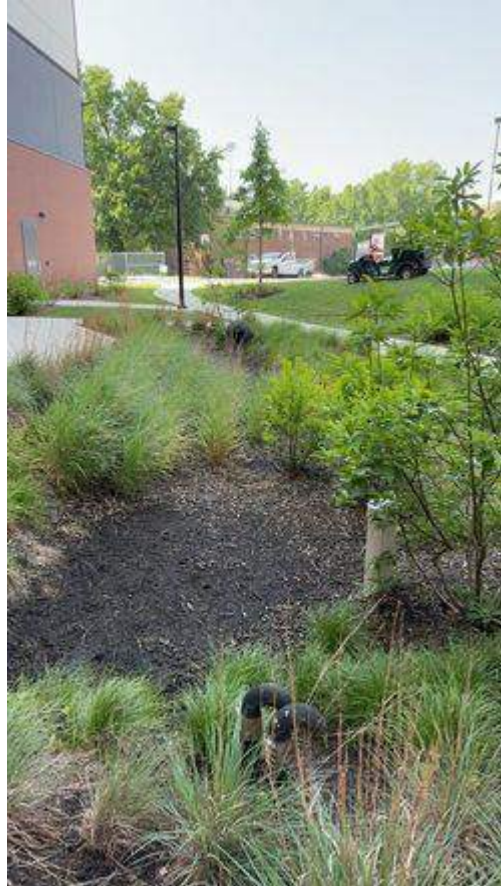
Overall Photo:

- **BMP Access** - Fair
- **Debris & Sediment** - Good
- **Vegetation** - Good
- **BMP Contamination** - Good
- **General Site Conditions Comments:** Some trash

**Maintenance & Remediation Recommendations** - Flush sub drain

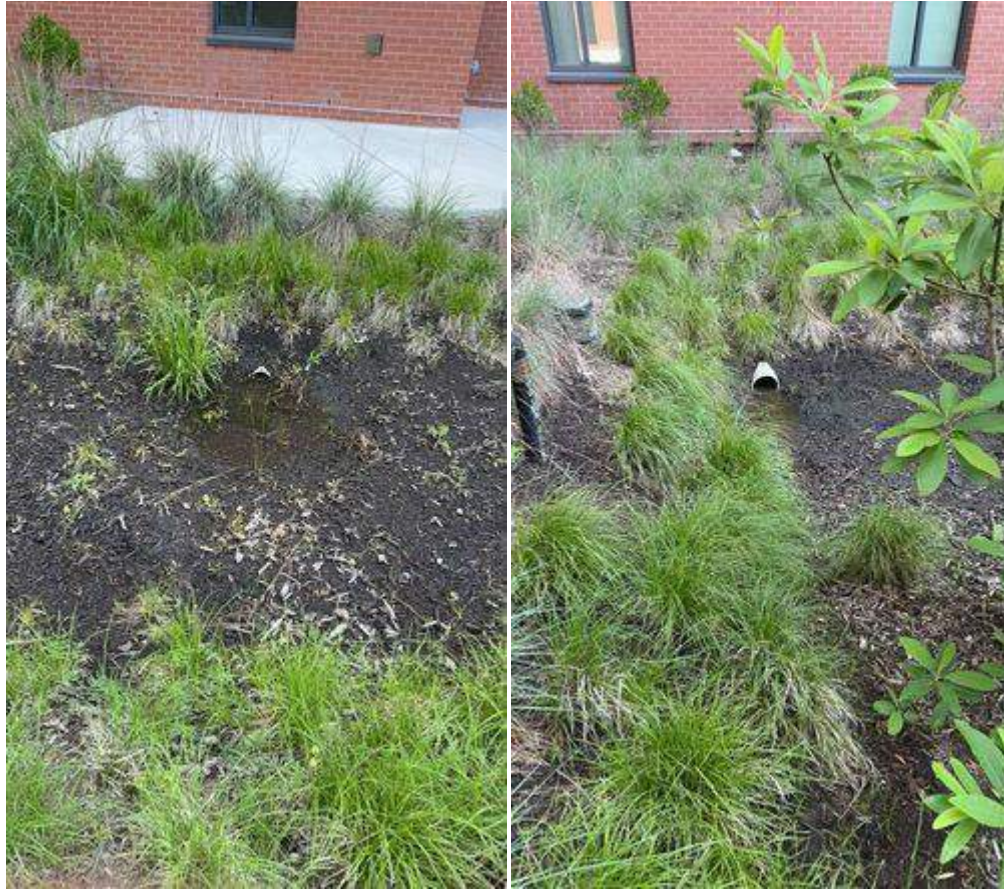
Inflow:

- **Inflow Condition** - Fair
- **Forebay** – N/A

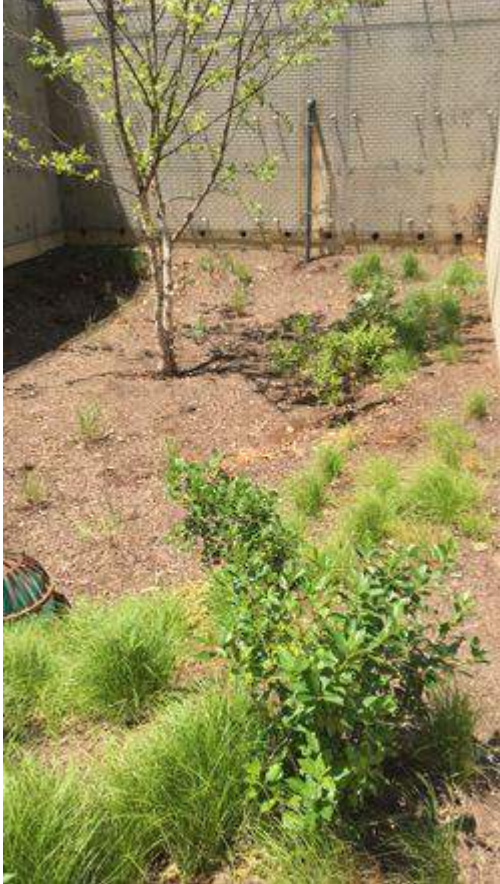
Overall Photos:

- **BMP Access** - Good
- **Debris & Sediment** - Good
- **Vegetation** - Fair
- **BMP Contamination** - Good
- **General Site Conditions Comments:** Vegetation is sparse

**Maintenance & Remediation Recommendations** – Continue with routine maintenance.

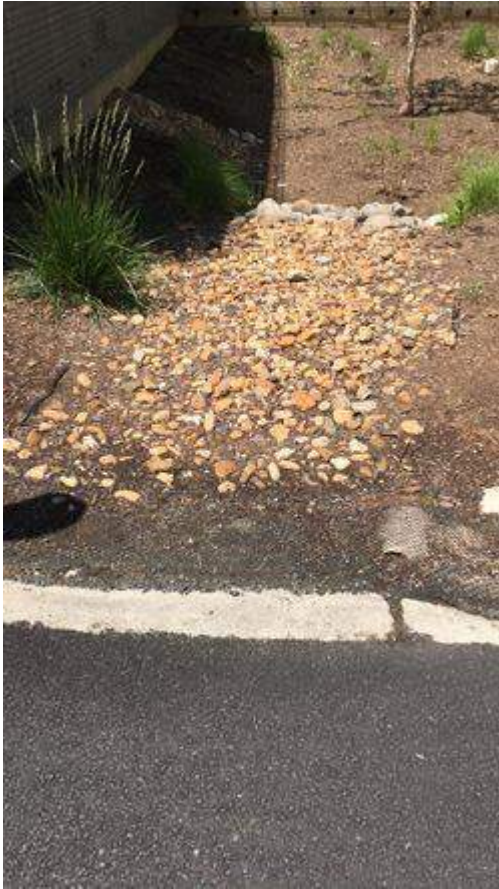
Inflow:

- **Inflow Condition** - Good
- **Forebay** – N/A

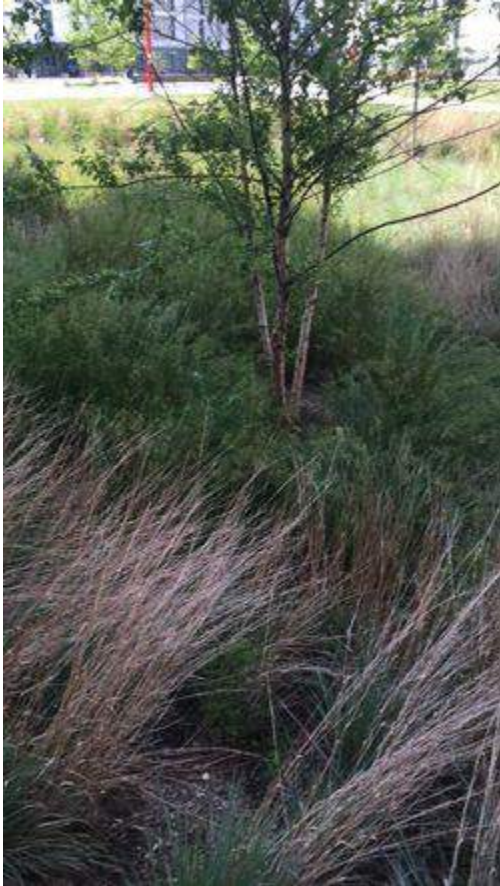
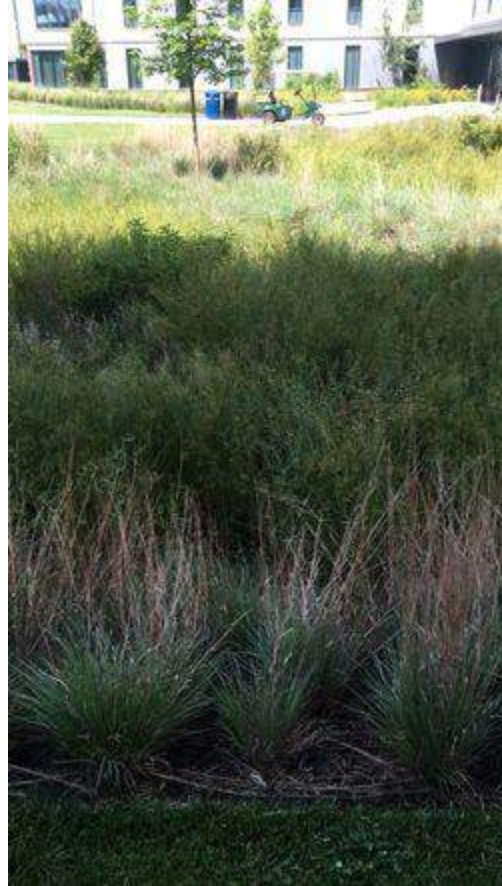
**Overall Photos**

- **BMP Access** - Good
- **Debris & Sediment** - Good
- **Vegetation** - Good
- **BMP Contamination** - Good
- **General Site Conditions Comments:** Excessive vegation needs trimming

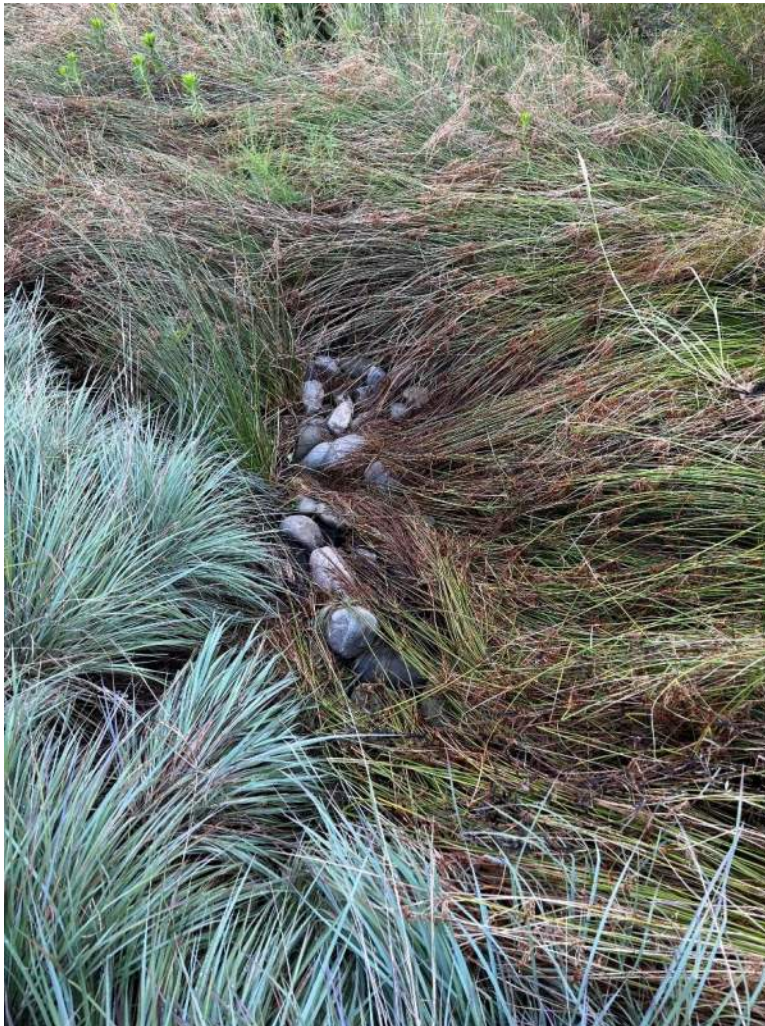
- **Inflow Condition** - Good
- **Forebay** - Not Rated

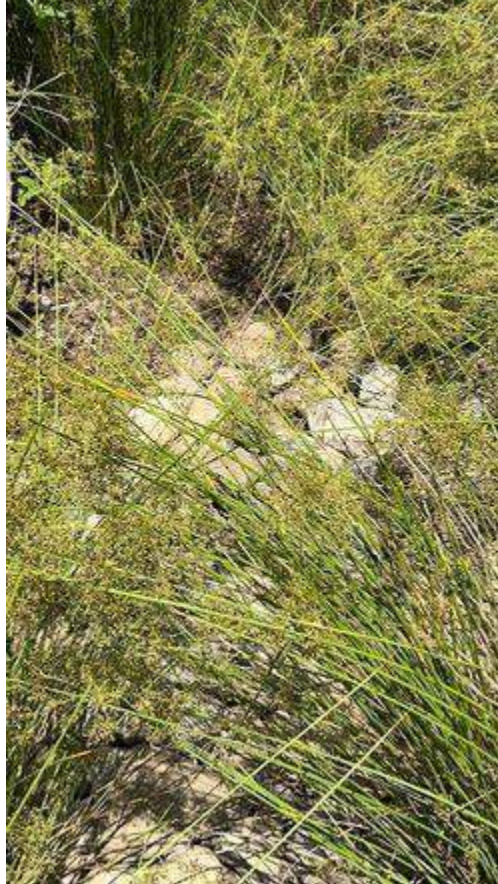
### Overgrown Vegetation

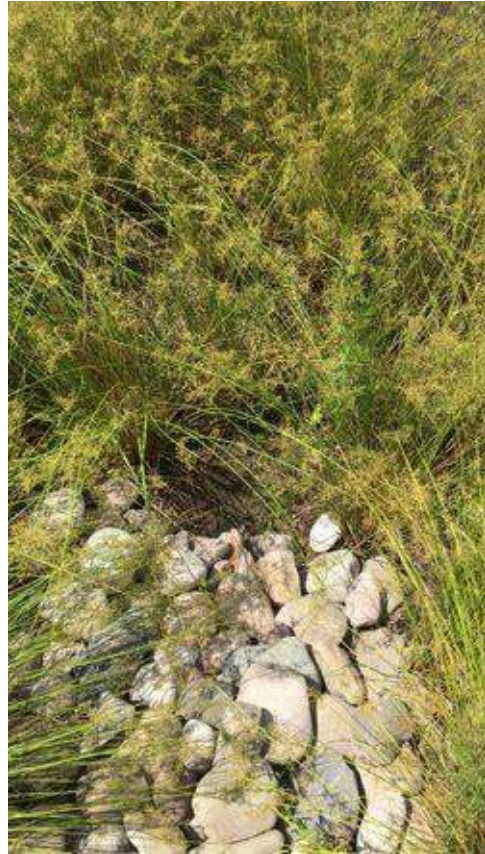
**Inflow**

- **Inflow Condition** - Good
- **Forebay** - Not Rated

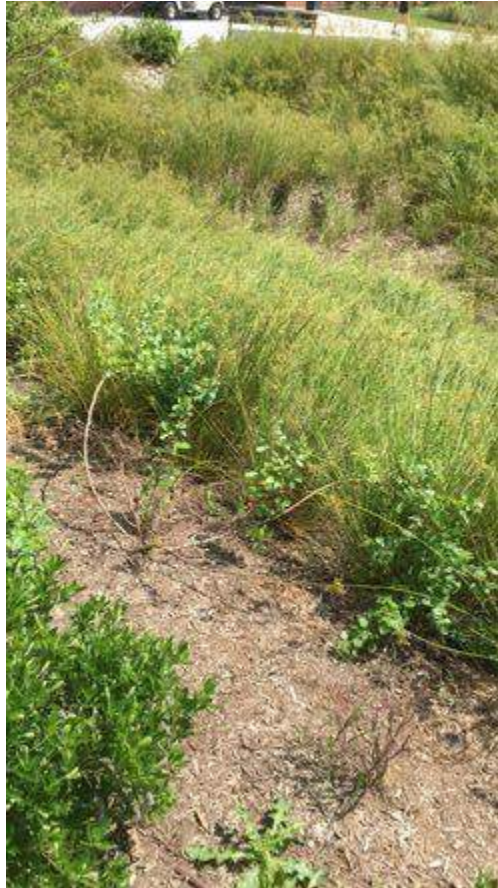
## Vegetation

- **BMP Access** - Good
- **Debris & Sediment** - Good
- **Vegetation** - Good
- **BMP Contamination** - Good
- **General Site Conditions Comments:**

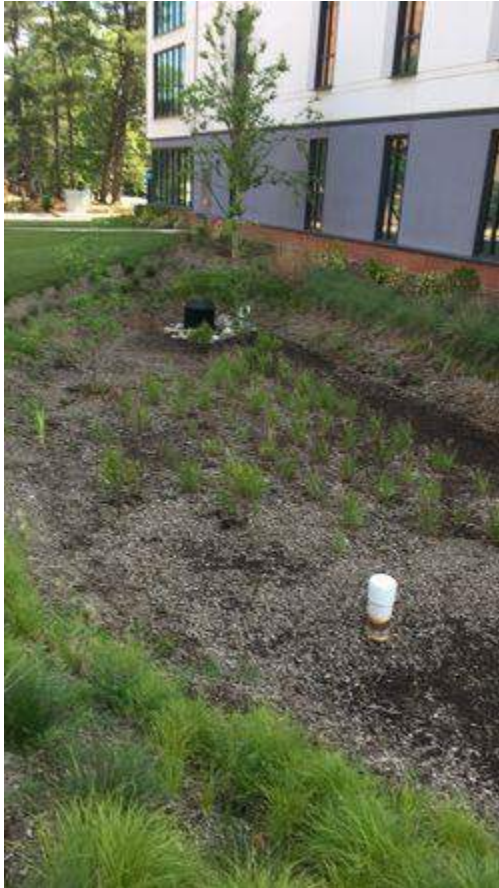
Overall Photos:

- **BMP Access** - Good
- **Debris & Sediment** - Good
- **Vegetation** - Good
- **BMP Contamination** - Good
- **General Site Conditions Comments:**

**Maintenance & Remediation Recommendations**- Continue with routine maintenance.

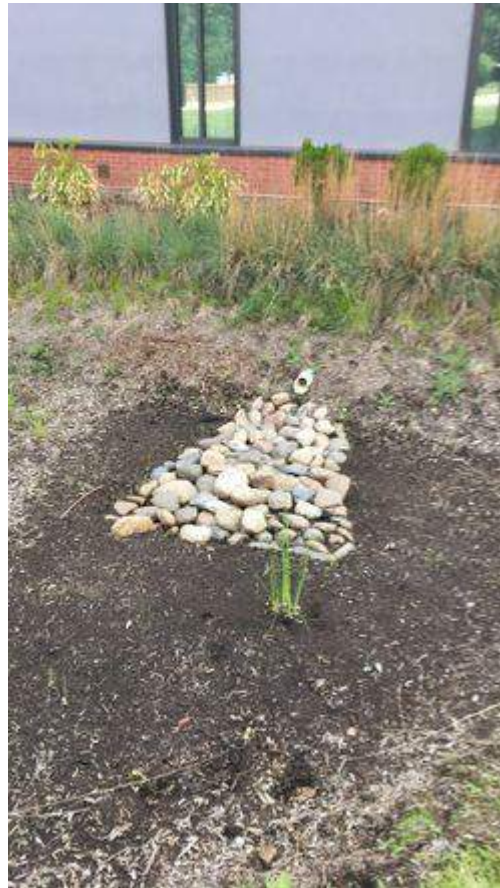
Inflow:

- **Inflow Condition** - Good
- **Forebay** – N/A

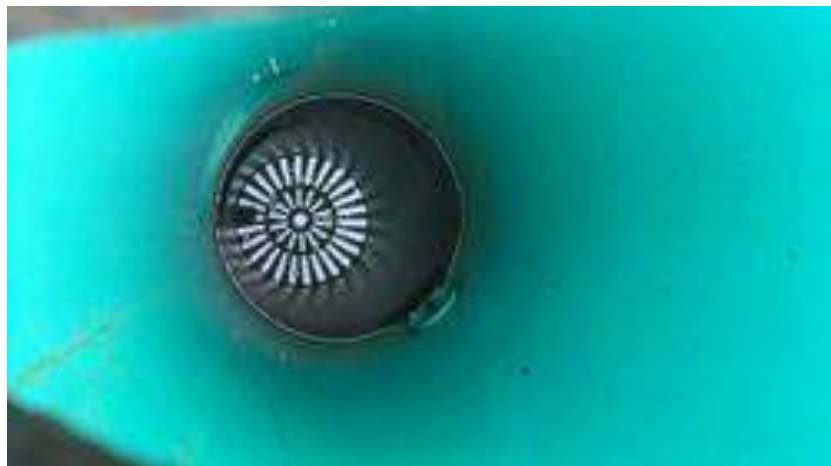
Principal Spillway:

- **Spillway Outfall** – N/A
- **Downstream Condition** – N/A

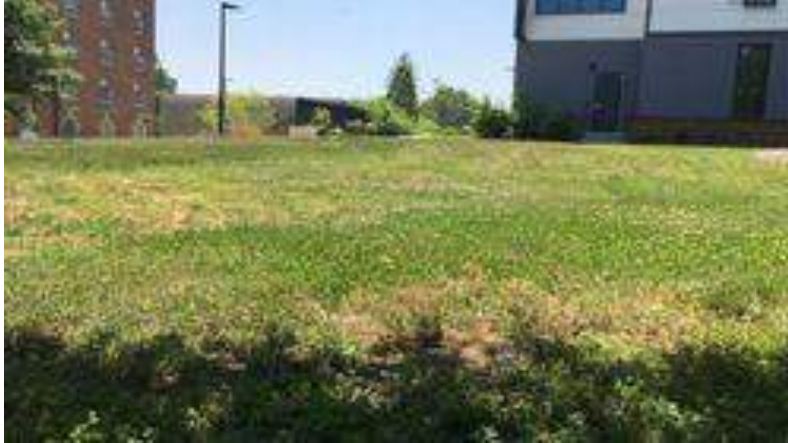
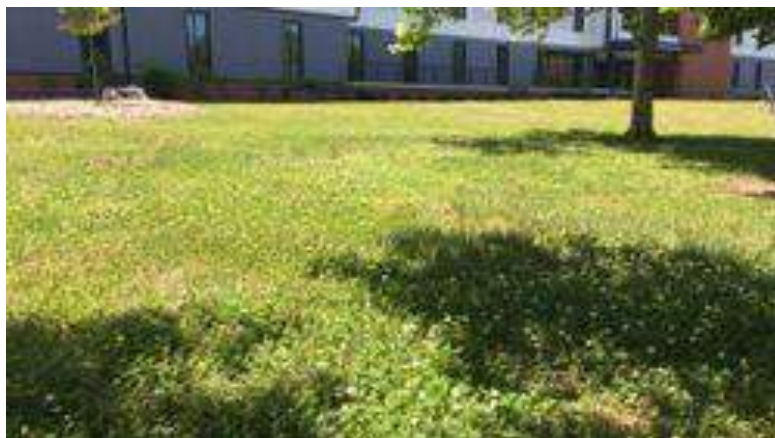
Overall Photos:

- **BMP Access** - Good
- **Debris & Sediment** - Good
- **Vegetation** - Fair
- **BMP Contamination** - Good
- **General Site Conditions Comments:**

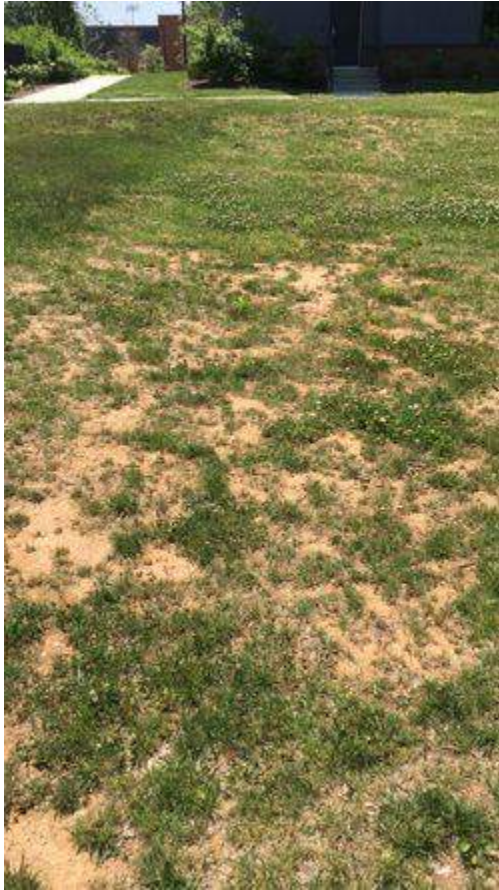
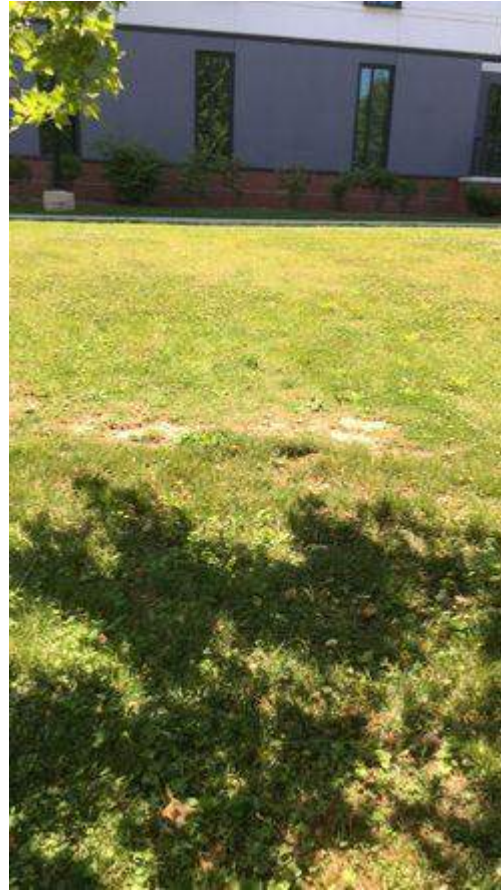
Bare Spots/Erosion:

**Maintenance Level** – Minor Maintenance (Use of Hand Equipment for Repairs)

**Maintenance & Remediation Recommendations** – Reseed areas of erosion/bare spots as needed

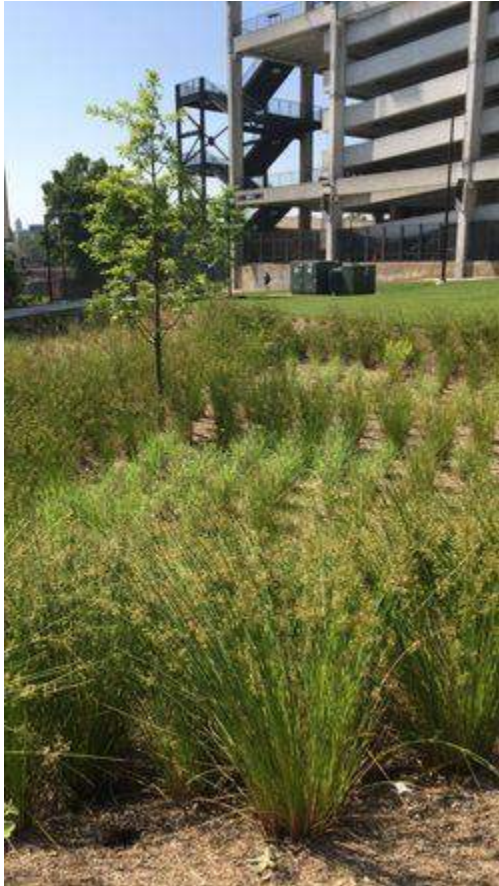
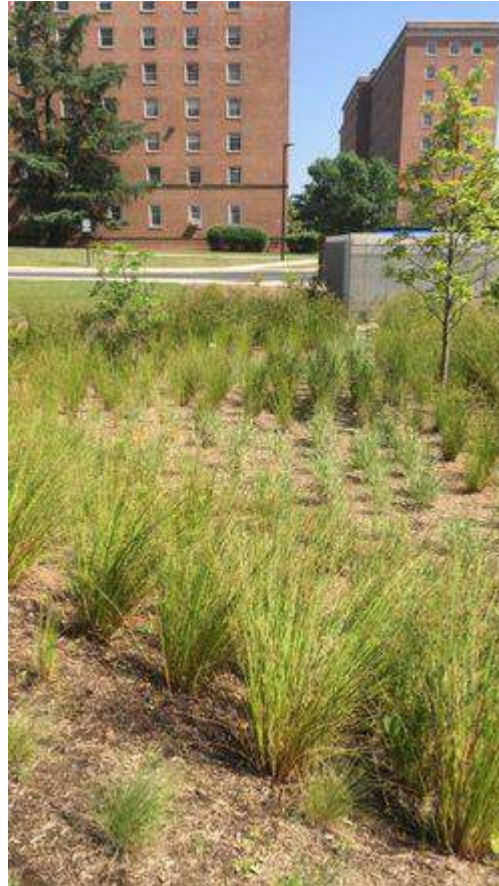
Overall Photo:

- **BMP Access** - Good
- **Debris & Sediment** - Good
- **Vegetation** - Good
- **BMP Contamination** - Good
- **General Site Conditions Comments:**

**Maintenance & Remediation Recommendations** – Continue with Routine Maintenance.

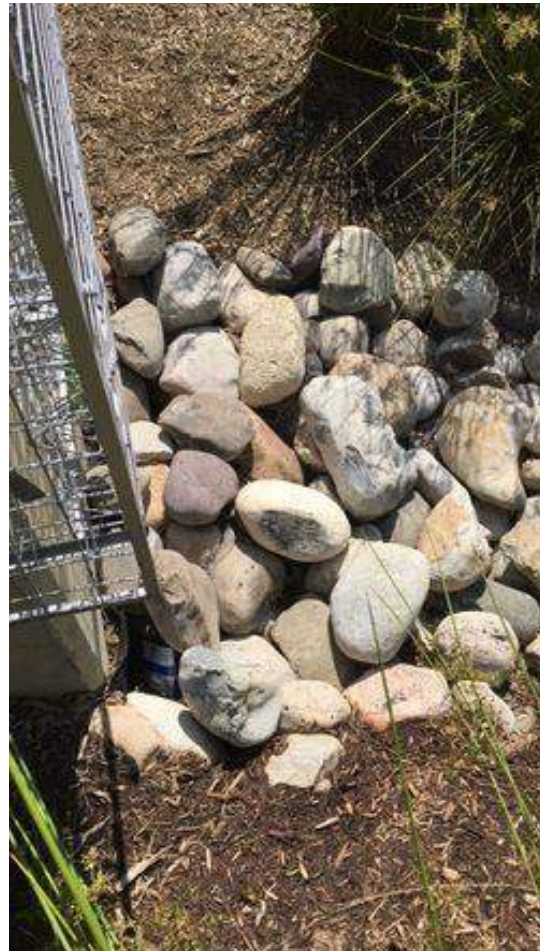
Inflow:

- **Inflow Condition** - Good
- **Forebay** - N/A

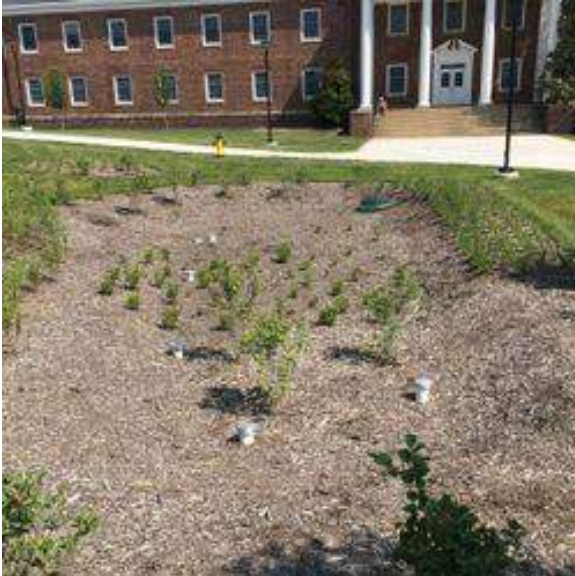
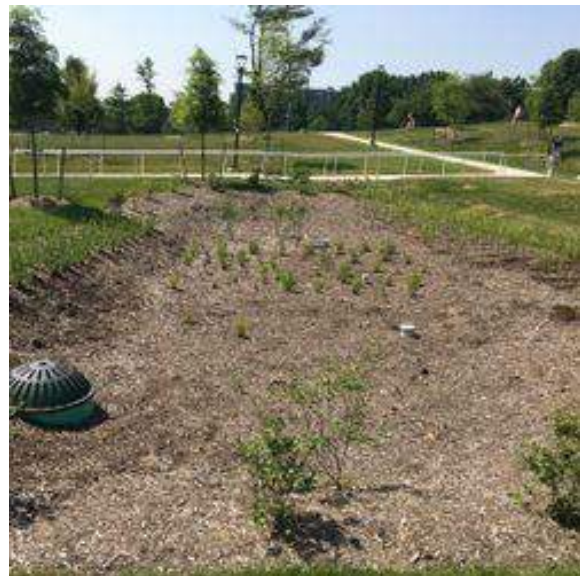
Overall Photos:

- **BMP Access** - Good
- **Debris & Sediment** - Good
- **Vegetation** - Good
- **BMP Contamination** - Good
- **General Site Conditions Comments:**

**Maintenance & Remediation Recommendations** - Continue routine maintenance

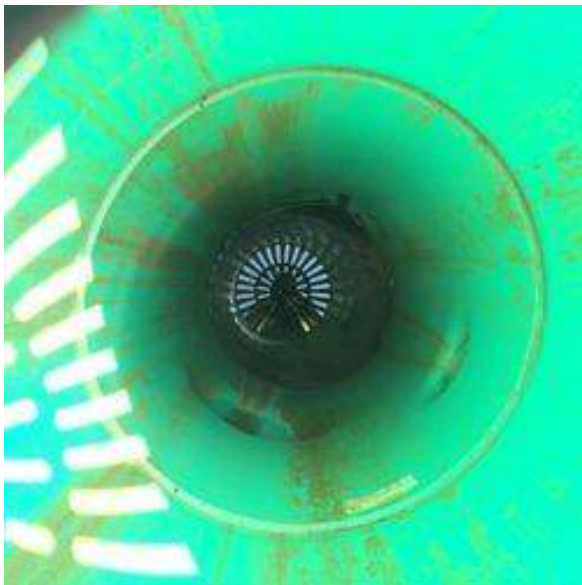
Principle Spillway:

- **Spillway Outfall** - N/A
- **Downstream Condition** - Good
