University of Maryland, College Park  
National Pollutant Discharge Elimination  
System MS4 Phase II  
FY2023 Annual Report  
General Discharge Permit #13-SF-5501

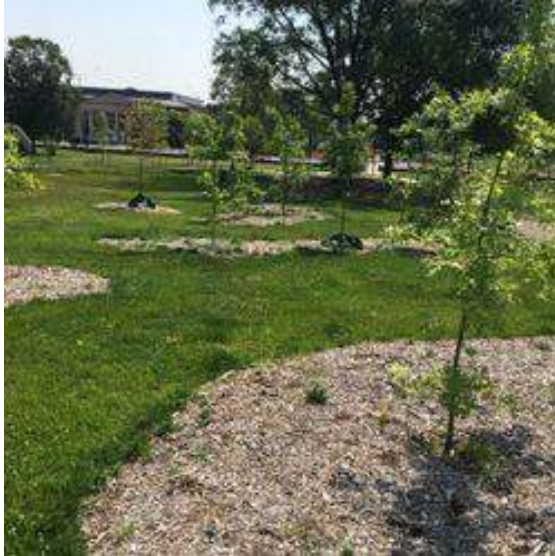
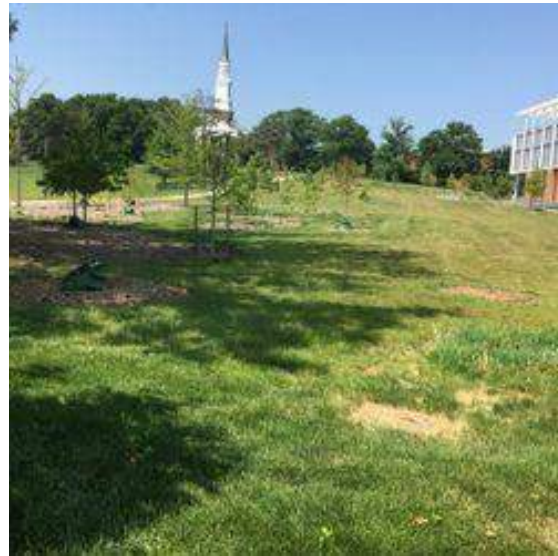
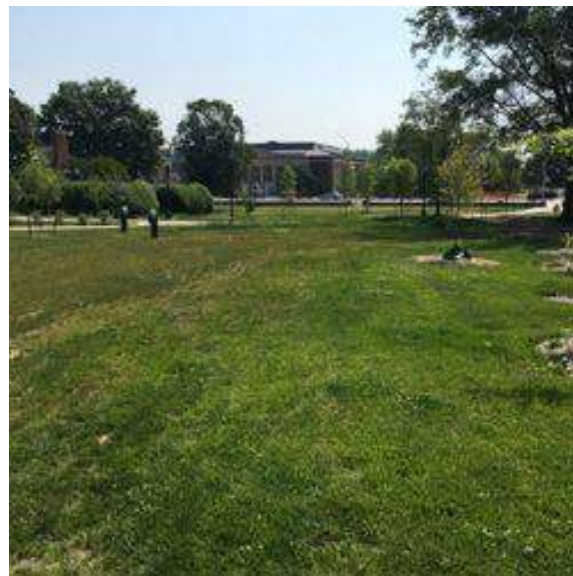
Overall Photos:

<b>Date of Inspection:</b>	June 2, 2023 8:59 AM	<b>Inspector Initials:</b>	SAL,PP
<b>BMP ID:</b>	UMCP22BMP0324	<b>Inspection Firm:</b>	MES
<b>BMP Type:</b>	Disconnection of Non-Rooftop Runoff	<b>Underground BMP?</b>	No
<b>BMP Status</b>	Pass	<b>Overall Inspection Comment:</b>	Minor erosion/bare spots at downstream
<b>Maintenance Level</b>	Minor Maintenance (Use of Hand Equipment for Repairs)

**Maintenance & Remediation Recommendations** - Reseed areas of erosion/bare spots as needed

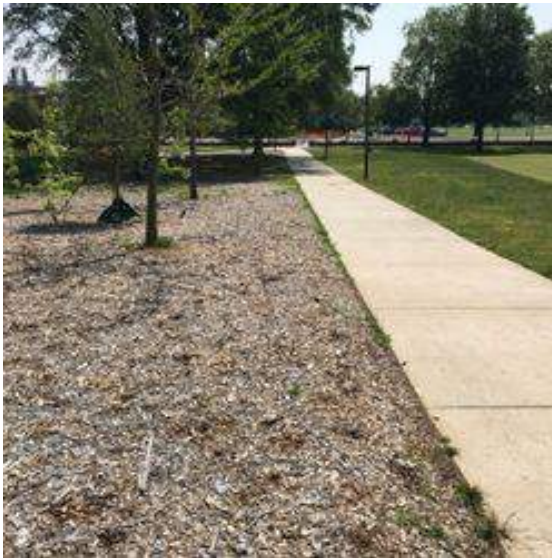
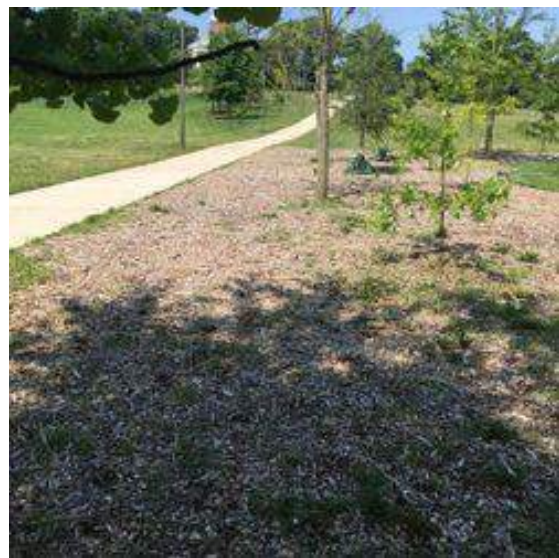
Inflow:

- **Inflow Condition** - Good
- **Forebay** - N/A

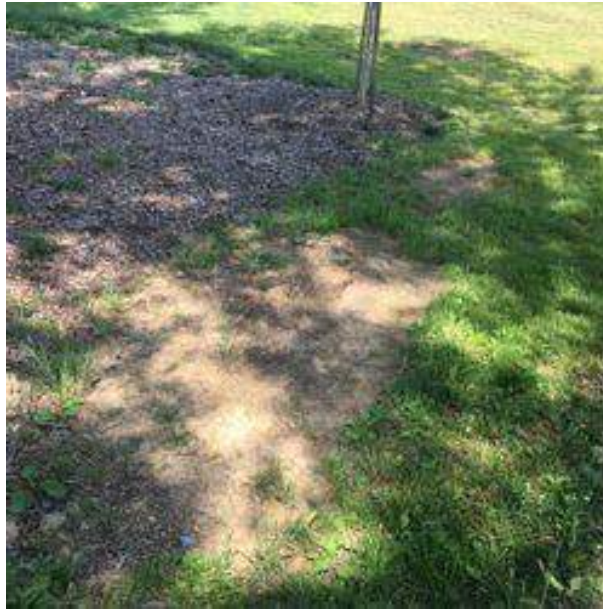
Sedimentation in Treatment area:

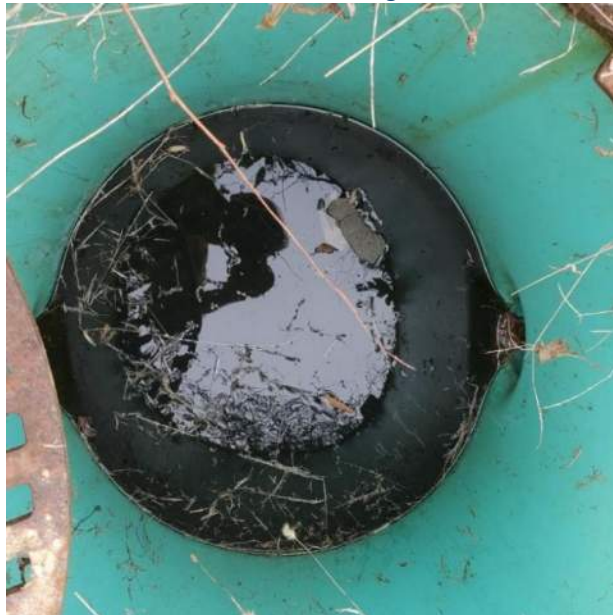
Cleanout 1 – Standing water

Mitigate ponding, replace damaged cleanout, remove trash above downstream cleanout

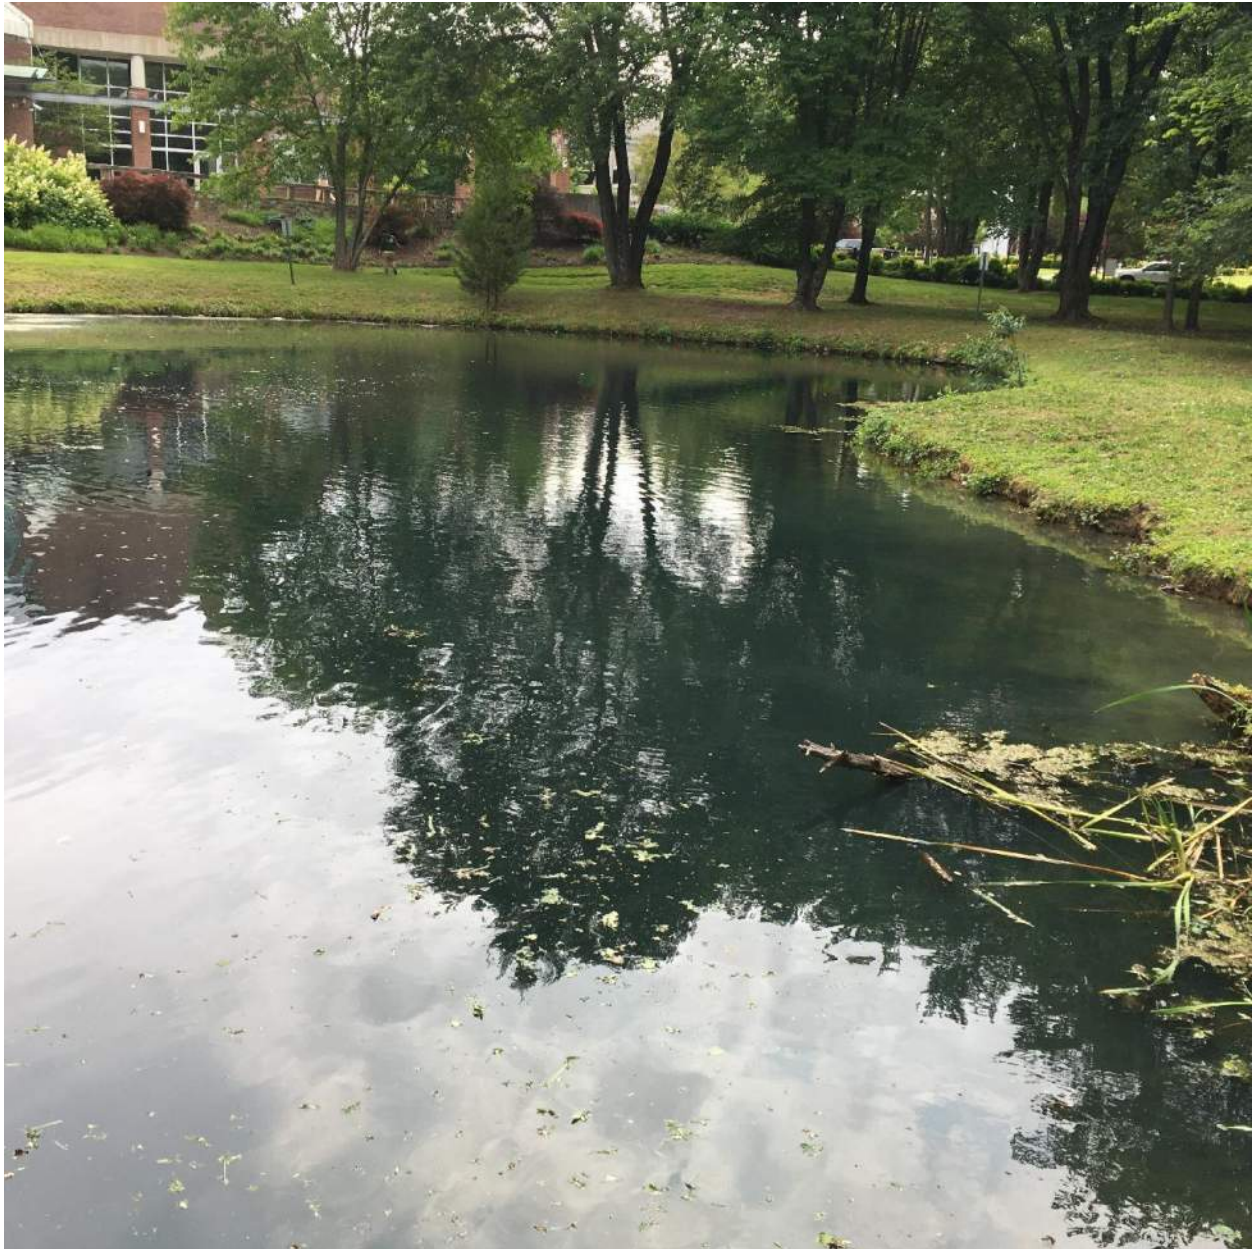
- **Inflow Condition** - Fair
- **Forebay** - N/A

- **Spillway Outfall** - Good
- **Downstream Condition** - Fair

Regrade control structure and downstream to reduce ponding, monitor erosion at inflow from roof, repair erosion around toe
