University of Maryland, College Park
National Pollutant Discharge Elimination
System MS4 Phase II
FY2025 Annual Report
General Discharge Permit #13-SF-5501

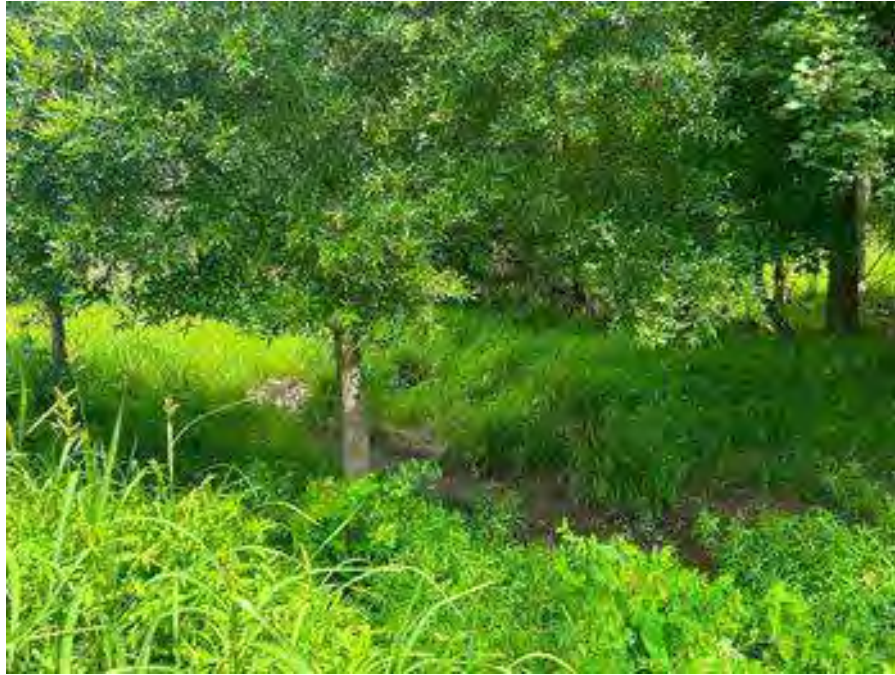
First Inflow

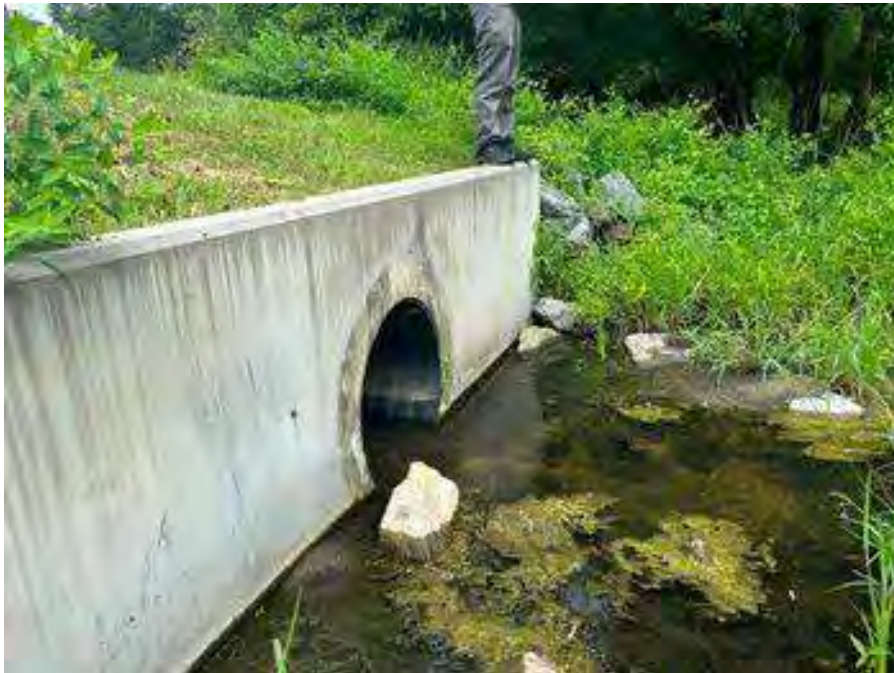
Second Inflow

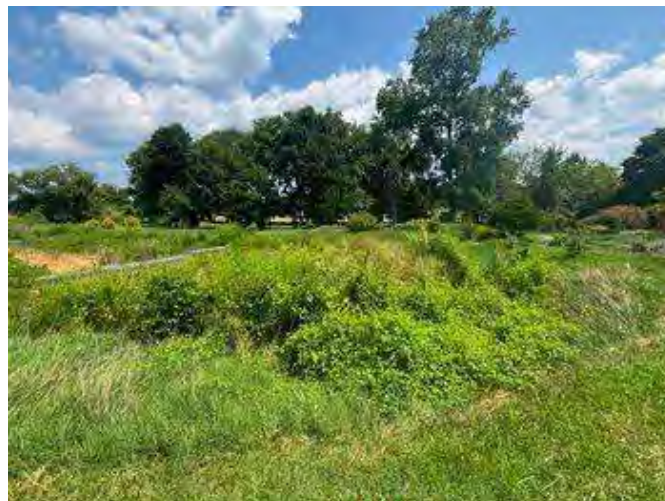
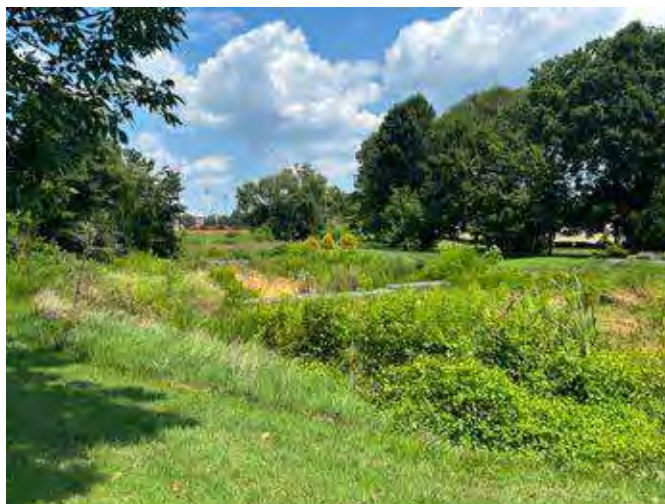
Overall Photo

Date of Inspection:	July 30, 2025 2:23 PM	Inspector Initials:	SM,SF
BMP ID:	UMCP19BMP0005	Inspection Firm:	MES
BMP Type:	Sand Filter	Underground BMP?	No
BMP Status	Pass	Overall Inspection Comment:	Both forebays are overgrown with herbaceous vegetation, possible fox burrow on west forebay berm
Maintenance Level	Routine Maintenance (Only needs Routine Maintenance)

Inspect overgrowth in west forebay for fox burrow, trim vegetation in both forebays

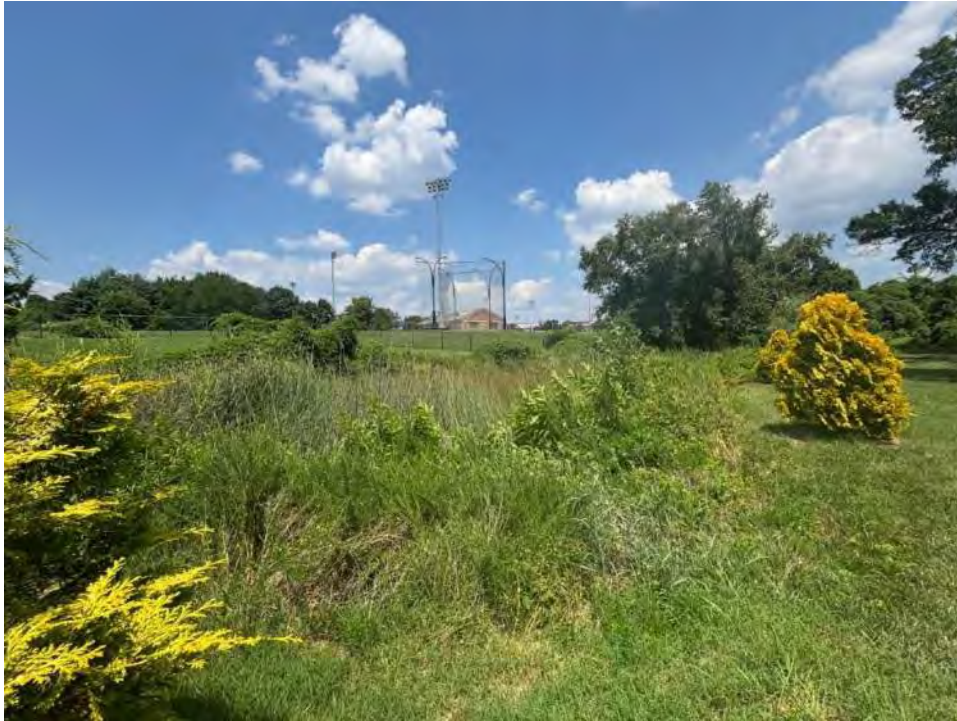
East forebay

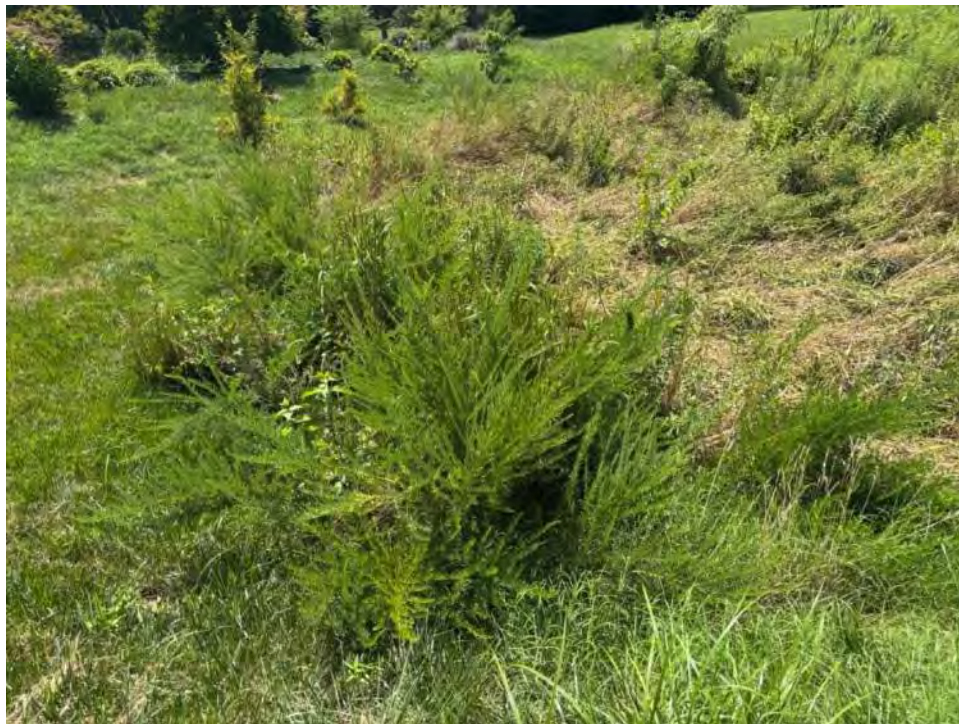
Potential fox burrow in west forebay

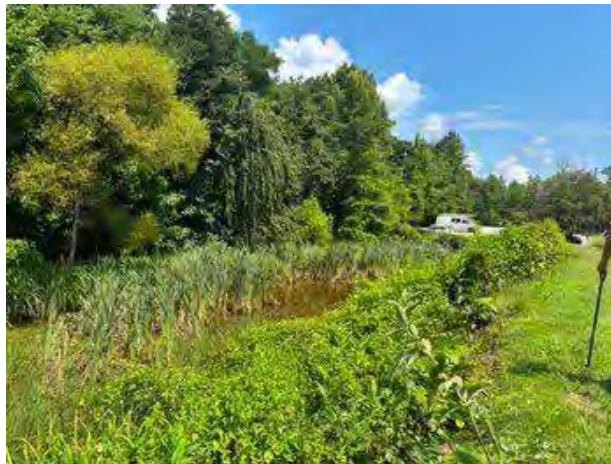
Overall Photo

Date of Inspection:	July 30, 2025 11:50 AM	Inspector Initials:	SM,SF
BMP ID:	UMCP19BMP0010	Inspection Firm:	MES
BMP Type:	Extended Detention Structure, Wet	Underground BMP?	No
BMP Status	Pass	Overall Inspection Comment:	Small eroded channel on north side of berm, cattails likely reducing storage capacity, pond berm heavily overgrown with herbaceous vegetation.
Maintenance Level	Minor Maintenance (Use of Hand Equipment for Repairs)

Clear overgrowth from pond berm and clear cattails from treatment area, fix small eroded channel on north side of berm

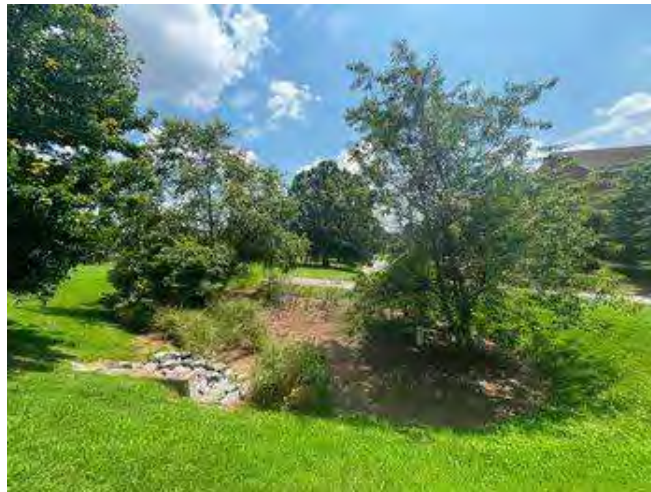
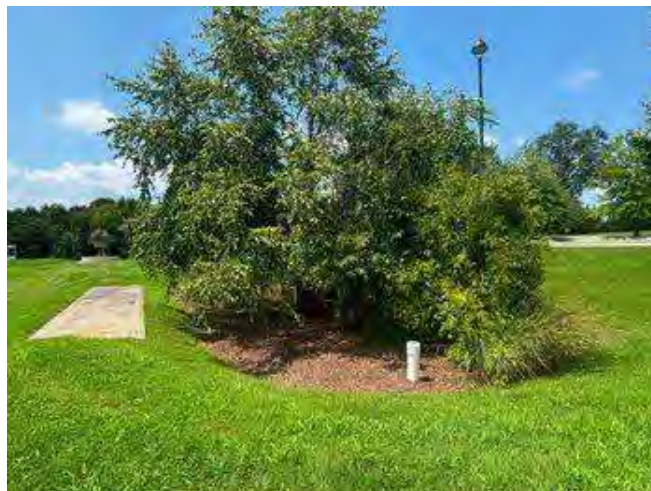
Overall Photo

Date of Inspection:	July 30, 2025 1:40 PM	Inspector Initials:	SF
BMP ID:	UMCP19BMP0019	Inspection Firm:	MES
BMP Type:	Micro-Bioretention	Underground BMP?	No
BMP Status	Pass	Overall Inspection Comment:	Minor debris in treatment area and some erosion, dead planted vegetation (bushes)
Maintenance Level	Minor Maintenance (Use of Hand Equipment for Repairs)

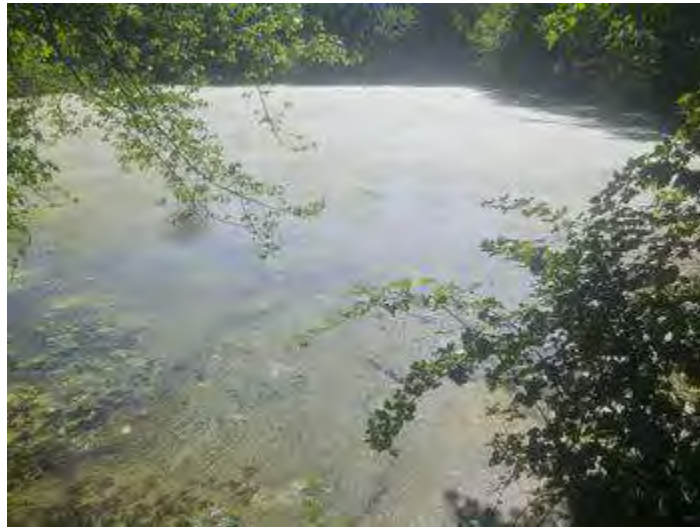
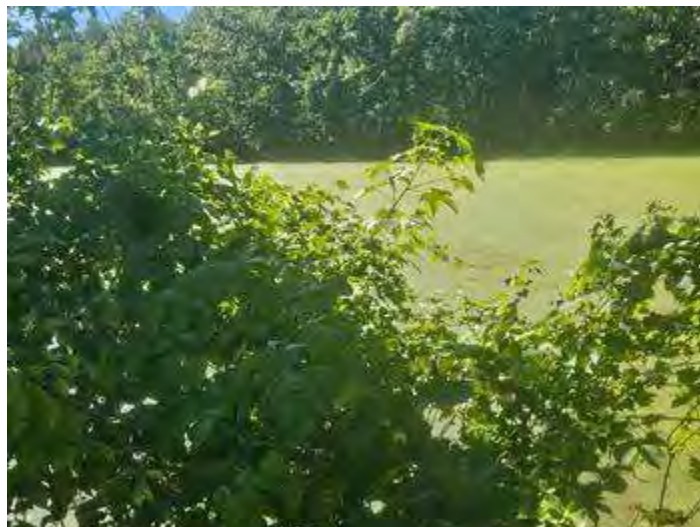
Overall Photo

Date of Inspection:	August 26, 2025 11:04 AM	Inspector Initials:	SK,PP
BMP ID:	UMCP19BMP0020	Inspection Firm:	UMD
BMP Type:	Retention Pond (Wet Pond)	Underground BMP?	No
BMP Status	Pass	Overall Inspection Comment:	Woody Vegetation on Embankment
Maintenance Level	Major Maintenance (Use of Heavy Machinery for Repairs)

- **BMP Access** - Good
- **Debris & Sediment** - Good
- **Vegetation** - Poor
- **BMP Contamination** - Good
- **General Site Conditions Comments:** Woody Vegetation on Embankment

Remove Woody Vegetation from embankment

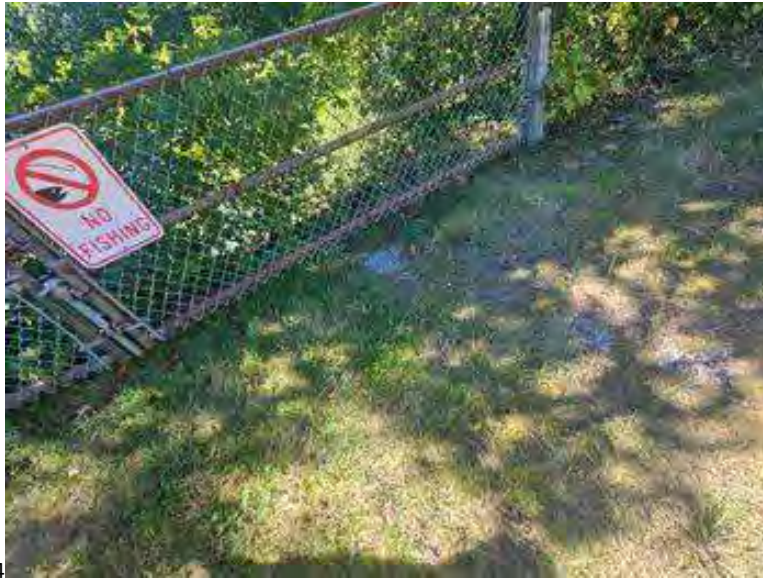
Minor erosion under fence

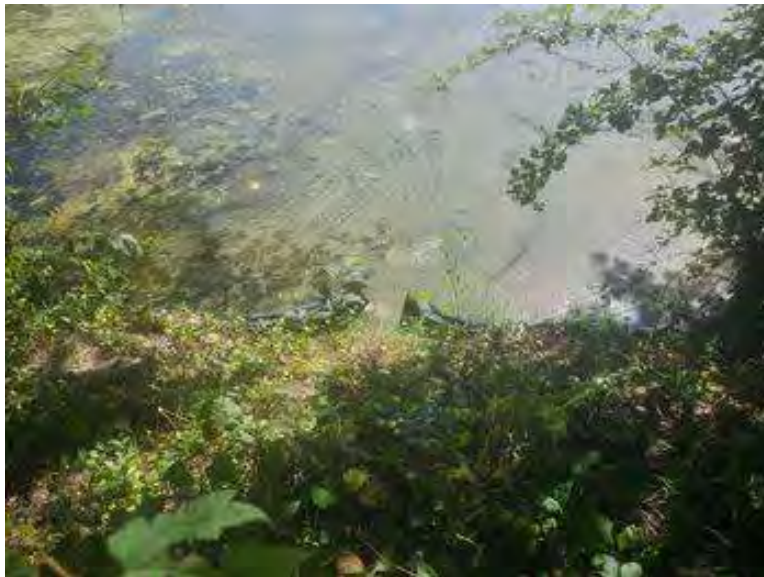
Algae growth within basin

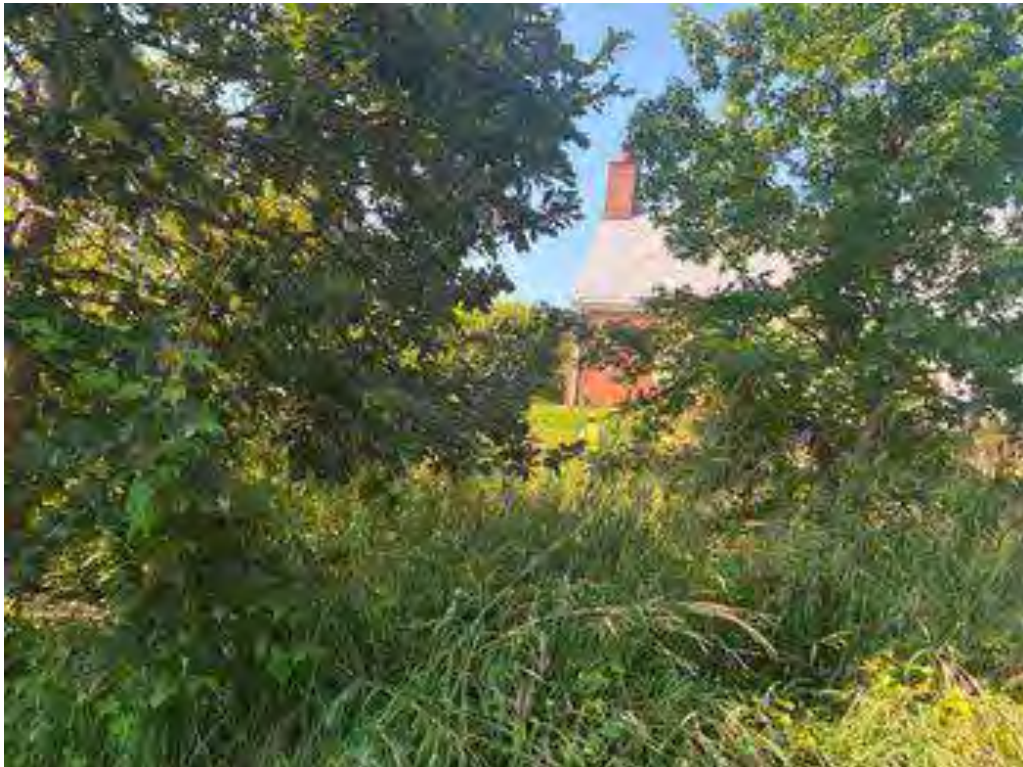
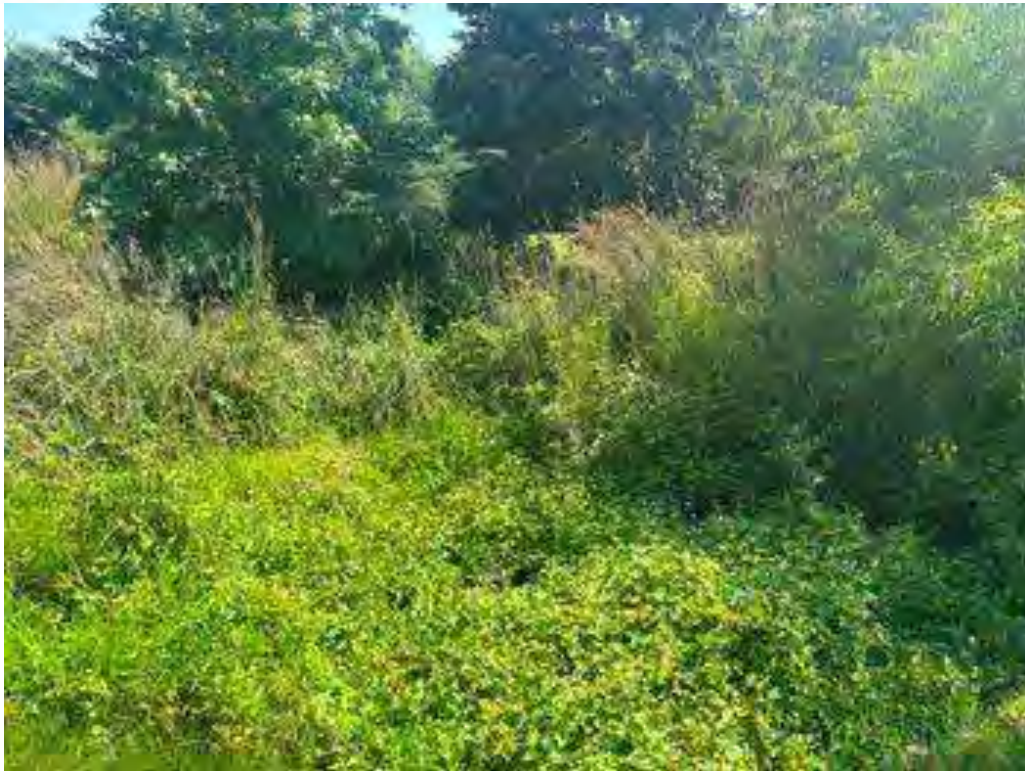
Overall Photo

Date of Inspection:	July 25, 2025 10:14 AM	Inspector Initials:	ML, EM, SM
BMP ID:	UMCP19BMP0034	Inspection Firm:	MES
BMP Type:	Micro-Bioretention	Underground BMP?	No
BMP Status	Pass	Overall Inspection Comment:	Overgrown vegetation. Unable to locate control structure, principal spillway, embankment. Basin overgrown with vegetation
Maintenance Level	Major Maintenance

Remove unplanned vegetation. Trim planned vegetation. Locate & reinspect control structure following maintenance.

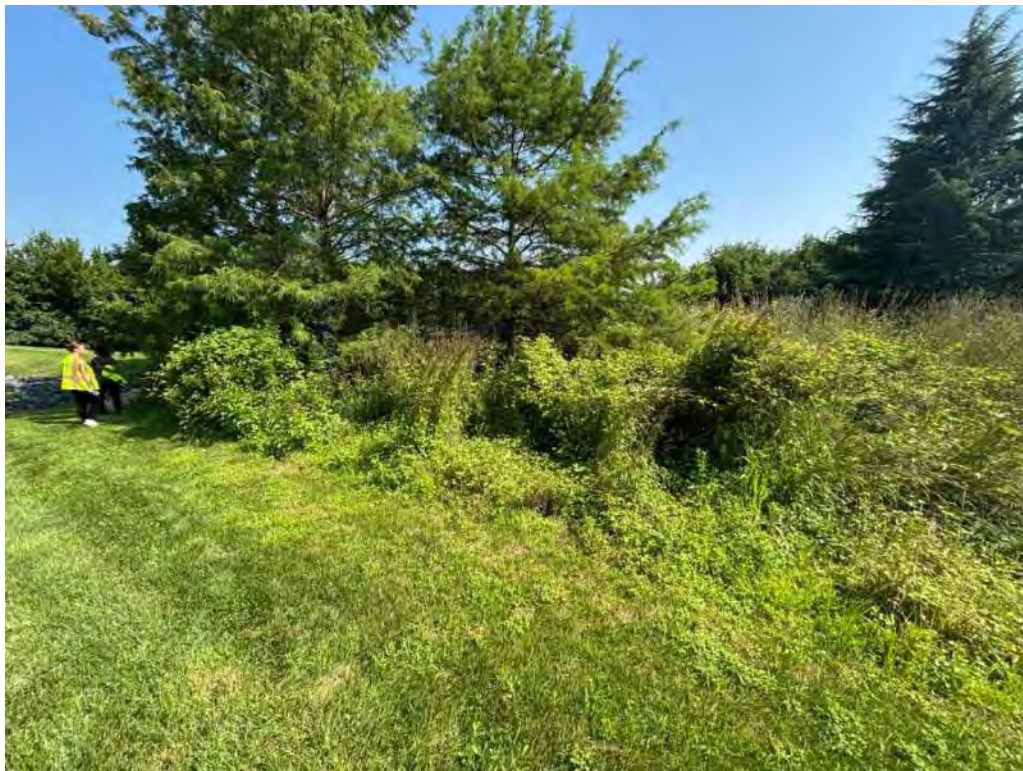
Overall Photo

Date of Inspection:	July 25, 2025 10:20 AM	Inspector Initials:	EM
BMP ID:	UMCP19BMP0035	Inspection Firm:	MES
BMP Type:	Micro-Bioretenention	Underground BMP?	No
BMP Status	Pass	Overall Inspection Comment:	Overgrown vegetation. Unable to locate control structure
Maintenance Level	Major Maintenance

Remove unwanted vegetation and trim planned vegetation. Locate & reinspect control structure following maintenance.

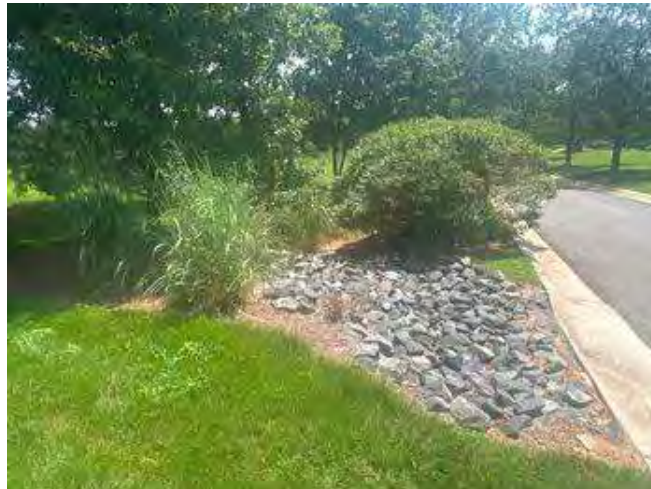
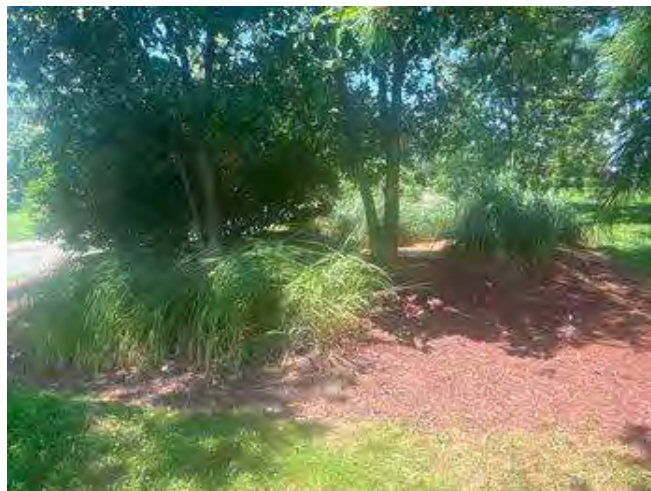
Overall Photo

Date of Inspection:	July 30, 2025 1:40 PM	Inspector Initials:	SM
BMP ID:	UMCP19BMP0040	Inspection Firm:	MES
BMP Type:	Micro-Bioretention	Underground BMP?	No
BMP Status	Pass	Overall Inspection Comment:	Animal burrows within basin
Maintenance Level	Minor Maintenance (Use of Hand Equipment for Repairs)

- **BMP Access** - Good
- **Debris & Sediment** - Good
- **Vegetation** - Fair
- **BMP Contamination** - Good
- **General Site Conditions Comments:** Lacking vegetation in treatment basin, large and severe animal burrows in treatment area and near inflow

Fill and stabilize animal burrows. Replant as needed according to plan.

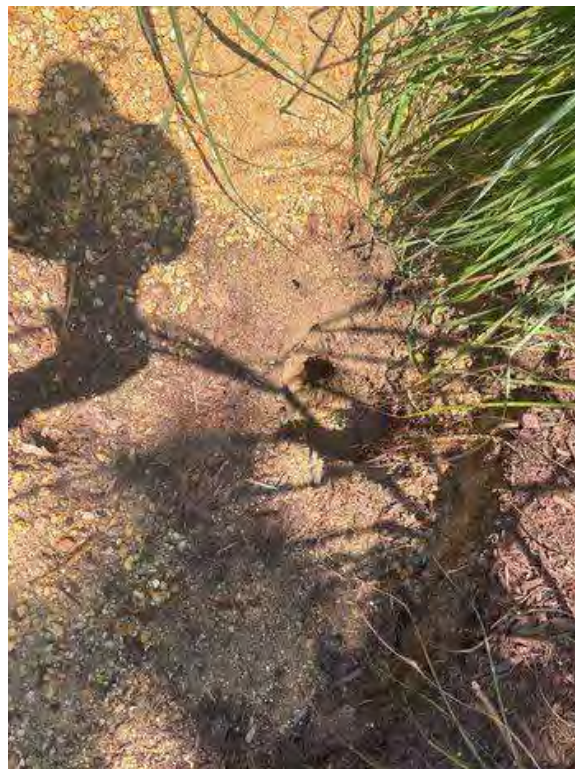
Animal burrow in basin wall

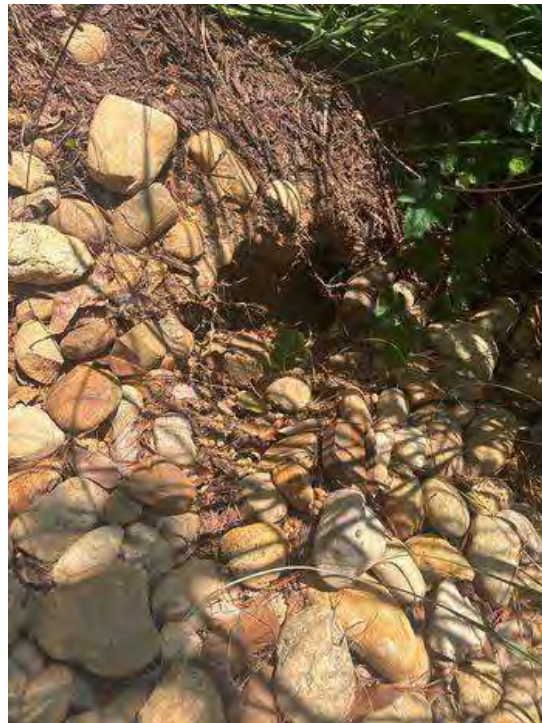
Animal burrow in treatment basin

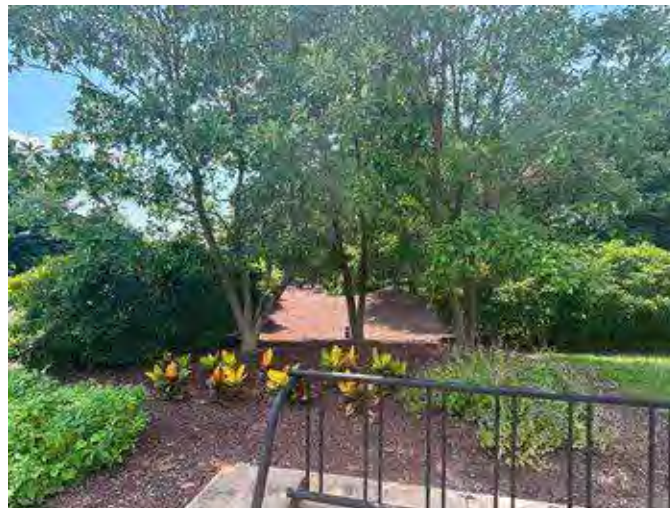
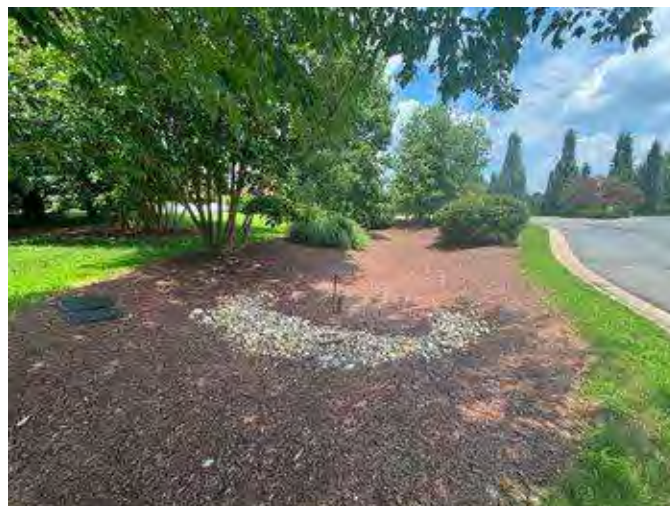
Overall Photo

Date of Inspection:	July 30, 2025 1:23 PM	Inspector Initials:	SM,SF
BMP ID:	UMCP19BMP0041	Inspection Firm:	MES
BMP Type:	Micro-Bioretenention	Underground BMP?	No
BMP Status	Pass	Overall Inspection Comment:	Both observation wells were uncapped, minor erosion and sediment deposits in inflow channel and upper treatment area
Maintenance Level	Minor Maintenance (Use of Hand Equipment for Repairs)

- **BMP Access** - Good
- **Debris & Sediment** - Fair
- **Vegetation** - Good
- **BMP Contamination** - Good
- **General Site Conditions Comments:** Sedimentation in eroded area near inflow

Re-mulch and monitor sediment deposits in inflow channel and upper treatment area, put caps on observation wells

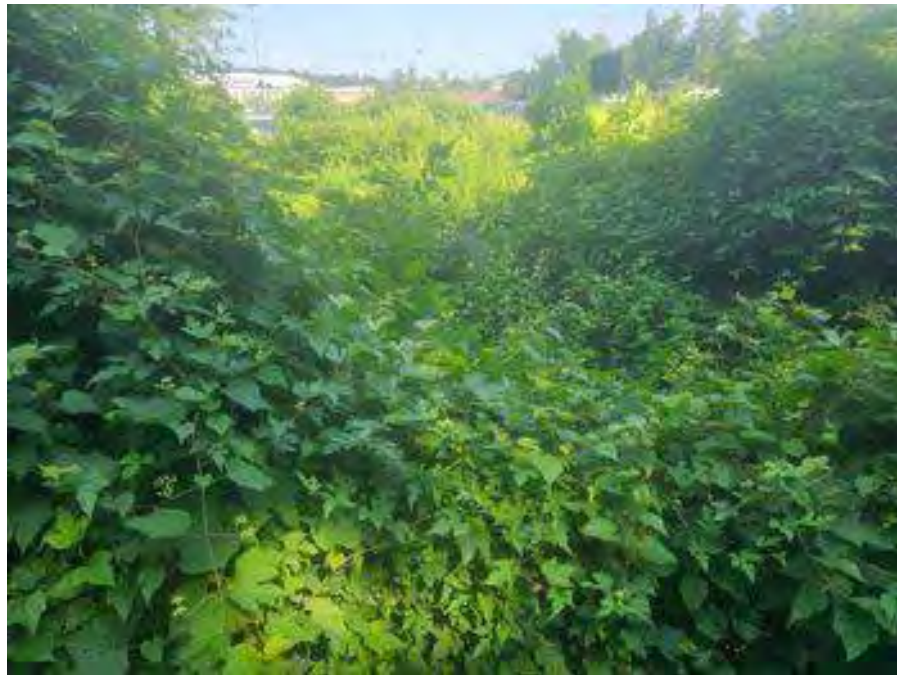
- **BMP Access** - Poor
- **Debris & Sediment** - Not Rated
- **Vegetation** - Poor
- **BMP Contamination** - Not Rated
- **General Site Conditions Comments:** Overgrown Vegetation

Overgrown Vegetation

Clear Vegetation

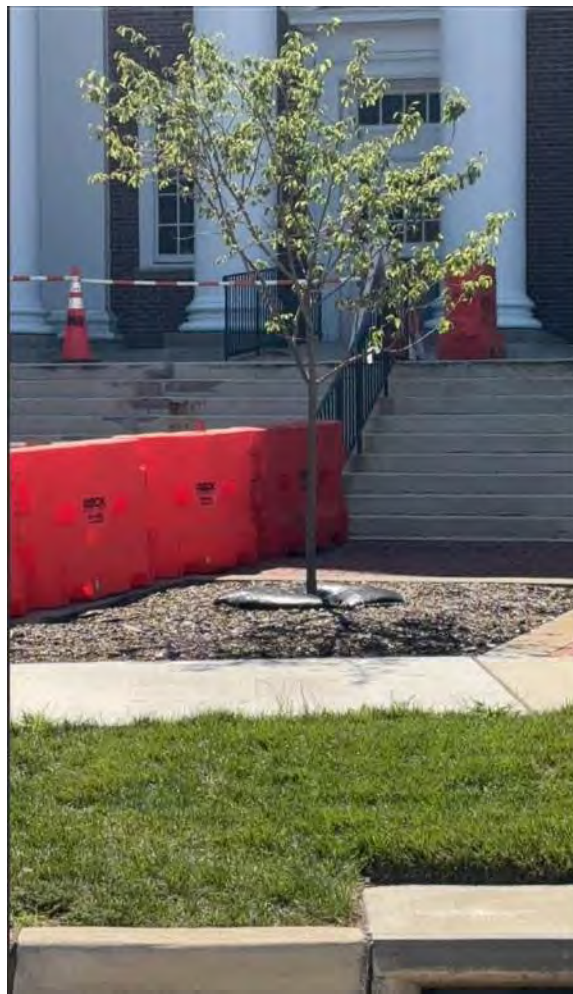
Overall Photo

Date of Inspection:	July 28, 2025 3:21 PM	Inspector Initials:	SM
BMP ID:	UMCP19BMP0046	Inspection Firm:	MES
BMP Type:	Rain Gardens	Underground BMP?	No
BMP Status	Pass	Overall Inspection Comment:	BMP in good condition
Maintenance Level	Routine Maintenance (Only needs Routine Maintenance)

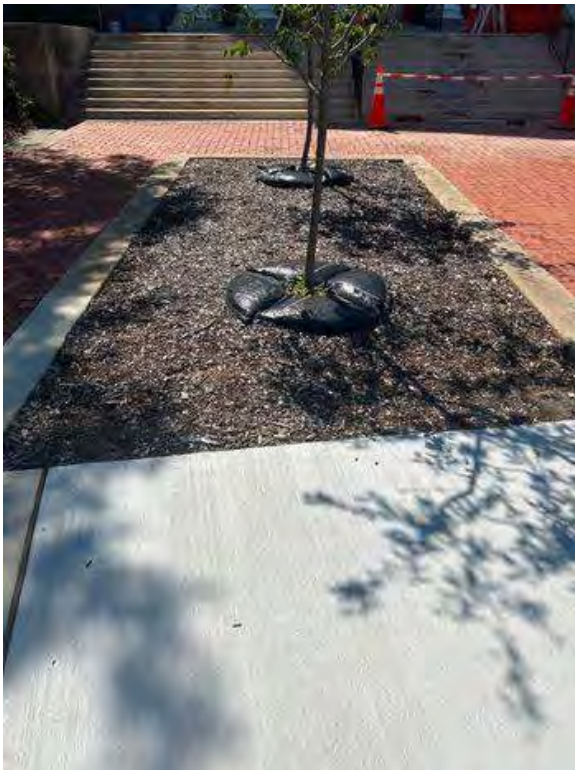
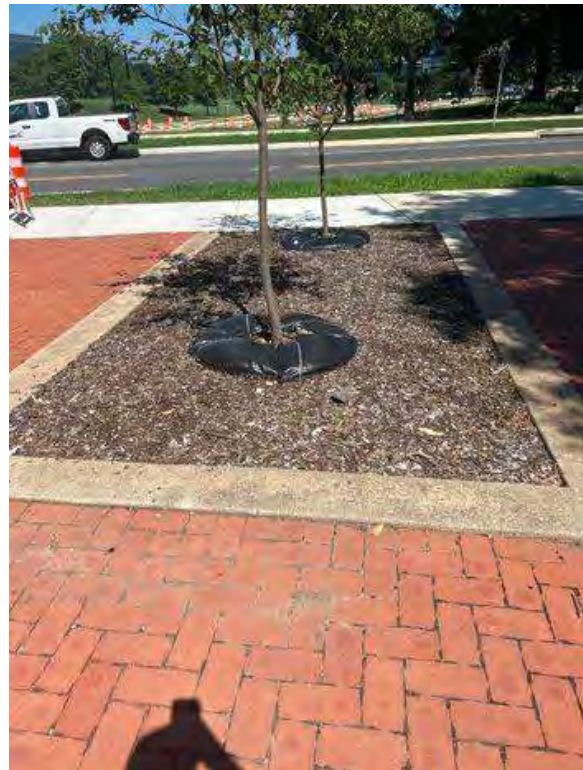
Date of Inspection:	July 28, 2025 3:21 PM	Inspector Initials:	SM
BMP ID:	UMCP19BMP0047	Inspection Firm:	MES
BMP Type:	Rain Gardens	Underground BMP?	No
BMP Status	Pass	Overall Inspection Comment:	BMP in good condition
Maintenance Level	Routine Maintenance (Only needs Routine Maintenance)

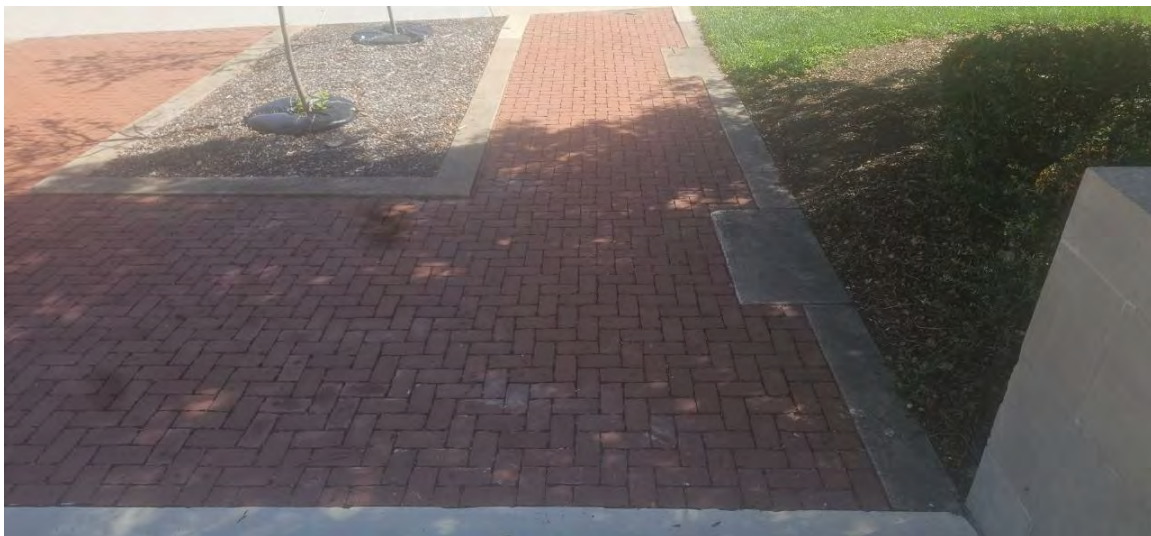
Overall Photo

Date of Inspection:	October 1, 2025	Inspector Initials:	SK, PP
BMP ID:	UMCP19BMP0048	Inspection Firm:	MES
BMP Type:	Permeable Pavements	Underground BMP?	No
BMP Status	Pass	Overall Inspection Comment:	BMP in good condition
Maintenance Level	Routine Maintenance (Only needs Routine Maintenance)

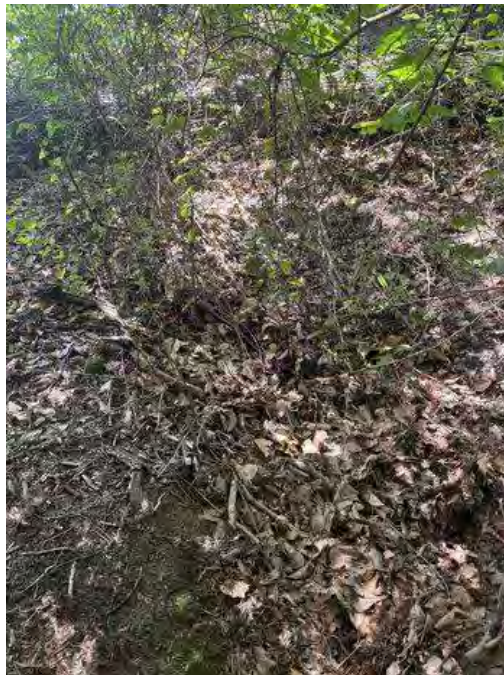
Minor Erosion Near Inflow

Trim back vegetation, stabilize and reseed erosion at inflow channel. Locate & reinspect structures following maintenance.

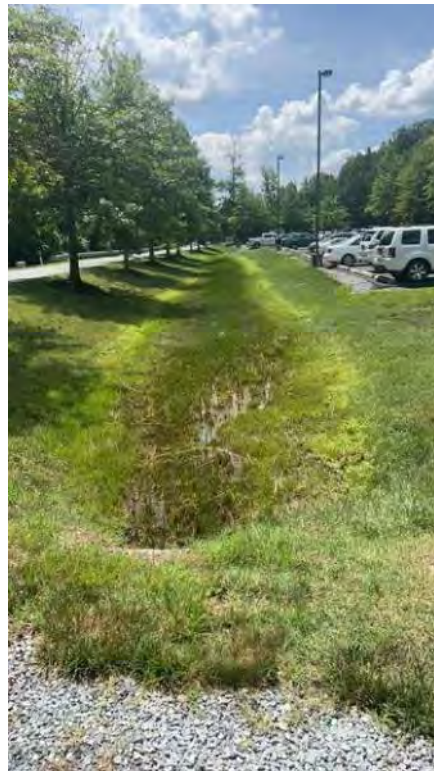
Date of Inspection:	July 28, 2025 12:30 PM	Inspector Initials:	PRW
BMP ID:	UMCP19BMP0066	Inspection Firm:	MES
BMP Type:	Grass Swale	Underground BMP?	No
BMP Status	Pass	Overall Inspection Comment:	Phragmites in conveyance
Maintenance Level	Minor Maintenance (Use of Hand Equipment for Repairs)

- **BMP Access** - Good
- **Debris & Sediment** - Good
- **Vegetation** - Poor
- **BMP Contamination** - Fair
- **General Site Conditions Comments:** Phragmites near north end

Remove phragmites

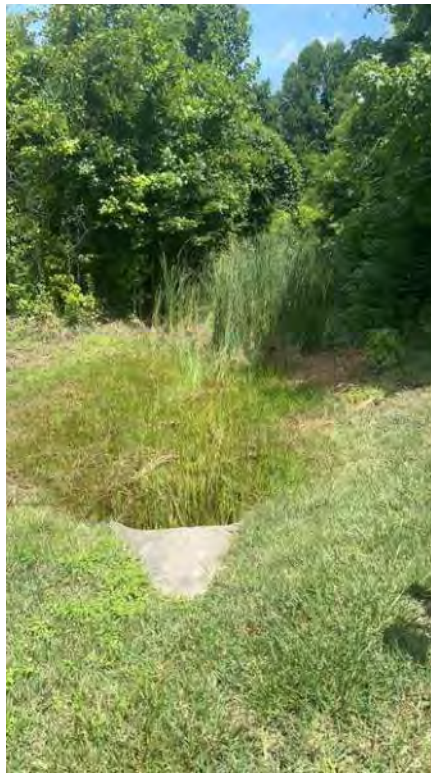
Outfall Conveyance with Invasive Phragmites

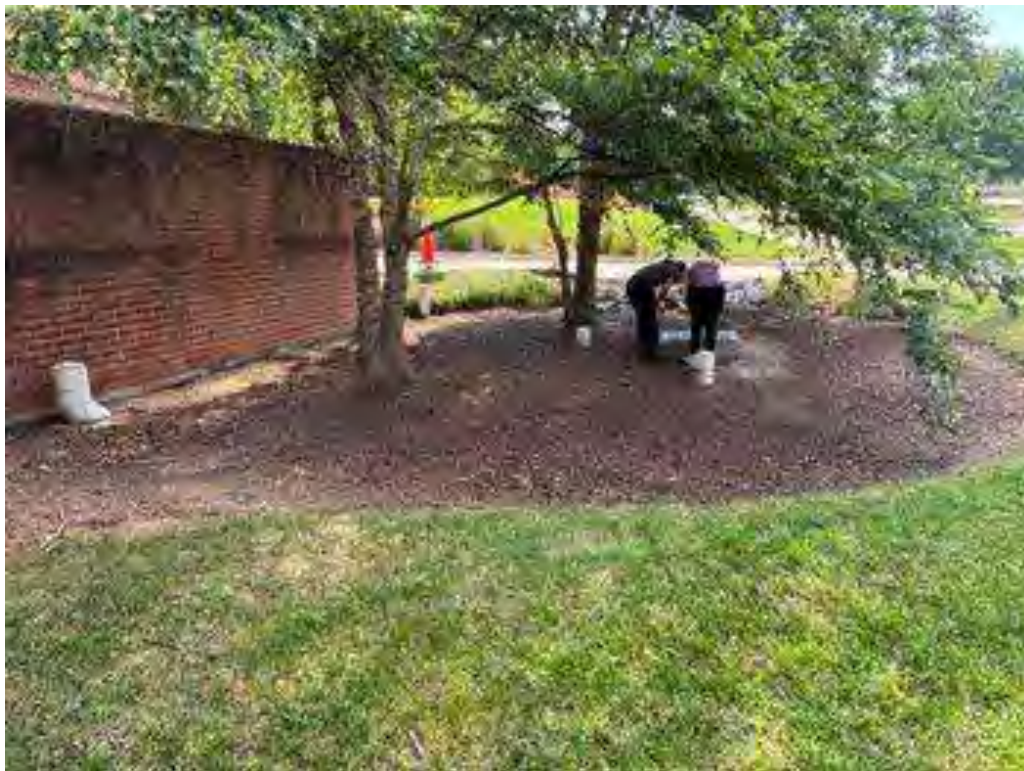
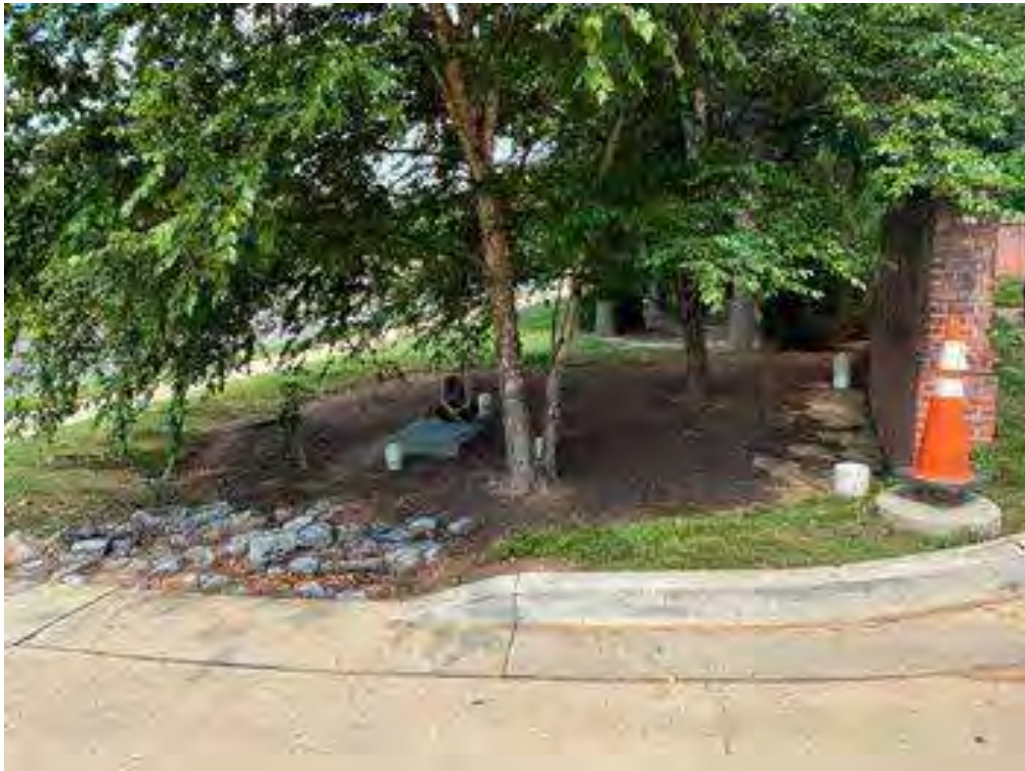
Overall Photo

Date of Inspection:	July 25, 2025 11:08 AM	Inspector Initials:	SM
BMP ID:	UMCP19BMP0070	Inspection Firm:	MES
BMP Type:	Micro-Bioretenion	Underground BMP?	No
BMP Status	Pass	Overall Inspection Comment:	Debris buildup in control structure, minor erosion on treatment basin side, sediment accumulation in treatment basin from inflow
Maintenance Level	Routine Maintenance (Only needs Routine Maintenance)

- **BMP Access** - Good
- **Debris & Sediment** - Fair
- **Vegetation** - Good
- **BMP Contamination** - Good
- **General Site Conditions Comments:** Minor sediment buildup near inflow

Clean out control structure, remove excess sediment, remulch as needed

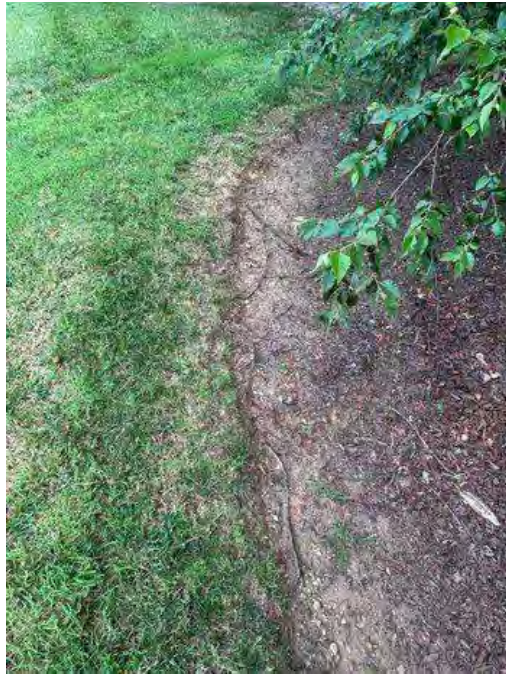
Minor Erosion

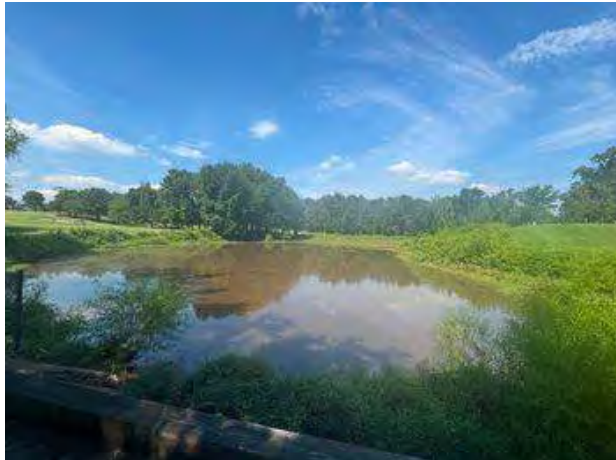
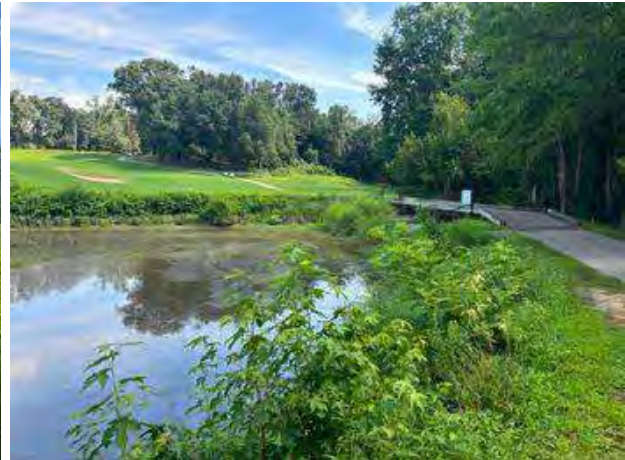
Overall Photo

Date of Inspection:	July 29, 2025 10:55 AM	Inspector Initials:	SK,SF
BMP ID:	UMCP19BMP0089	Inspection Firm:	MES
BMP Type:	Retention Pond (Wet Pond)	Underground BMP?	No
BMP Status	Fail	Overall Inspection Comment:	Spillway outfall redirected completely by collapsed embankment, heavily sedimented west side, woody vegetation within embankment and buffer
Maintenance Level	Major Maintenance (Use of Heavy Machinery for Repairs)

- **BMP Access** - Good
- **Debris & Sediment** - Poor
- **Vegetation** - Fair
- **BMP Contamination** - Good
- **General Site Conditions Comments:** Pond heavily sedimented on west side, young woody vegetation (willow oak) growing in concrete embankment

- **Spillway Outfall** - Poor
- **Downstream Condition** - Poor

Repair collapsed concrete embankment, remove woody vegetation on and within buffer of embankment, clean out sedimented west side of pond

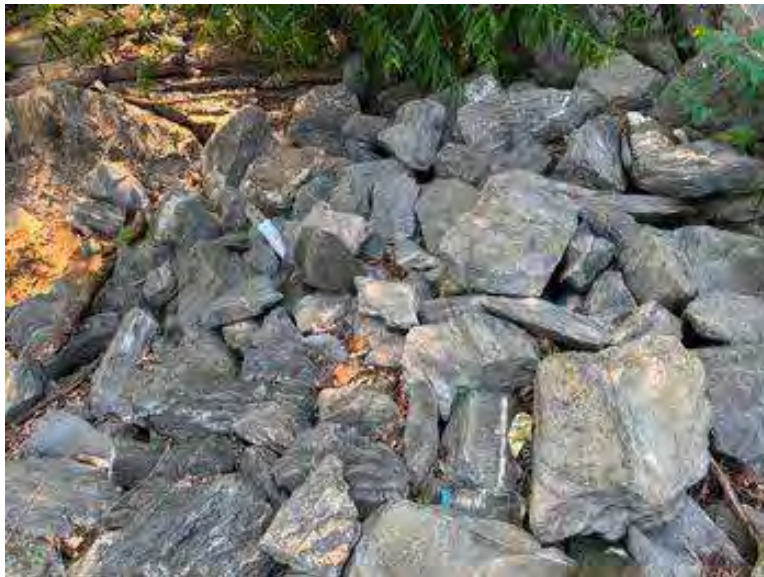
Stone fill beneath collapsed concrete spillway

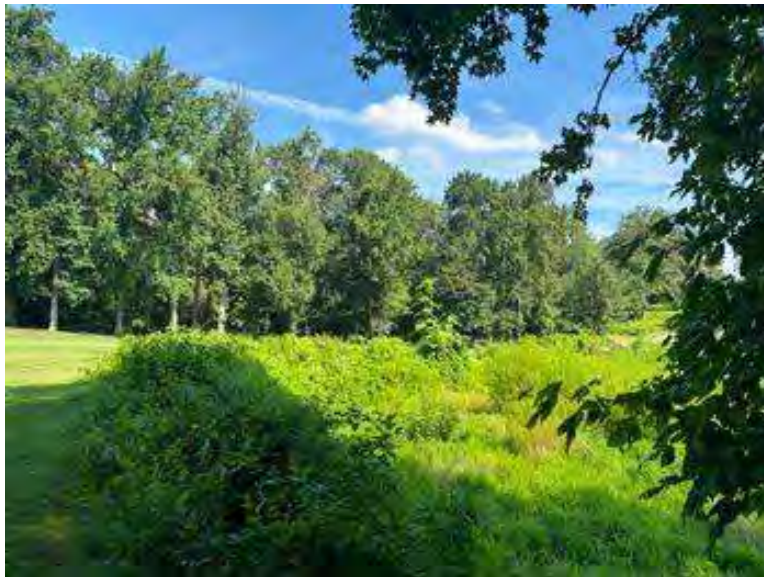
Cracks within concrete spillway. Golfcart path constructed on top.

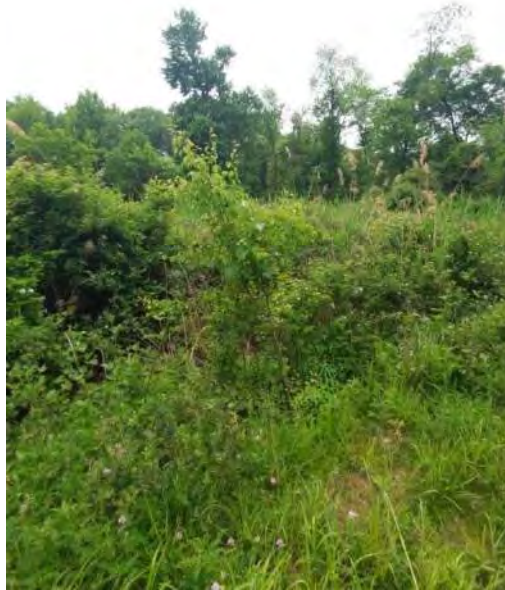
- **BMP Access** - Fair
- **Debris & Sediment** - Good
- **Vegetation** - Poor
- **BMP Contamination** - Good
- **General Site Conditions Comments:** Invasive phragmites and overgrown vegetation

Overgrown Vegetation

Trim vegetation

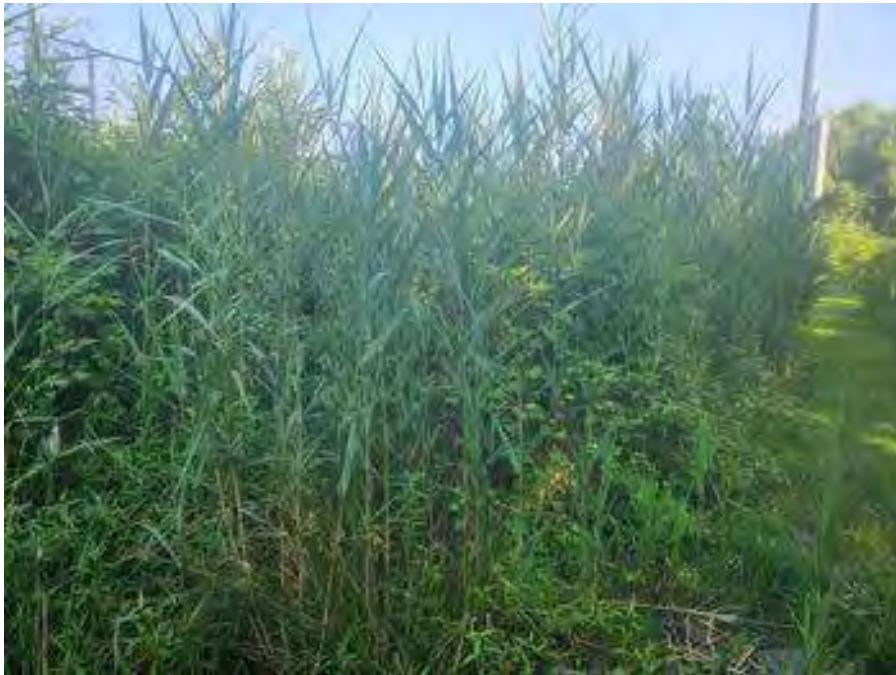
- **BMP Access** - Good
- **Debris & Sediment** - Fair
- **Vegetation** - Poor
- **BMP Contamination** - Good
- **General Site Conditions Comments:** Pond infested with phragmites and cattails, and invasive princess tree has grown on the north side of the pond.

Overgrown Invasive Phragmites

Remove invasive cattails, phragmites, and princess tree (tree on northernmost part of treatment area).

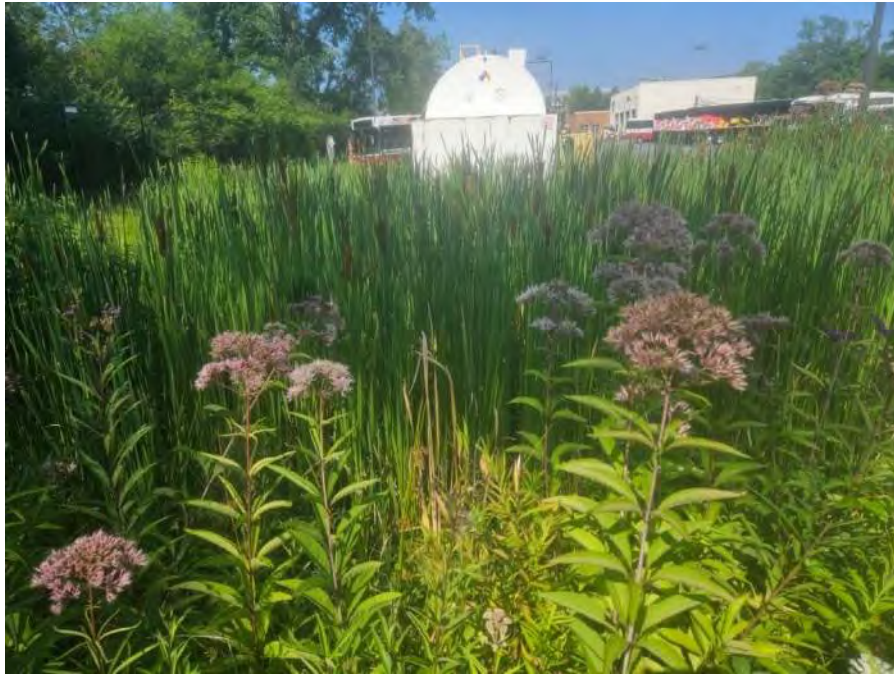
- **BMP Access** - Good
- **Debris & Sediment** - Good
- **Vegetation** - Poor
- **BMP Contamination** - Good
- **General Site Conditions Comments:** Invasive Cattails

Invasive Cattails in Treatment Area

Repair erosion at principal spillway, remove invasive cattails

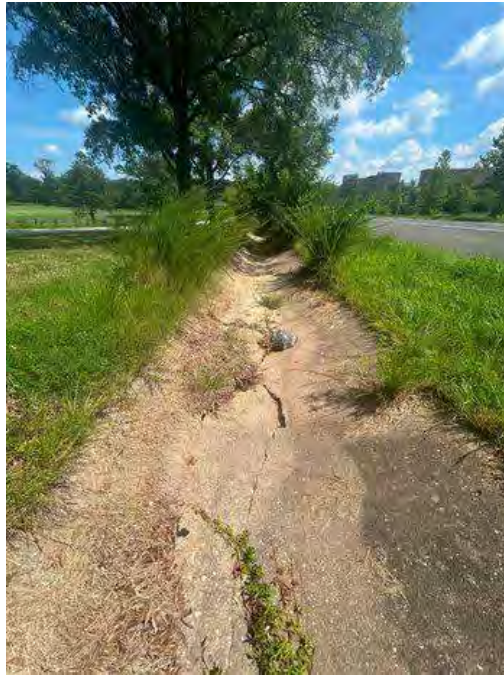
Cracked Outfall

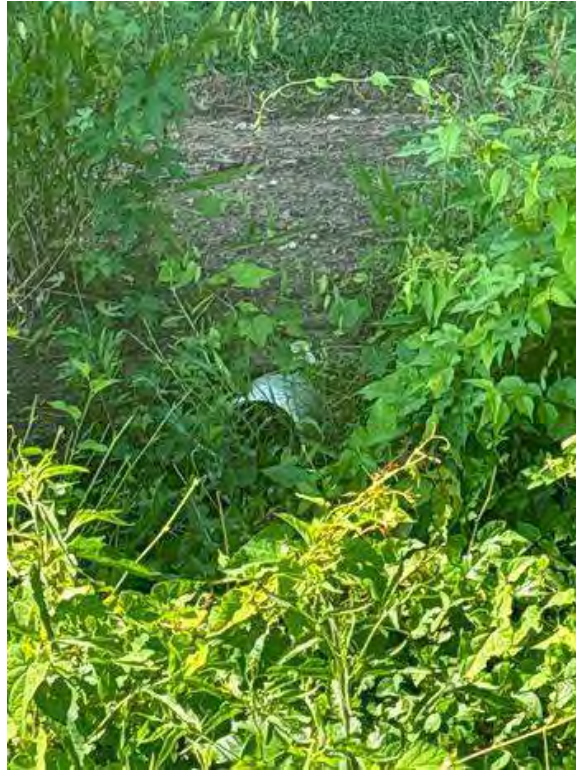
- **Inflow Condition** - Fair
- **Forebay** - N/A
- **Inflow Comments** – Heavily vegetated

Inflow

Remove some vegetation, especially around access to serviceable features

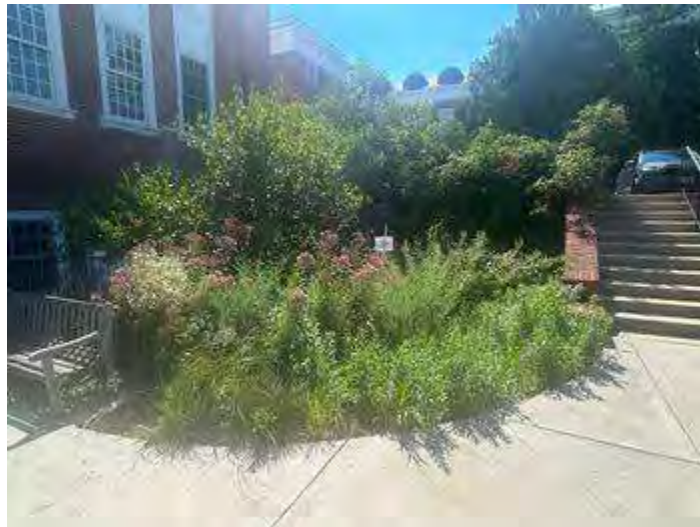
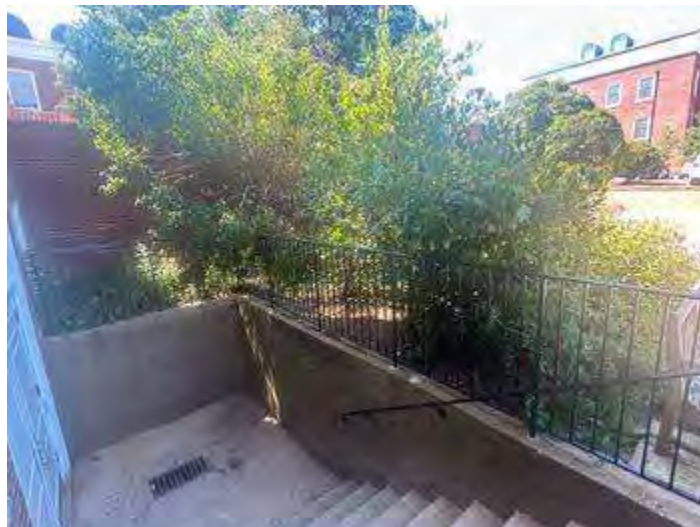
Overall Photo

Date of Inspection:	July 28, 2025 3:15 PM	Inspector Initials:	SM
BMP ID:	UMCP19BMP0129	Inspection Firm:	MES
BMP Type:	Rain Gardens	Underground BMP?	No
BMP Status	Pass	Overall Inspection Comment:	BMP in good condition
Maintenance Level	Routine Maintenance (Only needs Routine Maintenance)

Continue routine maintenance
