University of Maryland, College Park
National Pollutant Discharge Elimination
System MS4 Phase II
FY2025 Annual Report
General Discharge Permit #13-SF-5501

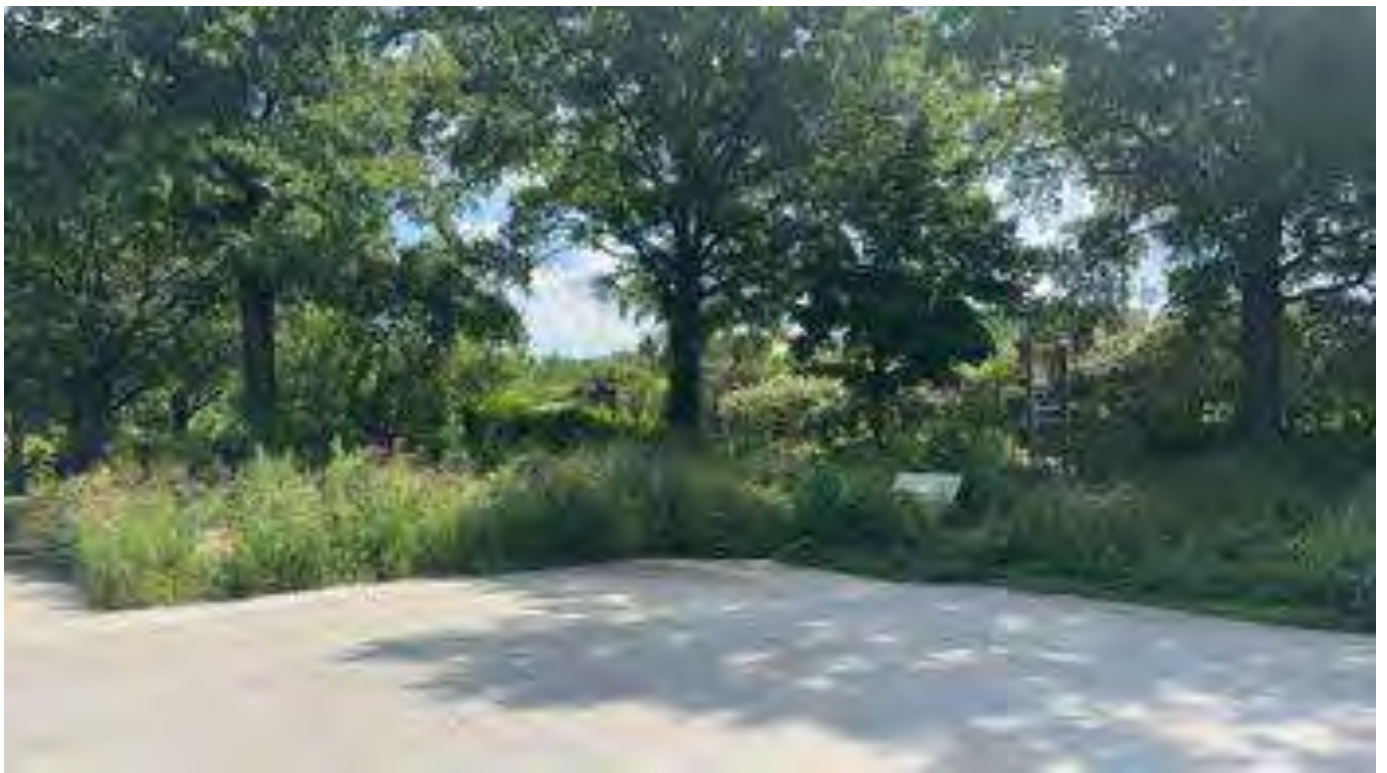
Overall Photo

Date of Inspection:	July 28, 2025 11:26 AM	Inspector Initials:	PRW
BMP ID:	UMCP19BMP0144	Inspection Firm:	MES
BMP Type:	Rain Gardens	Underground BMP?	No
BMP Status	Pass	Overall Inspection Comment:	Heavily vegetated/poison ivy
Maintenance Level	Minor Maintenance (Use of Hand Equipment for Repairs)

- **BMP Access** - Poor
- **Debris & Sediment** - Good
- **Vegetation** - Poor
- **BMP Contamination** - Good
- **General Site Conditions Comments:** Heavily vegetated/Poison Ivy

Remove some vegetation/poison ivy, remove debris at parking lot inflow

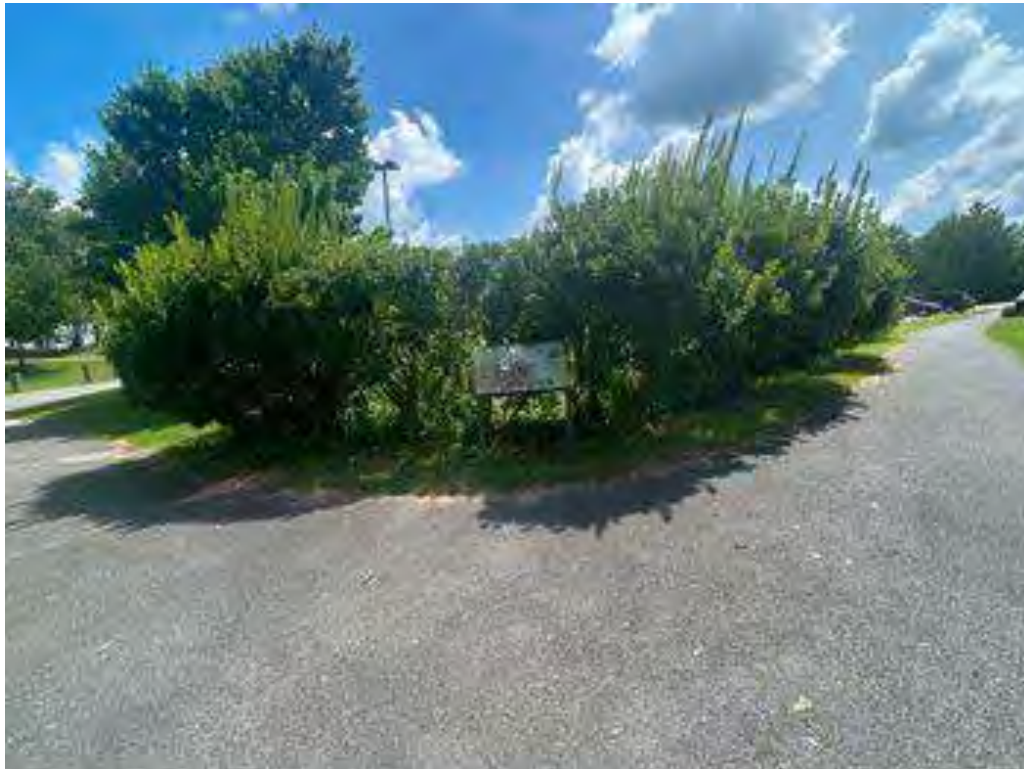
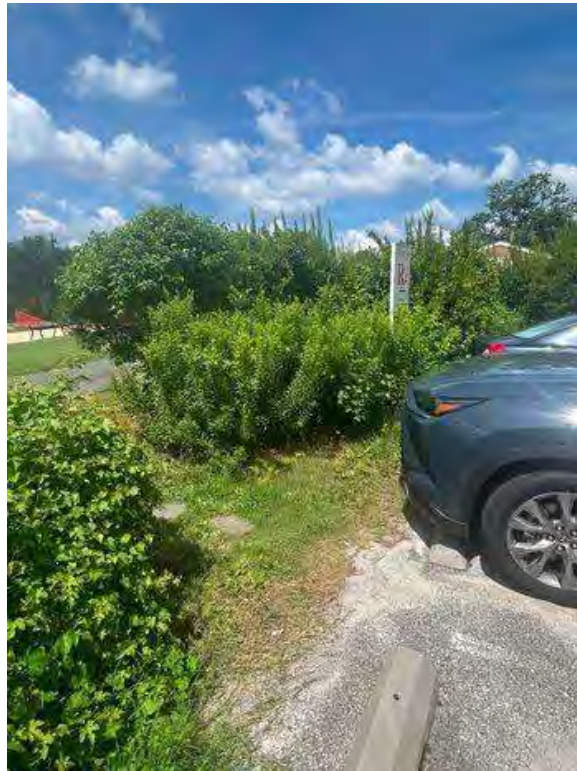
Overall Photo

Date of Inspection:	July 28, 2025 11:56 AM	Inspector Initials:	SM
BMP ID:	UMCP19BMP0146	Inspection Firm:	MES
BMP Type:	Rain Gardens	Underground BMP?	No
BMP Status	Pass	Overall Inspection Comment:	Unable to locate control structure, minor sediment buildup at sheet inflow from parking lot
Maintenance Level	Routine Maintenance (Only needs Routine Maintenance)

Trim back vegetation to locate control structure if present

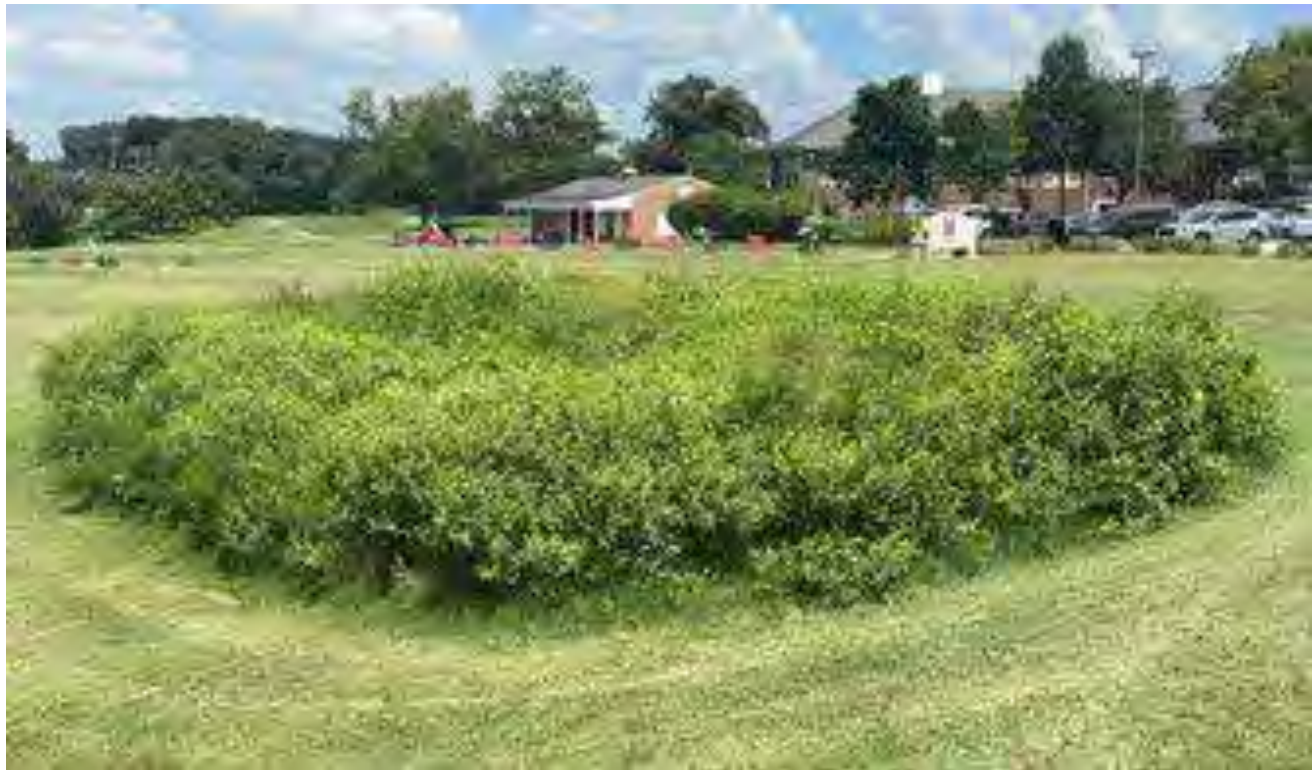
Overall Photo

Date of Inspection:	July 28, 2025 11:56 AM	Inspector Initials:	PRW
BMP ID:	UMCP19BMP0147	Inspection Firm:	MES
BMP Type:	Rain Gardens	Underground BMP?	No
BMP Status	Pass	Overall Inspection Comment:	Heavily vegetated, most likely affecting storage capacity
Maintenance Level	Routine Maintenance (Only needs Routine Maintenance)

- **BMP Access** - Poor
- **Debris & Sediment** - Good
- **Vegetation** - Poor
- **BMP Contamination** - Good
- **General Site Conditions Comments:** Heavily vegetated

Remove some vegetation, especially to expose serviceable features

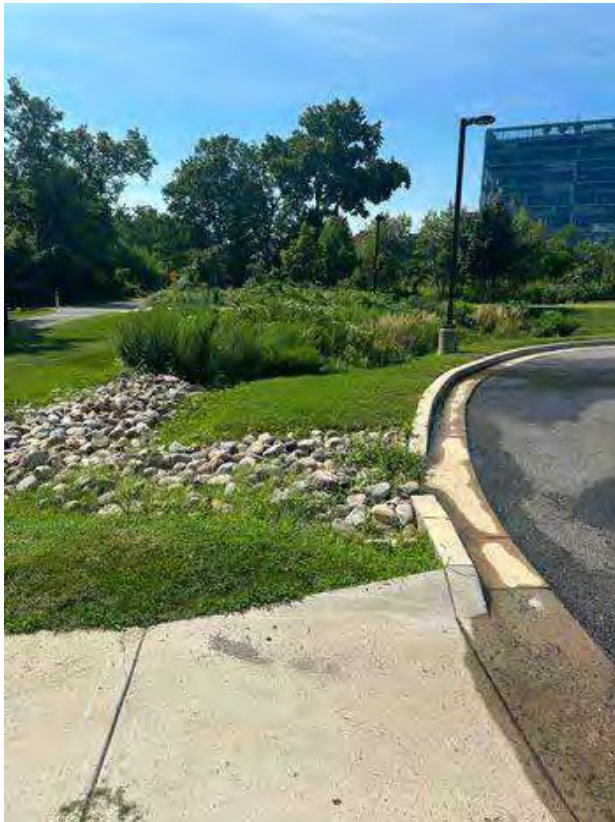
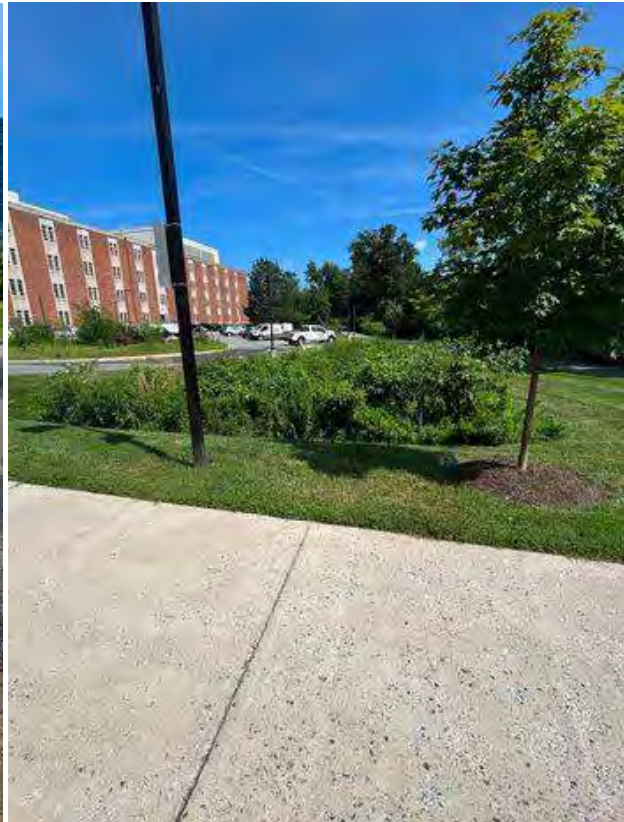
Overall Photo

Date of Inspection:	July 28, 2025 10:40 AM	Inspector Initials:	SM
BMP ID:	UMCP19BMP0152	Inspection Firm:	MES
BMP Type:	Micro-Bioretention	Underground BMP?	No
BMP Status	Pass	Overall Inspection Comment:	Excess vegetation above principal spillway near upstream embankment
Maintenance Level	Routine Maintenance (Only needs Routine Maintenance)

Remove excess vegetation above principal spillway around upstream embankment

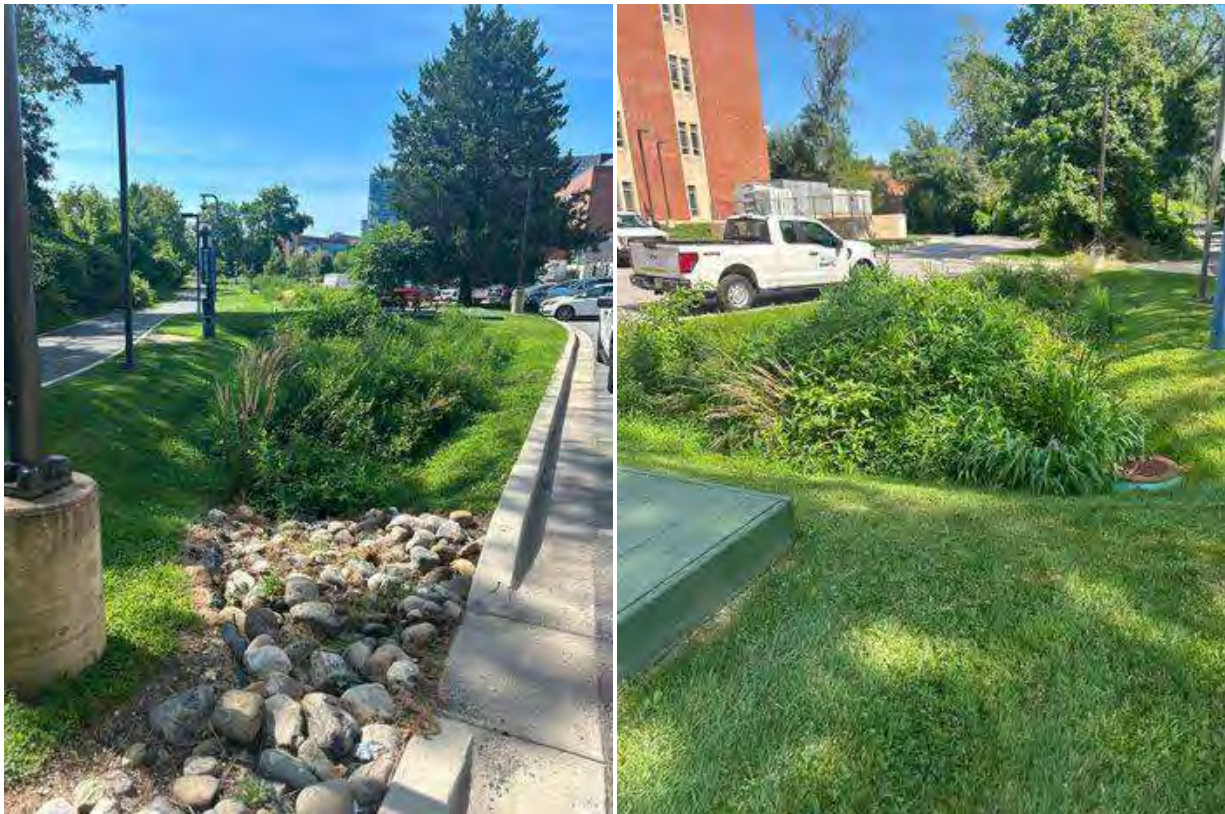
Overall Photo

Date of Inspection:	July 28, 2025 10:13 AM	Inspector Initials:	SM
BMP ID:	UMCP19BMP0153	Inspection Firm:	MES
BMP Type:	Micro-Bioretenention	Underground BMP?	No
BMP Status	Pass	Overall Inspection Comment:	Moderate erosion on berm near picnic tables, small weeds in rip rap, broken inflow pipe from picnic tables
Maintenance Level	Routine Maintenance (Only needs Routine Maintenance)

Fill erosion on berm, fix broken inflow pipe

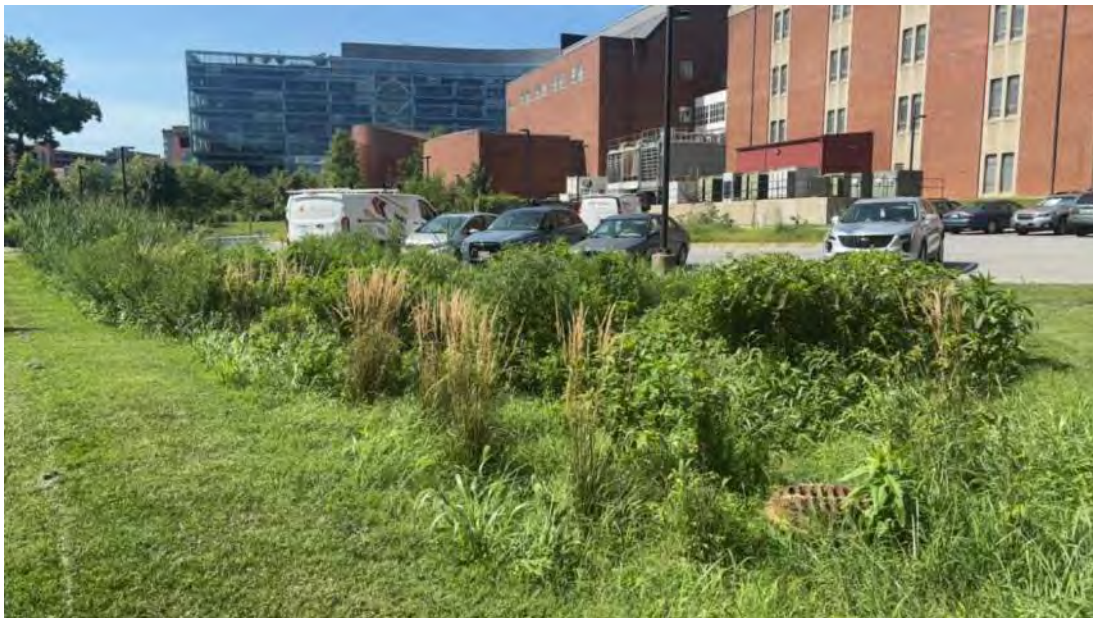
Overall Photo

Date of Inspection:	July 28, 2025 10:22 AM	Inspector Initials:	PRW
BMP ID:	UMCP19BMP0154	Inspection Firm:	MES
BMP Type:	Micro-Bioretention	Underground BMP?	No
BMP Status	Pass	Overall Inspection Comment:	Heavily vegetated in conveyance and inflow
Maintenance Level	Routine Maintenance (Only needs Routine Maintenance)

- **BMP Access** - Good
- **Debris & Sediment** - Good
- **Vegetation** - Poor
- **BMP Contamination** - Good
- **General Site Conditions Comments:** Vegetation may be affecting storage capacity

- **Inflow Condition** - Poor
- **Forebay** - N/A

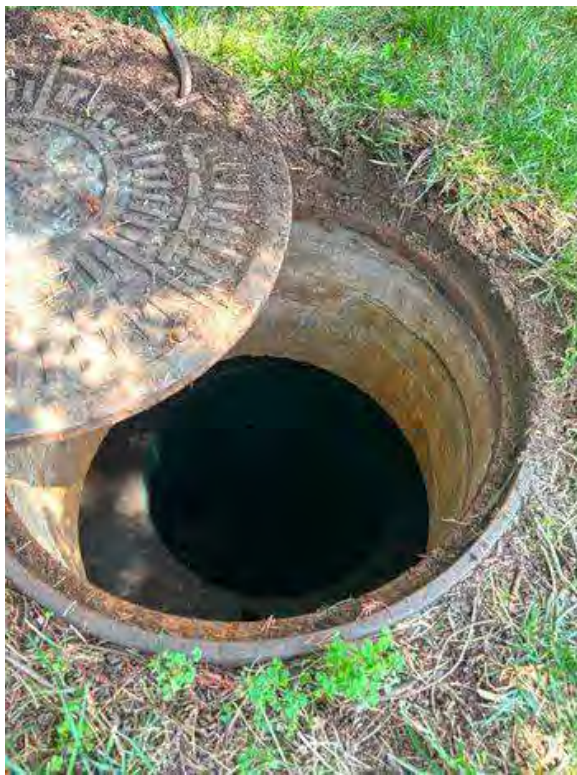
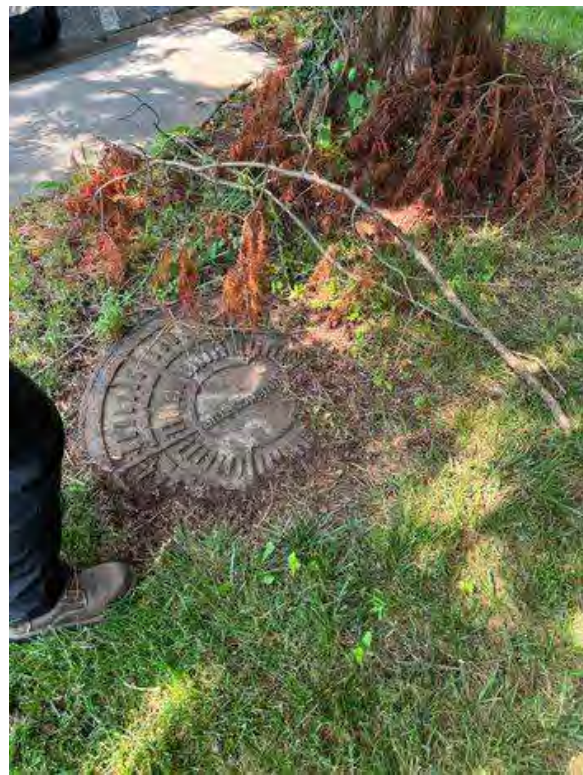
Overall Photo

Date of Inspection:	July 29, 2025 11:43 AM	Inspector Initials:	SK,SF
BMP ID:	UMCP19BMP0166	Inspection Firm:	MES
BMP Type:	Other	Underground BMP?	Yes
BMP Status	Pass	Overall Inspection Comment:	Stormceptor sedimented and odor present in water
Maintenance Level	Routine Maintenance (Only needs Routine Maintenance)

- **BMP Access** - Good
- **Debris & Sediment** - Fair
- **Vegetation** - N/A
- **BMP Contamination** - Fair
- **General Site Conditions Comments:** Odor present but could be due to old water, stormceptor bottom is sedimented

Remove sediment and investigate potential contamination

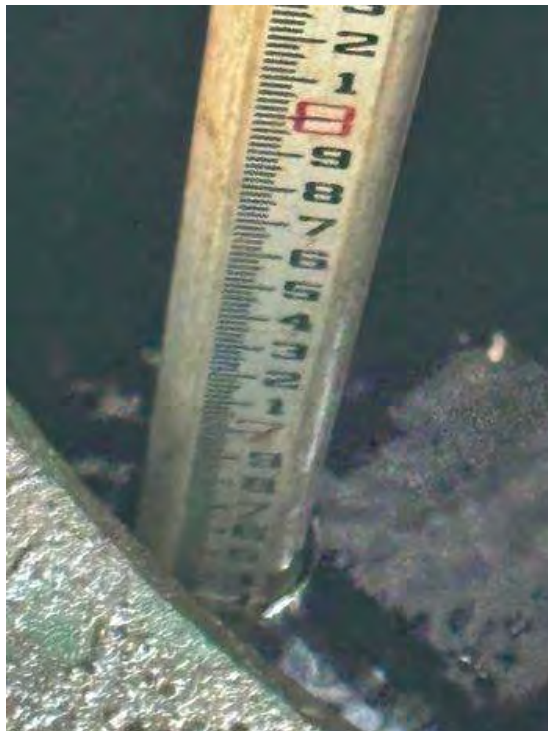
Water depth

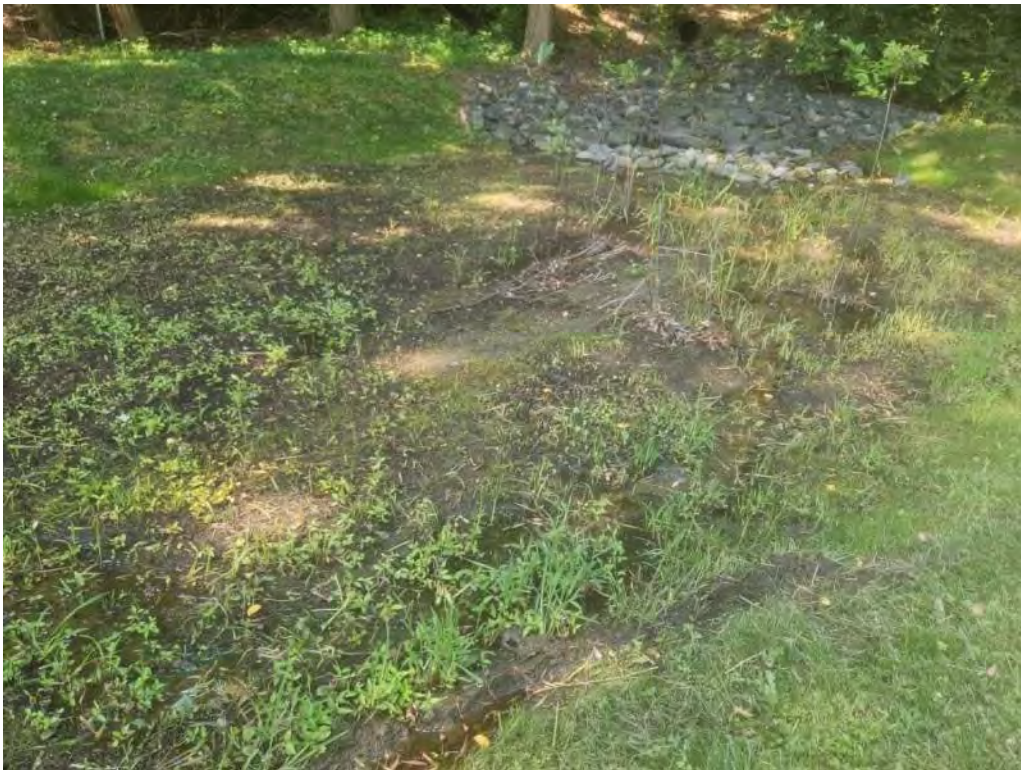
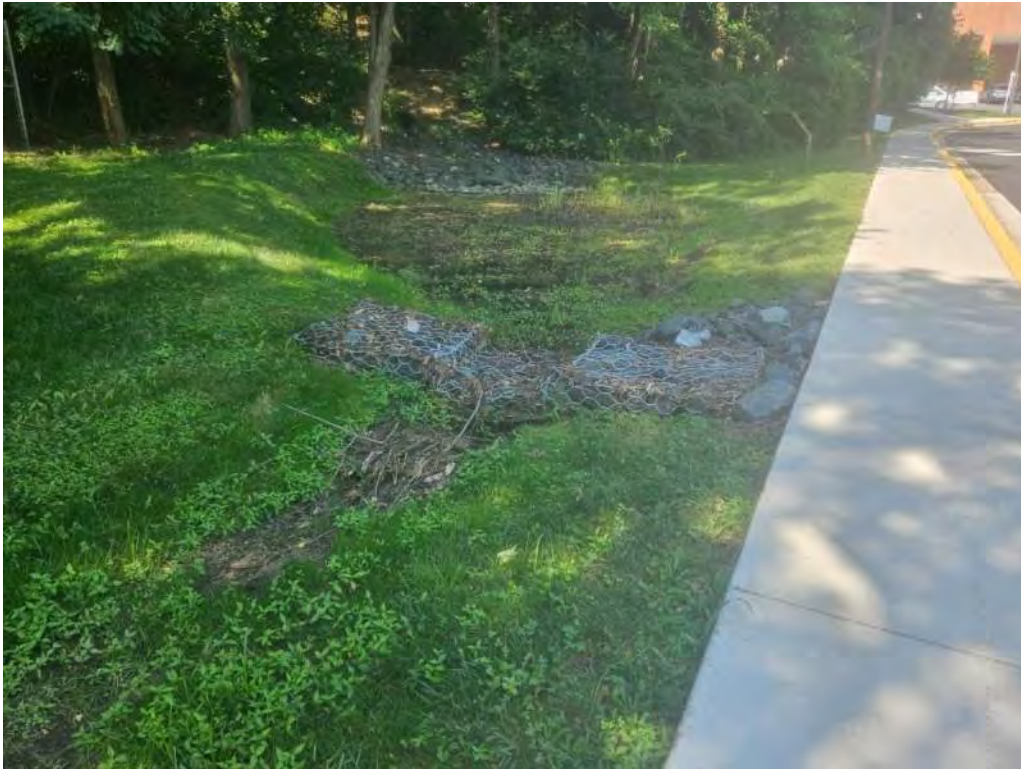
Overall Photo

Date of Inspection:	July 25, 2025 10:42 AM	Inspector Initials:	SK,SF
BMP ID:	UMCP19BMP0238	Inspection Firm:	MES
BMP Type:	Bio-Swale	Underground BMP?	No
BMP Status	Pass	Overall Inspection Comment:	Inflow has active Illicit Discharge causing some ponding in BMP area.
Maintenance Level	Minor Maintenance (Use of Hand Equipment for Repairs)

- **BMP Access** - Good
- **Debris & Sediment** - Fair
- **Vegetation** - Good
- **BMP Contamination** - Fair
- **General Site Conditions Comments:** BMP has some excess sediment and water in treatment area

Investigate source of dry weather flow and eliminate.

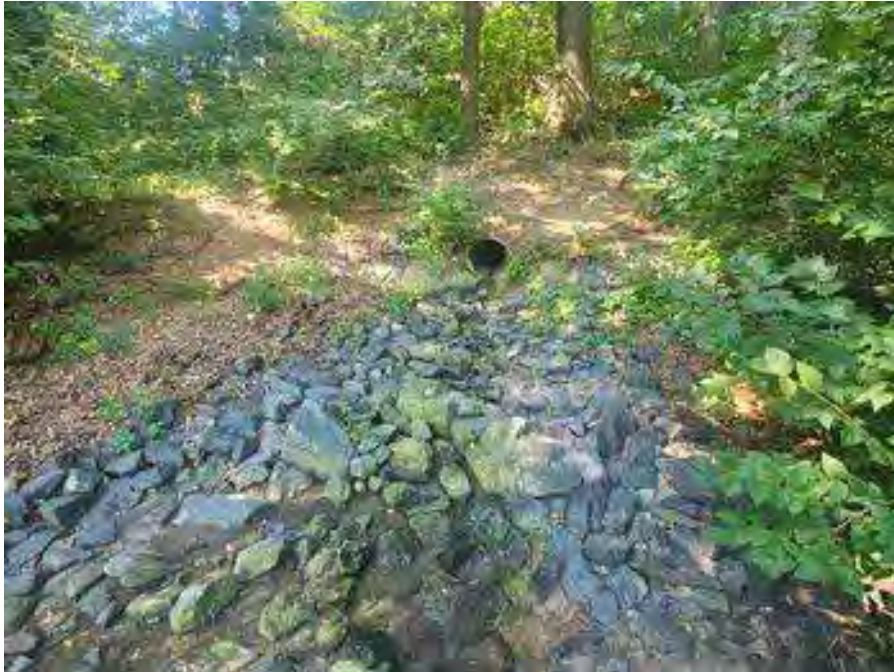
Inflow 1 Area with Active dry weather flow

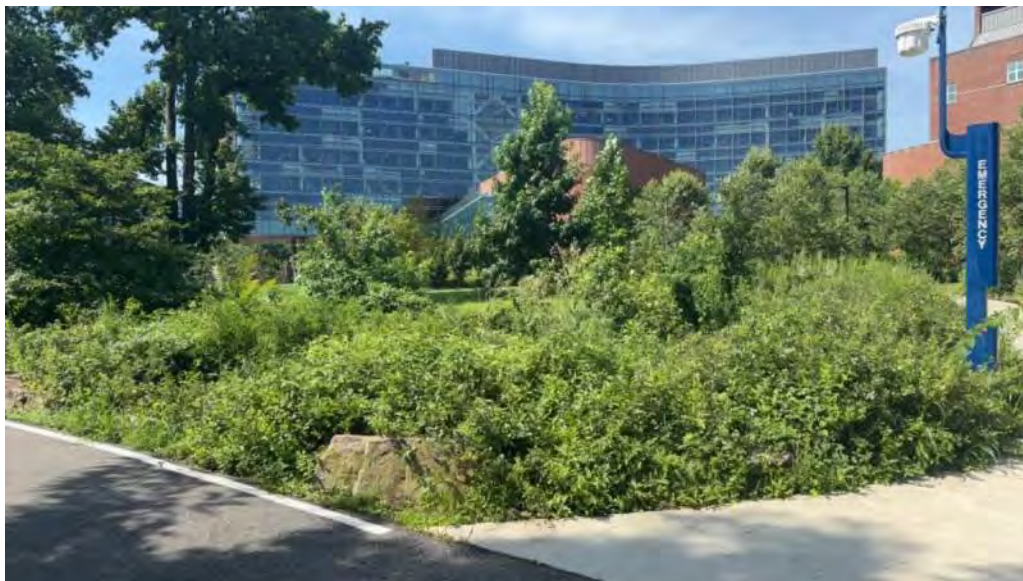
Overall Photo

Date of Inspection:	July 28, 2025 10:39 AM	Inspector Initials:	PRW
BMP ID:	UMCP19BMP0241	Inspection Firm:	MES
BMP Type:	Micro-Bioretenion	Underground BMP?	No
BMP Status	Pass	Overall Inspection Comment:	Heavily vegetated, could not locate inflow
Maintenance Level	Routine Maintenance (Only needs Routine Maintenance)

Remove vegetation at inflow

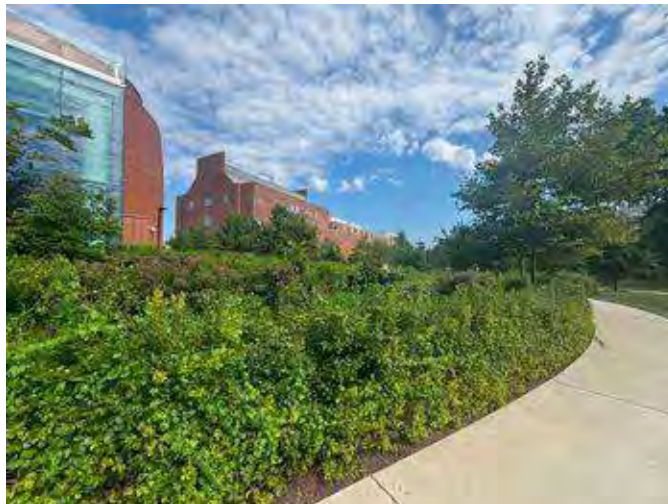
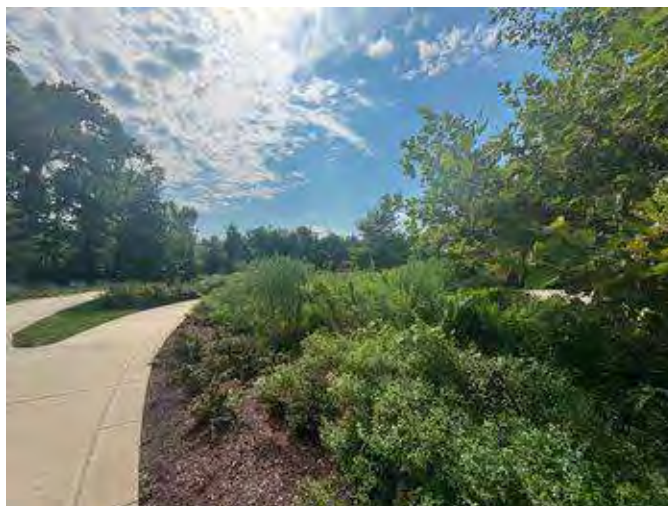
Overall Photo

Date of Inspection:	July 30, 2025 10:16 AM	Inspector Initials:	SM,SF
BMP ID:	UMCP19BMP0242	Inspection Firm:	MES
BMP Type:	Micro-Bioretention	Underground BMP?	No
BMP Status	Pass	Overall Inspection Comment:	BMP in good condition, with only minor erosion in inflow channels
Maintenance Level	Routine Maintenance (Only needs Routine Maintenance)

Monitor erosion and sedimentation in inflow channels, continue routine trimming of treatment area vegetation

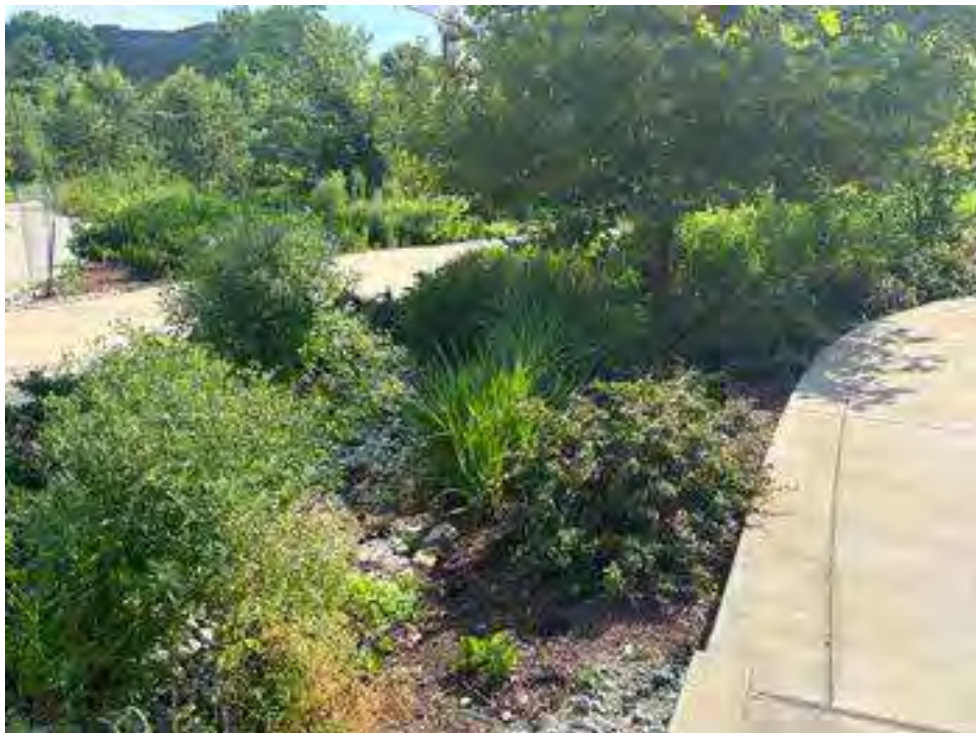
Inflow angle 1

- **Inflow Condition** - Fair
- **Forebay** - N/A

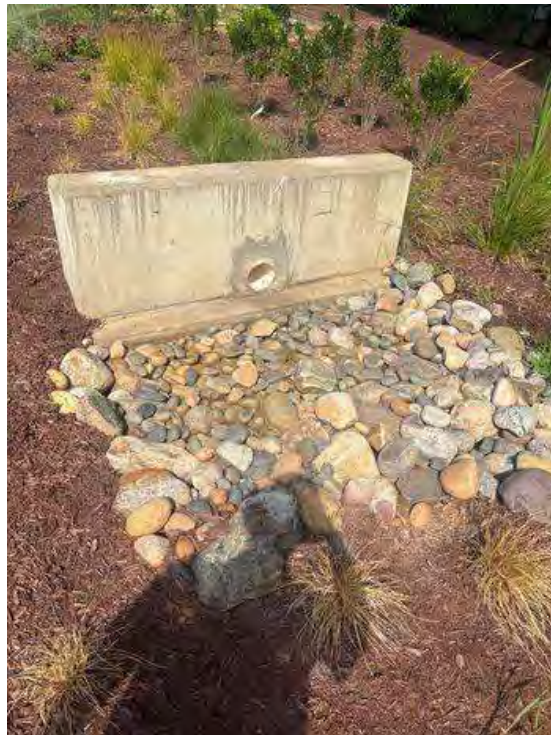
Inflow into forebay

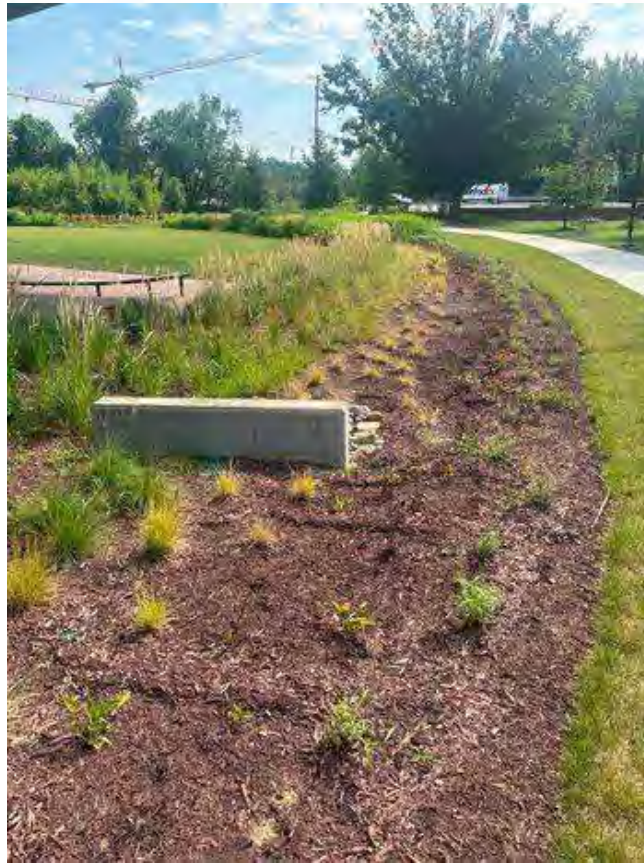
Forebay

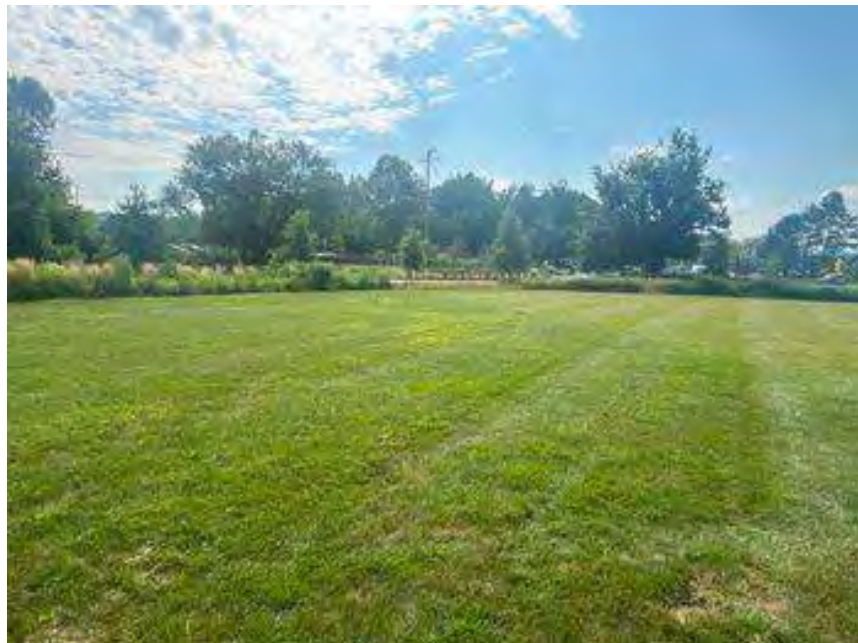
Sheet inflow

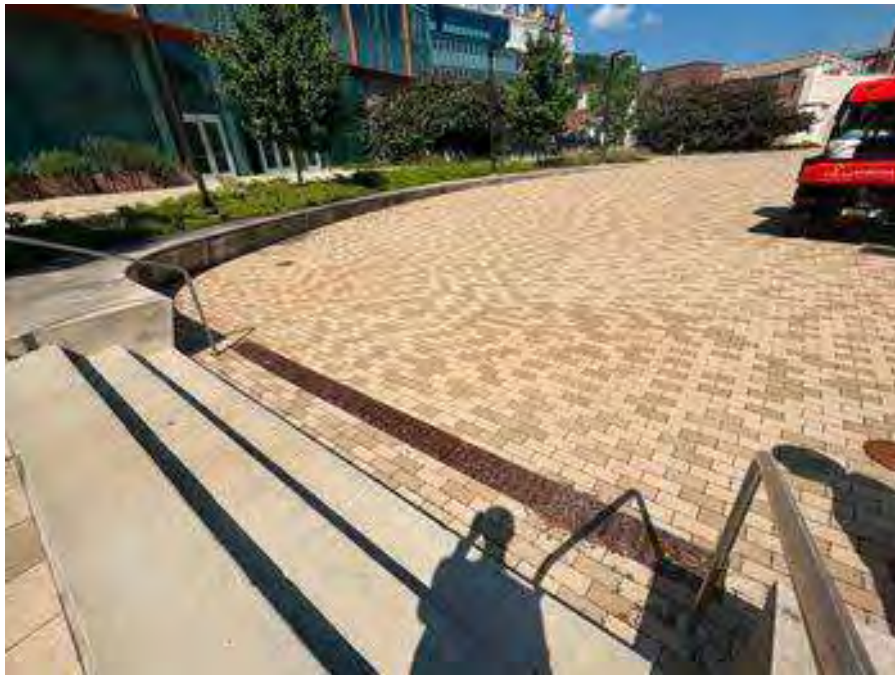
Outflow

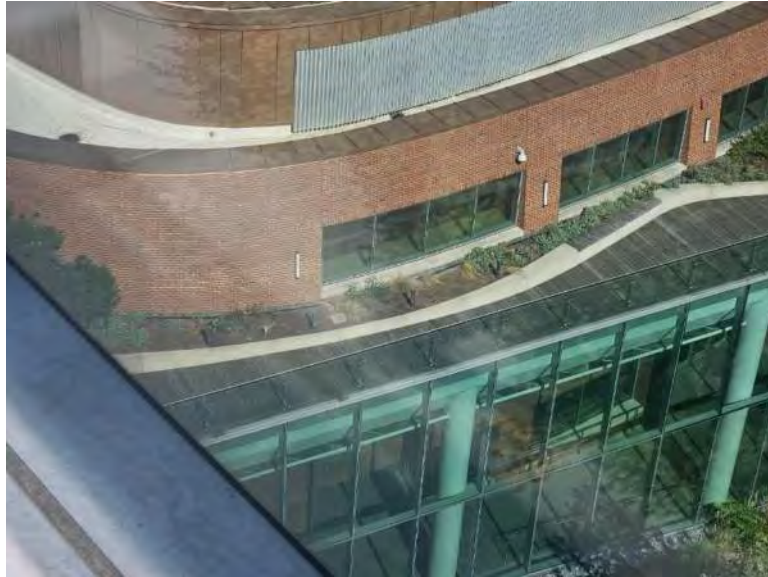
Overall from elevated view

Continue Routine Maintenance

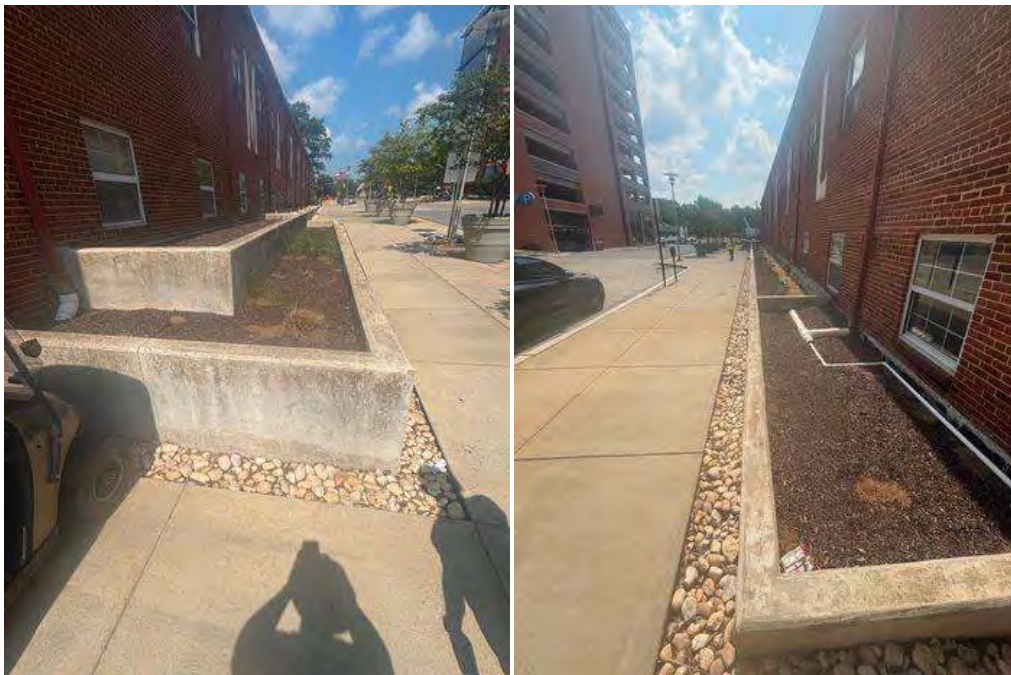
Overall Photo

Date of Inspection:	July 30, 2025 11:10 AM	Inspector Initials:	SM
BMP ID:	UMCP19BMP0248	Inspection Firm:	MES
BMP Type:	Bioretention	Underground BMP?	No
BMP Status	Pass	Overall Inspection Comment:	Lacking vegetation (which may be intentional), some minor dirt piles from ants or other animals
Maintenance Level	Routine Maintenance (Only needs Routine Maintenance)

- **BMP Access** - Good
- **Debris & Sediment** - Good
- **Vegetation** - Fair
- **BMP Contamination** - Good
- **General Site Conditions Comments:** Lacking vegetation in treatment basin; could be by design

Plant if necessary, remove excess sediment from animals

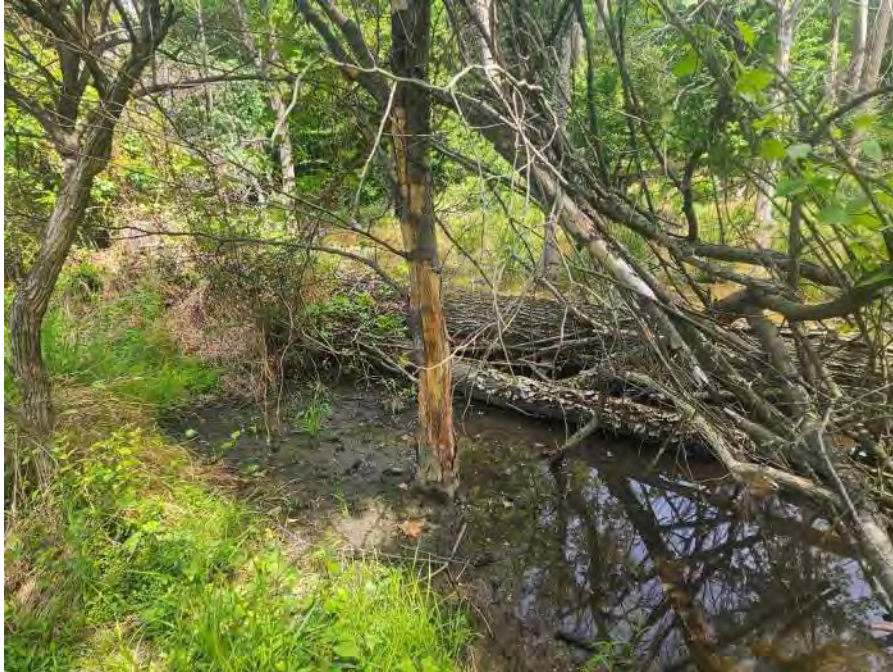
Downed Trees in Channel

Remove Fallen Trees from Stream and Repair Erosion

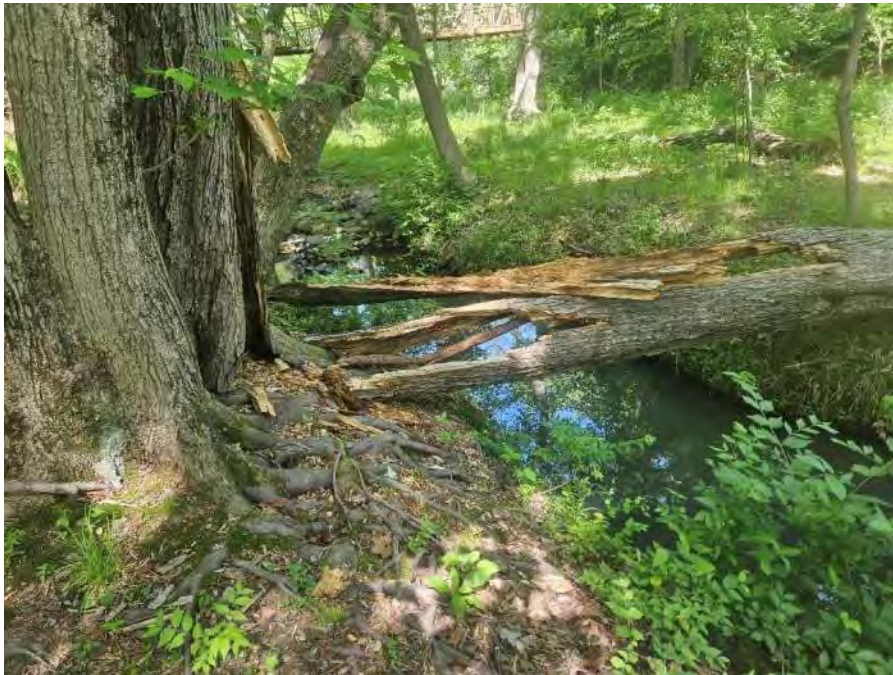
Downed Tree

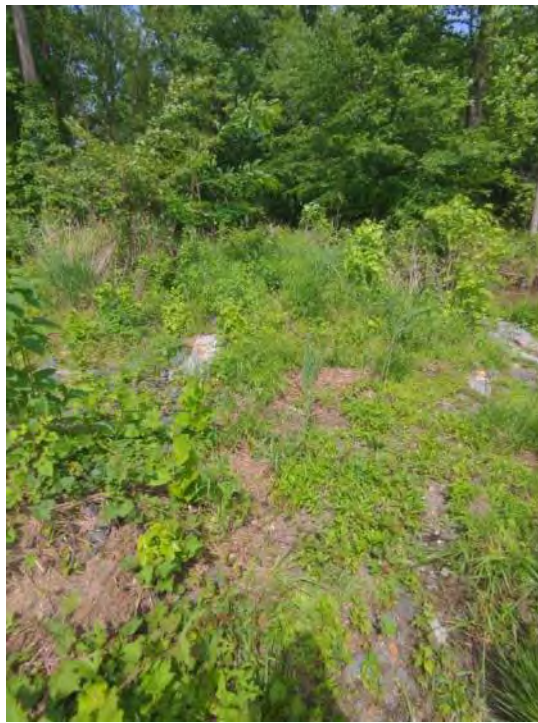
Invasive Vegetation in Channel

Clear Debris and Invasive Vegetation

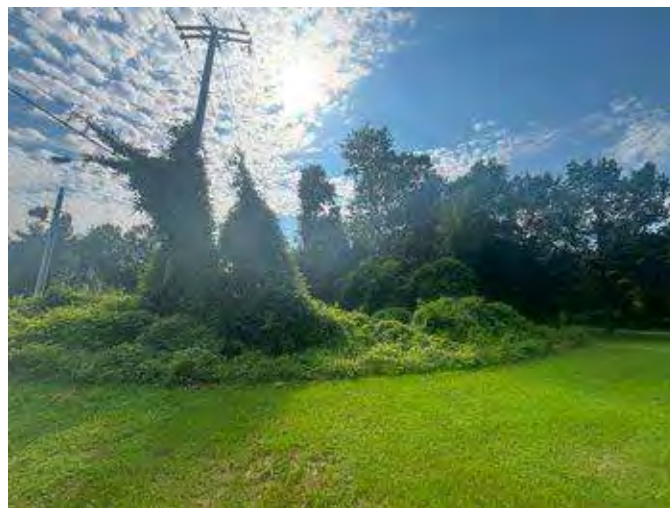
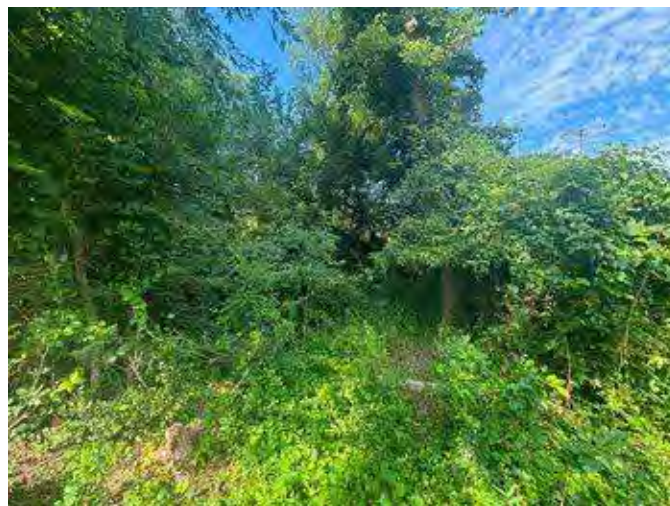
Overall Photo

Date of Inspection:	July 30, 2025 9:52 AM	Inspector Initials:	SM,SF
BMP ID:	UMCP20BMP0251	Inspection Firm:	MES
BMP Type:	Infiltration Trench	Underground BMP?	No
BMP Status	Fail	Overall Inspection Comment:	Outfall pipe and rip rap heavily clogged due to sediment, treatment area severely overgrown
Maintenance Level	Minor Maintenance (Use of Hand Equipment for Repairs)

- **BMP Access** - Fair
- **Debris & Sediment** - Poor
- **Vegetation** - Fair
- **BMP Contamination** - Good
- **General Site Conditions Comments:** Outfall heavily sedimented, treatment area extremely overgrown

Clear sediment and overgrowth from outfall and rip rap, clear out overgrowth from treatment area

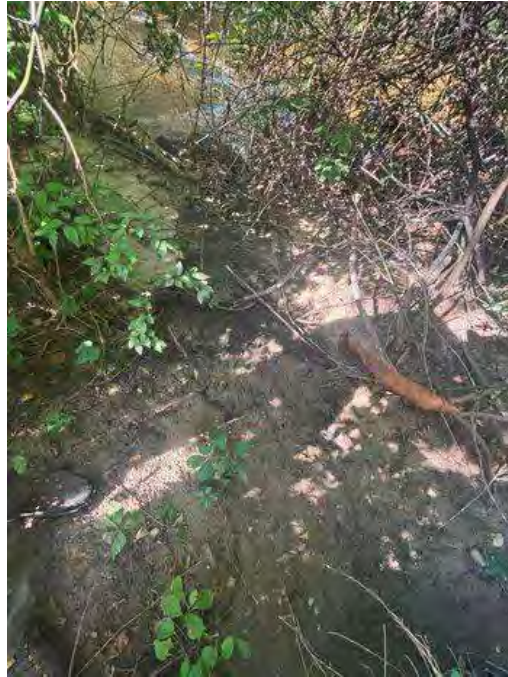
- **Spillway Outfall** - Poor
- **Downstream Condition** - Good

Outflow conditions

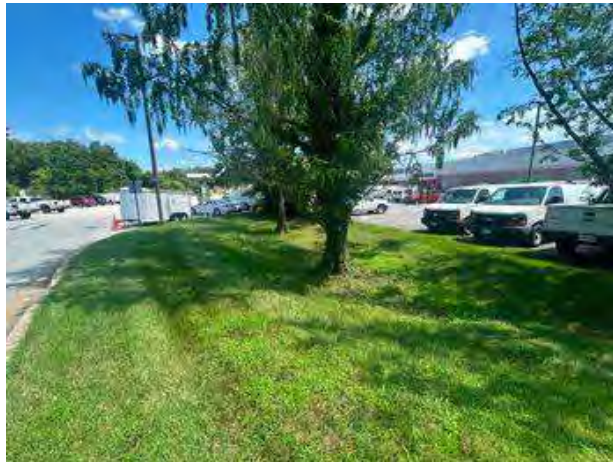
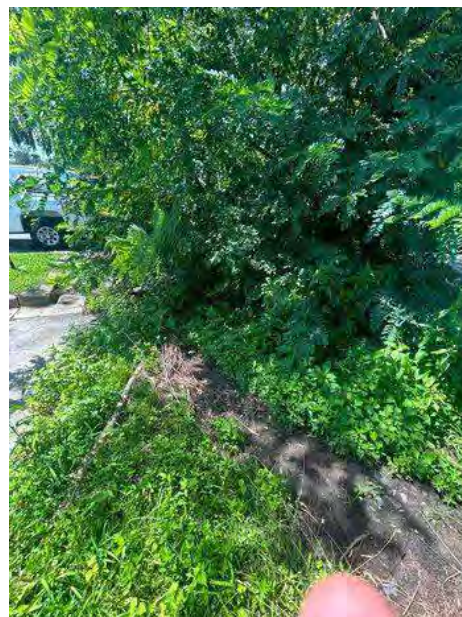
Overall Photo

Date of Inspection:	July 28, 2025 2:34 PM	Inspector Initials:	SM
BMP ID:	UMCP20BMP0280	Inspection Firm:	MES
BMP Type:	Micro-Bioretenion	Underground BMP?	No
BMP Status	Pass	Overall Inspection Comment:	Excess debris and sediment buildup at inflow and control structures
Maintenance Level	Routine Maintenance (Only needs Routine Maintenance)

Remove excess debris and sediment

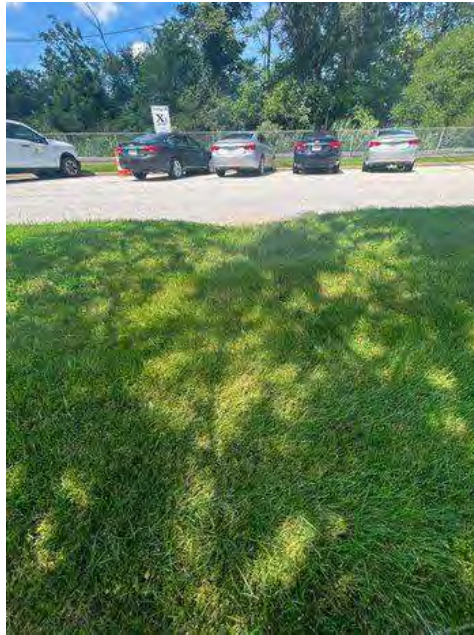
Inflow 1

- **BMP Access** - Good
- **Debris & Sediment** - Fair
- **Vegetation** - Good
- **BMP Contamination** - Good
- **General Site Conditions Comments:** Debris and sediment buildup at inflows

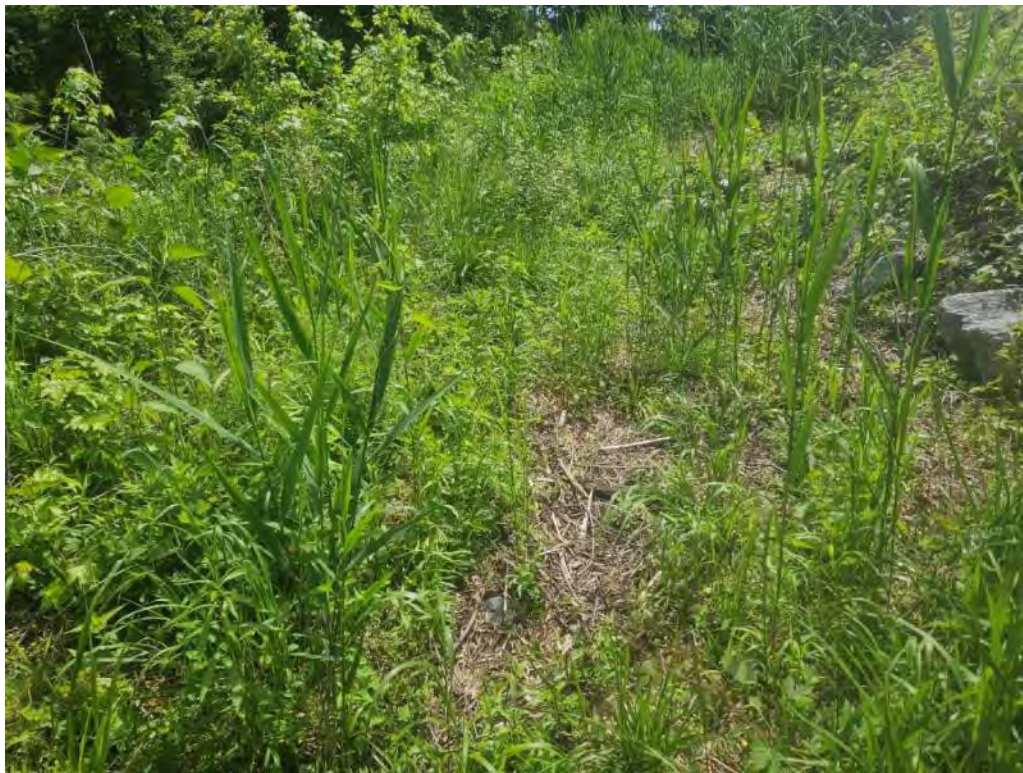
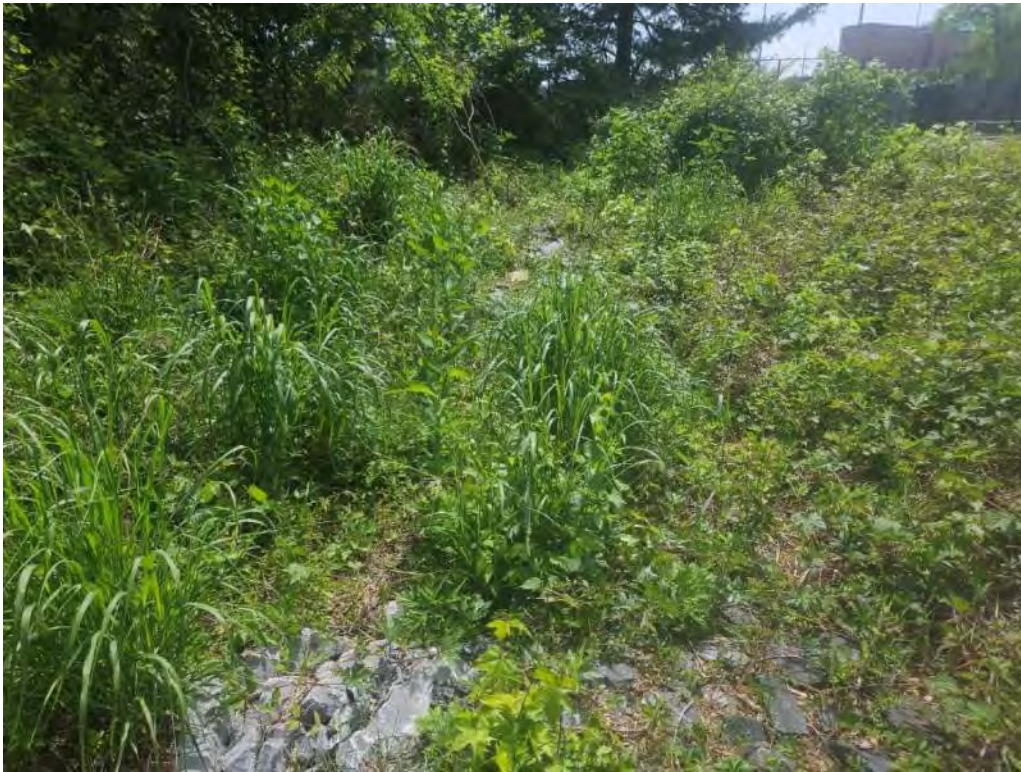
Overall Photo

Date of Inspection:	May 12, 2025 1:56 PM	Inspector Initials:	SK,SD
BMP ID:	UMCP19BMP0290	Inspection Firm:	MES
BMP Type:	SPSC	Underground BMP?	No
BMP Status	Pass	Overall Inspection Comment:	Invasive Phragmites in Channel
Maintenance Level	Minor Maintenance

Clear Invasive Vegetation

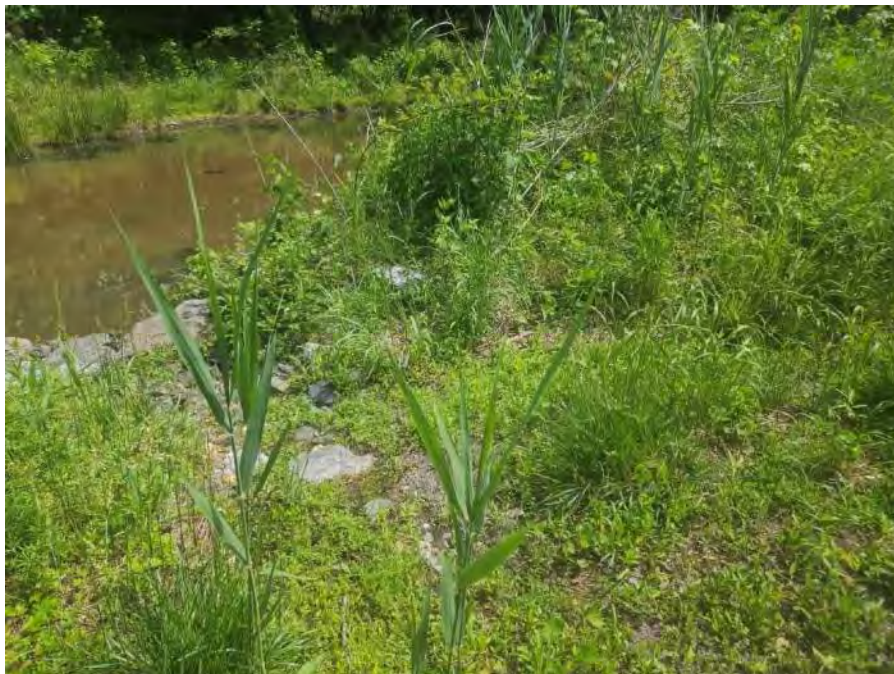
Invasive Vegetation in Channel
