University of Maryland, College Park
National Pollutant Discharge Elimination
System MS4 Phase II
FY2025 Annual Report
General Discharge Permit #13-SF-5501

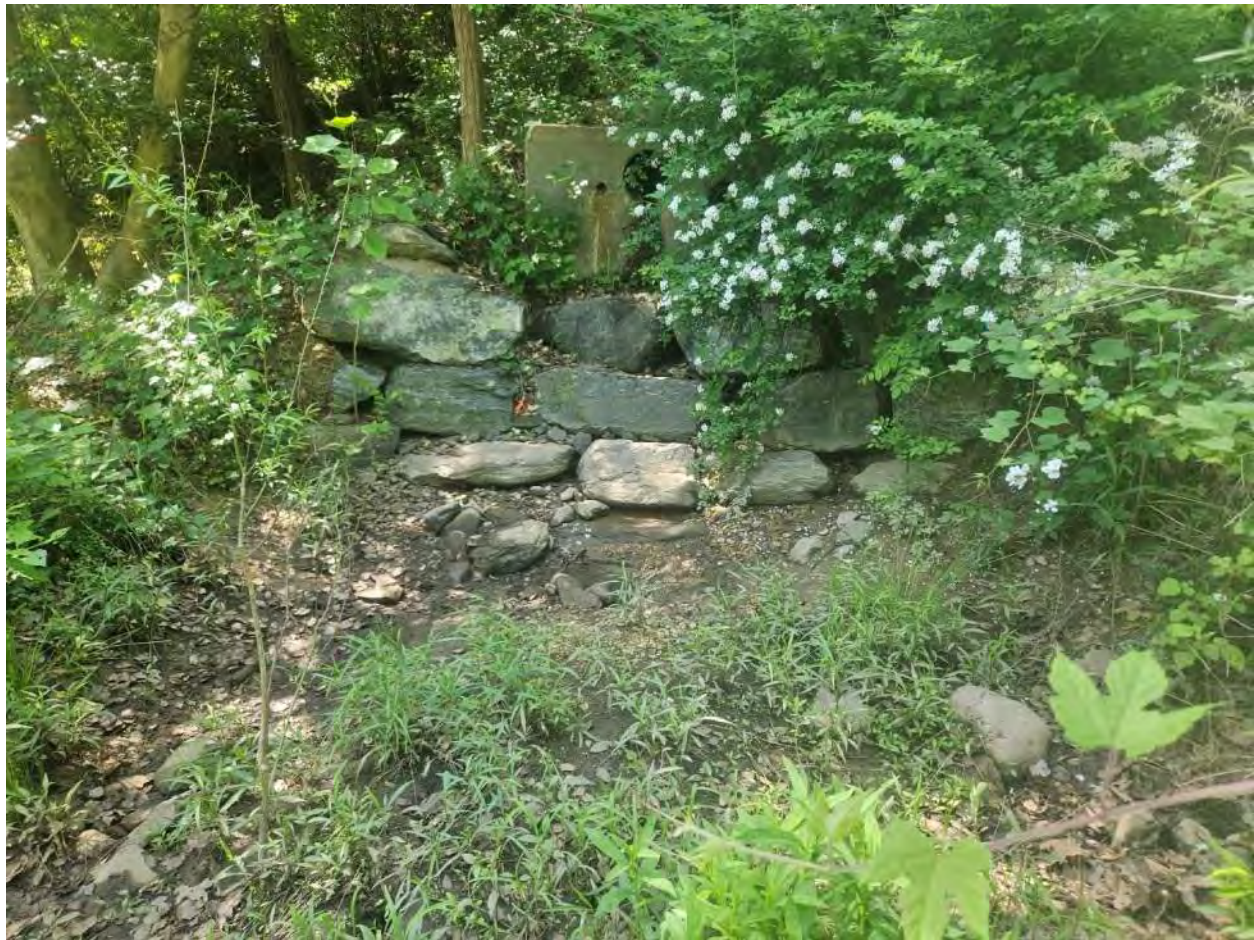
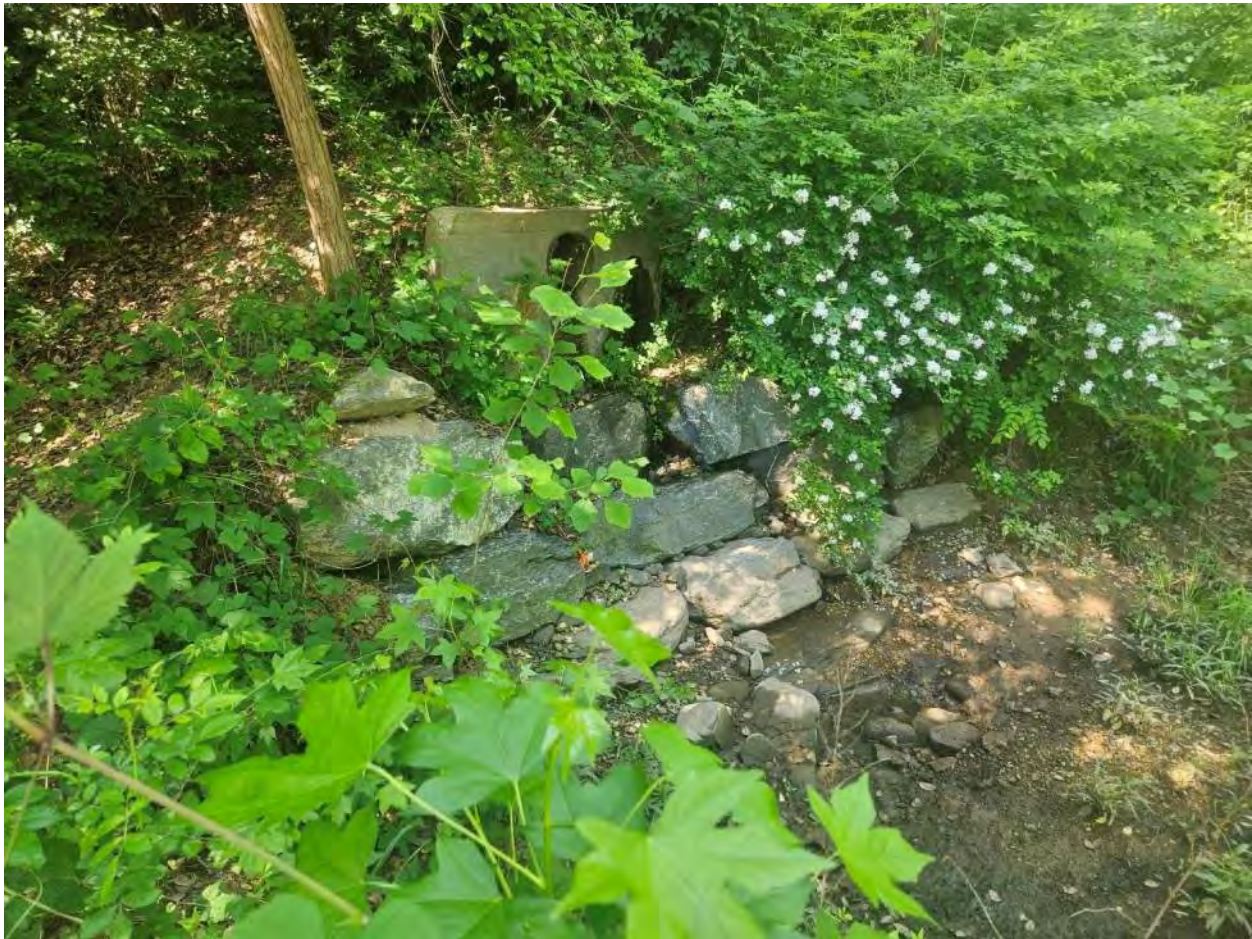
Overall Photo

Date of Inspection:	May 12, 2024 11:07 AM	Inspector Initials:	SK,SD
BMP ID:	UMCP20BMP0291	Inspection Firm:	MES
BMP Type:	Stormwater Bar	Underground BMP?	No
BMP Status	Pass	Overall Inspection Comment:	BMP in Good Condition, Very Minor Erosion in Treatment Area
Maintenance Level	Routine Maintenance

Continue Routine Maintenance

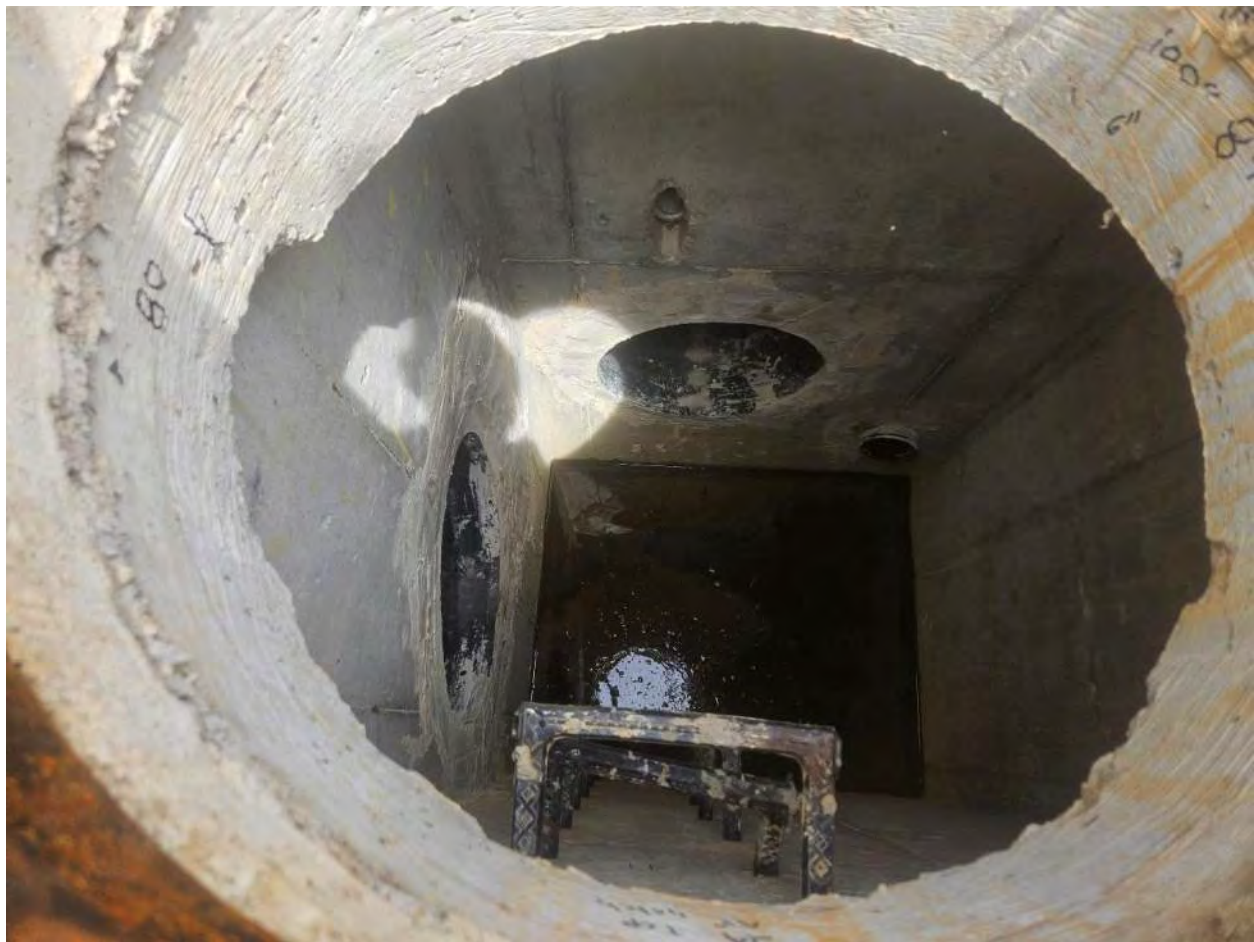
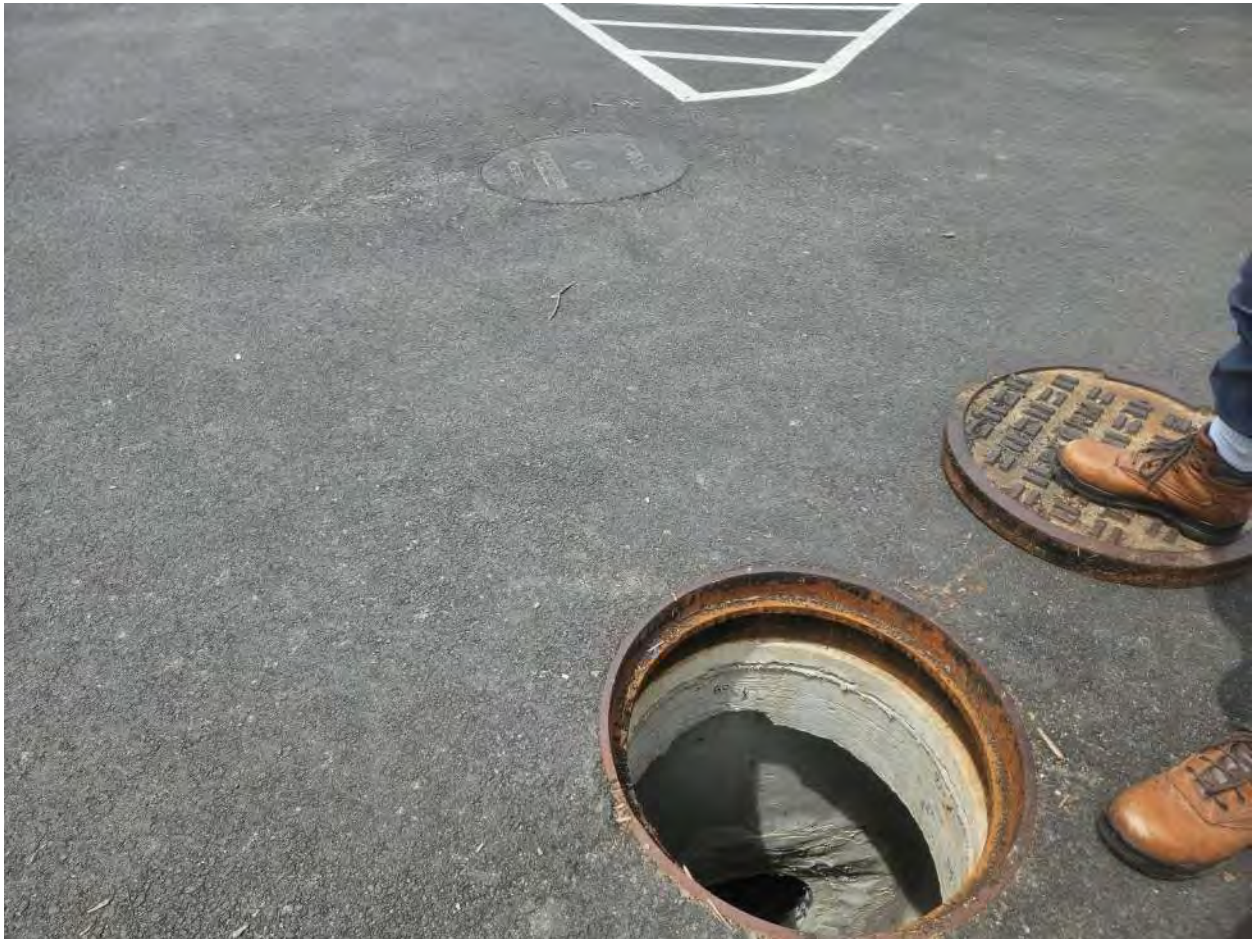
Overall Photo

Date of Inspection:	May 12, 2024 1:32 PM	Inspector Initials:	SK,SD
BMP ID:	UMCP25BMP0334	Inspection Firm:	MES
BMP Type:	Underground Filter	Underground BMP?	Yes
BMP Status	Pass	Overall Inspection Comment:	BMP in Good Condition
Maintenance Level	Routine Maintenance

Continue Routine Maintenance

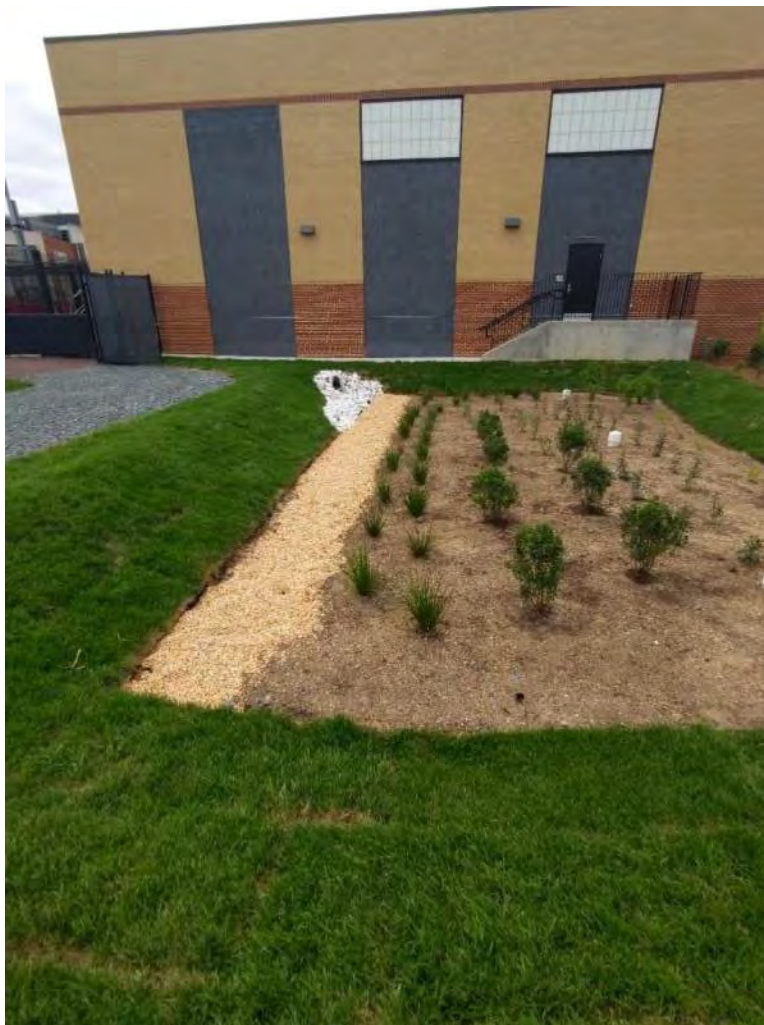
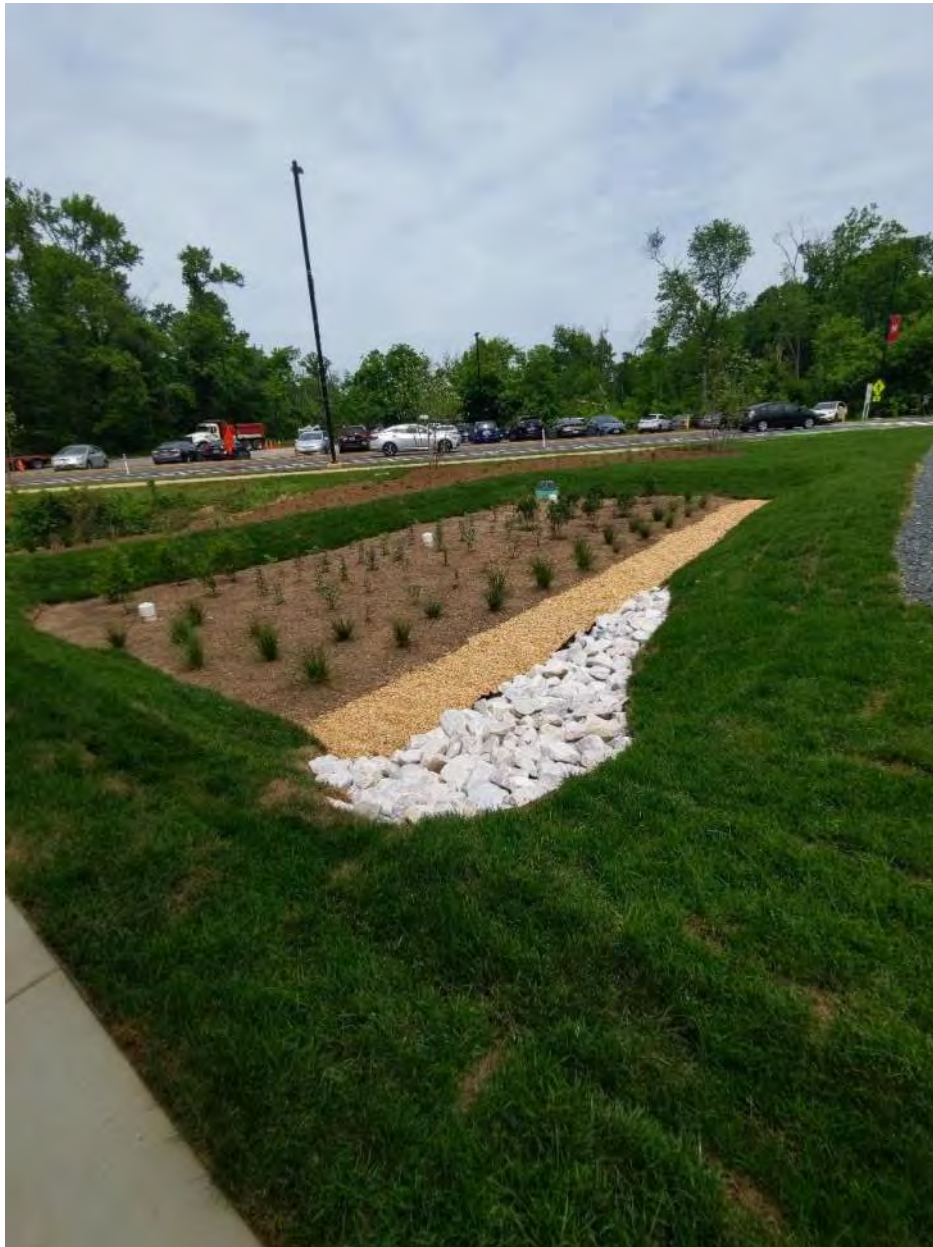
Overall Photo

Date of Inspection:	May 12, 2024 2:07 PM	Inspector Initials:	SK,SD
BMP ID:	UMCP25BMP0335	Inspection Firm:	MES
BMP Type:	Submerged Gravel Wetland	Underground BMP?	No
BMP Status	Pass	Overall Inspection Comment:	BMP in Good Condition
Maintenance Level	Routine Maintenance

Continue Routine Maintenance

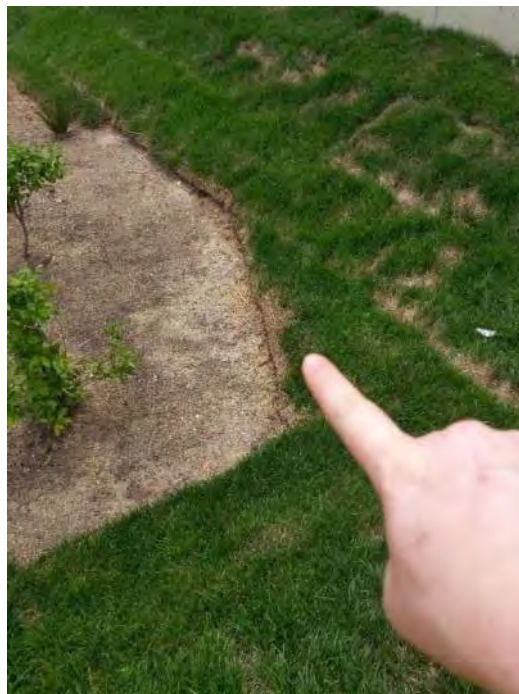
Minor Slumping
